## Bat Emergence and Re-Entry Surveys (BERS)

12 & 14 Eastern Road, Haywards Heath, West Sussex, RH16 3NN

This report is prepared to inform a planning application for the proposal described as a proposed partial demolition and extension of the existing building

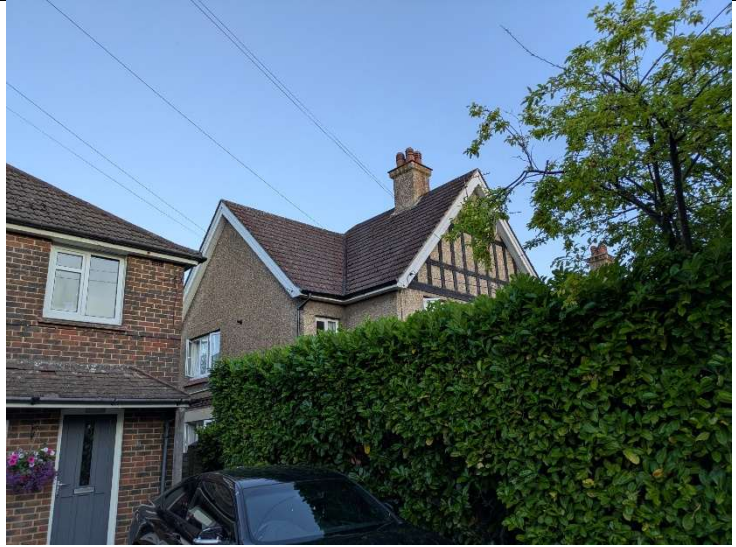
| Results | | | | | | |
|---|---|---|---|---|---|---|
| Surveyor 1 - SM | | <b>No emergences observed.</b><br>There were low levels of bat activity during the survey. There were five occurrences of common pipistrelles that were heard but not seen at 22:02, 22:06, 22:09, 22:37 and 22:46.<br><br>These species were confirmed on site using an Echo Meter Touch 2 bat detector.<br><br>No further bat activity was detected throughout the remainder of the survey. | | | <p>Photo 1: elevation photo showing the view from position 1.</p> | |

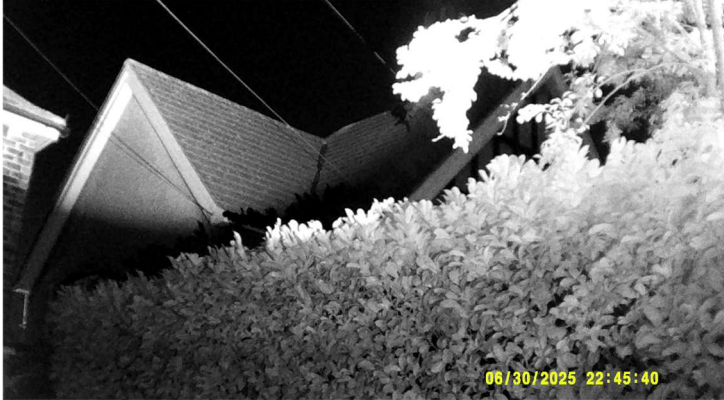
| <p><i>IR position 1</i><br/> 1 x Nightfox Whisker +<br/> 1 x Nightfox XB5 PRO</p> <p><i>Recording the north and west elevations and manned by surveyor 1.</i></p> | <p><b>No emergencies recorded.</b></p> <p>IR analysis reflects the surveyor's observations and no additional bat activity was recorded or observed upon full footage review.</p> | <p>Photo 2: darkest point photo from the IR camera at position 1.</p> |

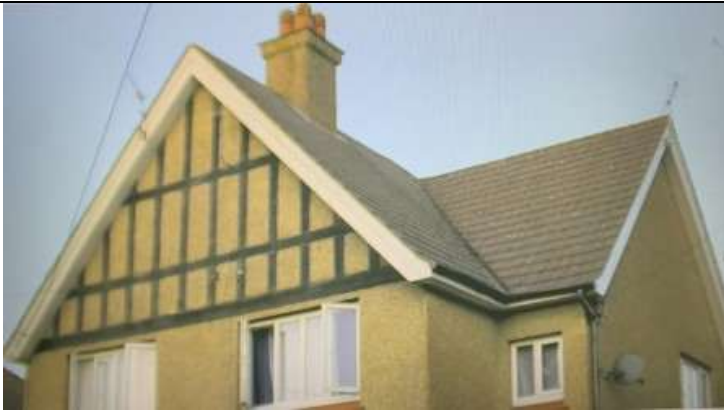
| <p><i>Surveyor 2 - LH</i></p> | <p><b>No emergencies observed.</b></p> <p>Bat activity was very low. Only one common pipistrelle was heard but not seen at 22:37.</p> <p>This species was confirmed on site using an Echo Meter Touch 2 bat detector.</p> <p>No further bat activity was detected throughout the remainder of the survey.</p> | <p>Photo 3: elevation photo showing the view from position 2.</p> |

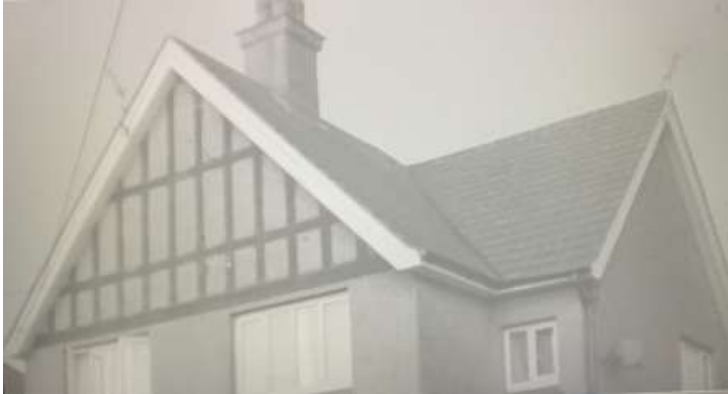
| <p><i>IR position 2</i></p> <p>1 x Nightfox Whisker +<br/> 1 x Nightfox XB5 PRO</p> | <p><b>No emergencies recorded.</b></p> <p>IR analysis reflects the surveyor's observations and no additional bat activity was recorded or observed upon full footage review.</p> | |

| <p><i>Recording the north and east elevations and manned by surveyor 2.</i></p> | | <p>Photo 4: darkest point photo from the IR camera at position 2.</p> |

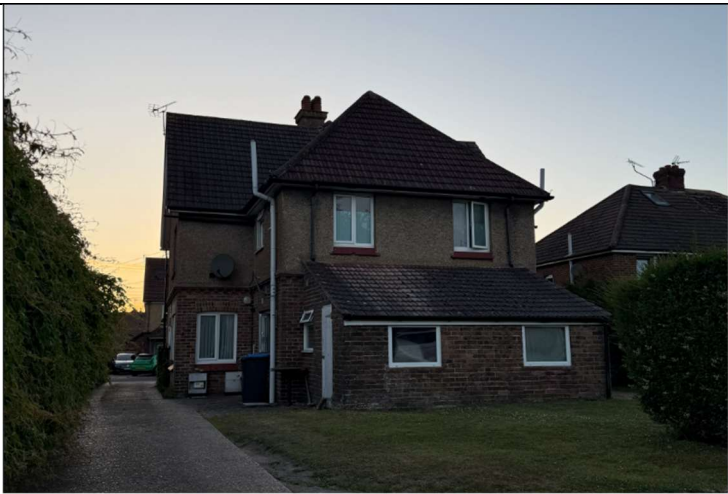
| <p><i>Surveyor 3 - SG</i></p> | <p><b>No emergencies observed.</b></p> <p>The first bat activity was a common pipistrelle that was seen passing from southeast to northwest towards B1 and B2 then turning in front of the building before flying southeast towards the back of the garden. Between 21:58 and 22:28 there were five instances where common pipistrelles were seen foraging at the back of the garden towards the southeast boundary of the site. Between 22:29 and 22:46 there were four occurrences of the common pipistrelles that were heard but not seen.</p> <p>This species was confirmed on site using an Echo Meter Touch 2 bat detector.</p> | <p>Photo 5: elevation photo showing the view from position 3.</p> |

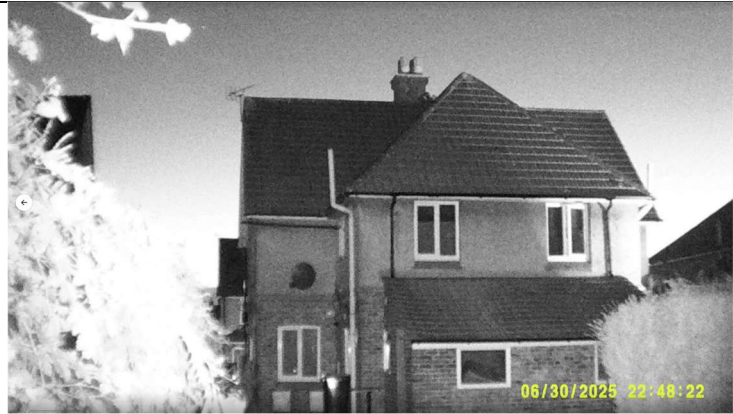
| <p><i>IR position 3</i></p> <p><i>1 x Nightfox Whisker +<br/>1 x Nightfox XB5 PRO</i></p> <p><i>Recording the north and east elevations and manned by surveyor 3.</i></p> | <p><b>No emergences recorded.</b></p> <p>IR analysis reflects the surveyor's observations and no additional bat activity was recorded or observed upon full footage review.</p> | <p>Photo 6: darkest point photo from the IR camera at position 3.</p> |

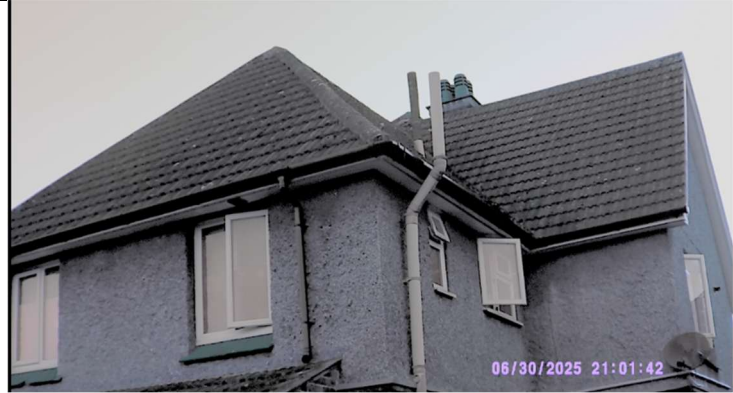
| <p><i>IR position 4</i></p> <p><i>1 x Nightfox Whisker +<br/>1 x Nightfox XB5 PRO</i></p> <p><i>Unmanned camera recording the north elevation and regularly checked by surveyor 3.</i></p> | <p><b>No emergences recorded.</b></p> <p>No additional bat activity was recorded or observed upon full footage review.</p> | <p>Photo 7: darkest point photo from the IR camera at position 4.</p> |

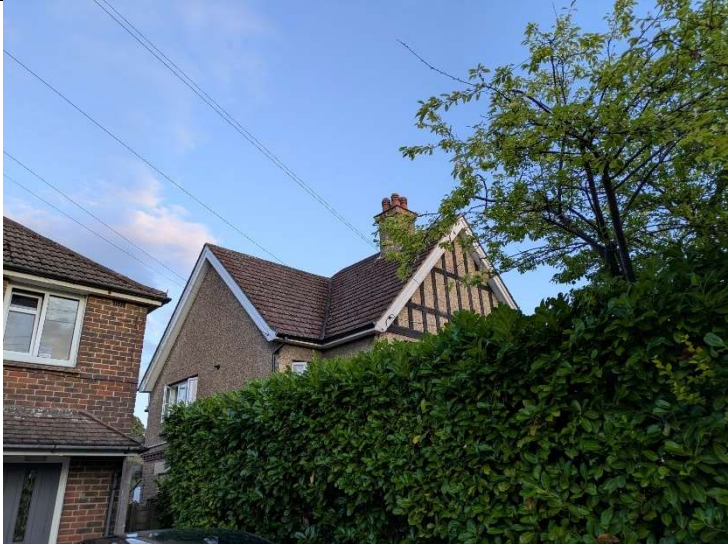
| Results | | | | | | |
|---|---|---|---|---|---|---|
| Surveyor 1 - SM | | <b>No emergences observed.</b><br><br>There were low levels of bat activity during the survey. At 21:39 one common pipistrelle was seen passing from southeast to northwest to the northeast of B1, also seen by surveyor 3. At 21:48 a second common pipistrelle was seen passing from the same direction, southeast to northwest.<br><br>These species were confirmed on site using an Echo Meter Touch 2 bat detector.<br><br>No further bat activity was detected throughout the remainder of the survey. | | | <p>Photo 8: elevation photo showing the view from position 1.</p> | |

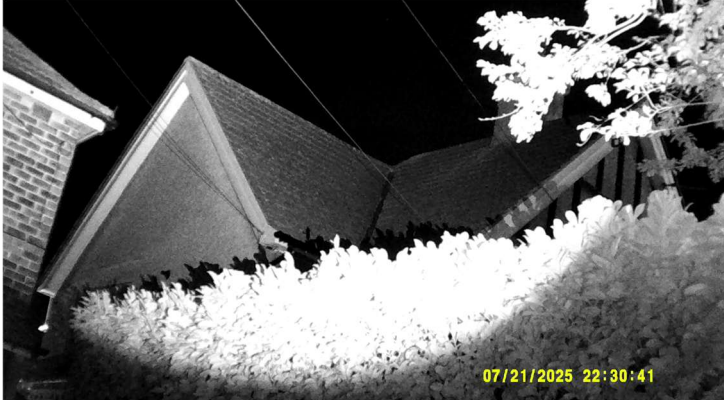
| <p><i>IR position 1</i><br/> <i>1 x Nightfox Whisker +</i><br/> <i>1 x Nightfox XB5 PRO</i></p> <p><i>Recording the north and west elevations and manned by surveyor 1.</i></p> | <p><b>No emergencies recorded.</b></p> <p>IR analysis reflects the surveyor's observations and no additional bat activity was recorded or observed upon full footage review.</p> | <p>Photo 9: darkest point photo from the IR camera at position 1.</p> |

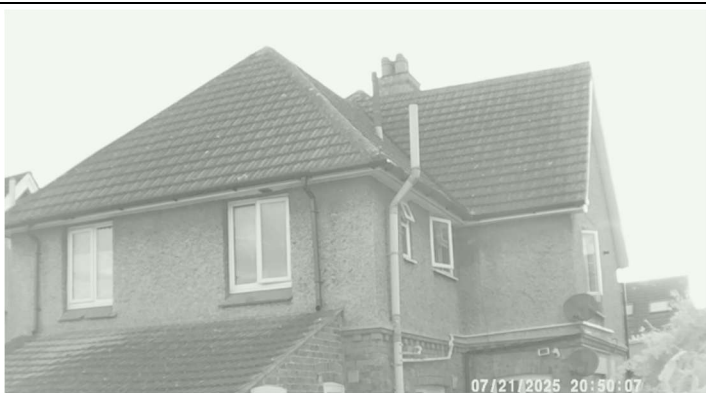
| <p><i>Surveyor 2 - LH</i></p> | <p><b>No emergencies observed.</b></p> <p>Bat activity was very low. The first echolocation was a common pipistrelle at 21:46 that passed southeast over surveyor 2 to surveyor 3. Two additional common pipistrelles were heard but not seen at 22:23 and 22:24.</p> <p>This species was confirmed on site using an Echo Meter Touch 2 bat detector.</p> <p>No further bat activity was detected throughout the remainder of the survey.</p> | <p>Photo 10: elevation photo showing the view from position 2.</p> |

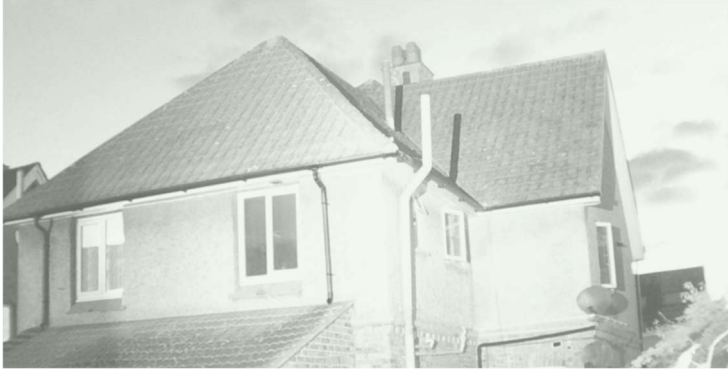
| <p><i>IR position 2</i></p> <p><i>1 x Nightfox Whisker +</i><br/> <i>1 x Nightfox XB5 PRO</i></p> | <p><b>No emergencies recorded.</b></p> <p>IR analysis reflects the surveyor's observations and no additional bat activity was recorded or observed upon full footage review.</p> | |

| <p><i>Recording the north and east elevations and manned by surveyor 2.</i></p> | | <p>Photo 11: darkest point photo from the IR camera at position 2.</p> |

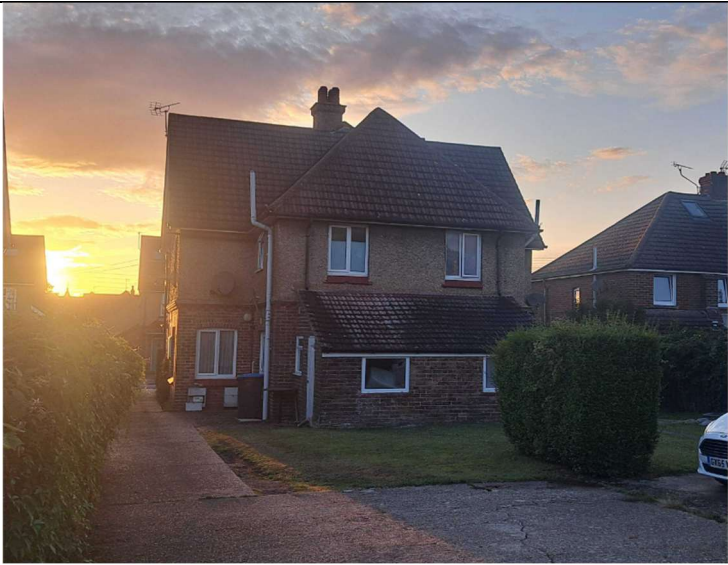
| <p><i>Surveyor 3 - ALD</i></p> | <p><b>No emergencies observed.</b></p> <p>First bat activity was a noctule that was heard but not seen at 21:11 and then again at 22:06. A common pipistrelle was heard and seen at 21:36 foraging from the east, directly over surveyor position and then began foraging around northern neighbours rear garden. Common pipistrelle foraging activity was heard and seen foraging both over northern neighbours rear garden and rear garden of surveyed dwelling from 21:36 until 21:48. A brown long-eared bat was very faintly heard but not seen at 22:09. A serotine was heard but not seen at 22:26 and a myotis species was heard and not seen at 22:29.</p> <p>This species was confirmed on site using an Echo Meter Touch 2 bat detector.</p> | <p>Photo 12: elevation photo showing the view from position 3.</p> |

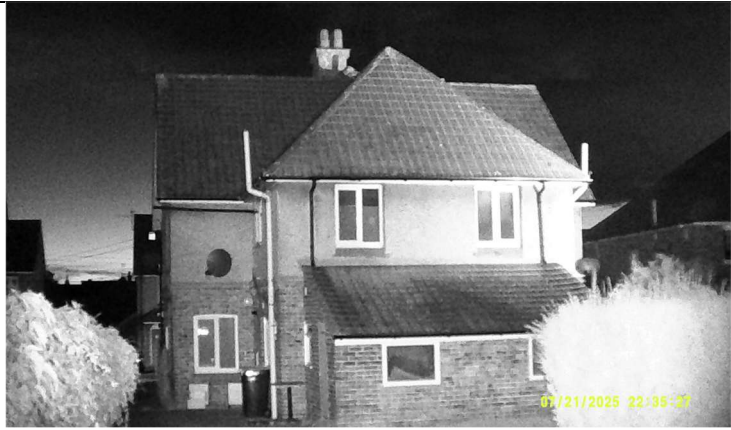
| <p><i>IR position 3</i></p> <p><i>1 x Nightfox Whisker +<br/>1 x Nightfox XB5 PRO</i></p> <p><i>Recording the north and east elevations and manned by surveyor 3.</i></p> | <p><b>No emergences recorded.</b></p> <p>IR analysis reflects the surveyor's observations and no additional bat activity was recorded or observed upon full footage review.</p> | <p>Photo 13: darkest point photo from the IR camera at position 3.</p> |

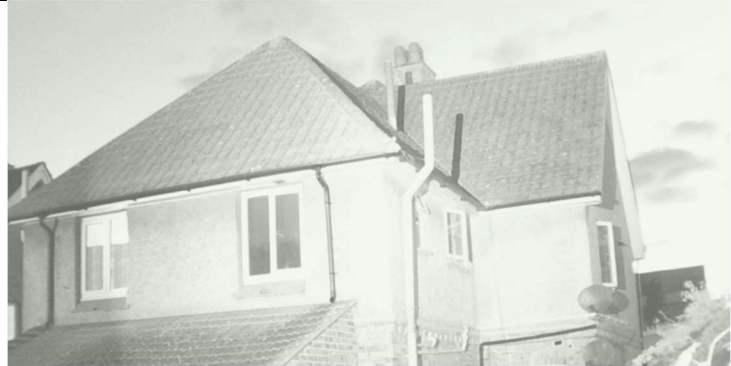
| <p><i>IR position 4</i></p> <p><i>1 x Nightfox Whisker +<br/>1 x Nightfox XB5 PRO +<br/>Magenta bat detector</i></p> <p><i>Unmanned camera recording the north elevation and regularly checked by surveyor 2.</i></p> | <p><b>No emergences recorded.</b></p> <p>There was common pipistrelle activity noted around B1 at 21:48 passing from east to north west between B1 and the neighbouring property – this was also seen and heard by surveyor 1.</p> | <p>Photo 14: darkest point photo from the IR camera at position 4.</p> |

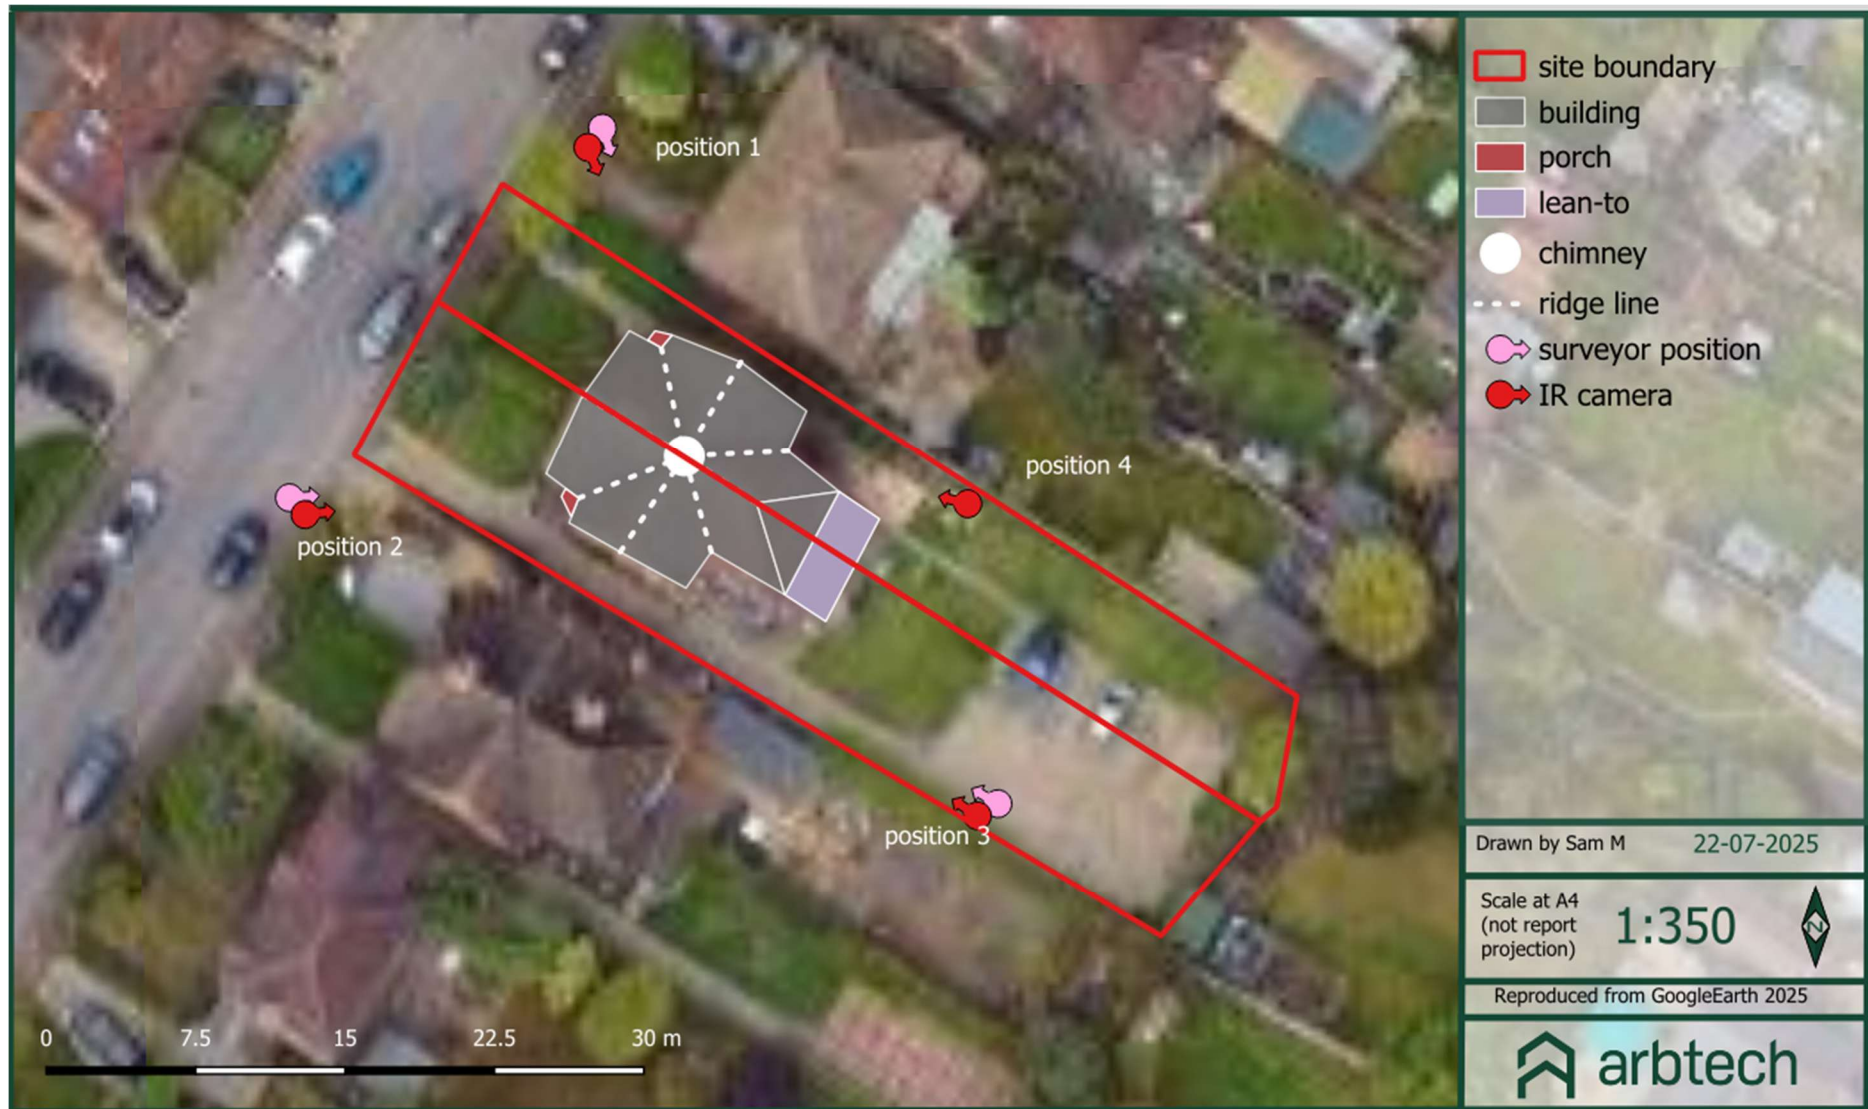
## Appendix 1: BERS plan

| <b>See surveyor locations in the</b> BERS plan in Appendix 1, proposed development plans in Appendix 2. | |
