# THE STABLES, COWFOLD ROAD, BOLNEY

## PRELIMINARY ECOLOGICAL APPRAISAL AND PRELIMINARY ROOST ASSESSMENT

**LOCATION: TQ 25744 22411**

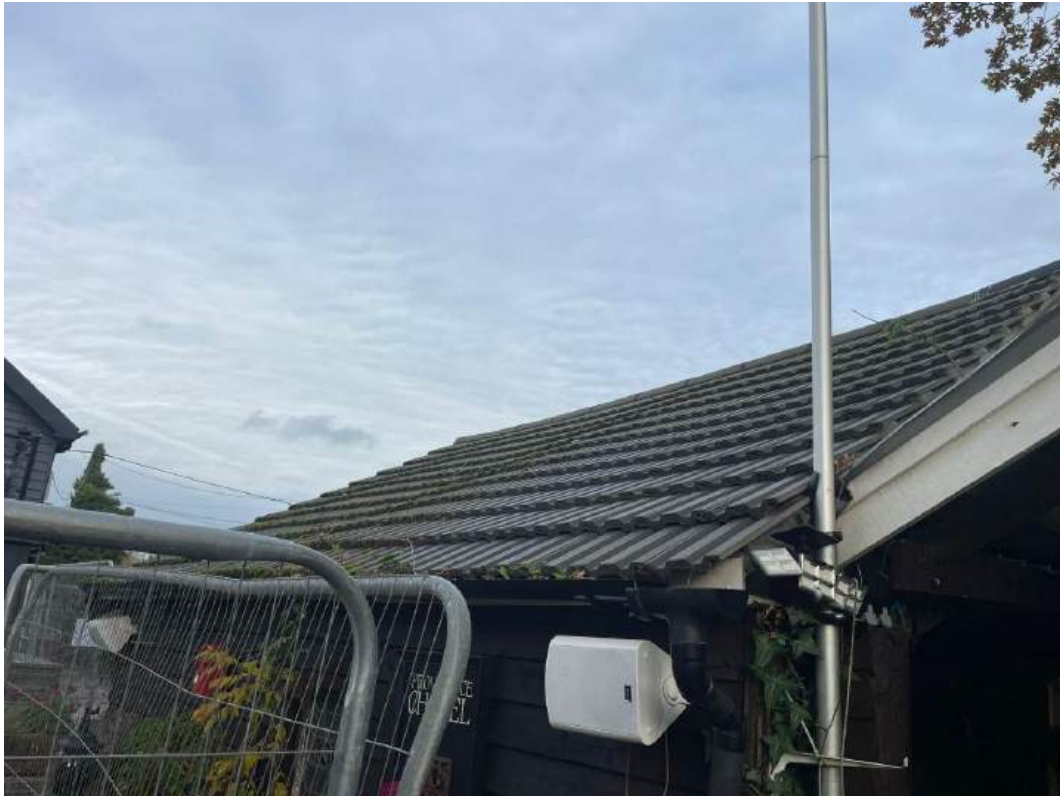
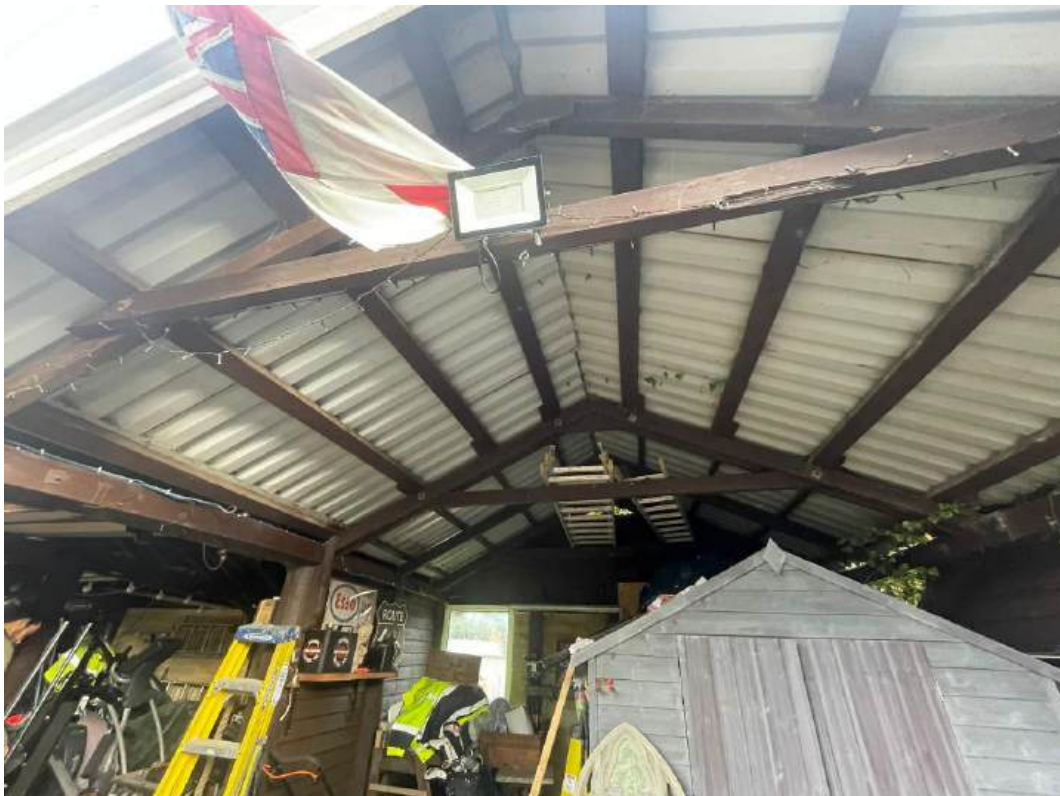
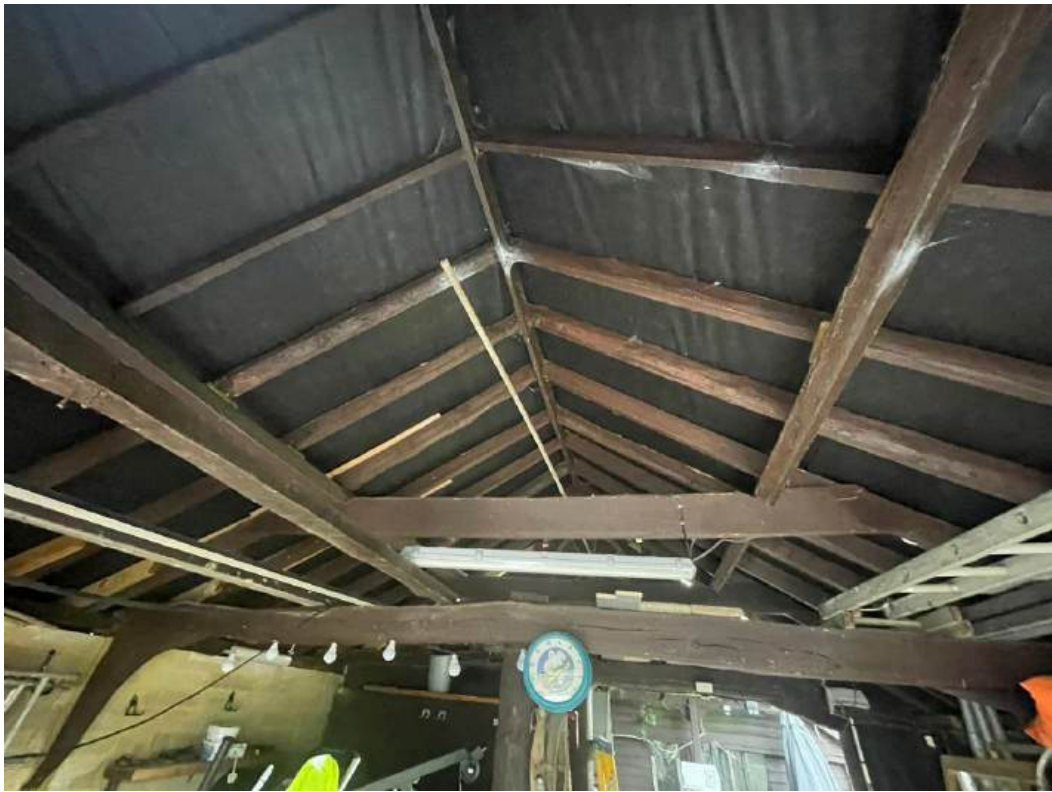
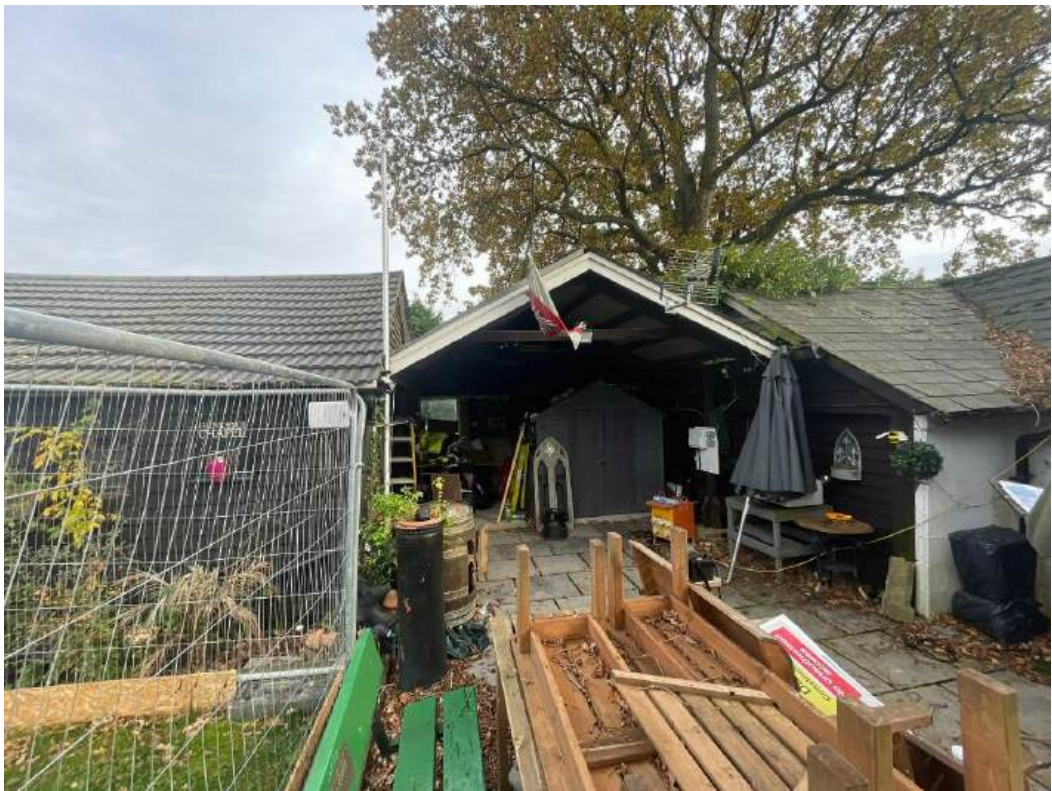
*Building 1*

| Building Number | Description | Potential Roosting Features | Bat Roost Potential |
|---|---|---|---|
| <b>B1</b> | A semi-open garage with 3 walls and 2 large open voids. The roofing is slate tile on top of corrugated tin lined with roofing felt | <ul style="list-style-type: none"> <li>Gaps underneath tiling across whole roof provide roosting space for crevice dwelling bats.</li> </ul> | <b>Moderate</b> |

- B1 requires 2 emergence surveys, surveys will be carried out between May and August, should emerging bats be observed or bats be found to be very active in the vicinity of B1 a third survey will be required.
- B2 requires 3 emergence surveys to be undertaken between May and August (the third survey can be conducted in September).

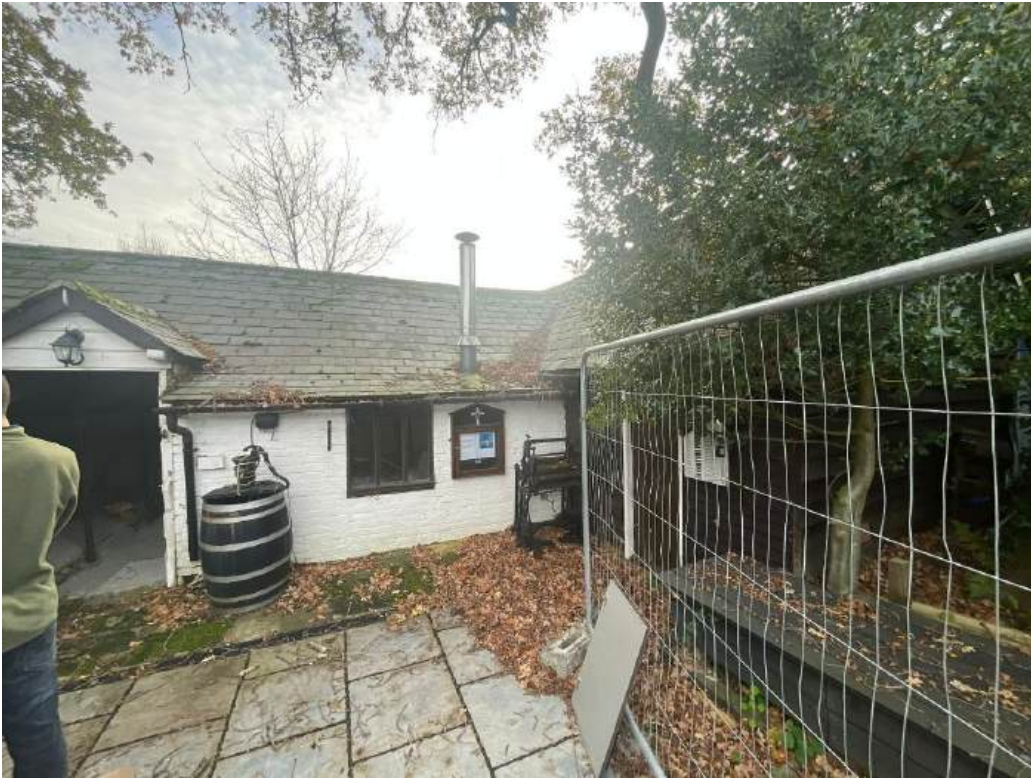
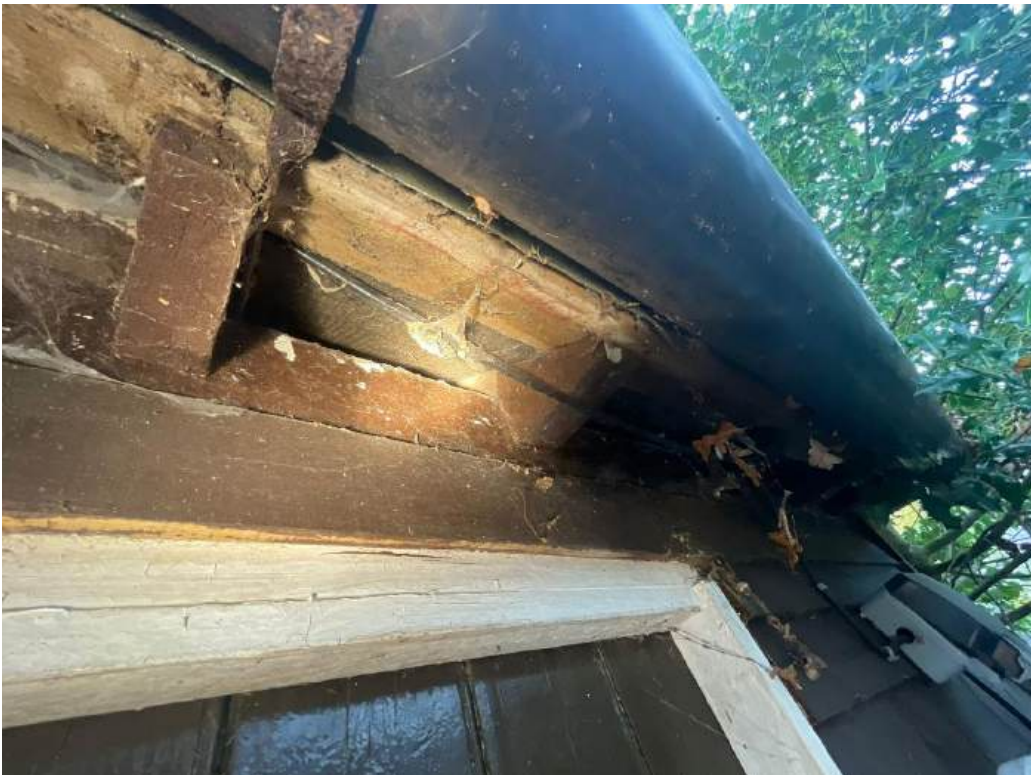
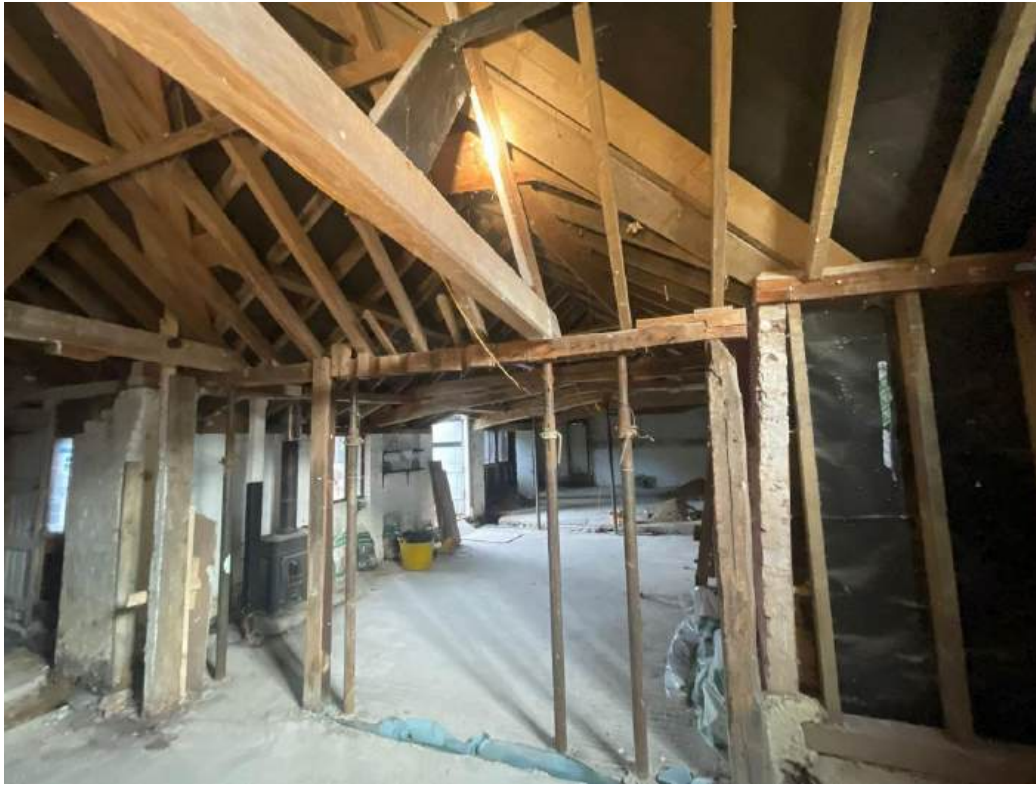
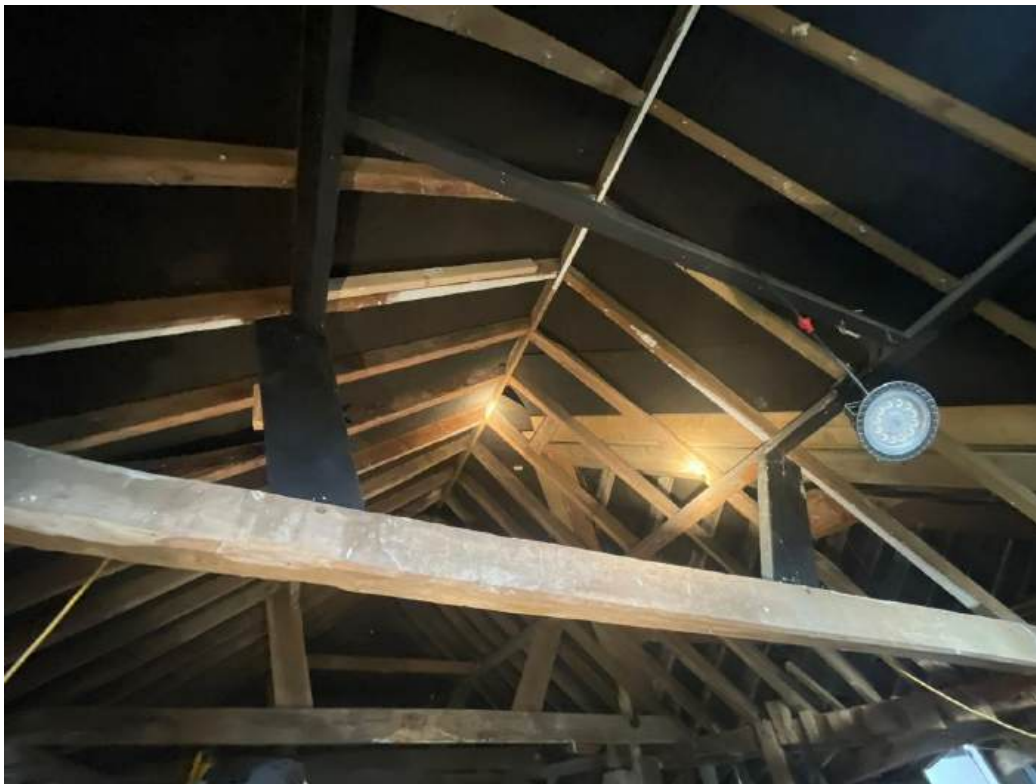
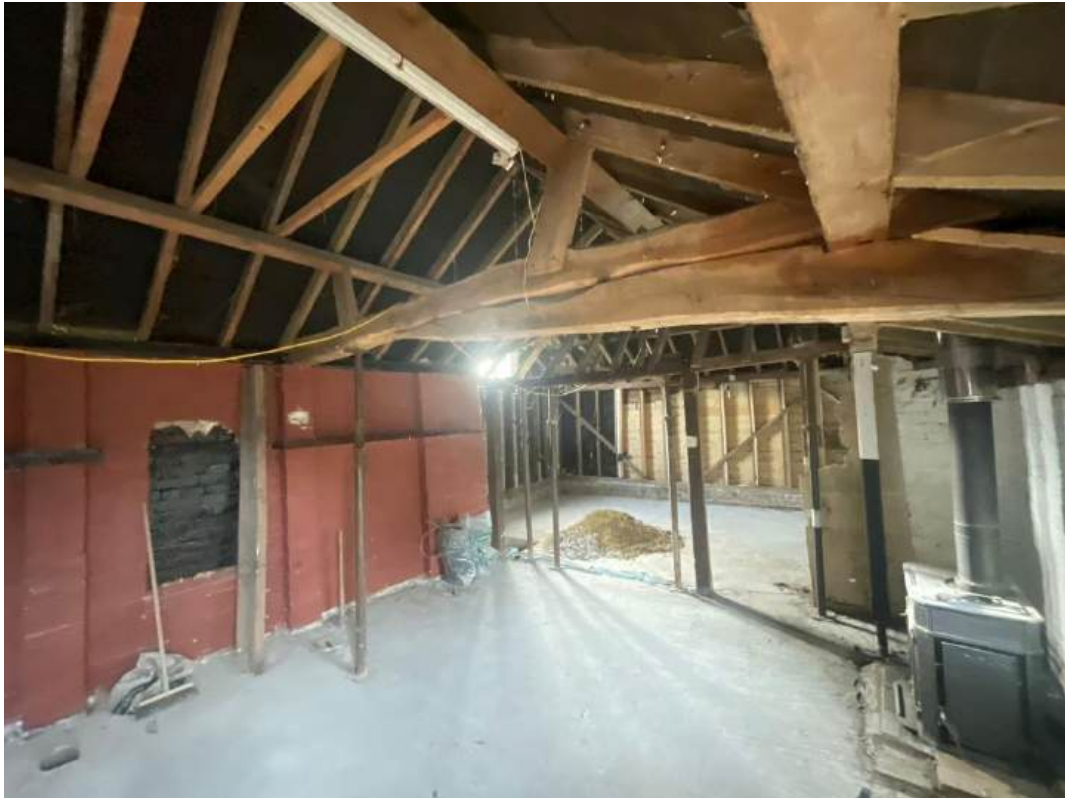
*Building 2*

| Building Number | Description | Potential Roosting Features | Bat Roost Potential |
|---|---|---|---|
| <b>B2</b> | A brick walled barn. The timber roof is lined with roofing felt and covered with slate tiles. | <ul style="list-style-type: none"> <li>Gaps underneath tiling across whole roof provide roosting space for crevice dwelling bats.</li> <li>There is a 2m gap in the soffit next to the front door on the northern aspect of the building.</li> <li>The interior wooden joinery offers spaces for crevice dwelling bats and feeding perches.</li> </ul> | <b>Moderate to High</b> |
