# HURSTWOOD FARM HAYWARDS HEATH

## ARBORICULTURAL IMPACT ASSESSMENT & METHOD STATEMENT

BARRATT DAVID  
WILSON HOMES  
SOUTHERN  
COUNTIES

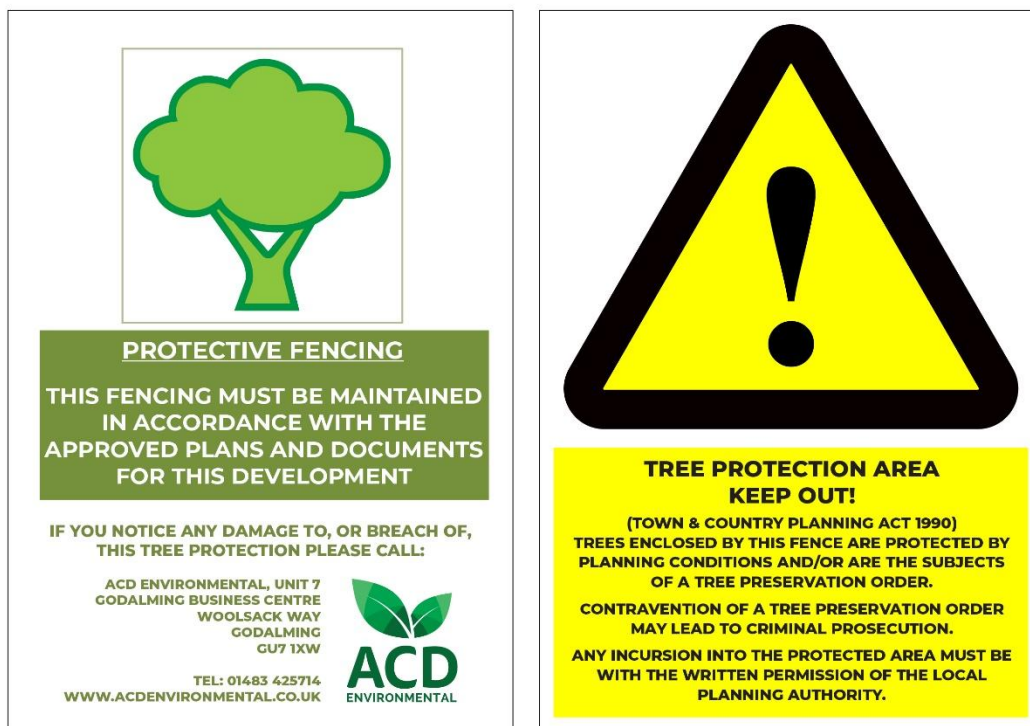
Figure 1: Tree protection sign (download from) <http://www.acdenvironmental.co.uk>

5.6.9. All weather notices should be erected on the barriers (for example see figure below).
