## Preliminary Ecological Appraisal and Roost Assessment

34 Cyprus Road, Burgess Hill, Burgess Hill, West Sussex, RH15 8DX

This report is prepared to inform a planning application with Mid Sussex District Council. The proposal is described as “Demolition of existing building; erection of a part -4, part-5 storey building to provide 14 no. supported living accommodation (Use Class C2) and commercial space (Use Class E)”.

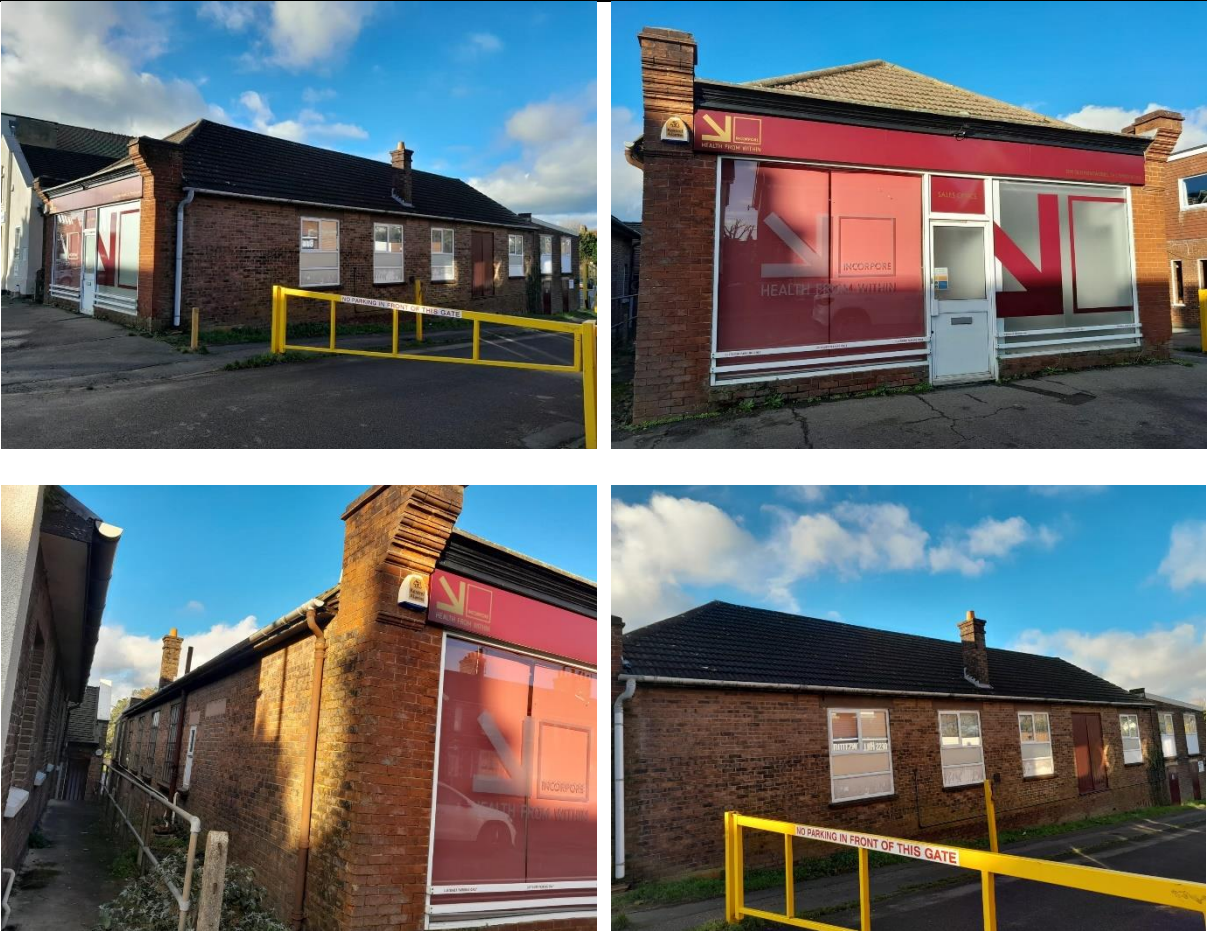
| Description | Photographs |
|---|---|
| Overview of building | <p>The photographs provide a comprehensive overview of the building from four different angles. The top-left image shows a side profile of the brick building with a dark roof and a yellow gate in the foreground. The top-right image is a close-up of the entrance, featuring large glass windows with red 'N' logos and the text 'INCORPORATE HEALTH CARE WITHIN'. The bottom-left image shows the side of the building with a brick chimney and a red sign. The bottom-right image shows the front of the building with a yellow gate and a sign that reads 'NO PARKING IN FRONT OF THIS GATE'.</p> |

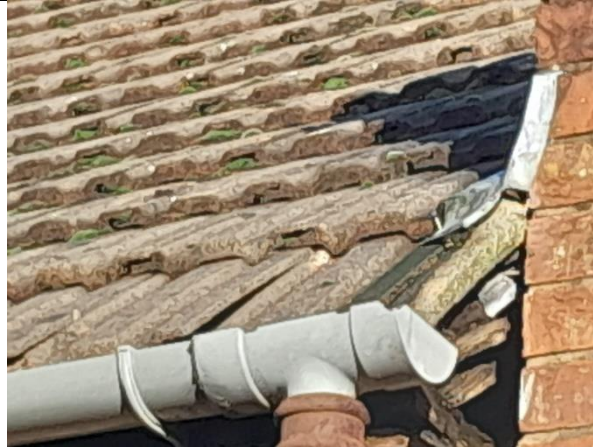
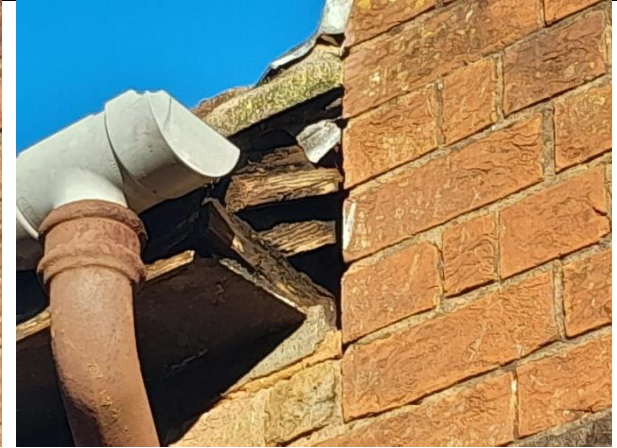
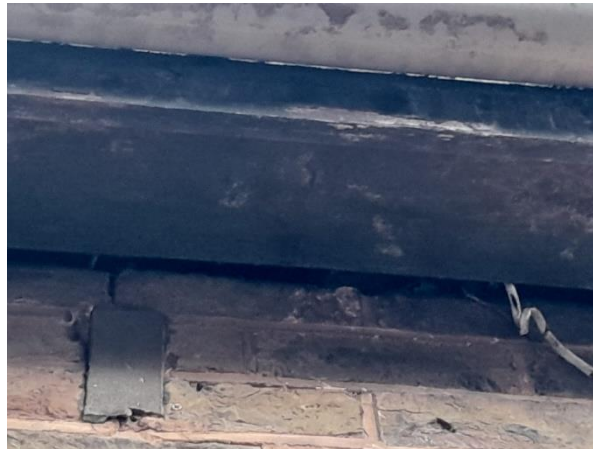
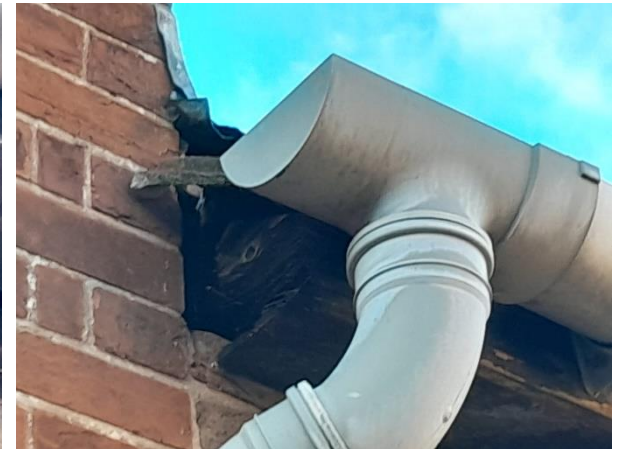
Suitable roosting features

| | The building is assessed as <b>low value</b> to roosting bats. |

| <i>Recommendations</i> | <p>One bat emergence survey is required during the active bat season (optimal May to August, suboptimal September) to confirm presence or likely-absence of a bat roost in the building.</p> <p>Infra-red cameras must be used as an aid. Four surveyors are required to provide full coverage of the building.</p> <p>If the absence of a bat roost cannot be determined during the first visit, then further surveys will be required.</p> <p>If bat roosts are confirmed in the building two additional surveys may be required to characterise the roost and to inform an EPSL application to Natural England. Surveys should be a minimum of two weeks apart. The EPSL application requires that surveys have been undertaken within the most recent active bat season and planning permission must have been granted and all relevant wildlife-related conditions have been discharged prior to submission.</p> |

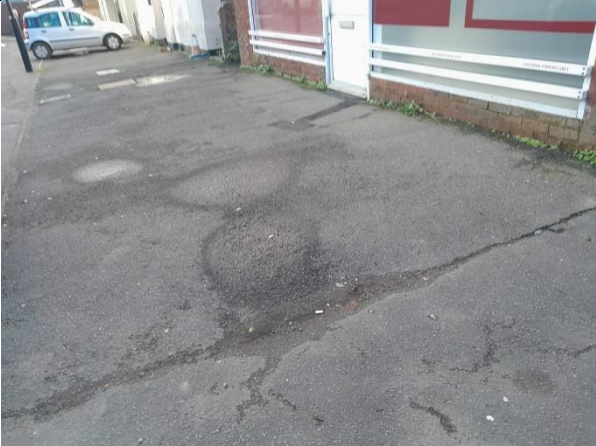
| Summary of Survey Findings | <p>The site is located in Burgess Hill at National Grid Reference at TQ 31447 19108 with an approximate area of 300m<sup>2</sup>, comprising one building, associated hard-standing and modified grassland with one small tree. The site is situated in a residential area, with scattered trees, hedgerows and green parks in the wider area.</p> <p><u>Buildings (u15b)</u></p> <p>There is one building within the site. This is described further in the bat section of this report.</p> <p><u>Developed land, sealed surface (u1b)</u></p> <p>The site is surrounded by concrete pathways.</p> |

| Description | Photographs |
|---|---|
| Developed land, Sealed surface | |

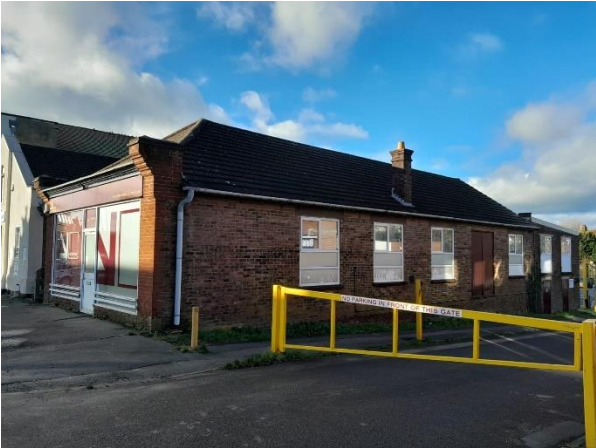
| <i>Summary of Survey Findings</i> | No evidence of breeding birds was observed during the survey; however, the building roof offers suitable habitat for breeding birds. |

| Description | Photographs |
|---|---|
| Building | |

| <i>Recommendations</i> | The demolition works should be undertaken outside the period 1st March to 31st August. If this timeframe cannot be avoided, a close inspection of the building should be undertaken immediately, by a qualified ecologist, prior to the commencement of work. All active nests will need to be retained until the young have fledged. |

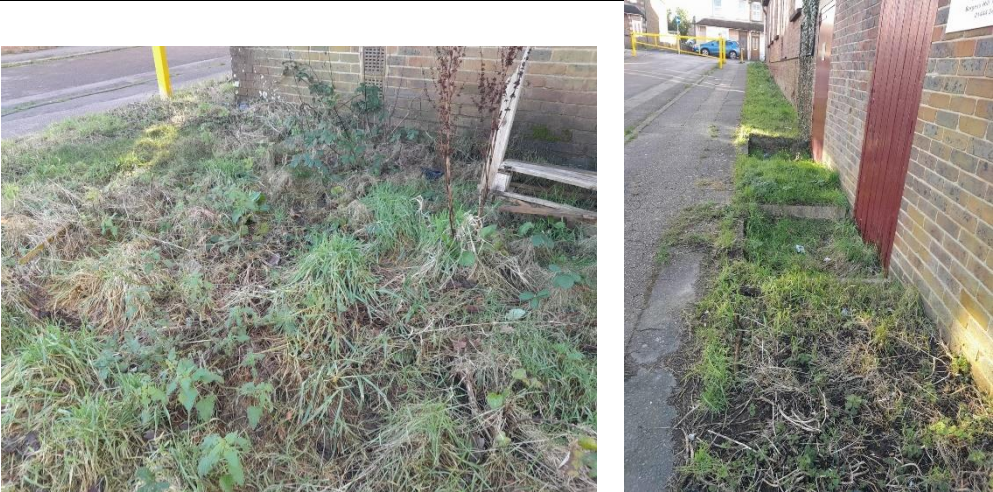
| | <p><u>Modified grassland (g4, secondary code 32)</u></p> <p>There is a strip of modified grassland on the east and north side of the building. The grass is dominated by perennial rye grass, with abundant bramble and frequent ribwort plantain and nettles. There is approximately 10% bare ground, no invasive species, no evidence of physical damage and the grass is uniform in height (&lt;7cm). There is one small rowan tree at the north of the site.</p> <p><b>Local notable habitats</b></p> <p>The following notable habitats are present within 2km of the site: Lowland dry acid grassland (closest of which is ~1.7km east), Ancient woodland (closest of which is ~600m south), and Wood-pasture and Parkland (closest of which is ~1.7km east).</p> |

| <p>Modified grassland</p> | |

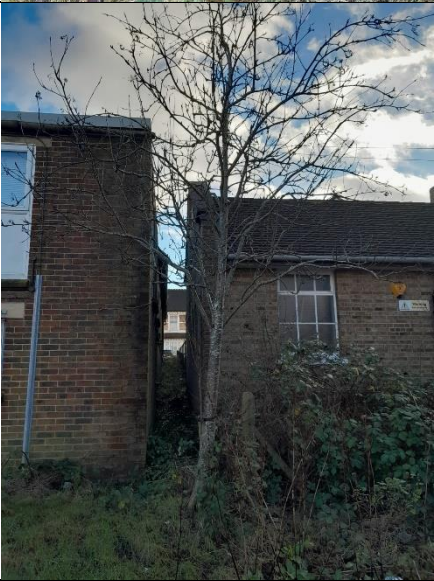
| <p>Individual tree</p> | |

| | Precautions should be taken with machinery and noise levels when working close to any retained nests so as not to disturb any nearby nesting birds (for example within the single tree within the site) during construction works. At least a 3-5m buffer should be created between any machinery and active nests until the young have fledged. |
