## SITE INVESTIGATION FACTUAL REPORT

Report No: 459592  
Client: Cunningham Lindsey - Maidstone  
Site: 22 Wheatsheaf Close

Client Ref: 6579875-Miss Carter  
Date of Visit: 13/09/17

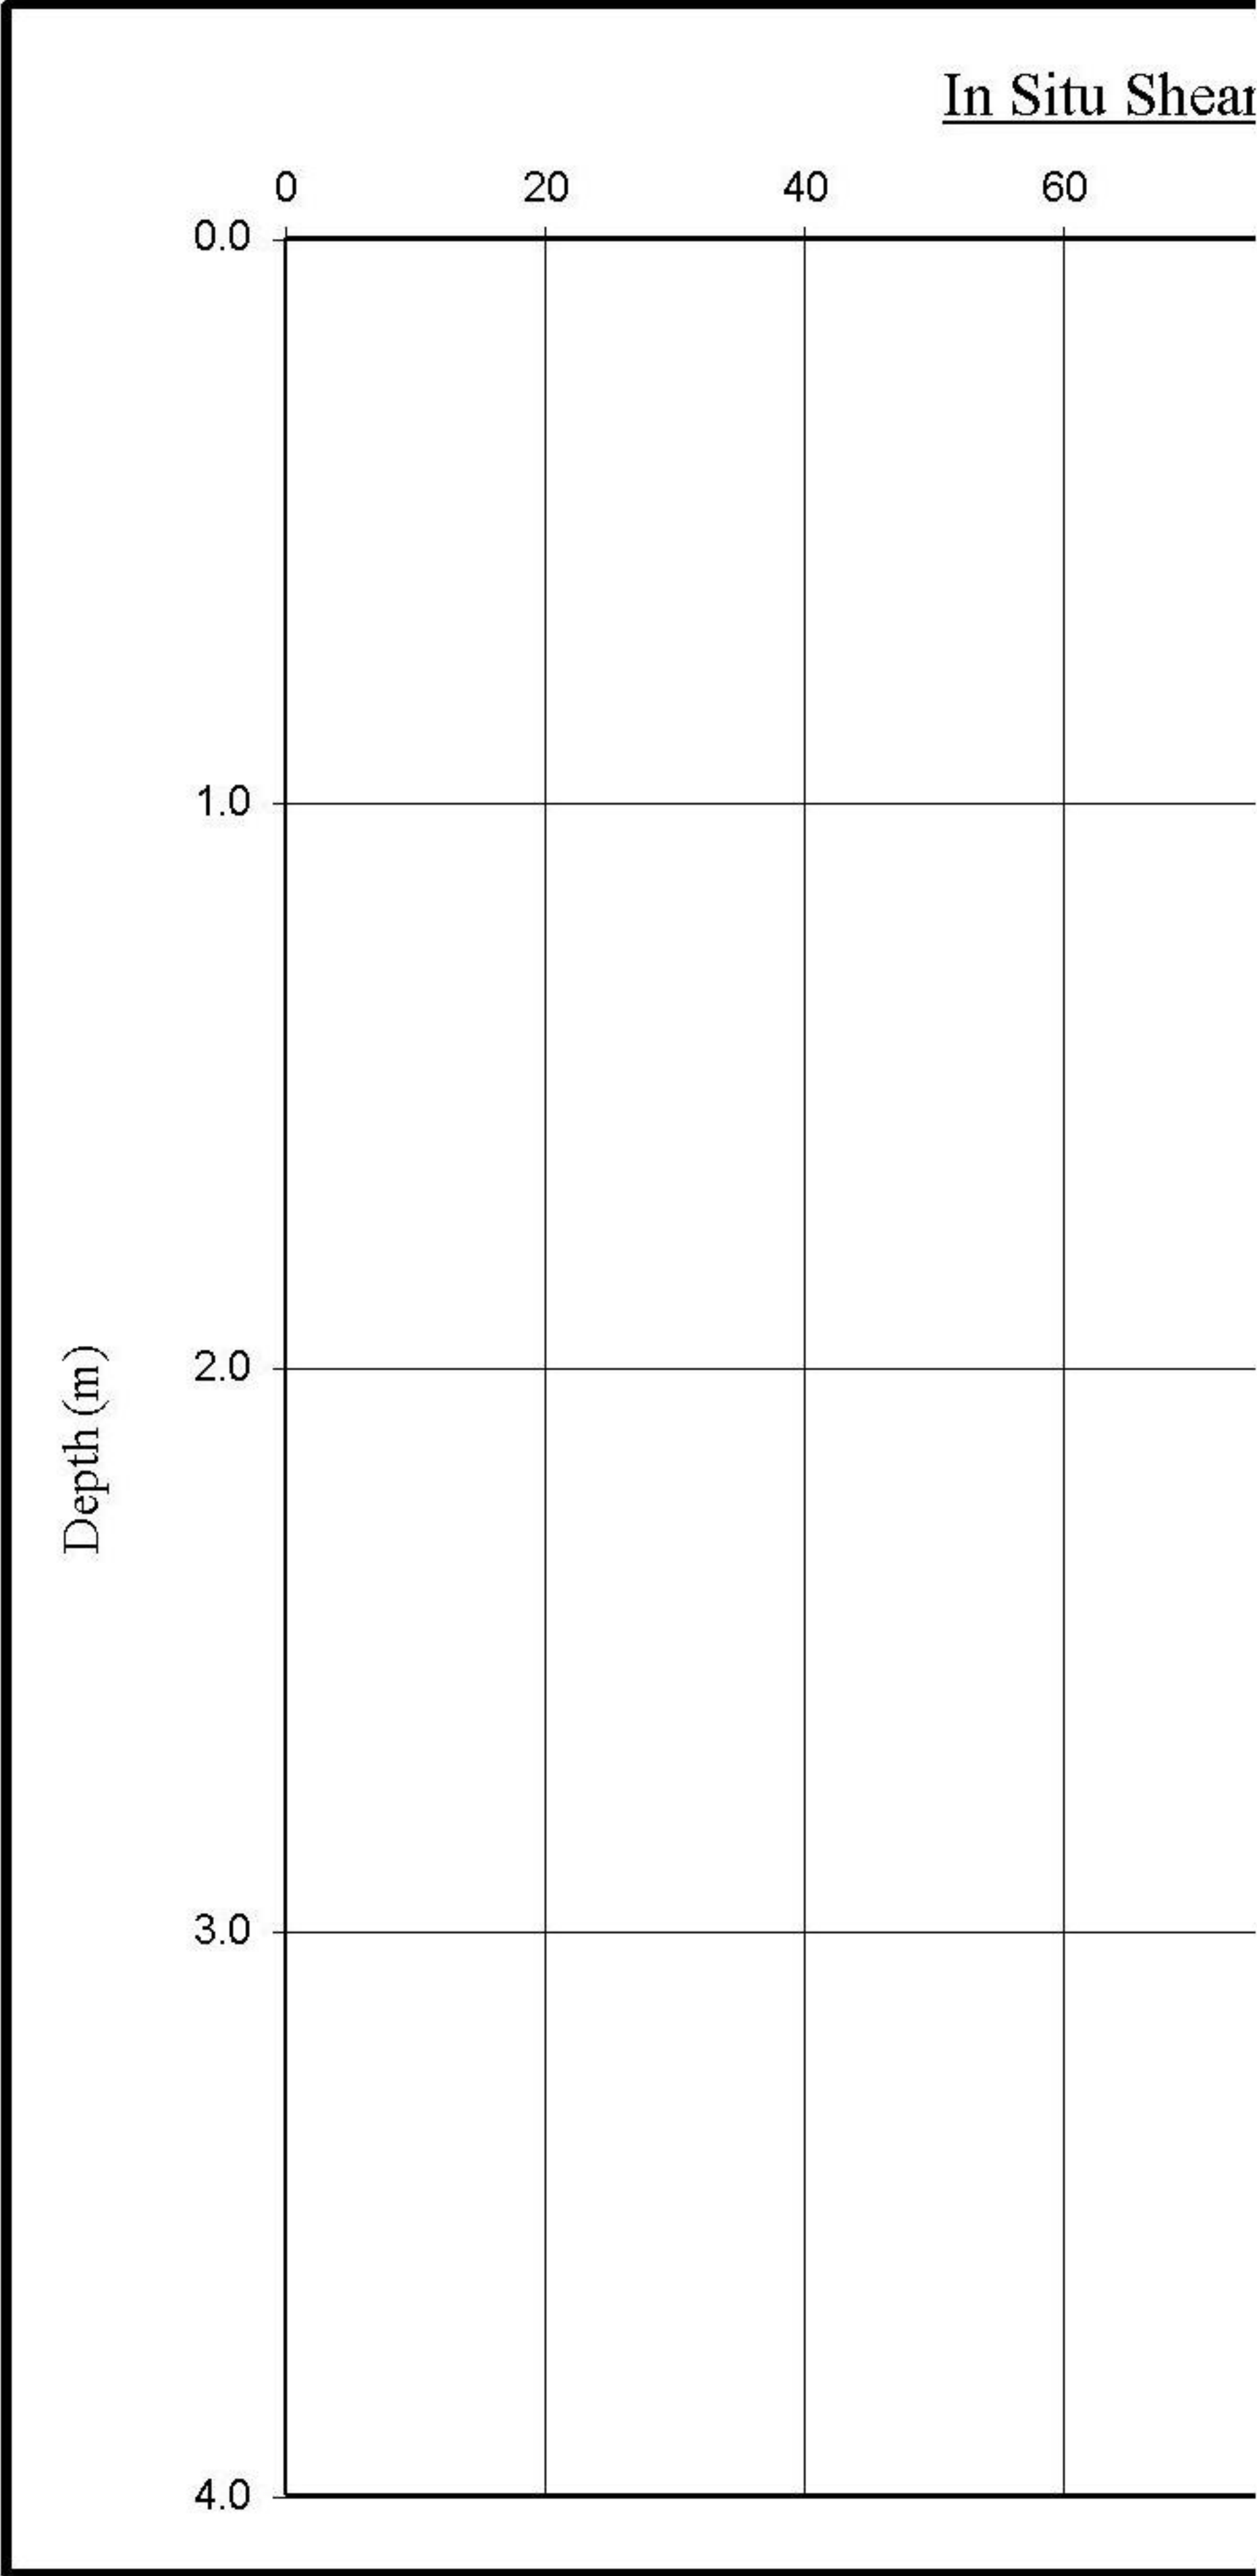
# Shear Str

- Note
1. Unless otherwise stated, values of Sh CET using a Pilcon Hand Vane the calit a maximum reading of 120 kPa.
  2. Unless specifically noted the profiles
