CROSSKEYS, 76 HIGH STREET,  
LINDFIELD, WEST SUSSEX, RH16 2HP

## HERITAGE STATEMENT & IMPACT ASSESSMENT

Commissioned by  
Gould Baxter on behalf of their clients

Report No. 2025588  
May 2026  
Prepared by Maggie Henderson

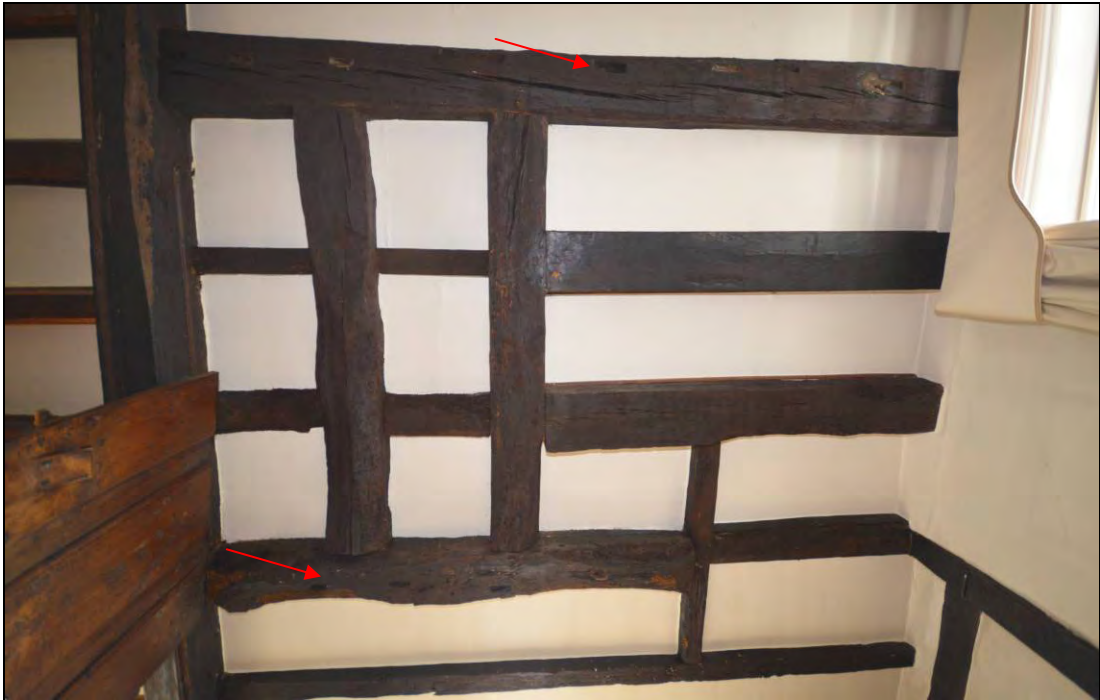
- 8.1.7 The redundant jointing on the joist to the east of the stair trap resulted in the provision of a passage at the east side of the house accommodated by the off-set location of the stair trap. A passage in the location indicated is an unusual feature and may well relate to later alterations to the property rather than being an integral feature of the house as first built.

Plate 11: The stair trap and the soffit jointing to each side of it

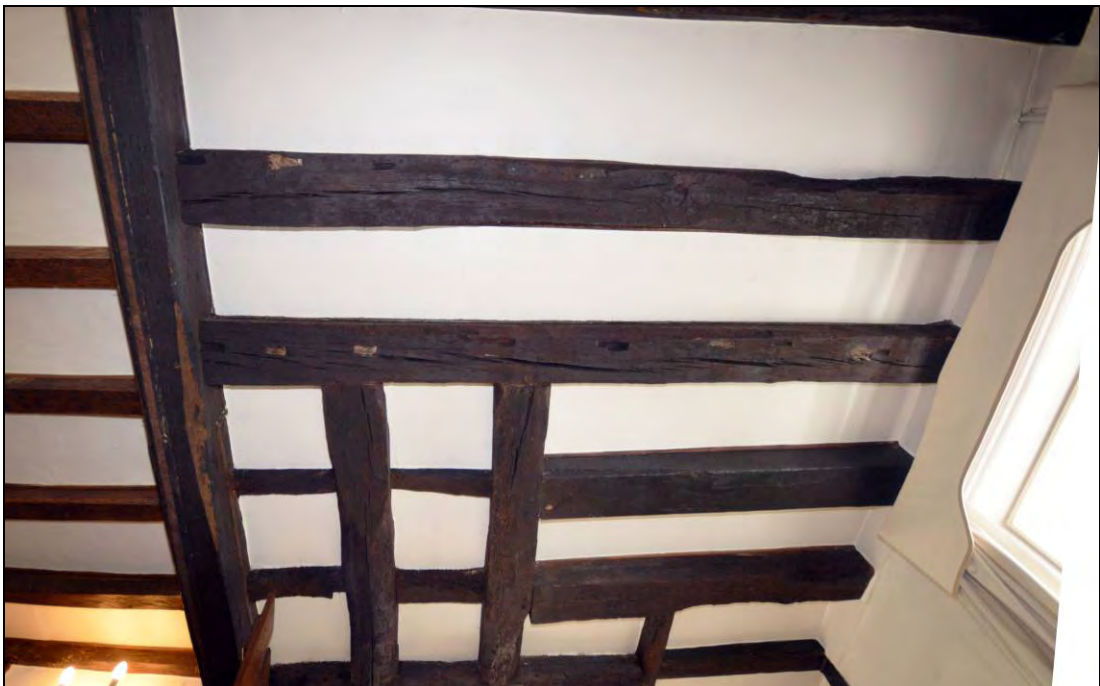
Plate 12: Two adjacent sets of mortises for partitioning on the bay 1 joists

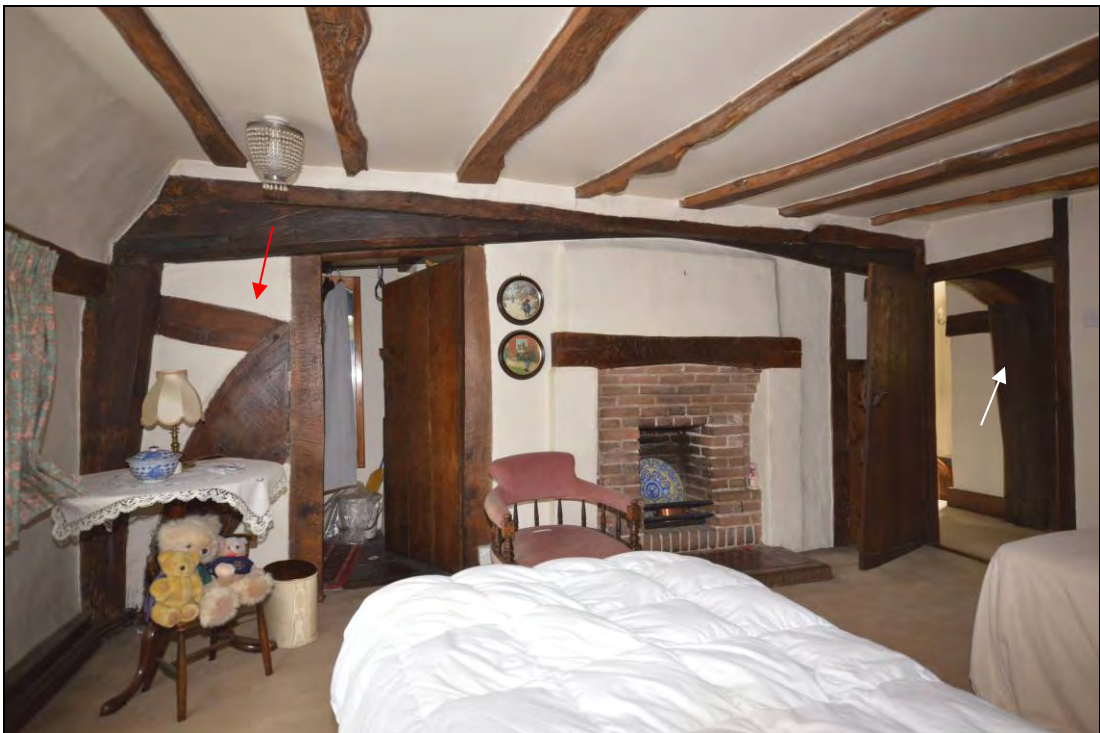
Plate 14: The south side of the open truss with the surviving parts of the head-brace and spur (red arrow); their counterparts to the east had been removed (white arrow)

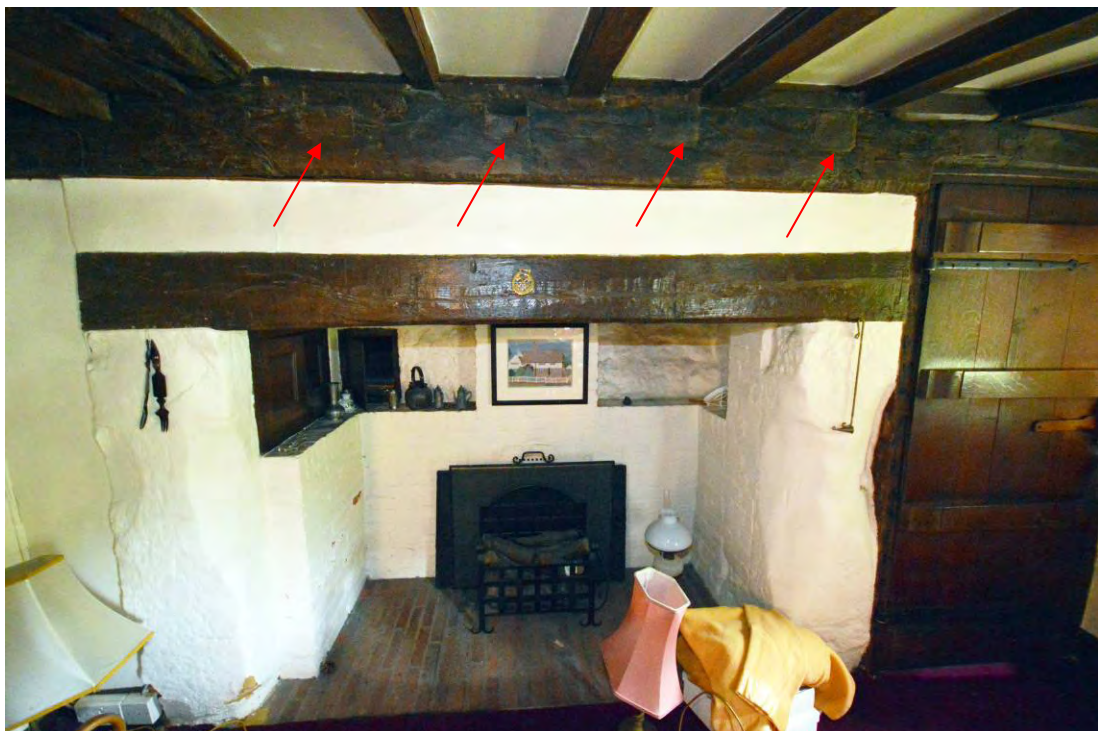
Plate 15: The north side of the T4 truss showing the original joist mortises in the cross-beam, now redundant, with new joists of lesser scantling above raising the height of the ceiling (arrows)

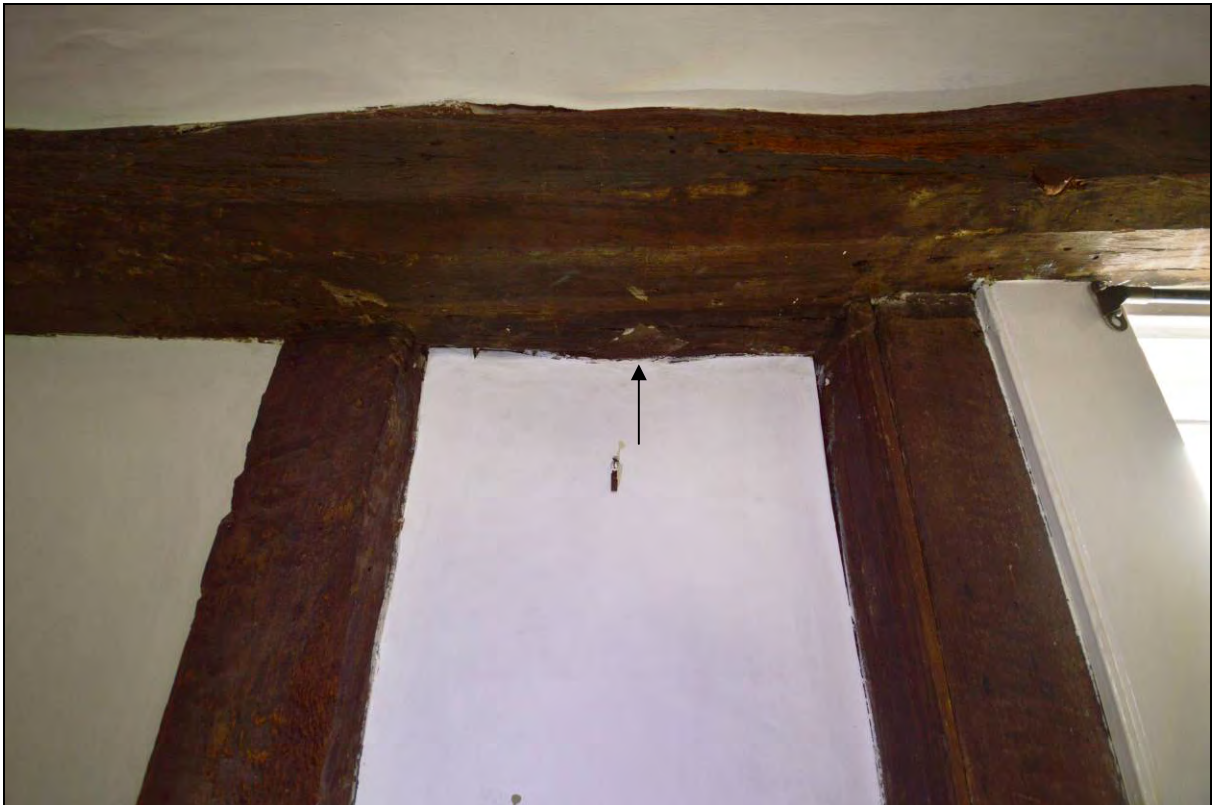
Plate 16: Detail of the wall plate soffit on the east side of bay 1 showing the diamond mortise for a window mullion (arrow)

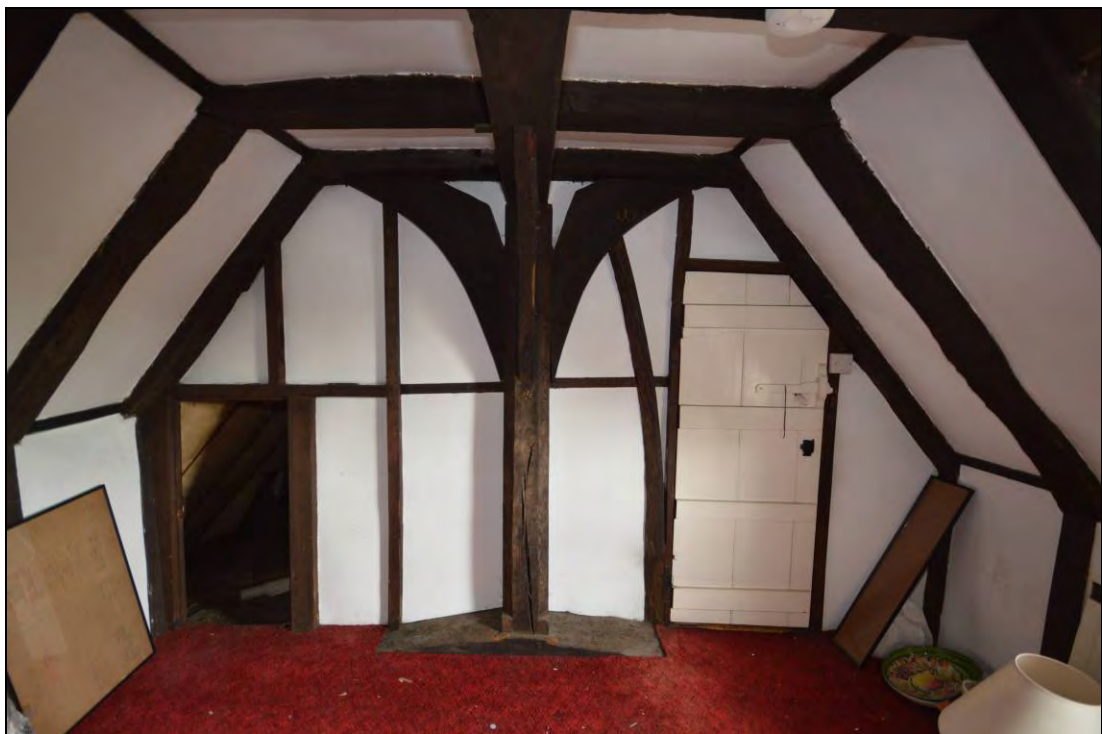
Plate 17: The former free-standing crown-post of the open-truss (T3)

- 8.1.20 The roof is of crown-post construction with the collars mortised-and-tenoned to the rafters. All three crown-posts survive *in situ* although only the free standing crown-post over the open truss remains intact (Plate 17). The two outer trusses (T2 and T4; Figure 2; are partition trusses, each with integral foot-braces and long curved head-braces between the posts and the collar purlin facing into the hall (Plate 18).
- 8.1.21 The free-standing crown-post of the open truss (T3) has an octagonal shaft that terminates in straight-cut stops at the square base (Plate 17). The four-way bracing is bracket-like, the braces almost filling the spandrel between the crown-post and collar-purlin, departing from a clean curve to create an almost pointed finish to the inner side of the brace (Plate 17; Figure 2).

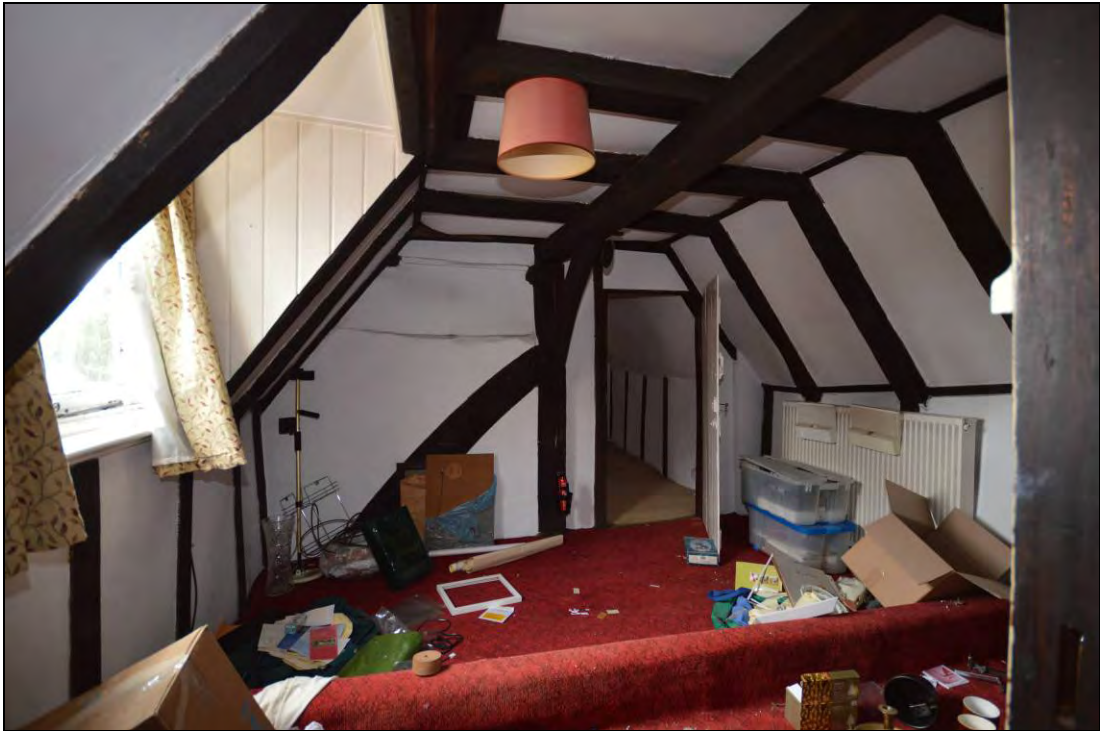
Plate 18: The north side of the T2 partition truss, the western foot-brace removed to create a doorway

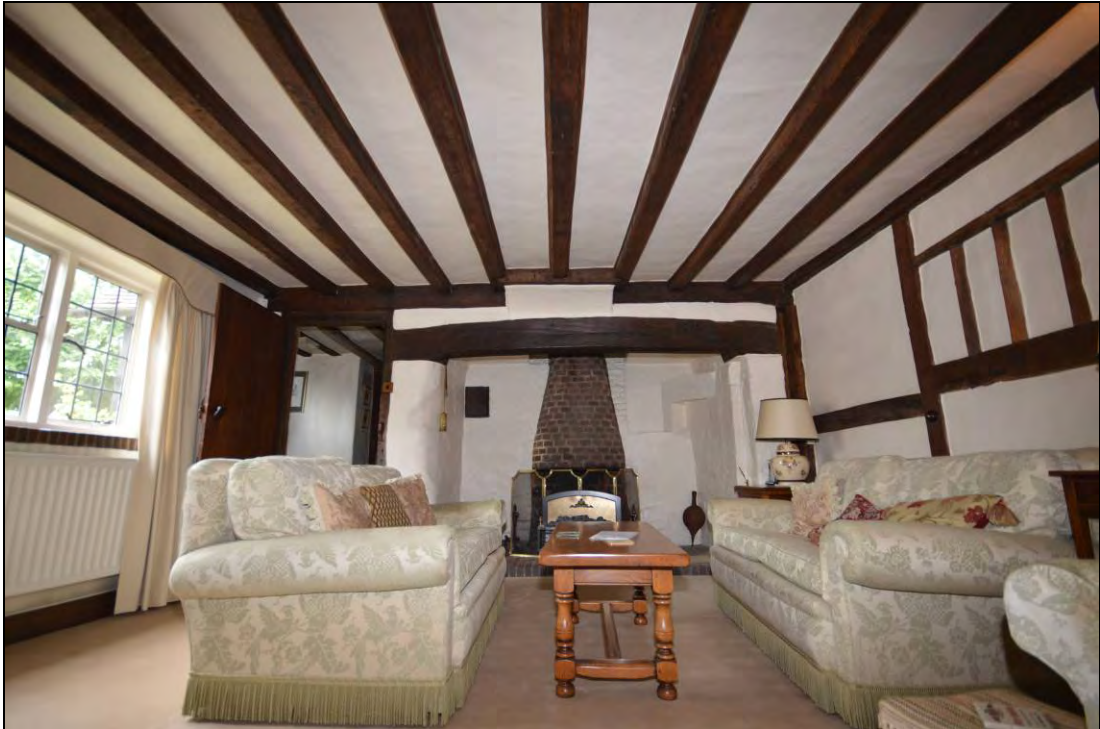
Plate 19: The new joists inserted into the open hall to create a chamber above and the masonry base of the southern hearth of the new multi-flue chimney stack

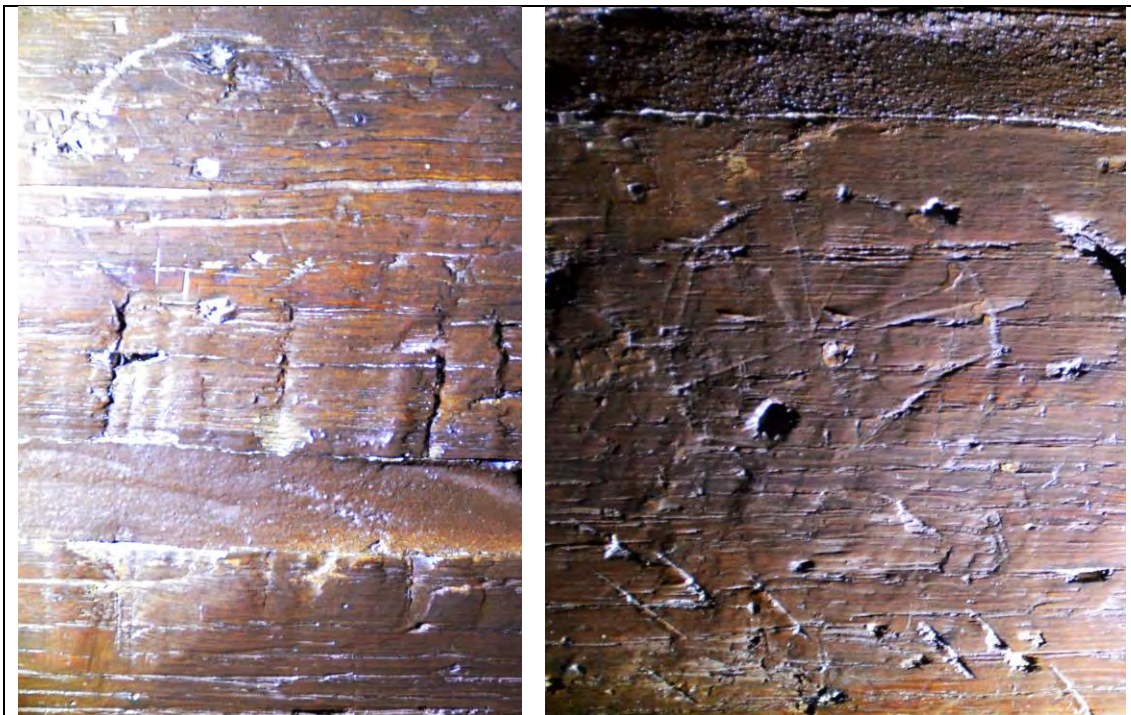
Plate 20: Two compass drawn circles, apotropaic marks in the bressumer of the north hearth on the ground floor

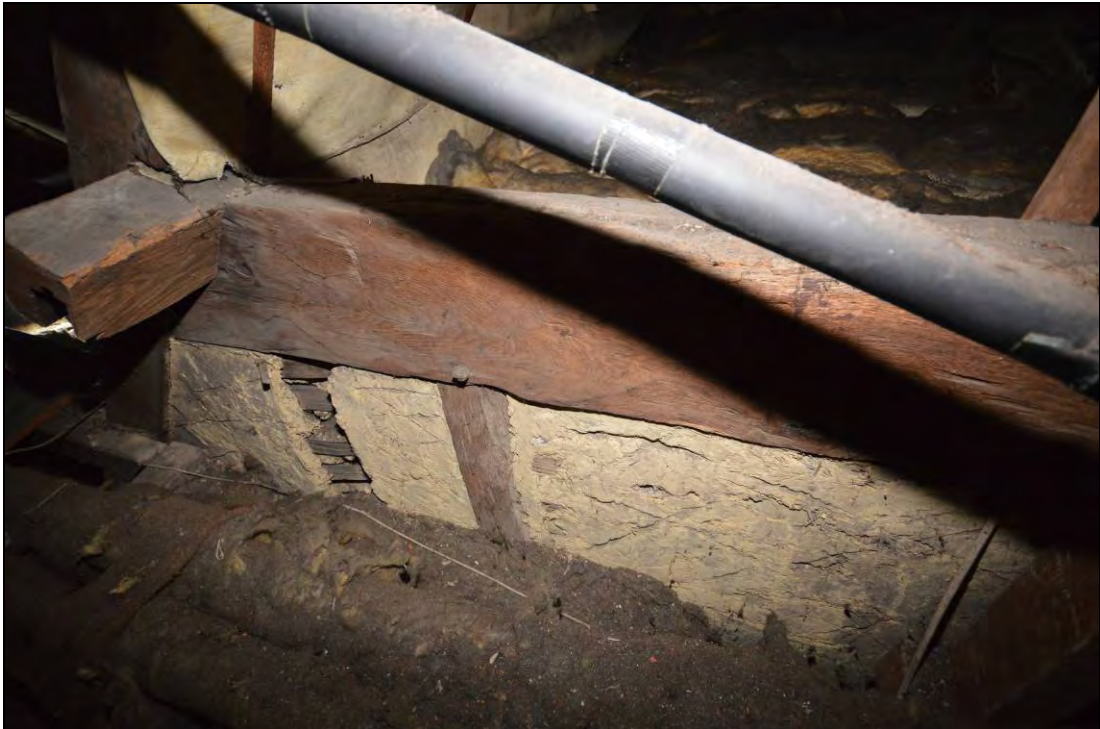
Plate 21: Lath and daub on the T6 partition truss surviving to collar level within the roof of the cross-wing

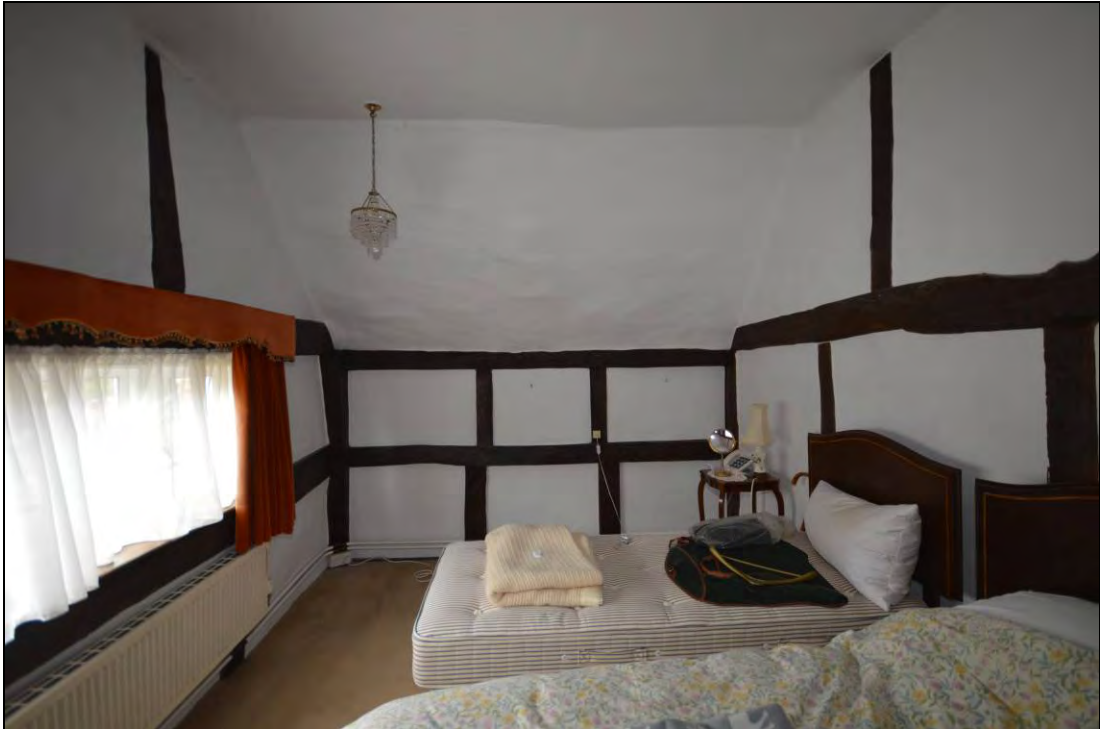
Plate 22: The small-panel framing in the cross-wing at first floor level, north end (bay 5)

- 8.3.7 The external wall construction, still surviving at first floor level to the rear (north) and front (west) is of small-panel framing type, with long, deep, mid-rails and the principal posts have swelling jowls (Plate 22). No bracing was visible within the limited areas of exposed timber frame.
- 8.3.8 The partition truss, of queen-post type, included three studs between the tie-beam and cross-beam, dividing the wall into four tall panels, the southern of which accommodated the doorway between the two bays. It is unclear if the southern panel included an integral doorway from the outset.
- 8.3.9 The wall infill is of lath and daub where it survives. The daub had been scored on its eastern face (at least; Plate 21): it is suggested due to the character of the scoring that this had been intended to act as a key for lime plaster rather than to create a decorative finish.

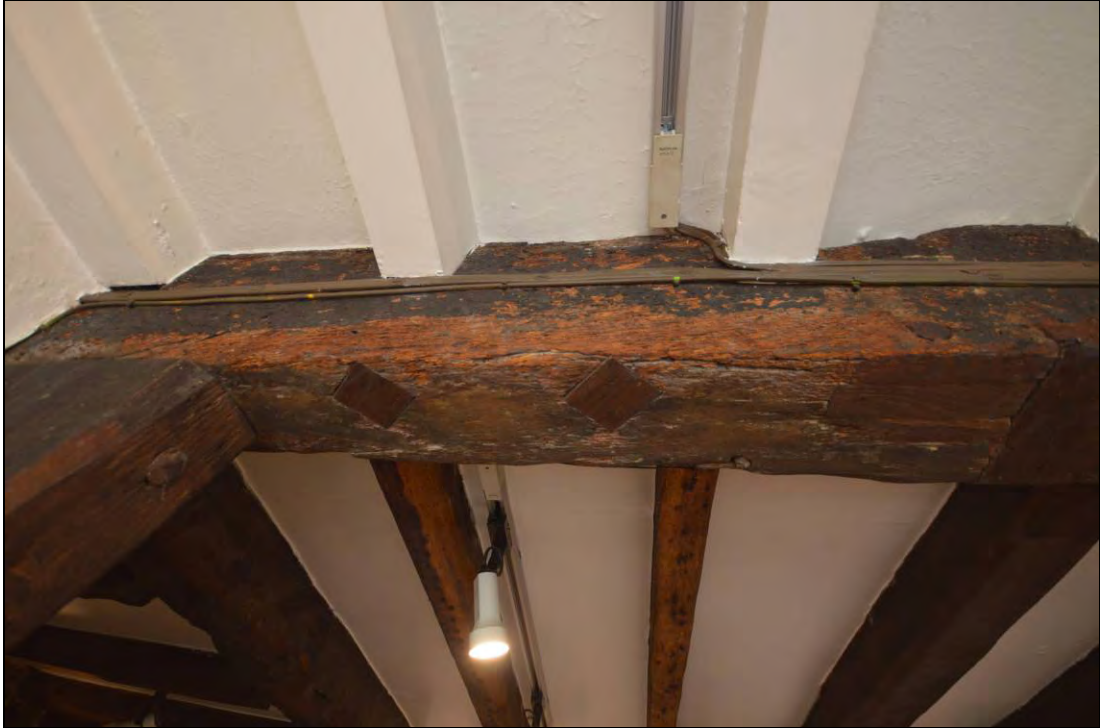
Plate 23: The soffit of the cross-beam of the T7 truss at the eastern end of the cross-wing with evidence of a three-light close-mullioned window

- 8.3.11 A single three light window is evidenced in the cross-beam of the T7 end truss: this includes two diamond mortises that would have carried the heads of a pair of diamond mullions for a close-mullioned, unglazed timber window (Plate 23; Figures 4 and 5).
- 8.3.12 The T6 partition truss had included a pair of doorways just south of centre (Plate 24; Figures 4 and 5). Both doorways have since been blocked; however, their former locations are clearly evidenced by the survival of robust iron pintles on the eastern face of the partition (Plate 25).

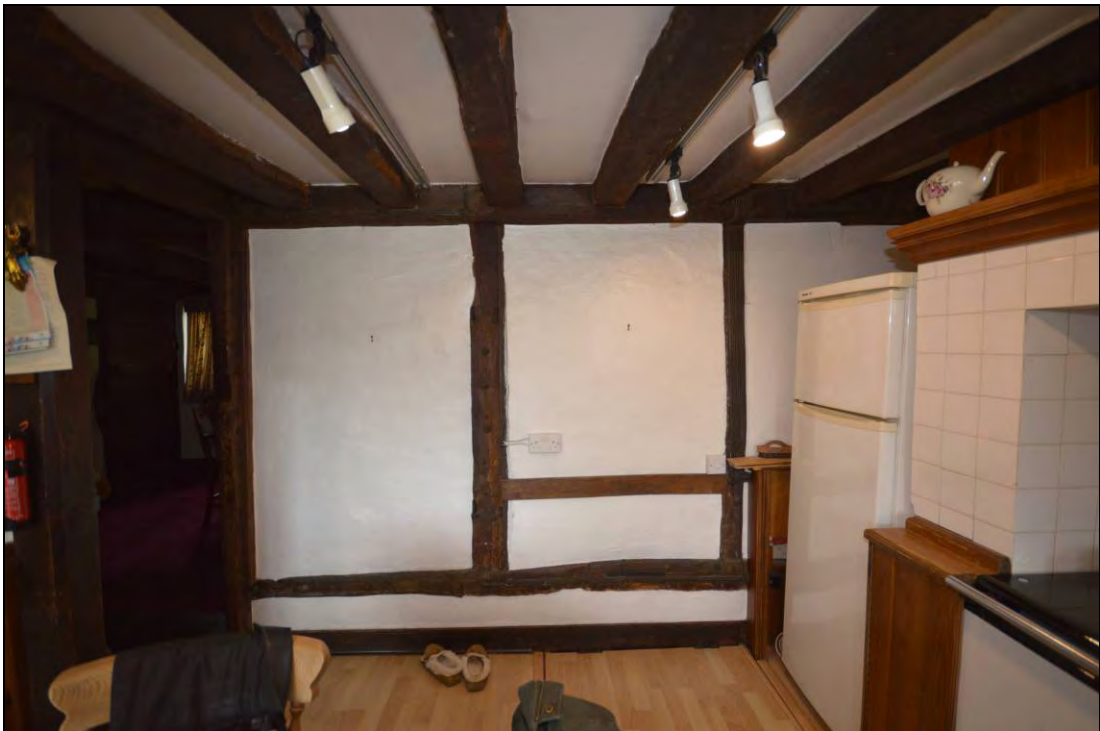
Plate 24: The two doorways in the T6 partition truss, east side

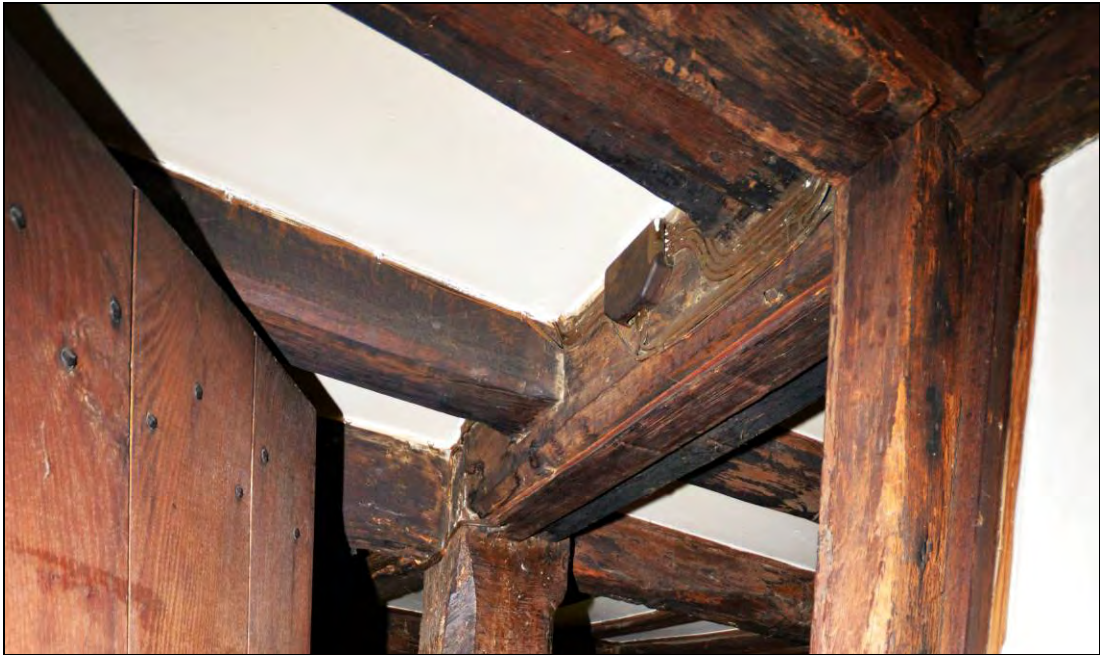
Plate 26: Detail of the cross-wing joists supporting the first floor in bay 7

- 8.3.13 The ceilings and first floor structure comprise a series of east- west oriented joists jointed and pegged to the cross-beam of the T6 truss; their outer ends jointed and pegged to the cross-beams of the two end trusses (T5 and T7). Joist dimensions are 130 mm wide by a minimum of 75 mm thick, finished with chamfered edges and step-and-hollow stops (Plate 26).
- 8.3.14 As outlined above, the first floor rooms were initially open to the roof; the current ceilings added during a later, albeit historic, programme of modernisation.
- 8.3.15 The floor in bay 7 on the east side of the cross-wing was refinished, at a lower level, in concrete when the building was remodelled in 1939. Bay 6 retains historic timber flooring that may relate to insertion at least in part when the cellar was added, or reinstatement of an earlier finish when work was complete.

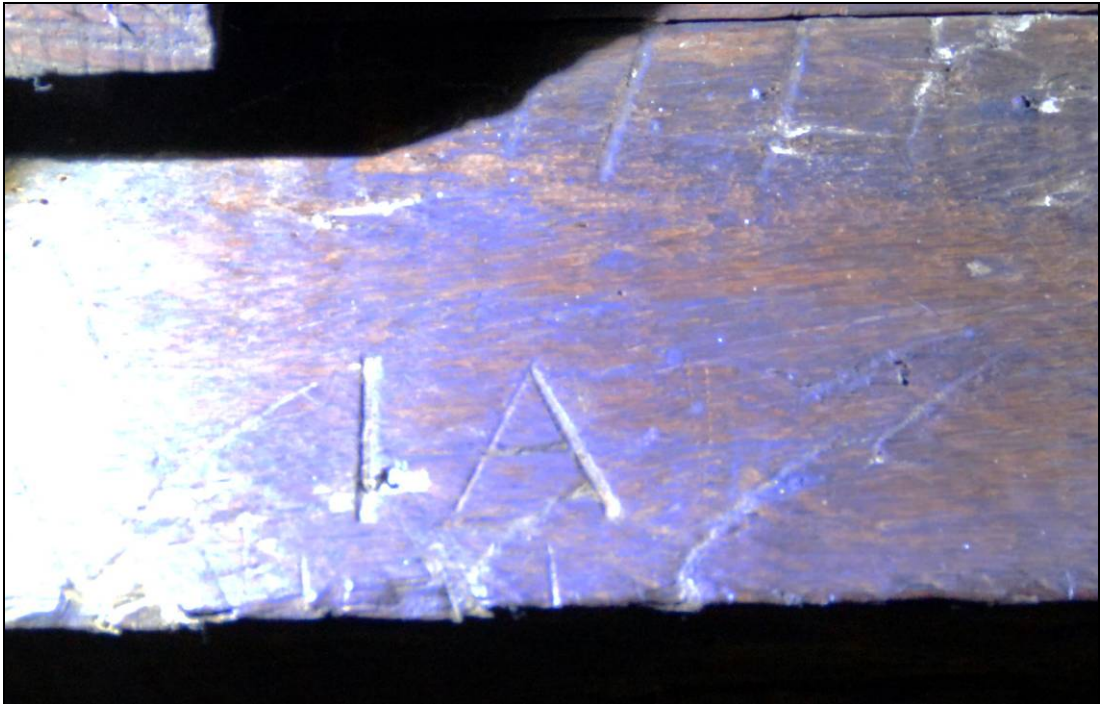
- 8.3.18 The south side of the side-girt in bay 5 of the cross-wing includes the initials *I. A* incised into the timber (Plate 27).

Plate 27: Graffiti on the south side of the cross-wing side girt

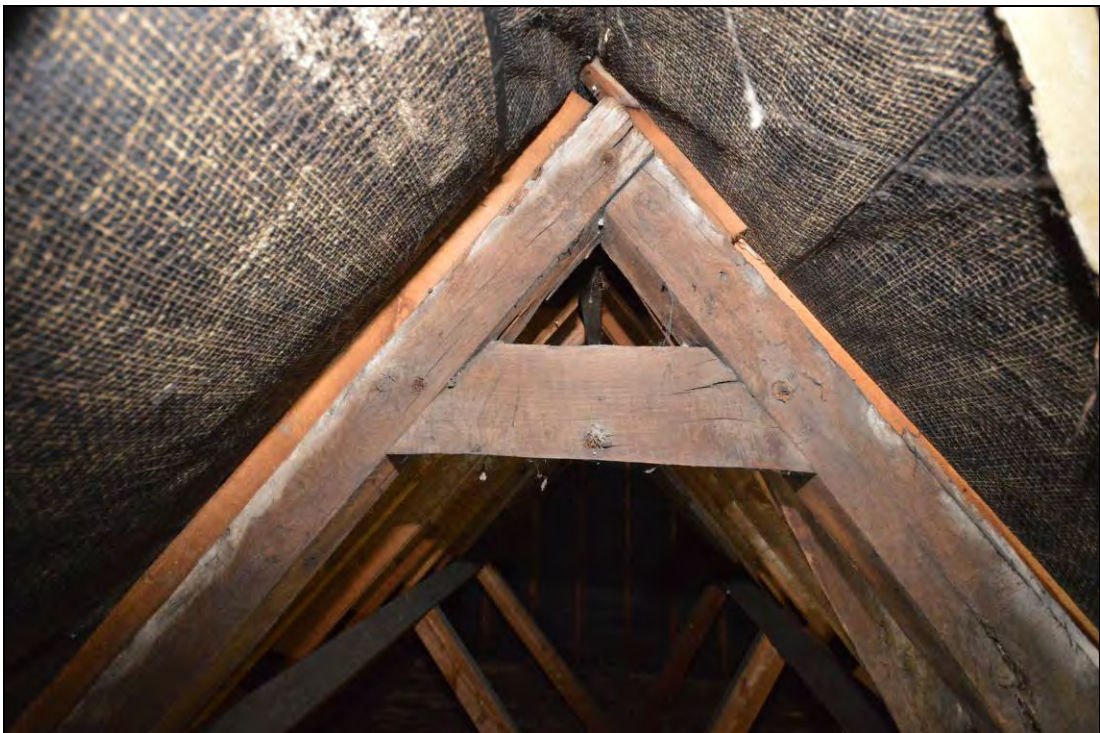
Plate 28: The high-set collar and jointing evidence for a central jack rafter indicative of a hipped roof terminal at the eastern end of the cross-wing

by the still in-situ high-set collar with its peg-hole evidence for a central jack rafter (Plate 28).

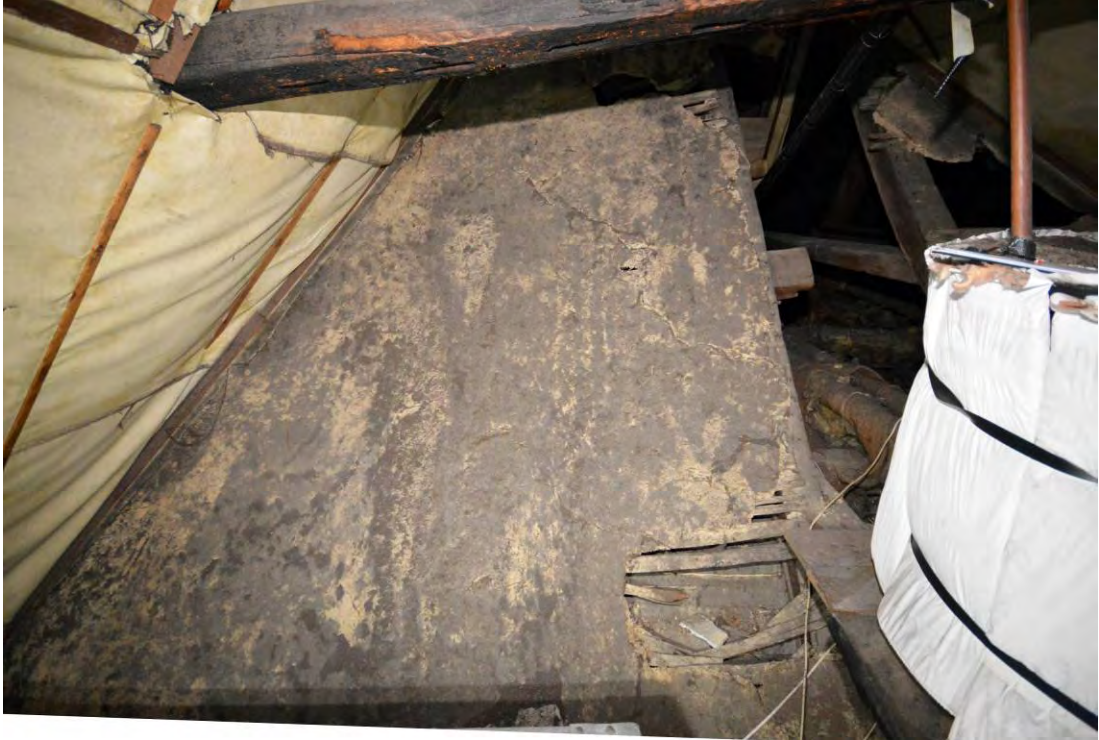
Plate 29: The lath and daub partition on the south slope of the cross-wing roof in bay 5

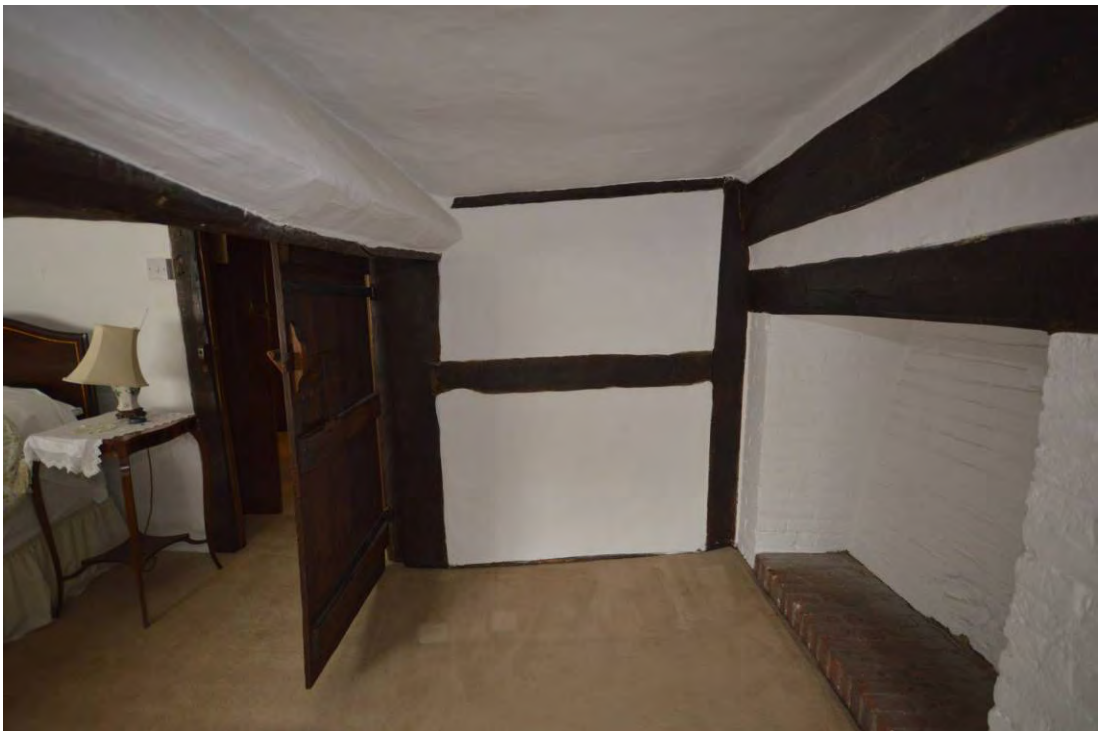
Plate 30: The lath and daub finish to the south slope of the bay 5 cross-wing roof, first floor

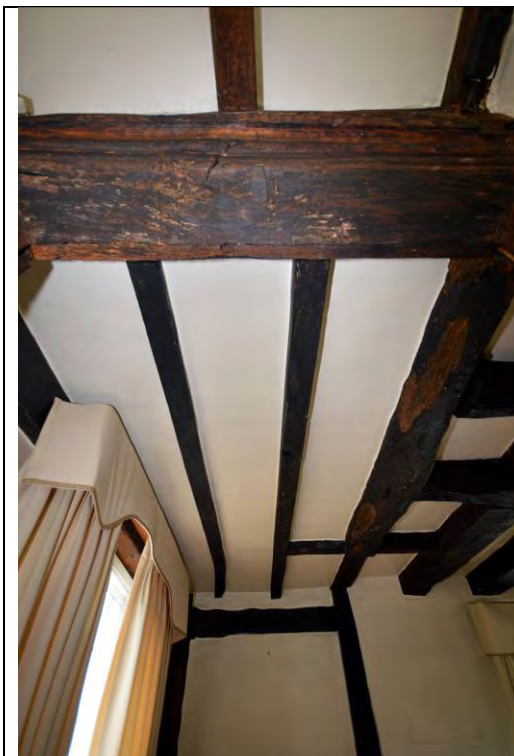
Plate 32: The eastern side of bay 1, looking south showing the two joists added to reinstate the ceiling over a probable staircase location. Note also the head-plate for a doorway in the south elevation

- 8.4.6 Two joists were subsequently reinstated filling any gap (Plate 32), and the staircase relocated further to the north within the passage: this is suggested by the series of trimmers currently supporting the first floor structure, in conjunction with several reinstated or truncated joists and supported by the proposal drawings prepared in 1939 (Figure 6).

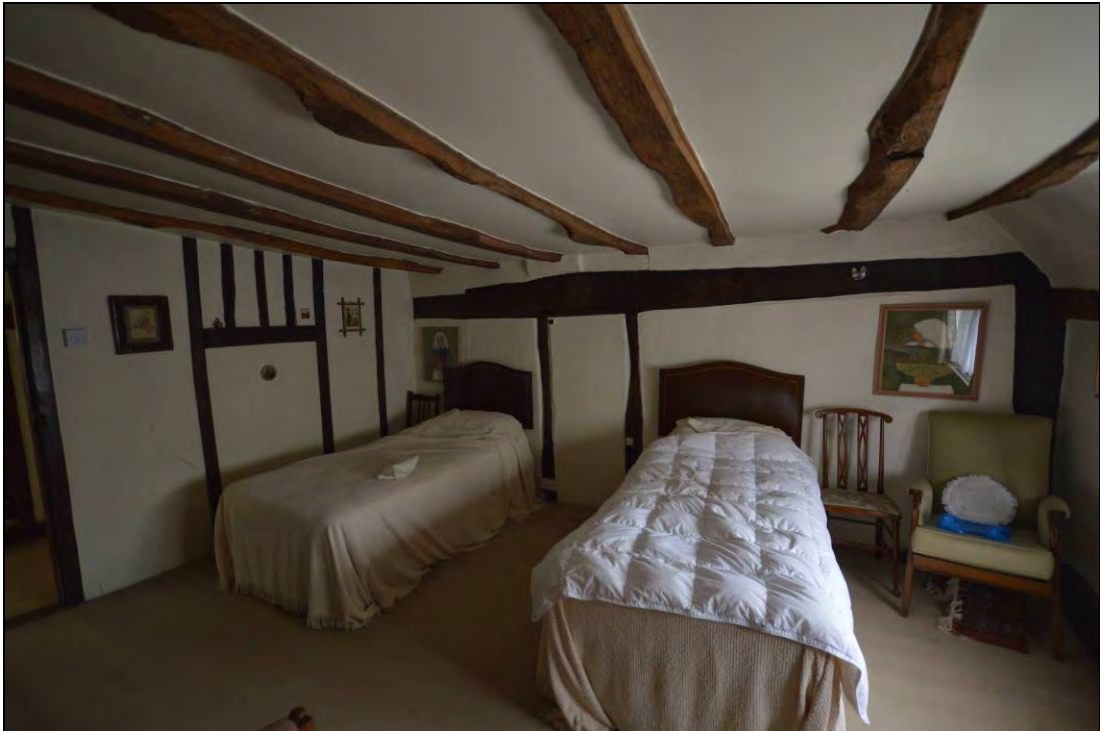
Plate 33: The attic floor joists in bay 2 looking south

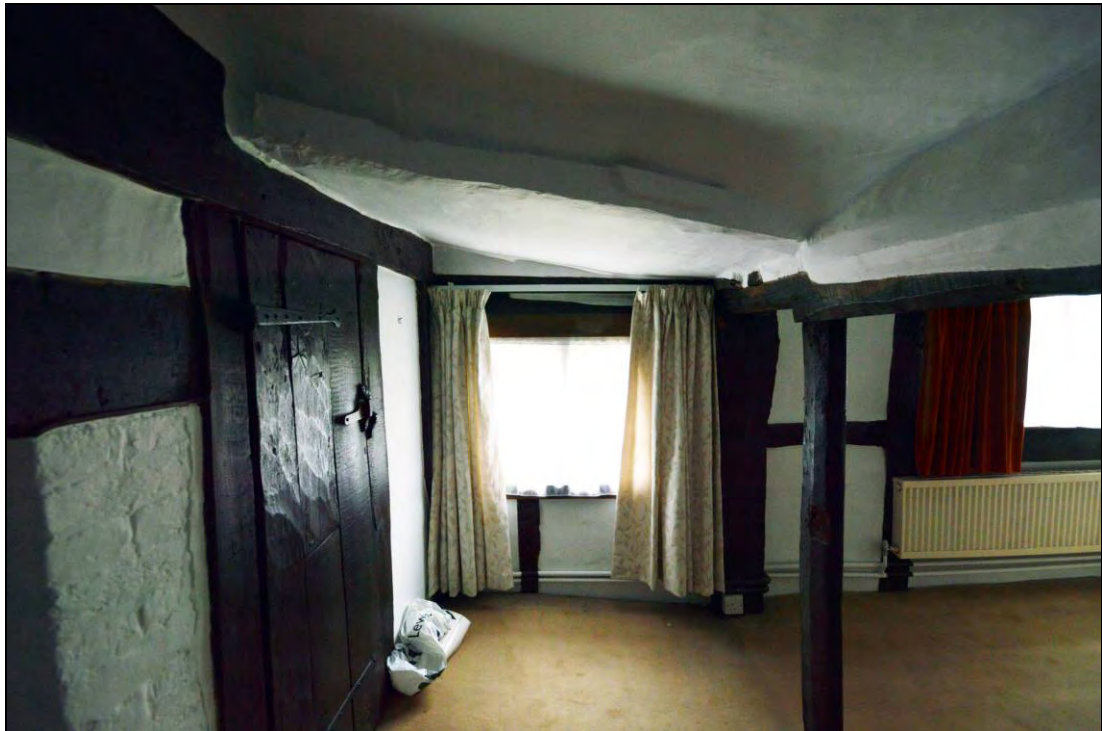
Plate 34: The stepped ceiling finish within bay 4 on the first floor of the main range

- 8.4.16 There is no clear reason for the differences although it is clear that the higher-set area of ceiling had been added at a later date – or reinstated at a higher level than its lower canted counterpart.

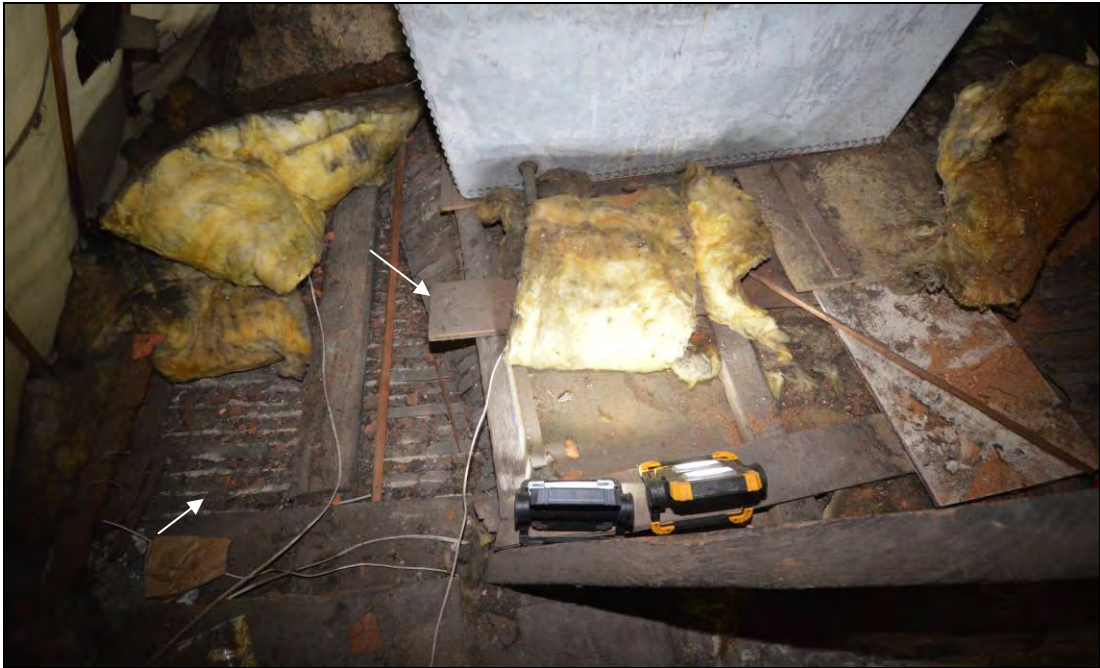
Plate 35: The two different ceiling levels in bay 4 viewed from the roof space (arrows)

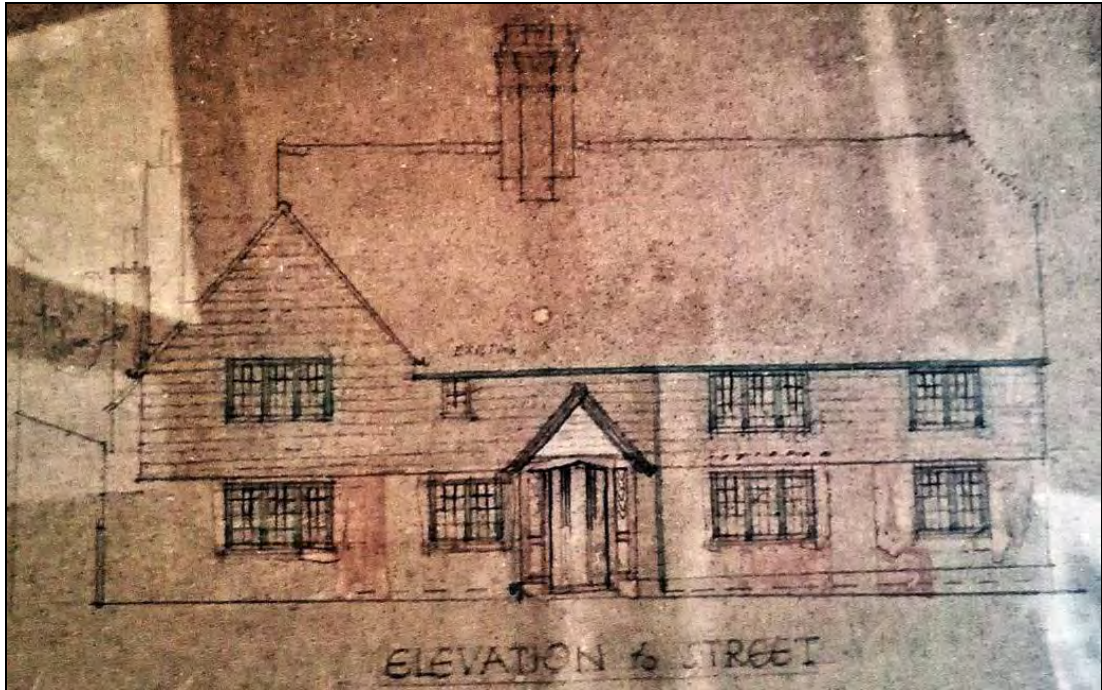
Plate 36: The front elevation as proposed in 1939 showing reinstatement of fabric on the ground floor, alterations to the fenestration and the addition of the porch

- Replacement of the windows: those *in situ* at first floor level in the historic ranges do not match the proportions indicated on the elevation drawings (Plates 36 and 37): this may be due to retaining the proportions of earlier window openings

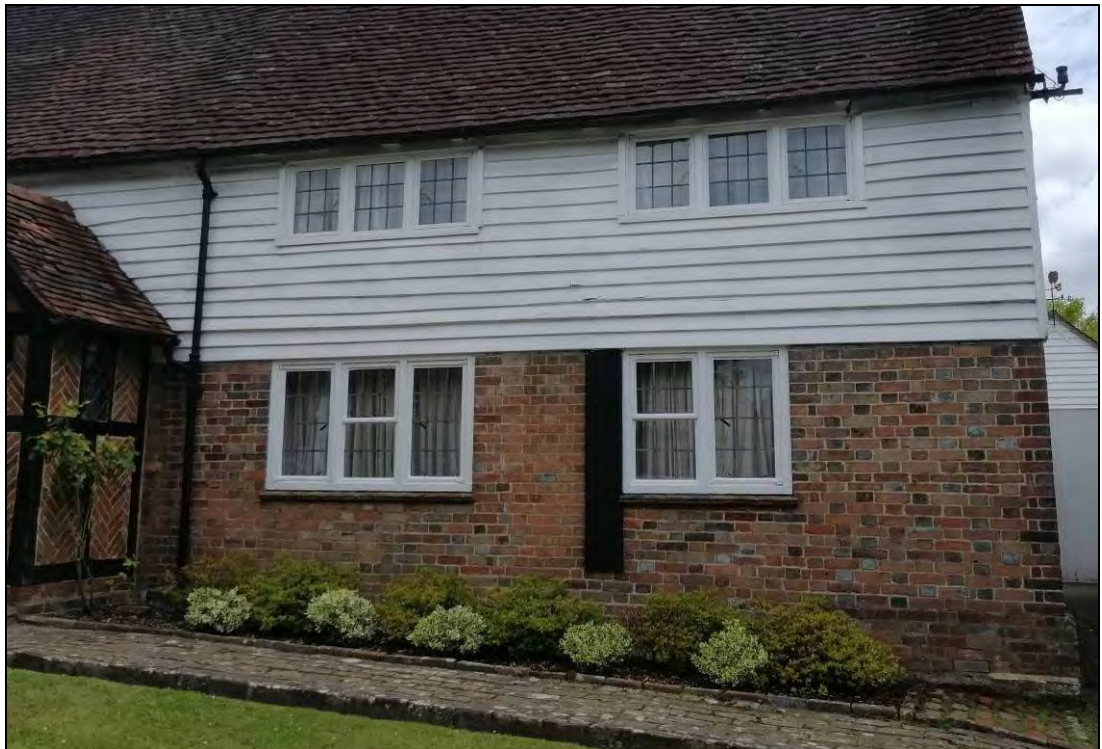
Plate 37: The front elevation showing the consistency of the brickwork across bays 1 and 2 and the differences in fenestration to those proposed in 1939

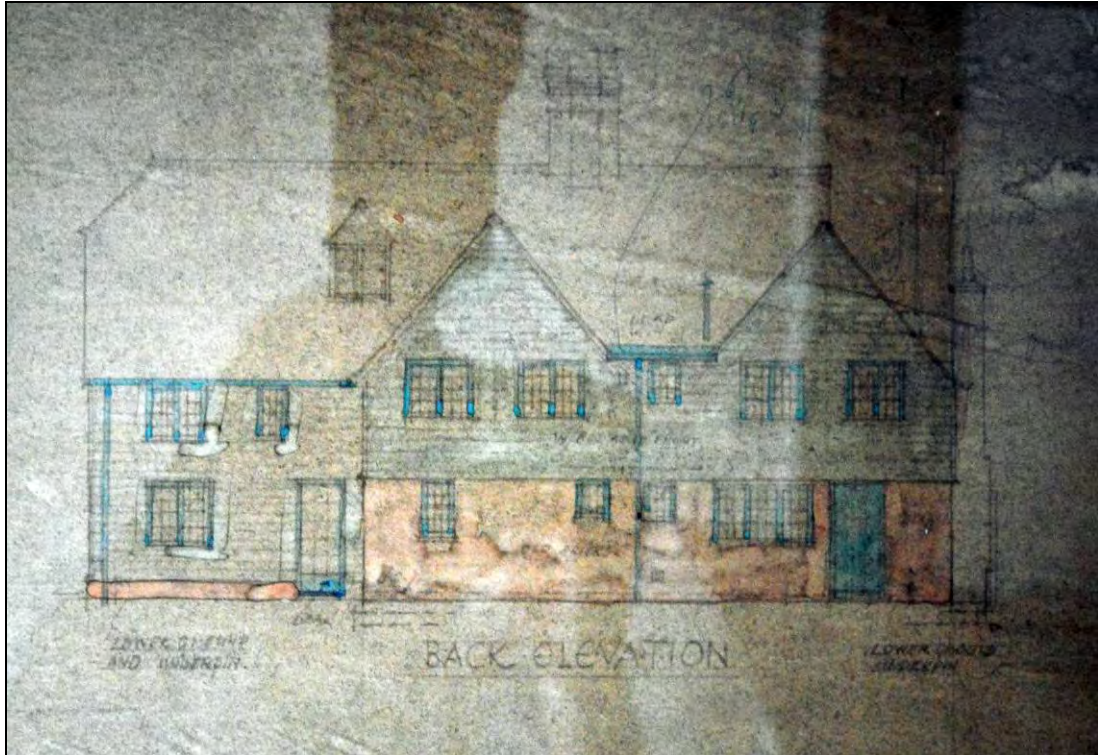
Plate 39: The rear elevation as proposed in 1939 with under-pinning indicated at the northeast and southeast corners

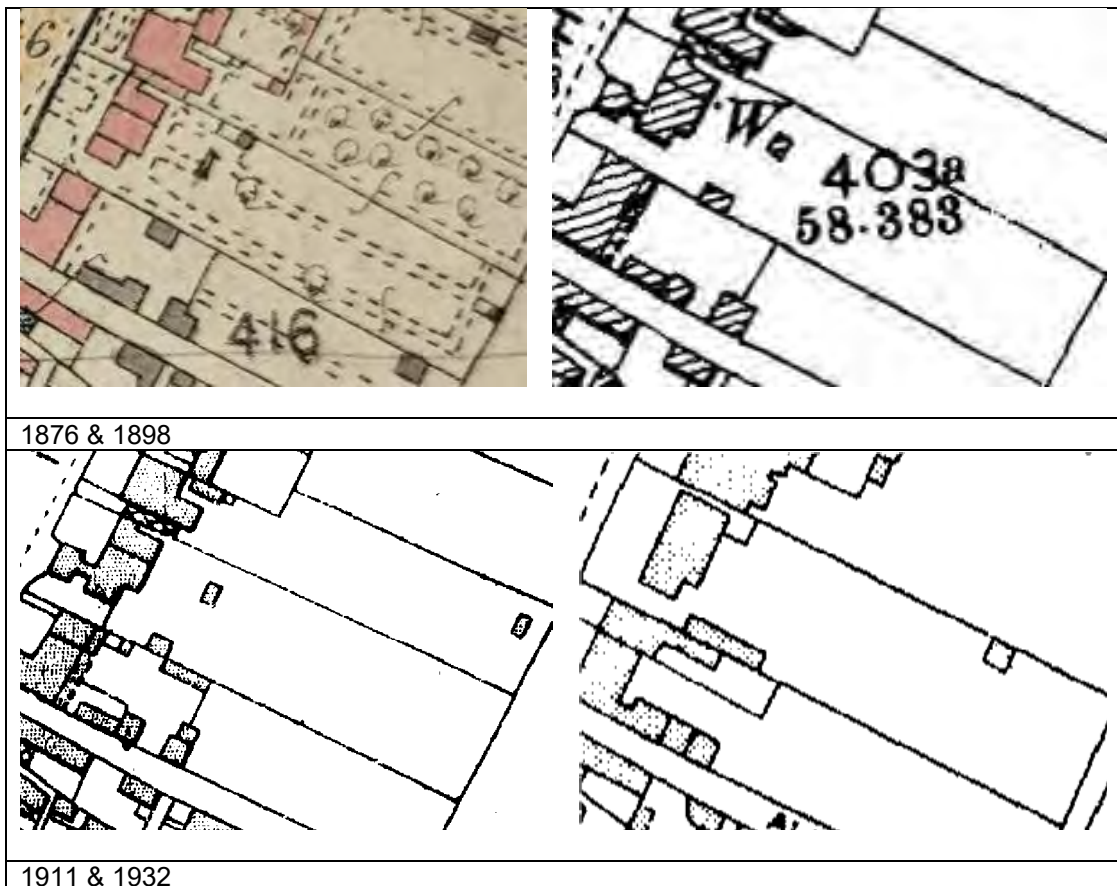
Plate 42: The evolution of the rear garden and the introduction of the garage between 1911 and 1932

- 8.3.1 A narrow range abutting the south boundary of the site is shown occupying much the same site as the garage in 1876; this was reduced to a single compact range by 1898 and replaced or substantially extended between 1911 and 1932 (Plate 42).
- 8.3.2 The current single storey building, 3.85 metres wide by 11.20 metres in length, has a north elevation in stretcher bond (Plate 43), multi-pane domestic-style casement two-light casement windows and a concrete tiled roof that is hipped at its eastern end, and has a weather-board clad gable at its western end. Access is via a single boarded-and-ledged door in north elevation and through garage doors in south elevation.
