CROSSKEYS, 76 HIGH STREET,  
LINDFIELD, WEST SUSSEX, RH16 2HP

## HERITAGE STATEMENT & IMPACT ASSESSMENT

Commissioned by  
Gould Baxter on behalf of their clients

Report No. 2025588  
May 2026  
Prepared by Maggie Henderson

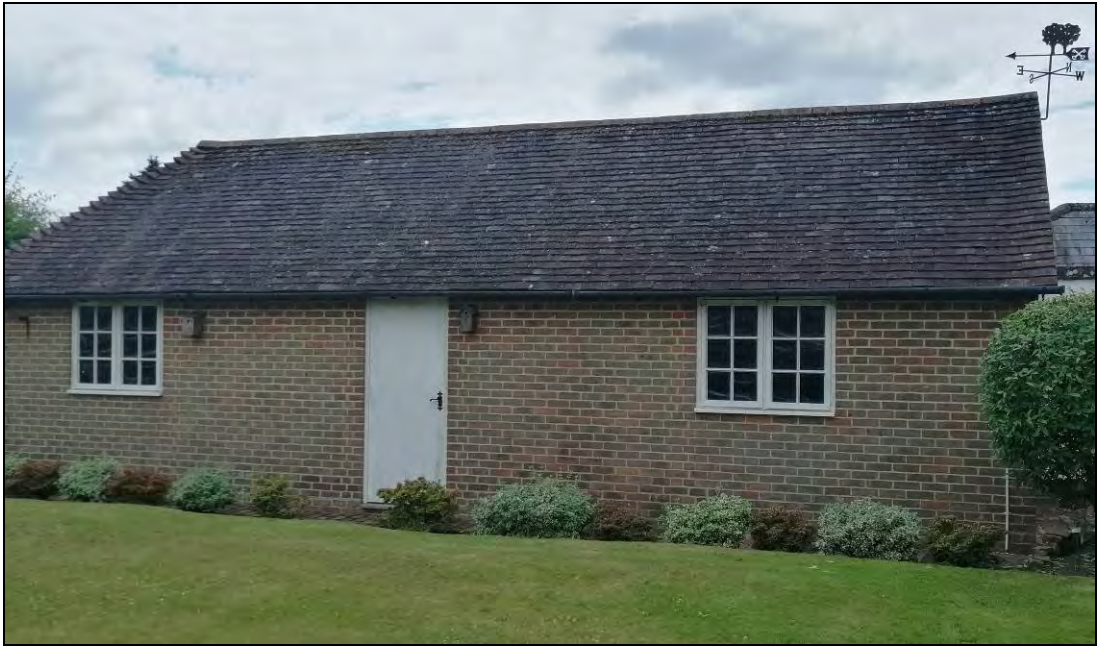
Plate 43: The north elevation of the garage

- 8.3.1 A narrow range abutting the south boundary of the site is shown occupying much the same site as the garage in 1876; this was reduced to a single compact range by 1898 and replaced or substantially extended between 1911 and 1932 (Plate 42).
- 8.3.2 The current single storey building, 3.85 metres wide by 11.20 metres in length, has a north elevation in stretcher bond (Plate 43), multi-pane domestic-style casement two-light casement windows and a concrete tiled roof that is hipped at its eastern end, and has a weather-board clad gable at its western end. Access is via a single boarded-and-ledged door in north elevation and through garage doors in south elevation.

- 8.3.3 The garage is modern in origin; its fabric is generic and mass-produced resulting in a rather functional building with domestic detail on its northern side fronting into the garden. The building lacks any particular interest in its own right, although it may have been built against an earlier boundary wall (not inspected). The low single-storey form does however ensure that the building does not detract from or compete with the host building.

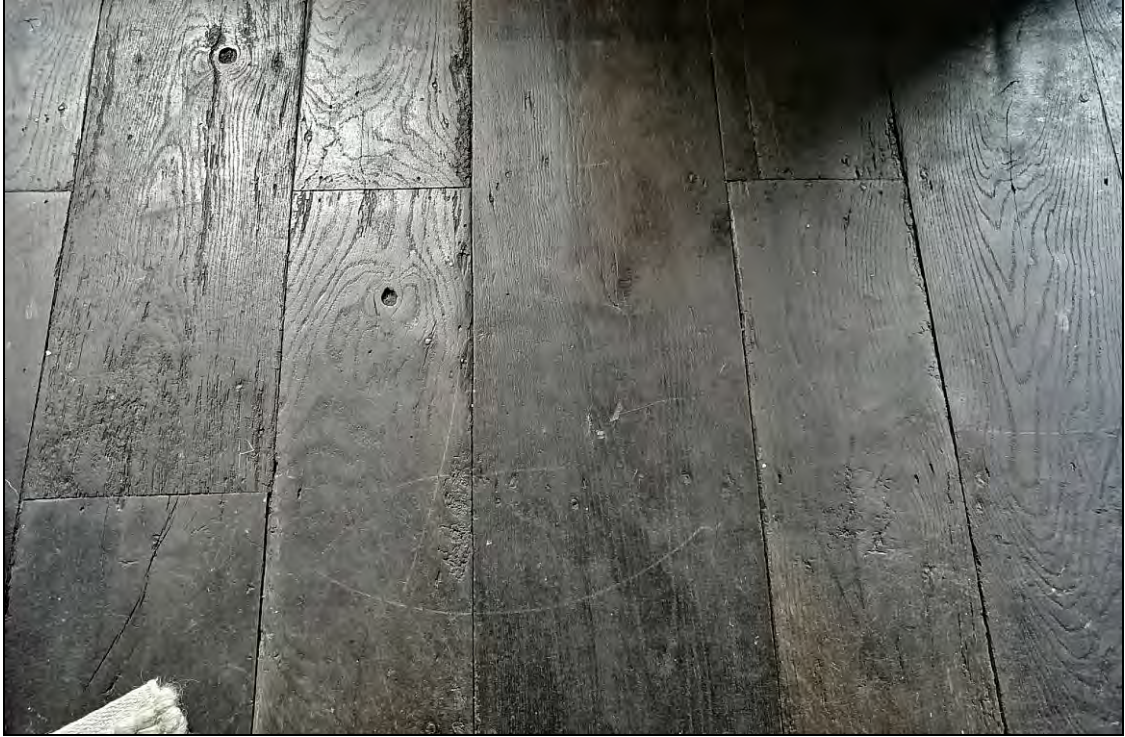
- 10.1.3 In the area proposed for alteration, the suspended timber floor extends east-wards past the T6 truss into the southwest corner of bay 6 and to the same extent in bay 4 (Plate 44). An assessment of the floor was undertaken on the 18<sup>th</sup> September 2025, the floor comprised boards of varying widths with a varied wear-pattern and a distinct lack of any gaps between the boards. The floor finish is considered to be the result of modern intervention, undertaken in 1939, utilising floorboards to hand tightly butt-jointed together to form a new surface. The resultant floor finish lacked any consistent

Plate 45: The floor laid c.1939 at the south end of the current dining room (bays 4 and 5), butt-jointed with no gaps, a variety of board sized and differential wear patterns inconsistent with the current location

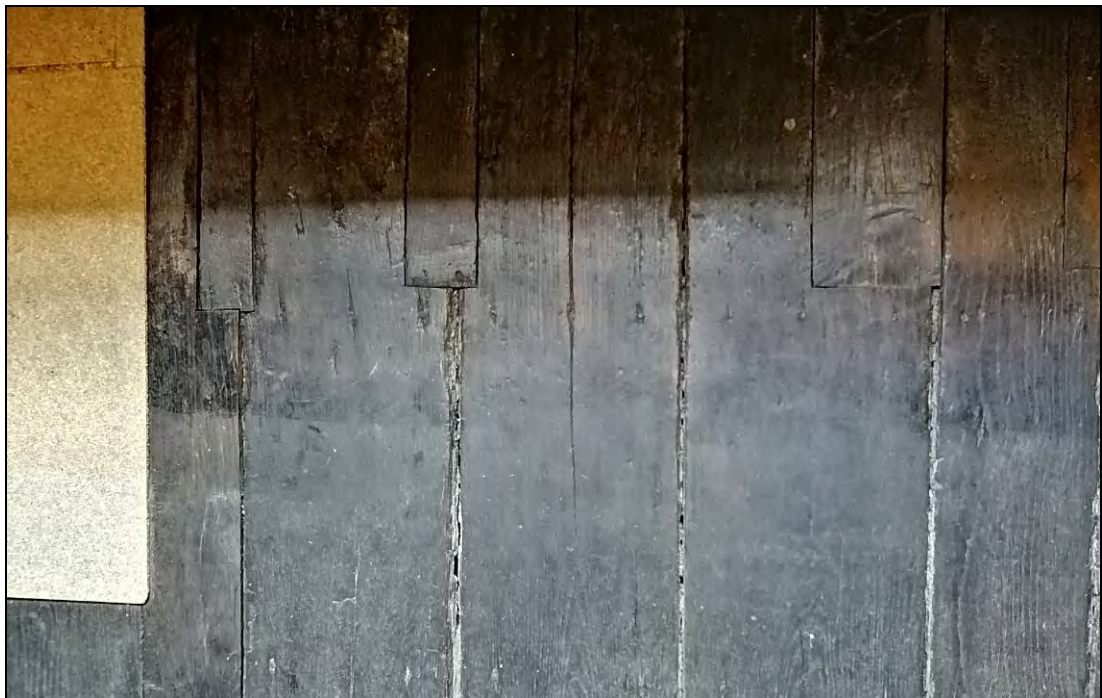
wear patterns and contrasted strongly with the floorboards that had been laid over the adjacent cellar and indeed the earlier floor finishes that survive within the house inside the first floor closet to the west of the chimney (bay 3) and in the attics (Plates 45-47).

Plate 46: The floor over the cellar at the north end of bay 5, complete with consistent board sizes, wear patterns and gaps between the boards

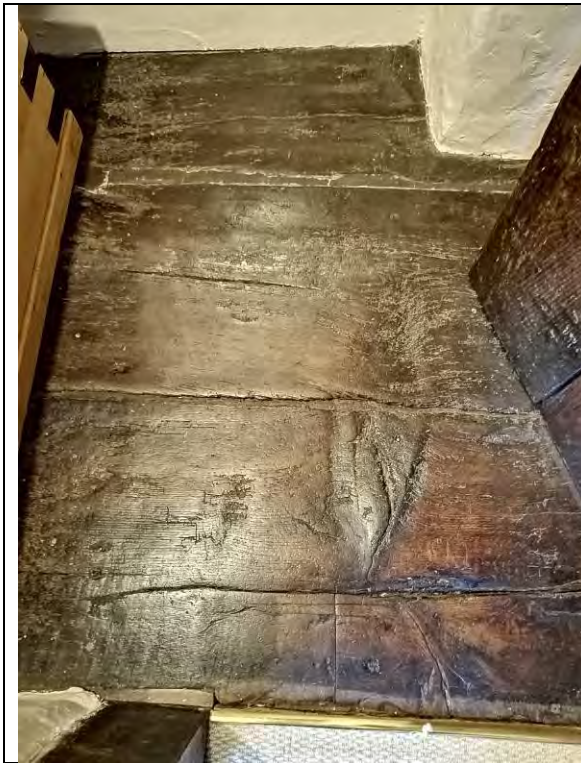
Plate 47: Detail of the *in situ* early floorboards within the closet at the west side of bay 3 (late 16<sup>th</sup> century)

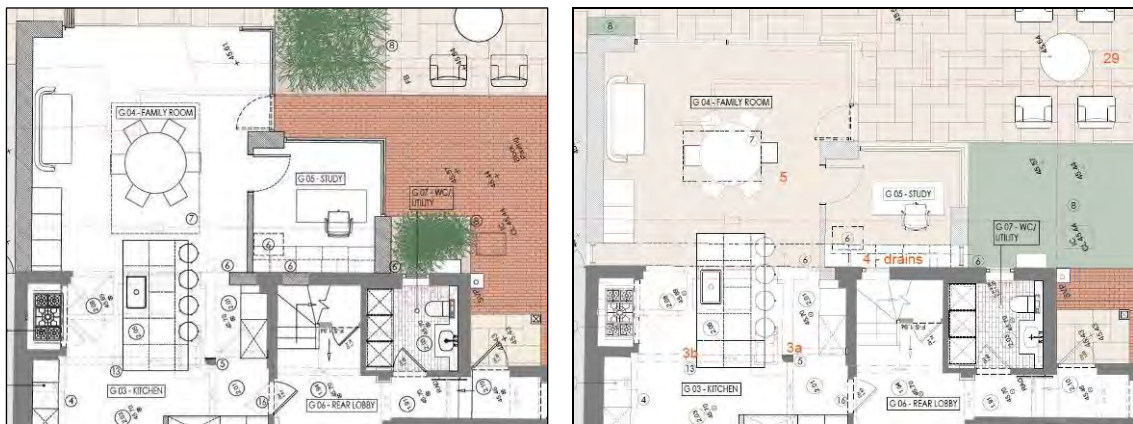
Plate 48: Detail of the proposed extension at the northeast corner of the house, initial scheme to the left and revised scheme, with glazed link and more compact footprint to the right

- 10.1.8 It is proposed that the east wall of the building as created in 1939 to the rear of the cross-wing is removed, leaving a short length of fabric at the northeast corner *in situ*. Part of the rear elevation of the adjacent store to the south will also be removed and the remains of its window blocked up. The window to the rear of the 1939 stair hall will be retained as an internal window looking into the proposed new study extension (Plate 48).

- 10.1.9 The fabric proposed for removal relates to the 1939 proposal scheme, as such, no earlier fabric will be lost or altered. The location of the extension is discrete, following on in a similar vein to the addition of the cross-wing, with accommodation at right-angles to that of the main range, added in the early 17<sup>th</sup> century. The single storey form of the proposed extension will allow substantial exposure of the first floor gabled additions to the house that were part of the building campaign undertaken in 1939, allowing the full narrative of the building's later evolution to remain extant.

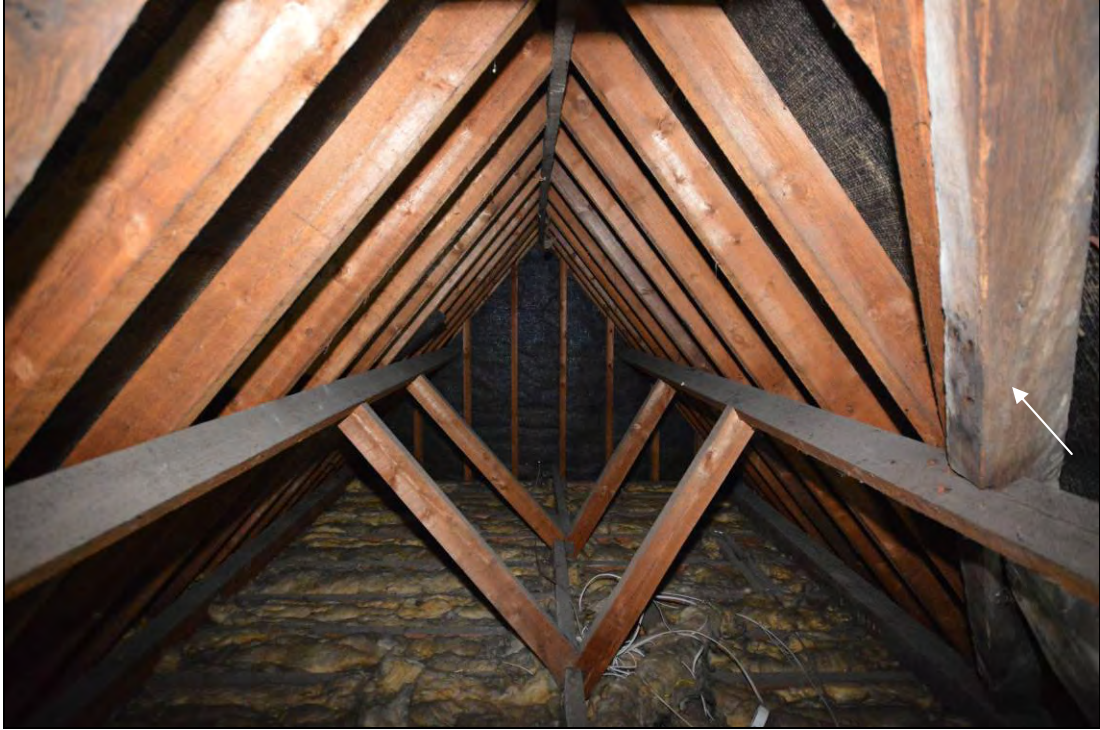
Plate 49: The interior of the roof added in 1939 over bay 6 of the cross-wing (south hip rafter of the phase 3 roof just visible – arrow)

10.2.11 There are no accompanying details at this pre-application stage pertaining to the treatment of a ceiling within this part of the house: if the plan is to remove the existing ceiling and create a high-set one with rooflights to each slope, then it is recommended that the ceiling and skelings remain plastered. This is due to the fact that the roof structure was never intended to be exposed to view, commensurate with the late date of construction.

10.2.12 Recommendations included in the pre-application stage report for the new rooflights to be placed over existing rafters (if that can be executed without undue build-up) in order to avoid cutting out any fabric, has been taken on board for this revised scheme.

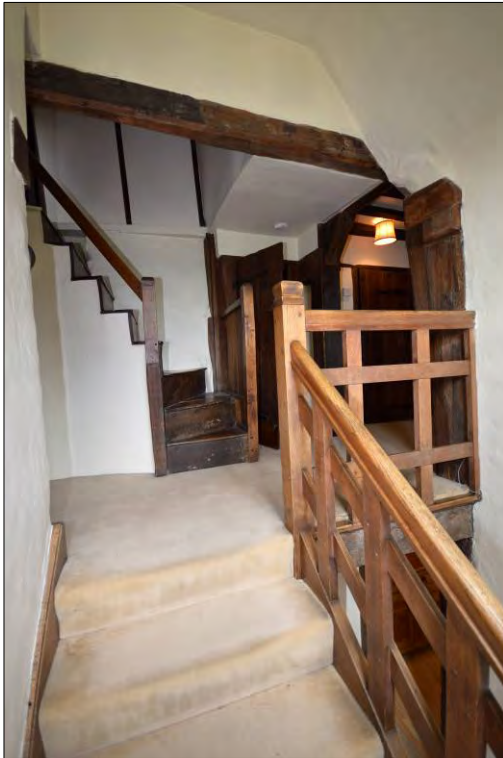
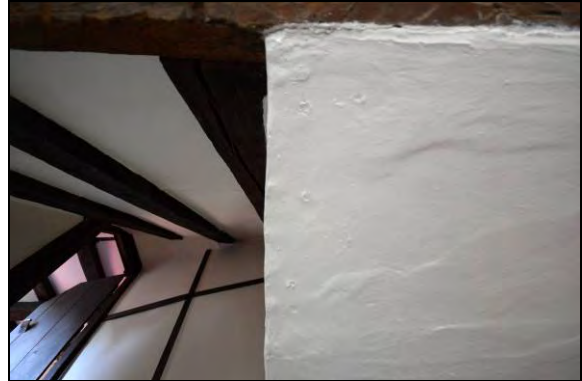
Plate 50: View towards the plasterboard ceiling adjacent to the attic staircase on the first floor

detail of the plaster-board nailed in place

10.2.13 It is proposed that an area of ceiling to the east of the attic staircase (bays 3 and 4) is removed to expose the crown-post roof of the early 15<sup>th</sup> century building. The ceiling structure appears to be the result of 20<sup>th</sup> century intervention, comprising plasterboard nailed to ceiling joists (Plate 50).

10.2.14 The removal of modern material, in conjunction with the 20<sup>th</sup> century fabric that encloses the chimney stack will certainly enhance and better reveal the phase 1 and 2 fabric allowing the remains to be visually accessible as originally intended.

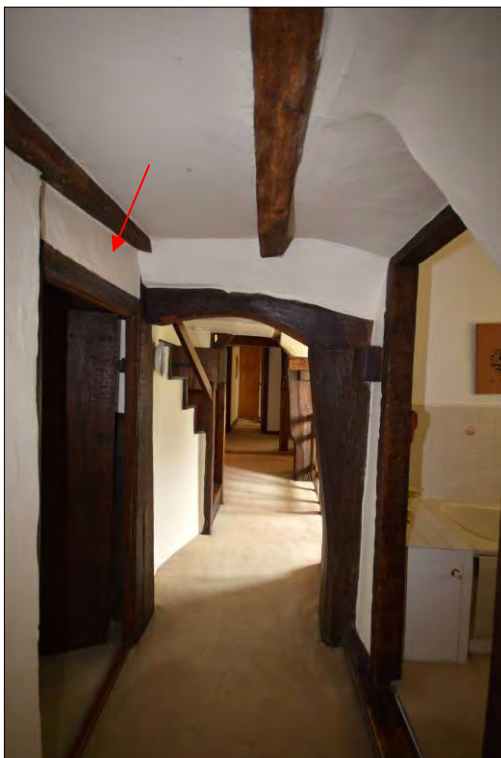
Plate 51: The entrance to the hall chamber in the partition in bay 2 (arrow)

10.2.15 It is proposed that the doorway in the partition leading to the hall chamber (bay 2) is increased in height and the door altered and lengthened to include additional timber at the base to correspond with the taller opening.

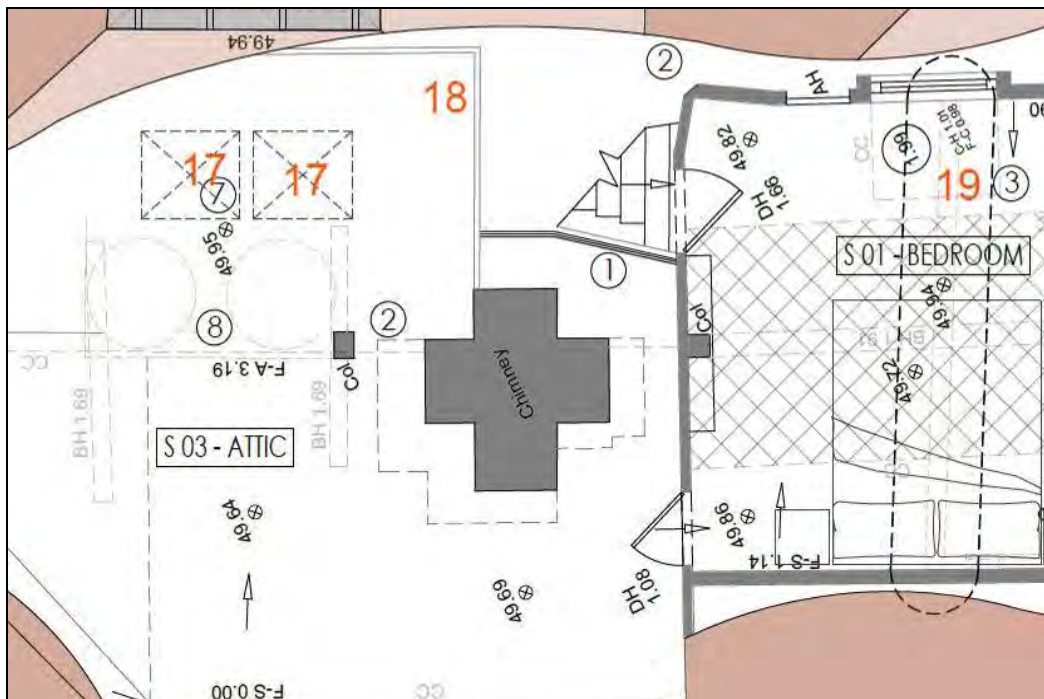
Plate 52: New partitions proposed in bay 3, east side

## 18. New partitions in bay 3, east side (1 and 2)

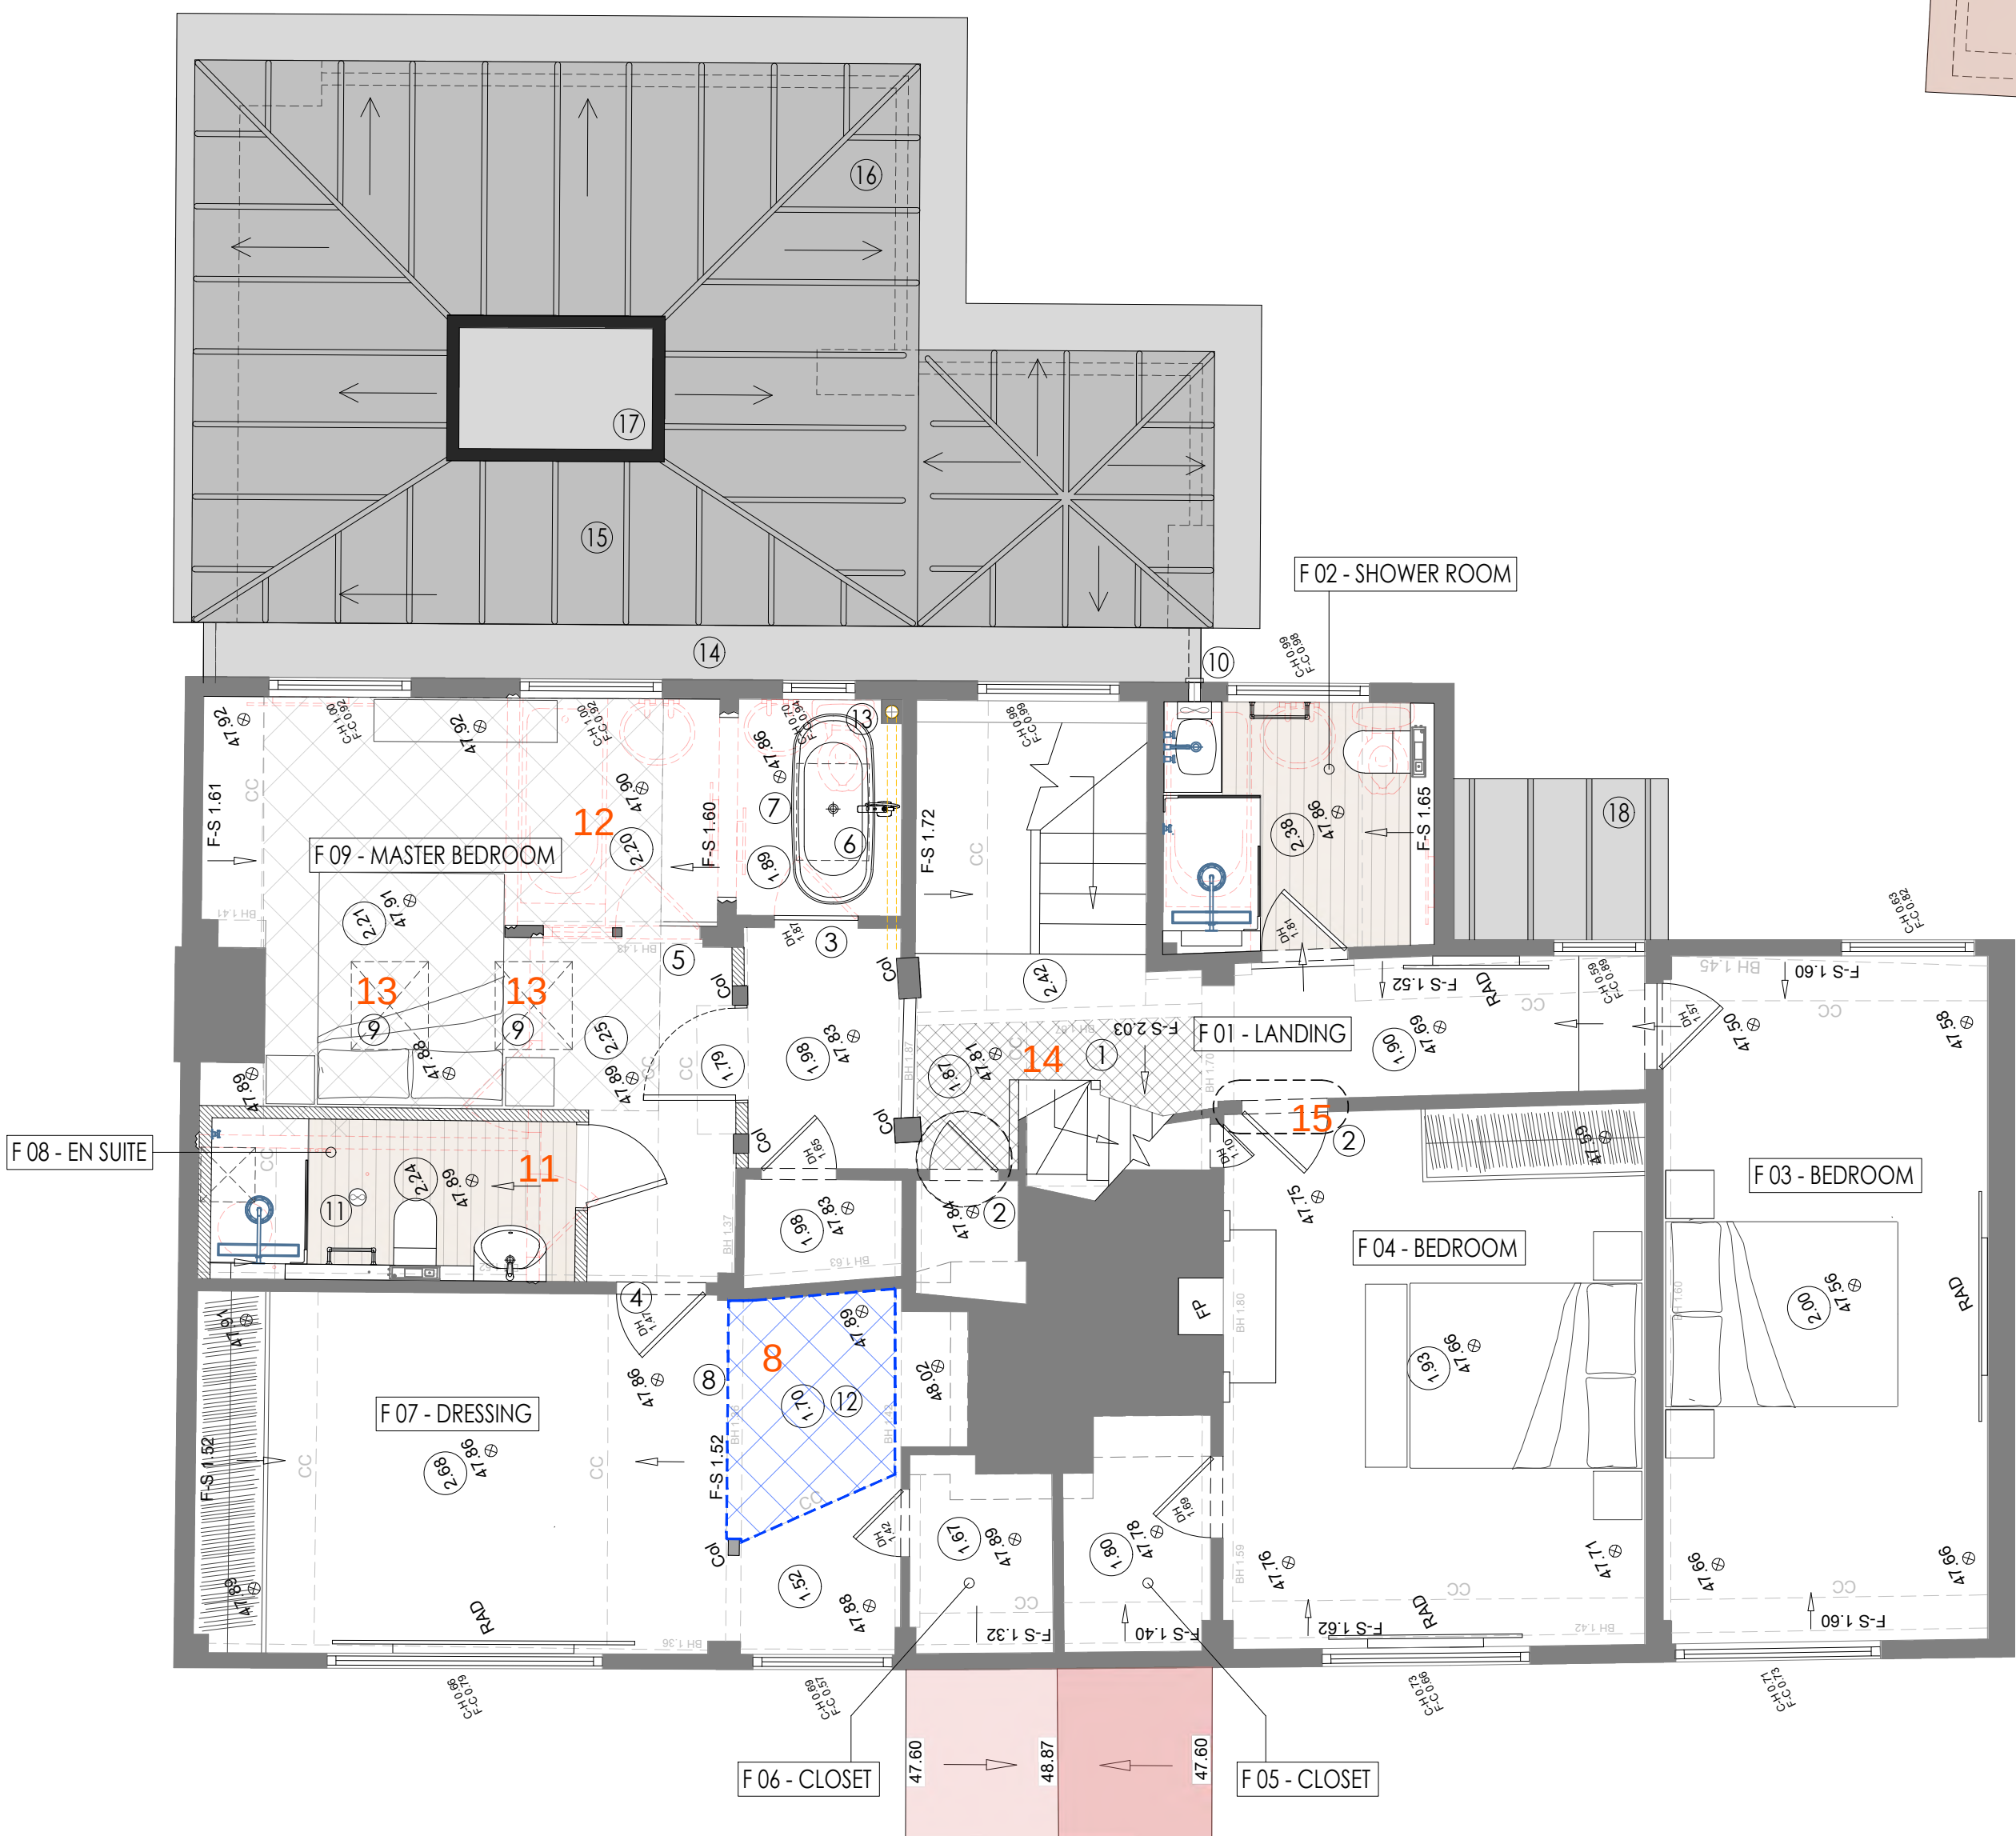
FIRST FLOOR GENERAL ARRANGEMENT - AS PROPOSED  
SCALE @ 1:50 ON AN A1 SHEET

- First Floor General Arrangement Key:
- 1 - Existing plasterboard ceiling to be removed to allow for opening up to the rafters, increasing visibility of the four-way braced Crown Post

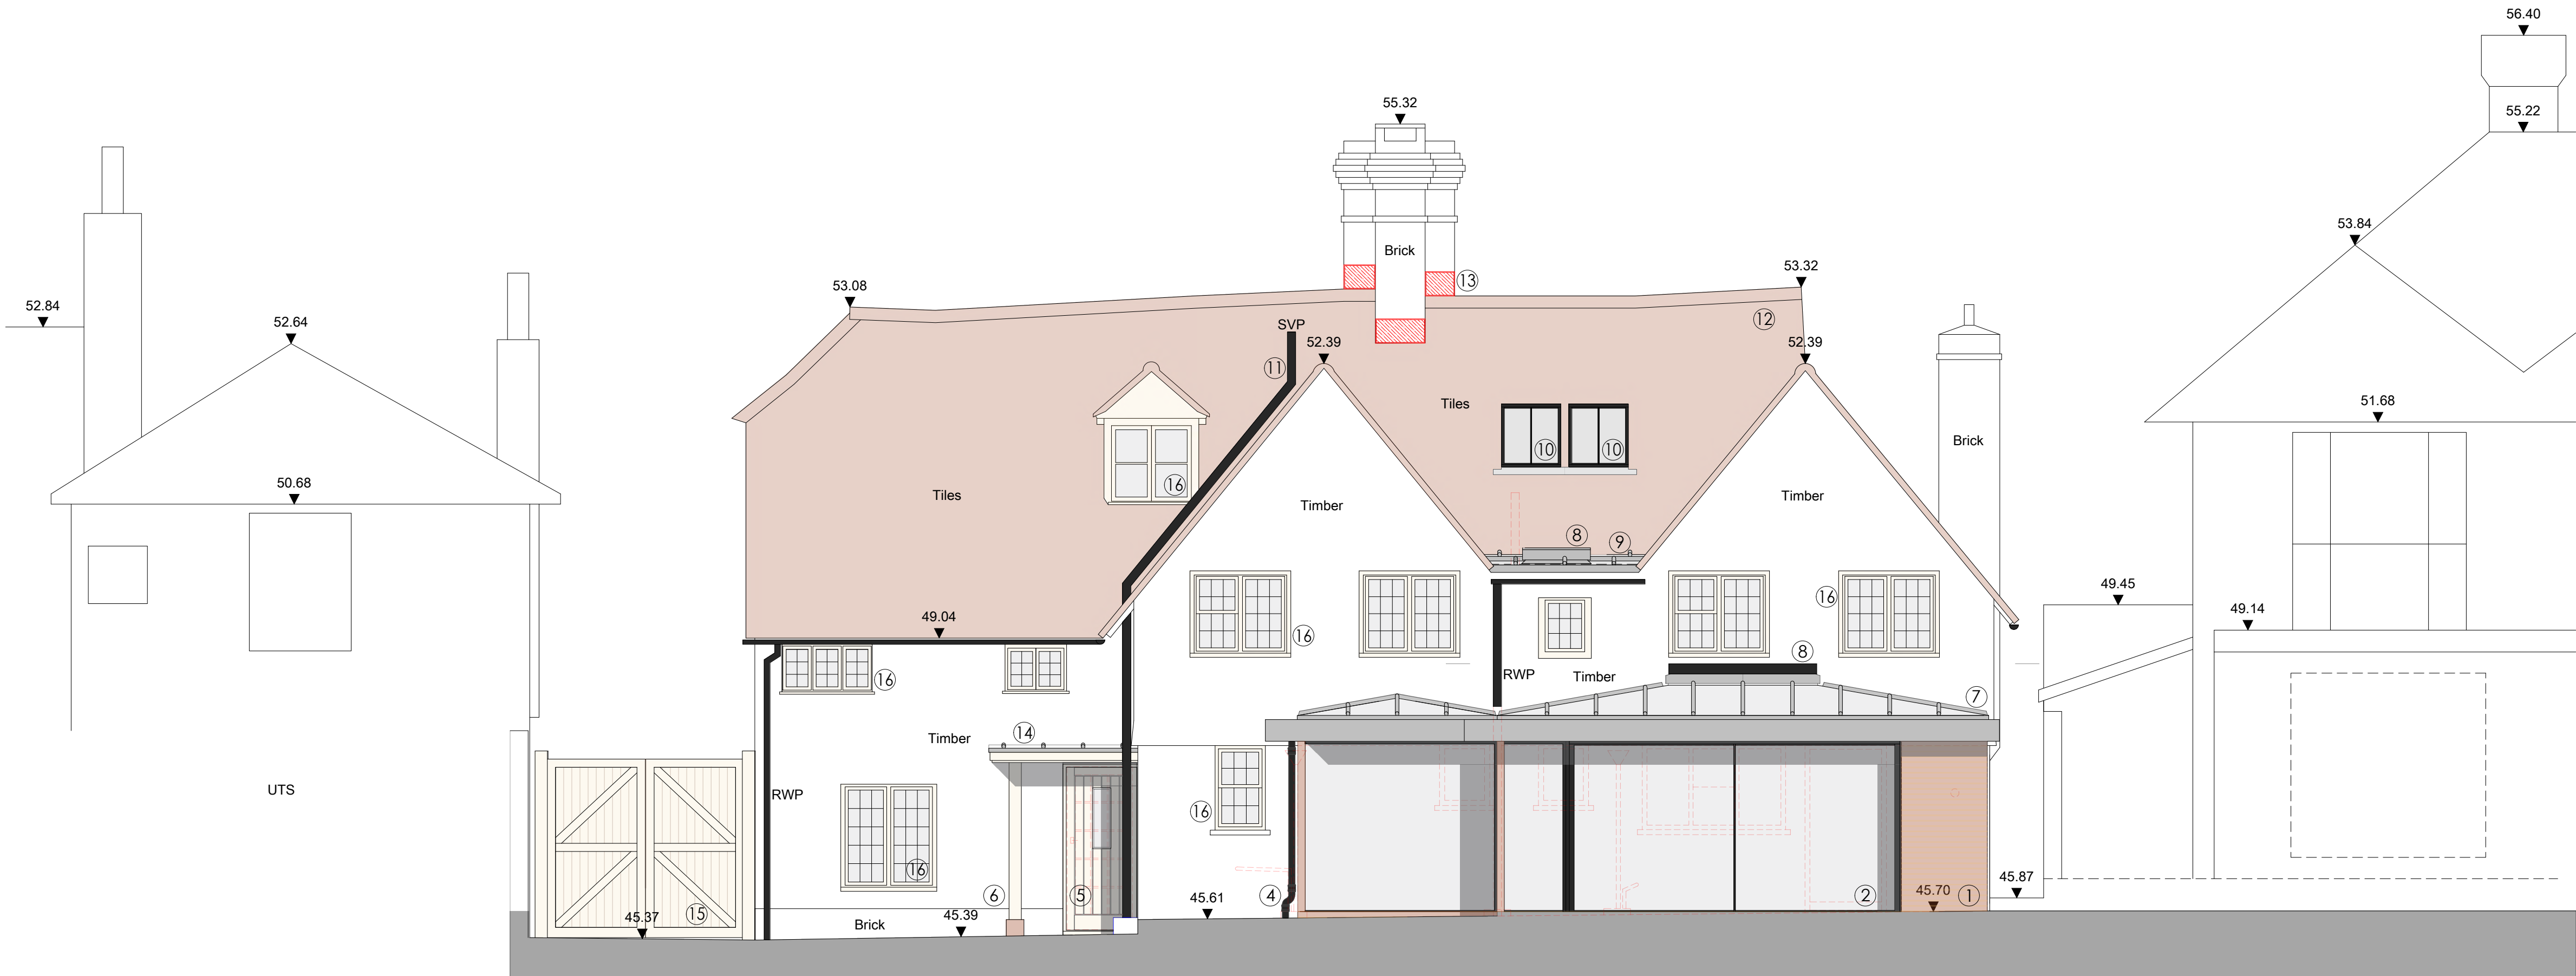
EAST ELEVATION - AS PROPOSED  
SCALE @ 1:50 ON AN A1 SHEET

- 13 - New Code 5 lead flashings to existing chimney
  - 14 - Code 5 lead to Porch roof, with painted timber fascia and soffit
  - 15 - Replacement timber gates, with a painted finish in white

- 16 - Replacement windows with slim double-glazed panes, in Crittall-style metal frames set in timber sub-frames
  - 17 - Structural glass link to separate new extension from the existing Listed Building
