**DM/25/1123 - EASTLANDS FARMHOUSE MALTHOUSE LANE HURSTPIERPOINT HASSOCKS WEST SUSSEX BN6 9LA**

**Project****Project Name:** Eastlands Farmhouse - SW**Project Description:** CCTV Survey, trace & plot**Project Status:** Complete**Project Date:** 05/10/2025**Inspection Standard:** MSCC5 Sewers & Drainage GB (SRM5 Scoring)

## Section Inspection - 05/10/2025 - RWPX

## Section Inspection - 03/10/2025 - RGX

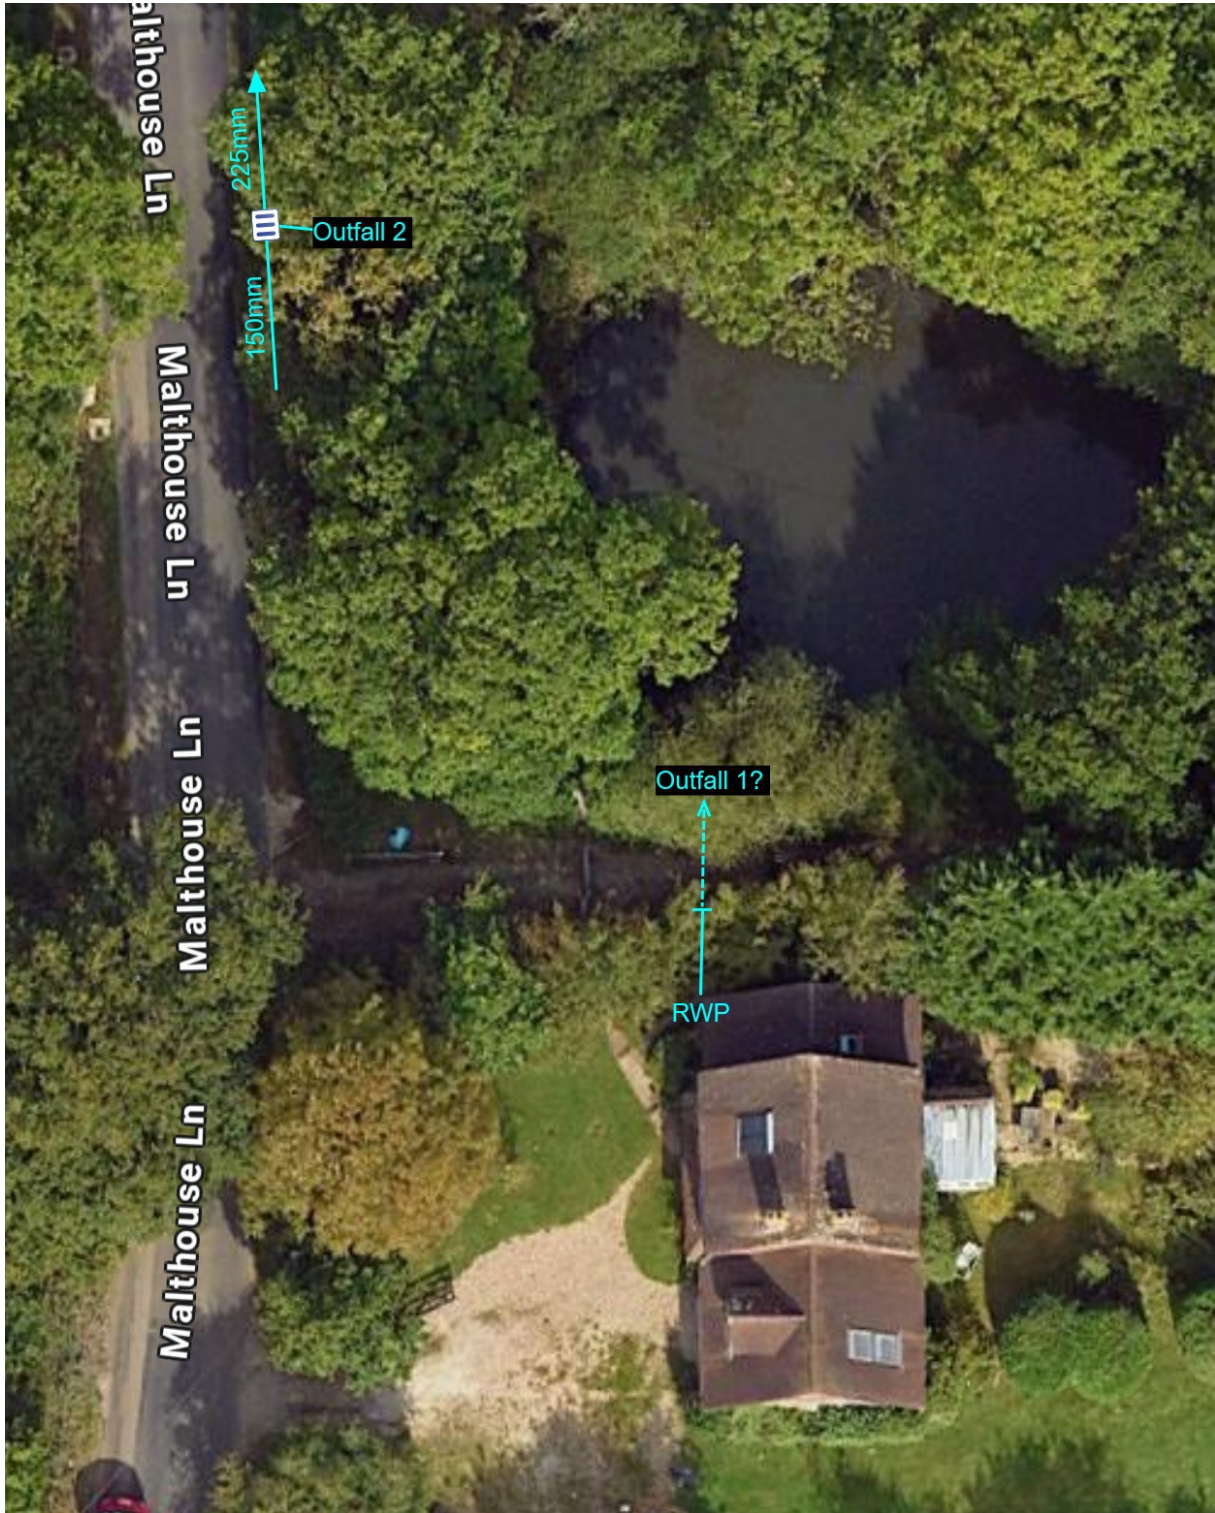
### Project Drawing, Page 'Eastlands Farm'

SDA response – The outlet has been exposed and CCTV traced (report attached) to the pond showing the 100mm pipe from the rainwater pipe is not only severely blocked but damaged thus requiring renewal. The survey was also able to prove that the pond has an outlet. Regarding the flowrates from the site, the 1.8 lit/sec is restricted run off rate given as less than the 10 year greenfield rate for the site boundary (see attached, the 30, & 100 year indicate 4.2 and 5.8 l/s greenfield rates). We have attached our GA drawing revised to suit the recent surveys.

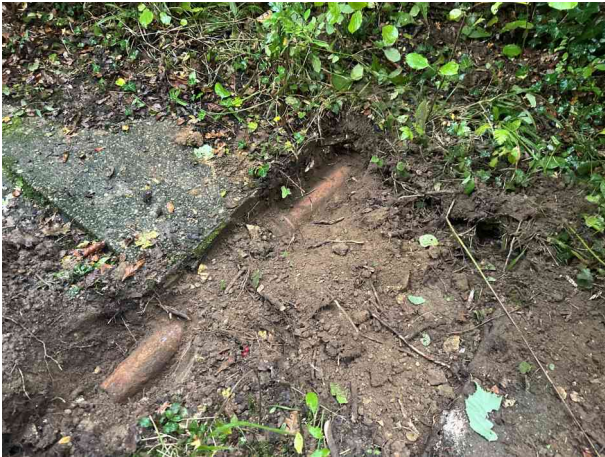
1, 0.00 m

Start node, manhole, reference: RWP, Exposed to confirm route.

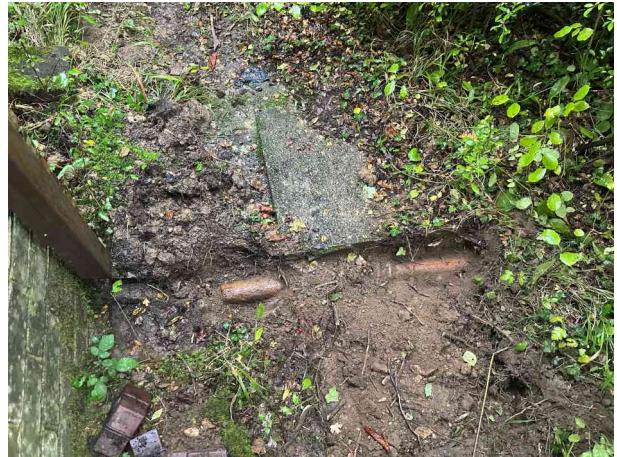
2, 0.00 m

Start node, manhole, reference: RWP, Exposed to confirm route.
