**PRELIMINARY BAT ROOST ASSESSMENT  
&  
GROUND LEVEL TREE ASSESSMENT**

LANE HOUSE  
37 DENMANS LANE  
LINDFIELD  
HAYWARDS HEATH

17<sup>TH</sup> AUGUST 2026

REF:25119

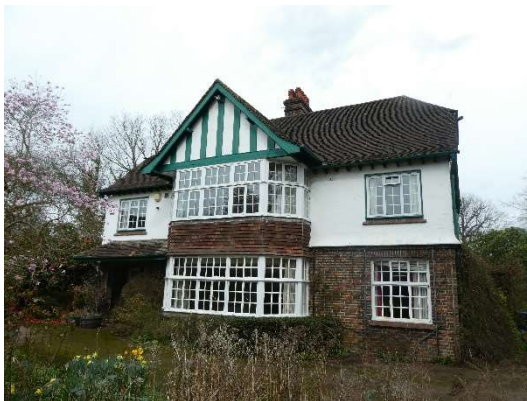
- 3.10 B1 was of brick construction with the upper walls rendered and painted white, with a small area of exposed timberwork associated with the south elevation gable end. A small area of hanging tiles was associated with a central bay window within the south elevation, hanging tiles were also associated with a north facing gable end and dormer window cheeks. All areas of clay hanging tiles were in good condition, with occasional raised edges to the tiles.

**Photograph 1:** South elevation of B1, showing tile hanging between the bay windows.

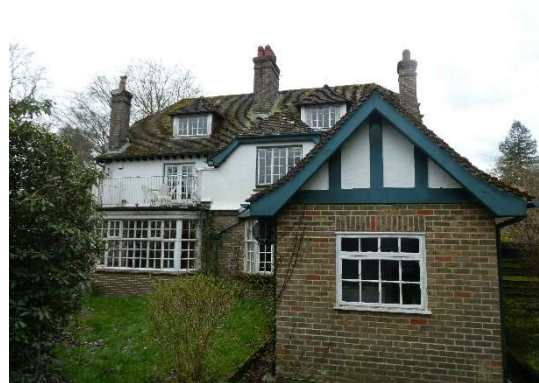
- 3.11 The roof was multi-pitched with several north elevation protruding gable ends. The main roof extent was half-hipped to the east and west, pitched north to south, and had two dormers within the northern roof pitch. All roof pitches were clad with manufactured clay tiles, a few were noted as raised upon the main southern roof pitch, with some slipped tiles on the roof pitches associated with the south elevation gable end, and gaps were noted under the hip tiles associated with the east elevation entrance roof area. The eaves were mainly closed, with the roof abutting the wall tops, however, some small gaps were noted along the east elevation of the ground floor extension extending north. Leadwork associated with chimneys was tight fitting.

**Photograph 2:** North elevation of B1 showing ground-floor northern gable ended extension and main roof dormers.

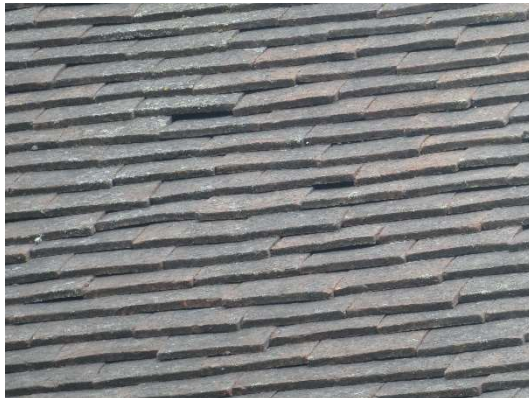
**Photograph 3:** Occasional gaps were present under roof tiles.

- 4.2 B1 supports a few potential bat roosting features and access opportunities associated with raised and lifted roof tiles, gaps under hip tiles and hanging tiles, and small gaps associated with isolated areas of eaves. Roof voids 1 and 2 are both of an overall small size, with reduced height, making these areas sub-optimal to support void dwelling bat species.

- 4.4 Owing to the site's location, the presence of a small number of potential roosting features and access opportunities, and the survey constraints, B1 is identified as having Moderate potential to support roosting bats during the bat active period.

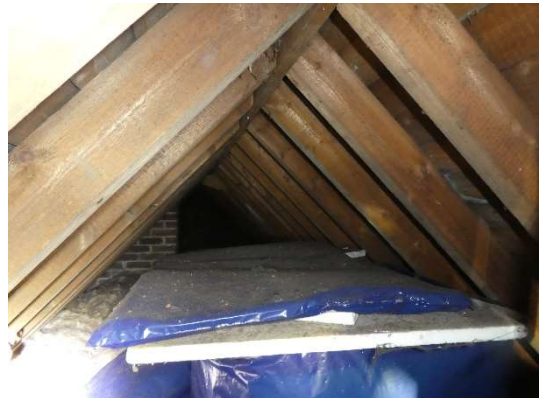
- 2.13 Both roof voids within Building 1 could only be inspected from the access hatches owing to the restricted height and the presence of water tanks in void 1, and potentially unsafe joists within void 2. However, an adequate view was gained to identify the presence of any significant accumulations of bat droppings.

- 3.13 Located within the main roof of the building, it measured approximately 11.6m (l) x 2.1m (w) x 1.2m (h). Rockwool insulation overlaid fibreglass insulation between the joists, and three enclosed water tanks were situated to the west extent of the roof void (immediately next to the access hatch) with associated pipework (this prevented access to the roof void and limited visibility along the length of the void). The underside of the roof pitches were boarded and exposed timbers included a ridge board and rafters.

**Photograph 4:** Roof Void 1 at B1 showing the immediate water tanks and reduced size of the roof void.

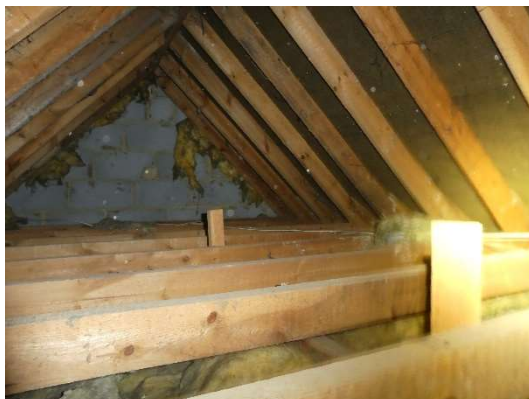
- 3.14 Located within the ground floor, north extension of the building, the roof void measured approximately 6.8m (l) x 2.6m (w) x 1.2m (h). A brick wall created a partial partition within the void; however this had a hole broken through, linking the two areas. Fibreglass insulation was present between the joists, which showed possible signs of water damage (in turn the roof void was not accessed). A small area of the floor of the roof void (kitchen ceiling) had fallen down. The southern extent of the void had timber boarding under the roof pitches, with bitumen felt lining the northern extent of the roof pitches. The exposed roof timbers included a ridge board and rafters.

**Photograph 5:** Northern extent of Roof Void 2 at B1.

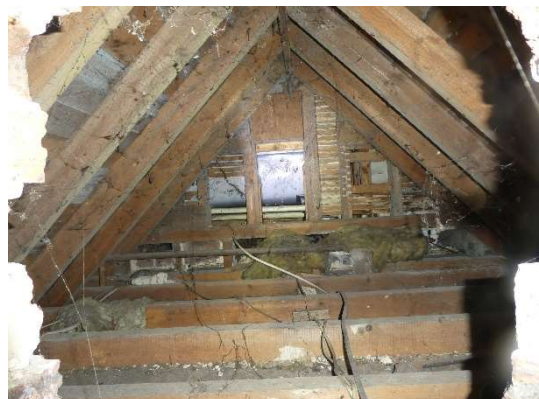
**Photograph 6:** Southern extent of Roof Void 2 at B1.

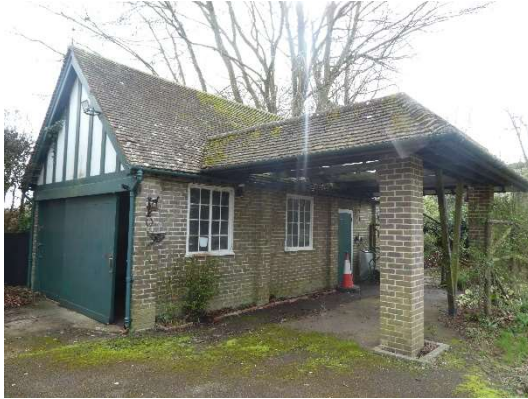
- 3.17 An open car port was attached to the west elevation of main area of the building. This was supported by brick pillars, with a tiled roof surround and Perspex central area, supported by timbers. The roof tiles were in good condition and tight fitting.

**Photograph 7:** North and west elevations of B2, showing the attached car port.

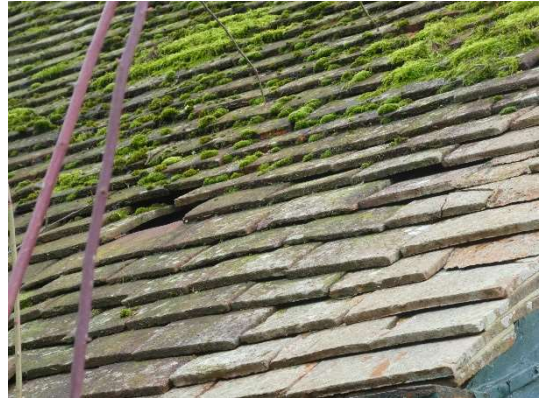
- 3.15 B2 was constructed of brick with a timber frame and rendered panels associated with the north elevation gable end. Timber sliding doors were present within the north elevation; these had a wire mesh above. Timber barge boards were present on the gable ends and the roof was generally pitched east to west, clad in clay tiles. An area of slipped and raised roof tiles was present upon the lower area of the western roof pitch, towards the southwest corner. A tree was overhanging the eastern roof pitch. Some very small gaps were noted along the west elevation eaves.

**Photograph 8:** A few slipped roof tiles upon the western roof pitch.

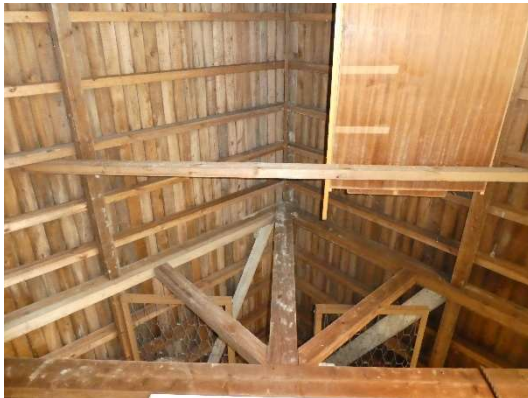
- 3.16 Internally, B2 was separated into two areas, a garage space to the north and a store to the south. The roof pitches were lined with timber boarding and the roof structure included exposed rafters, a ridge board and tie beams. There was moderate natural light levels to both areas. The glazing within the south elevation windows was broken, but this had been internally covered with plastic sheeting.

**Photograph 9:** Roof area within the northern garage space.

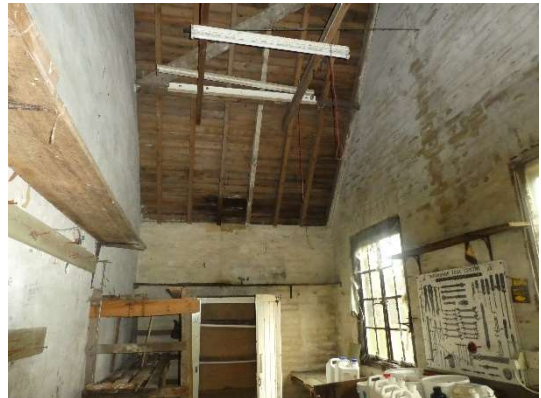
**Photograph 10:** Storeroom within the southern extent of B2.

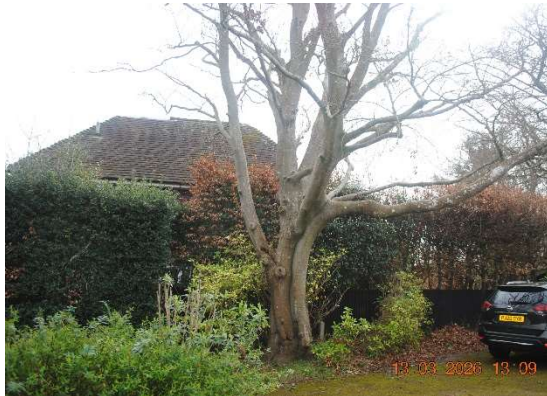
| Reference | Species | Description | Suitability | Evidence | Further Survey Required |
|---|---|---|---|---|---|
| <b>T32</b> | Beech | <ul style="list-style-type: none"> <li>• A mature specimen located to the east of the existing driveway.</li> <li>• A split limb (NE) 7m high, upward facing. Did not appear to extend to form a cavity.</li> <li>• A limb wound 2m high on main trunk. Upward facing. Did not appear to extend to form a cavity.</li> <li>• Knot holes on secondary branches (N; E and W) between 1m and 5m high. Did not appear to extend into branch.</li> <li>• Flaking bark on single branch Exposed to elements.</li> <li>• Split on branch (S) 8m high. Upward facing. Did not appear to extend to form a cavity.</li> <li>• No woodpecker holes were observed.</li> <li>• No ivy cover was present.</li> </ul> | <p>PRF-1.</p> <p>Small number of recessed splits/flaking bark may provide sheltering opportunities by small numbers of individual bats. Low potential.</p> | None | No |

**Photograph 11:** T32.

- 5.7 Tree 32 must be felled adopting a precautionary approach. This must be felled under an ecological watching brief by a suitably licenced ecologist. The tree must be felled outside the hibernation period for bats and when this species is considered to be least vulnerable. Felling must also avoid the breeding bird season; therefore, tree felling is recommended to be carried out between **1<sup>st</sup> September** and **1<sup>st</sup> November inclusive**. The ecologist will inspect the previously identified features immediately prior to felling, where access allows. The tree may then need to be section felled, with sections lowered to the ground, ensuring any features that could not be fully inspected remain intact within the felled section. The felled section in question must then be placed on the ground near to the tree ensuring any potential exit points remain unblocked. These sections must be left *in situ* for 24 hours before being removed off-site or relocated to the wider site if dead wood is being retained on-site.

- 5.10 To replace the loss of potential roosting features associated with the beech tree, a single bat box will be installed on a suitable retained tree. The box should be sited away from any low branches at a height of at least 4m. The following make/model is recommended although there are a range of suitable boxes on the market:

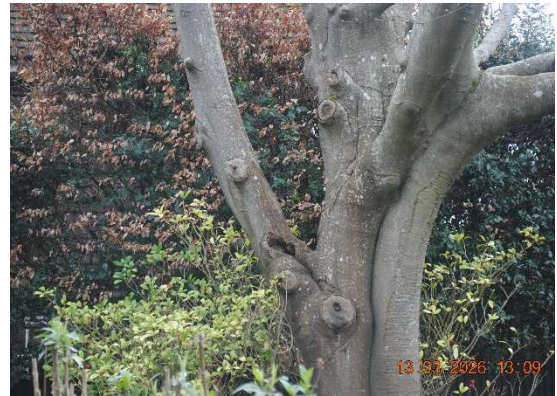
**Photograph 12:** Showing knot holes on T32.

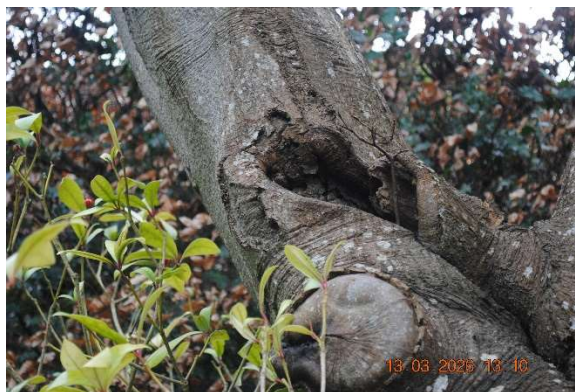
**Photograph 13:** An upward facing split on a branch (T32).
