## Bat Emergence Echolocation Surveys Report

Forest Lodge, Cross Colwood Lane  
Bolney, West Sussex, RH17 5RX

**Date:** 11<sup>th</sup> August 2025

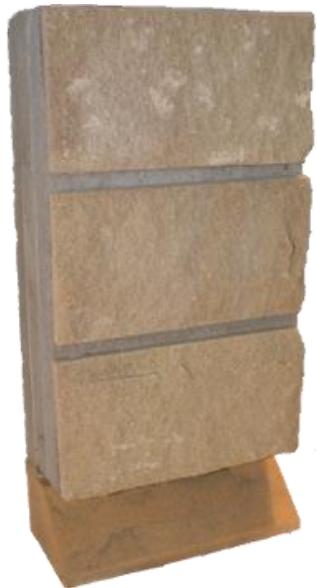
Bat Box	Notes	Bat Box Image
Habitat built-in bat box 001 or similar* 2 no.	<p>The Habitbat Bat Box is a large, solid box made of insulating concrete which provides an internal roost space, and can be seamlessly integrated into the fabric of a building as it is built or renovated. Suitable for most species commonly found in the UK, this single chambered unit features an integrated V system to increase the surface for bats to roost against, whilst allowing them to move around.</p> <p>The Habitbat Bat Box can be faced with a number of products to suit the design build. This includes, brick, block, stone, wood or a rendered finish, ensuring the box is unobtrusive and aesthetically pleasing.</p> <p><u>Unfaced</u>- There are a choice of 3 plinth colours are available: smooth blue, smooth red, or buff.</p> <p><u>Standard Facing</u>- This box is faced in standard smooth blue or red brick and is ideal for new builds.</p> <p><u>Bespoke Facing</u>- This box is made to order with a choice of finishes.</p> <p><b>Dimensions:</b> 215 x 440 x 102 mm plus facing bricks  <b>Material:</b> Concrete plus facing  <b>Weight:</b> approximately 7 kg</p>

**Roosting Bats** – Install two built-in bat boxes suitable for crevice-dwelling species, incorporated into the new building design at a height of 3–5 metres, orientated south or west, with a clear, unobstructed flight path to the entrance. Boxes should be maintenance-free, and any future checks must be carried out by a licensed bat surveyor. No external lighting should be positioned close to the bat boxes, and if lighting is necessary nearby, it should be directed away from the entrances.
