**LAND AT BIRCH TREE FARM,  
CUCKFIELD ROAD, ANSTY, RH17 5AG**  
PHASE II CONTAMINATION  
ASSESSMENT  
**BIRCH TREES FARM**  
23<sup>RD</sup> JANUARY 2026  
**LS8990 A**

| Title: | PHASE II CONTAMINATION ASSESSMENT | |
| Project: | RESIDENTIAL DEVELOPMENT | |
| Reference: | LS8990 A | |

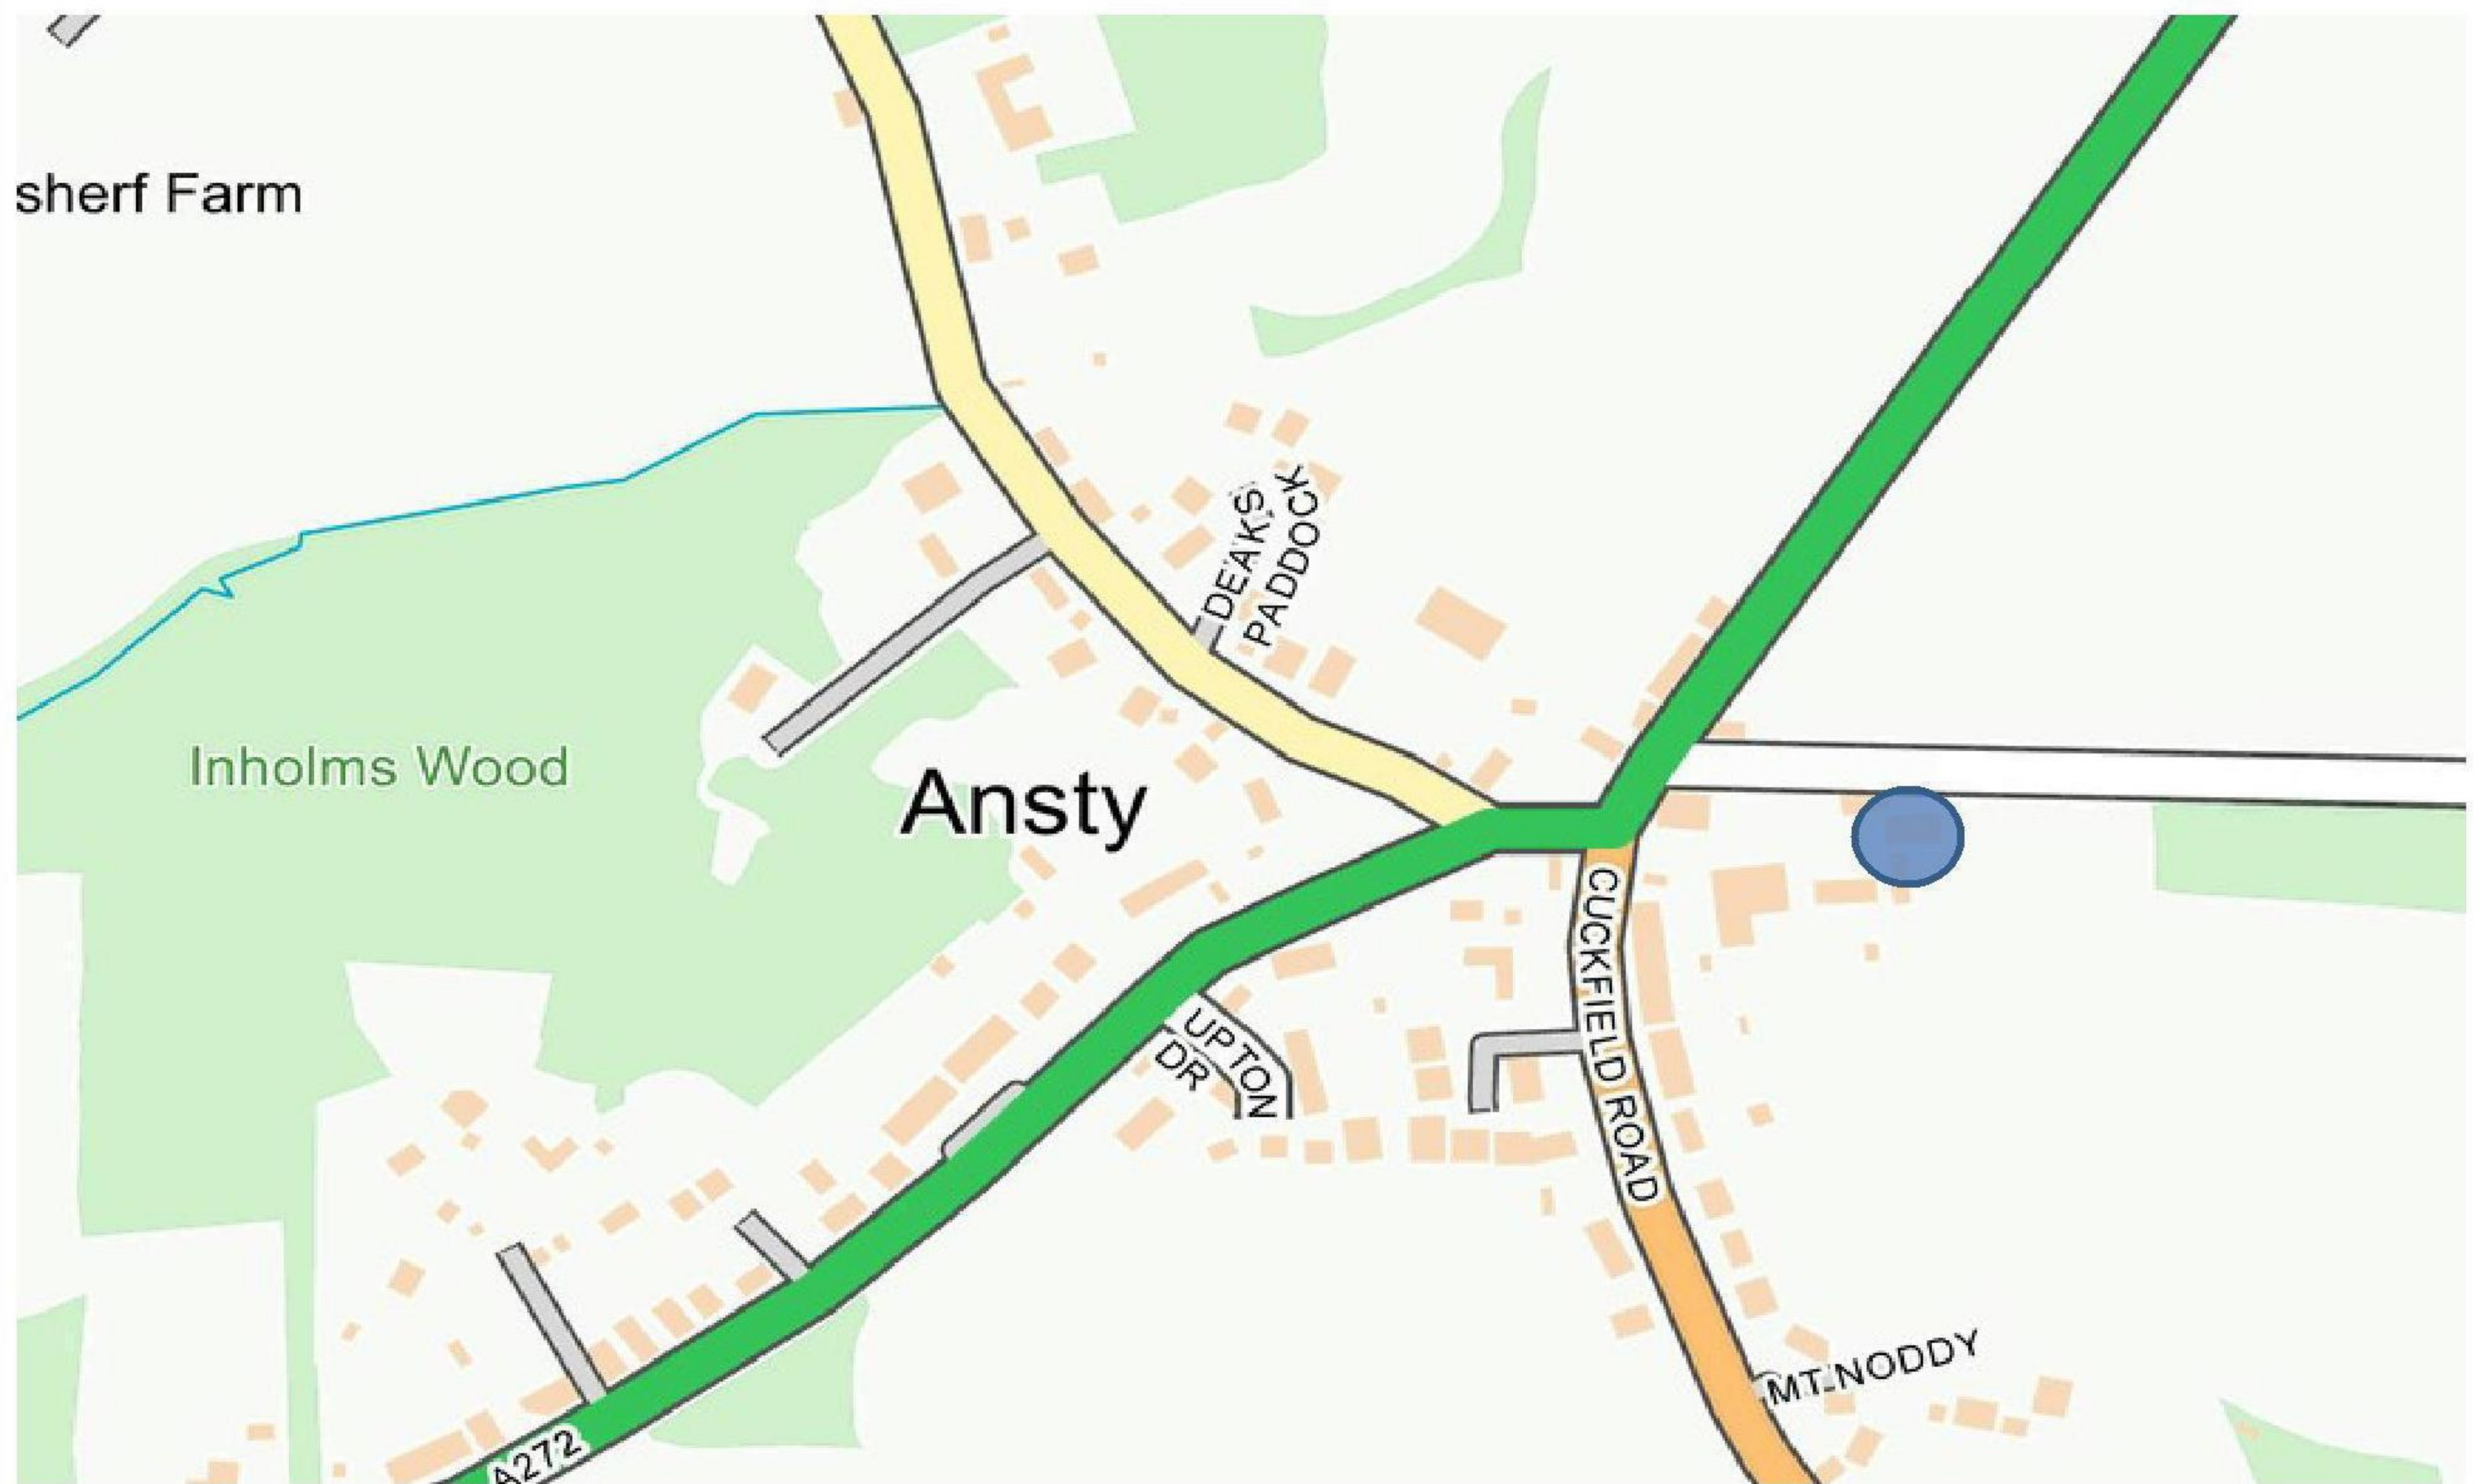
| | PROJECT: Birch Trees Farm, Ansty, RH17 5AG | | | FIGURE 1 |

| | TITLE: Site Location | | | REF: LS8990 |

Land Science was instructed to undertake a Phase II Contamination Assessment in relation to the proposed redevelopment at Land at Birch Tree Farm, Cuckfield Road, Ansty, RH17 5AG. The location is shown on Figure 1, which is centred at grid reference TQ 29270 23298.

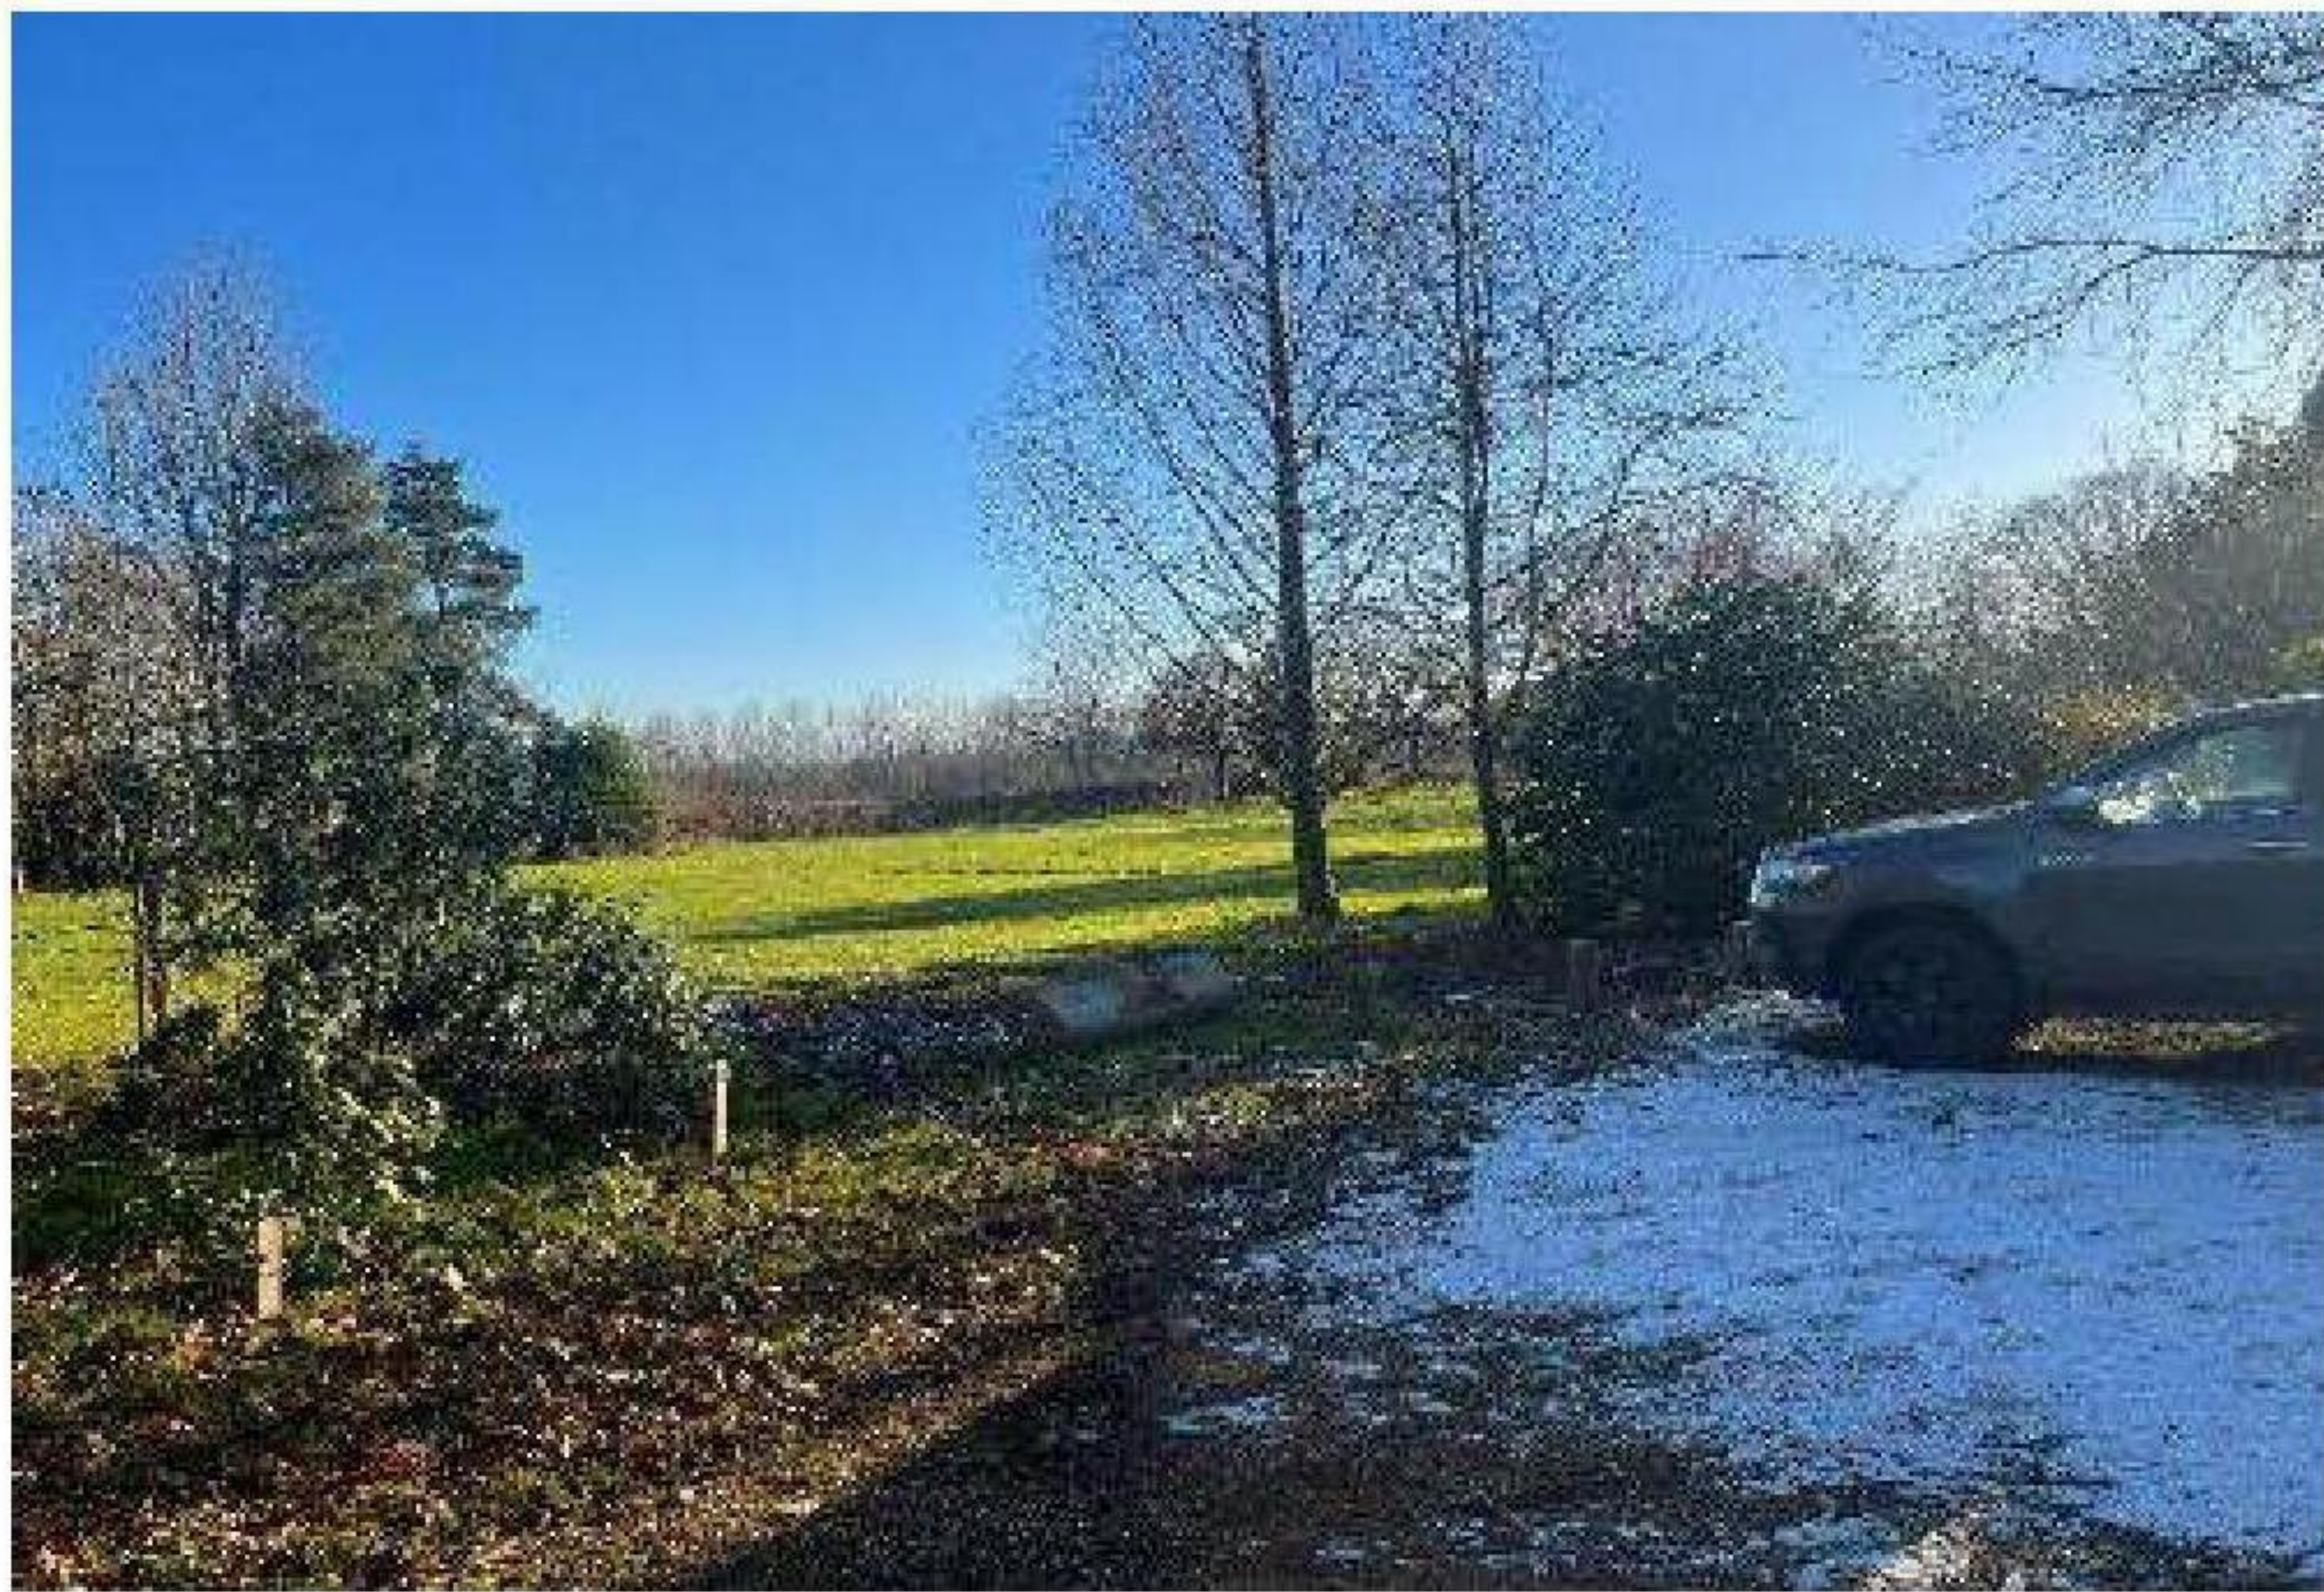
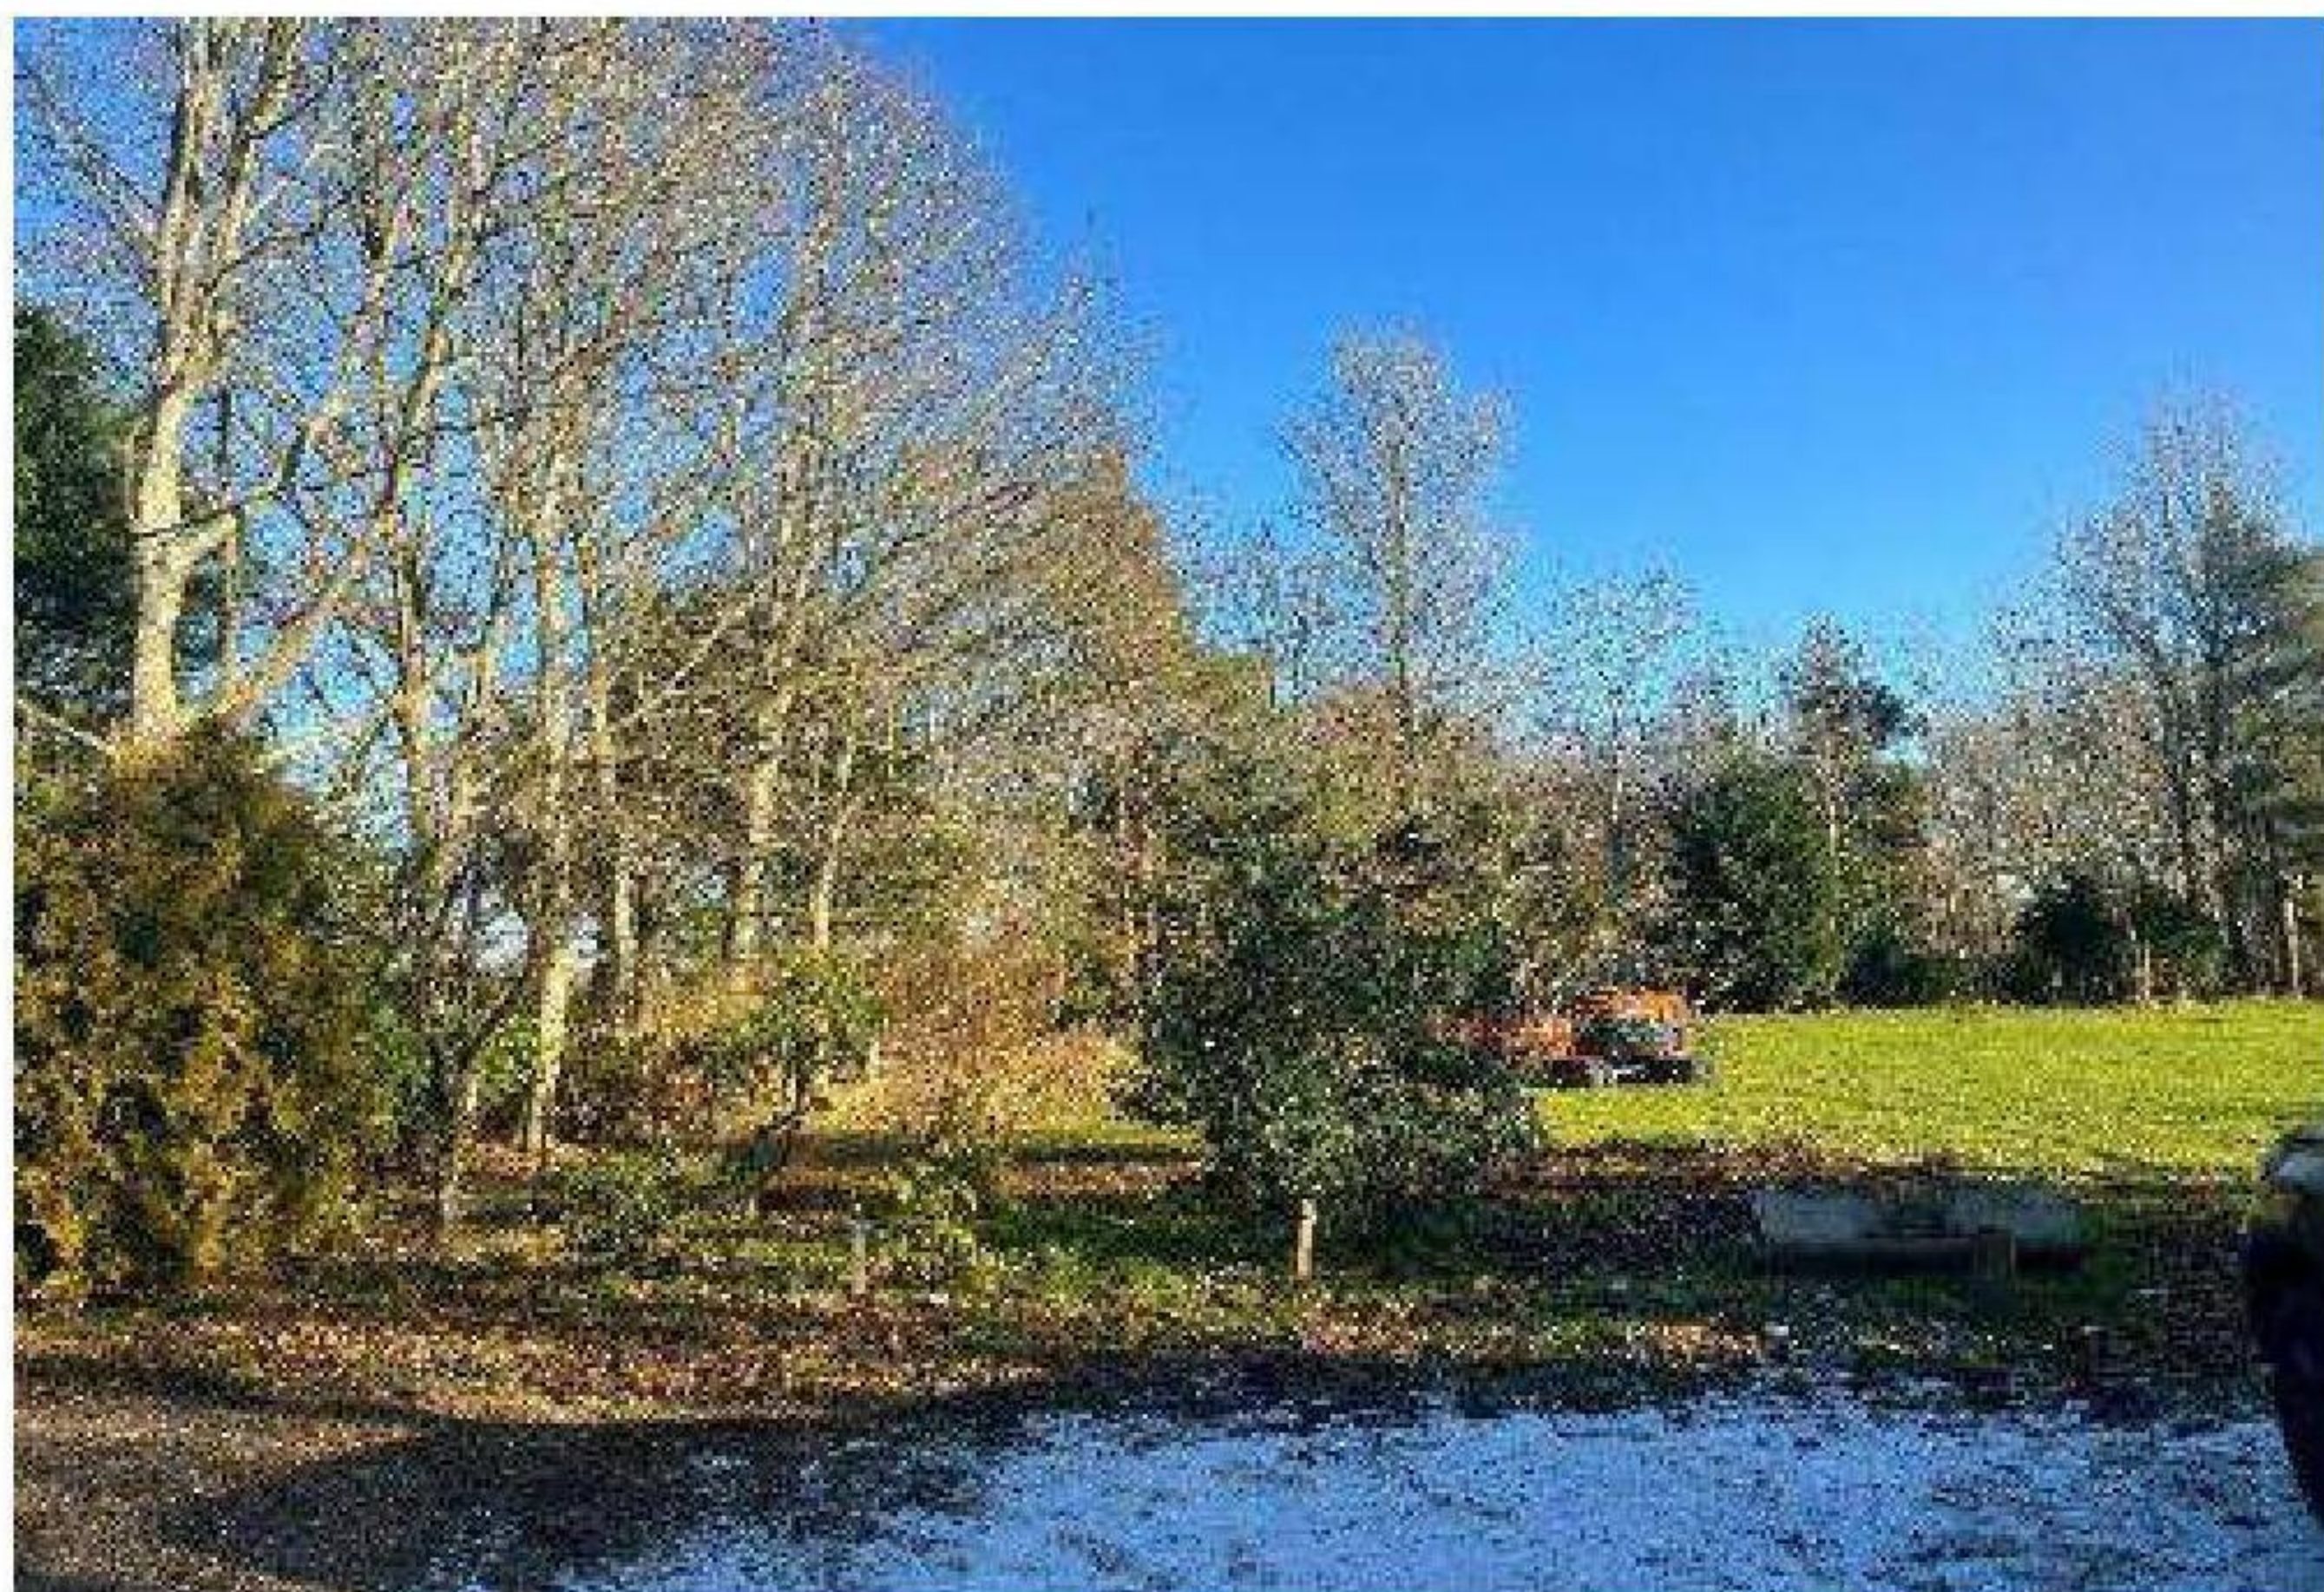
| | PROJECT: Birch Trees Farm, Ansty, RH17 5AG | | | Photos 1 to 3 |

General site photographs

| | TITLE: Site Photographs | | | REF: LS8990 |

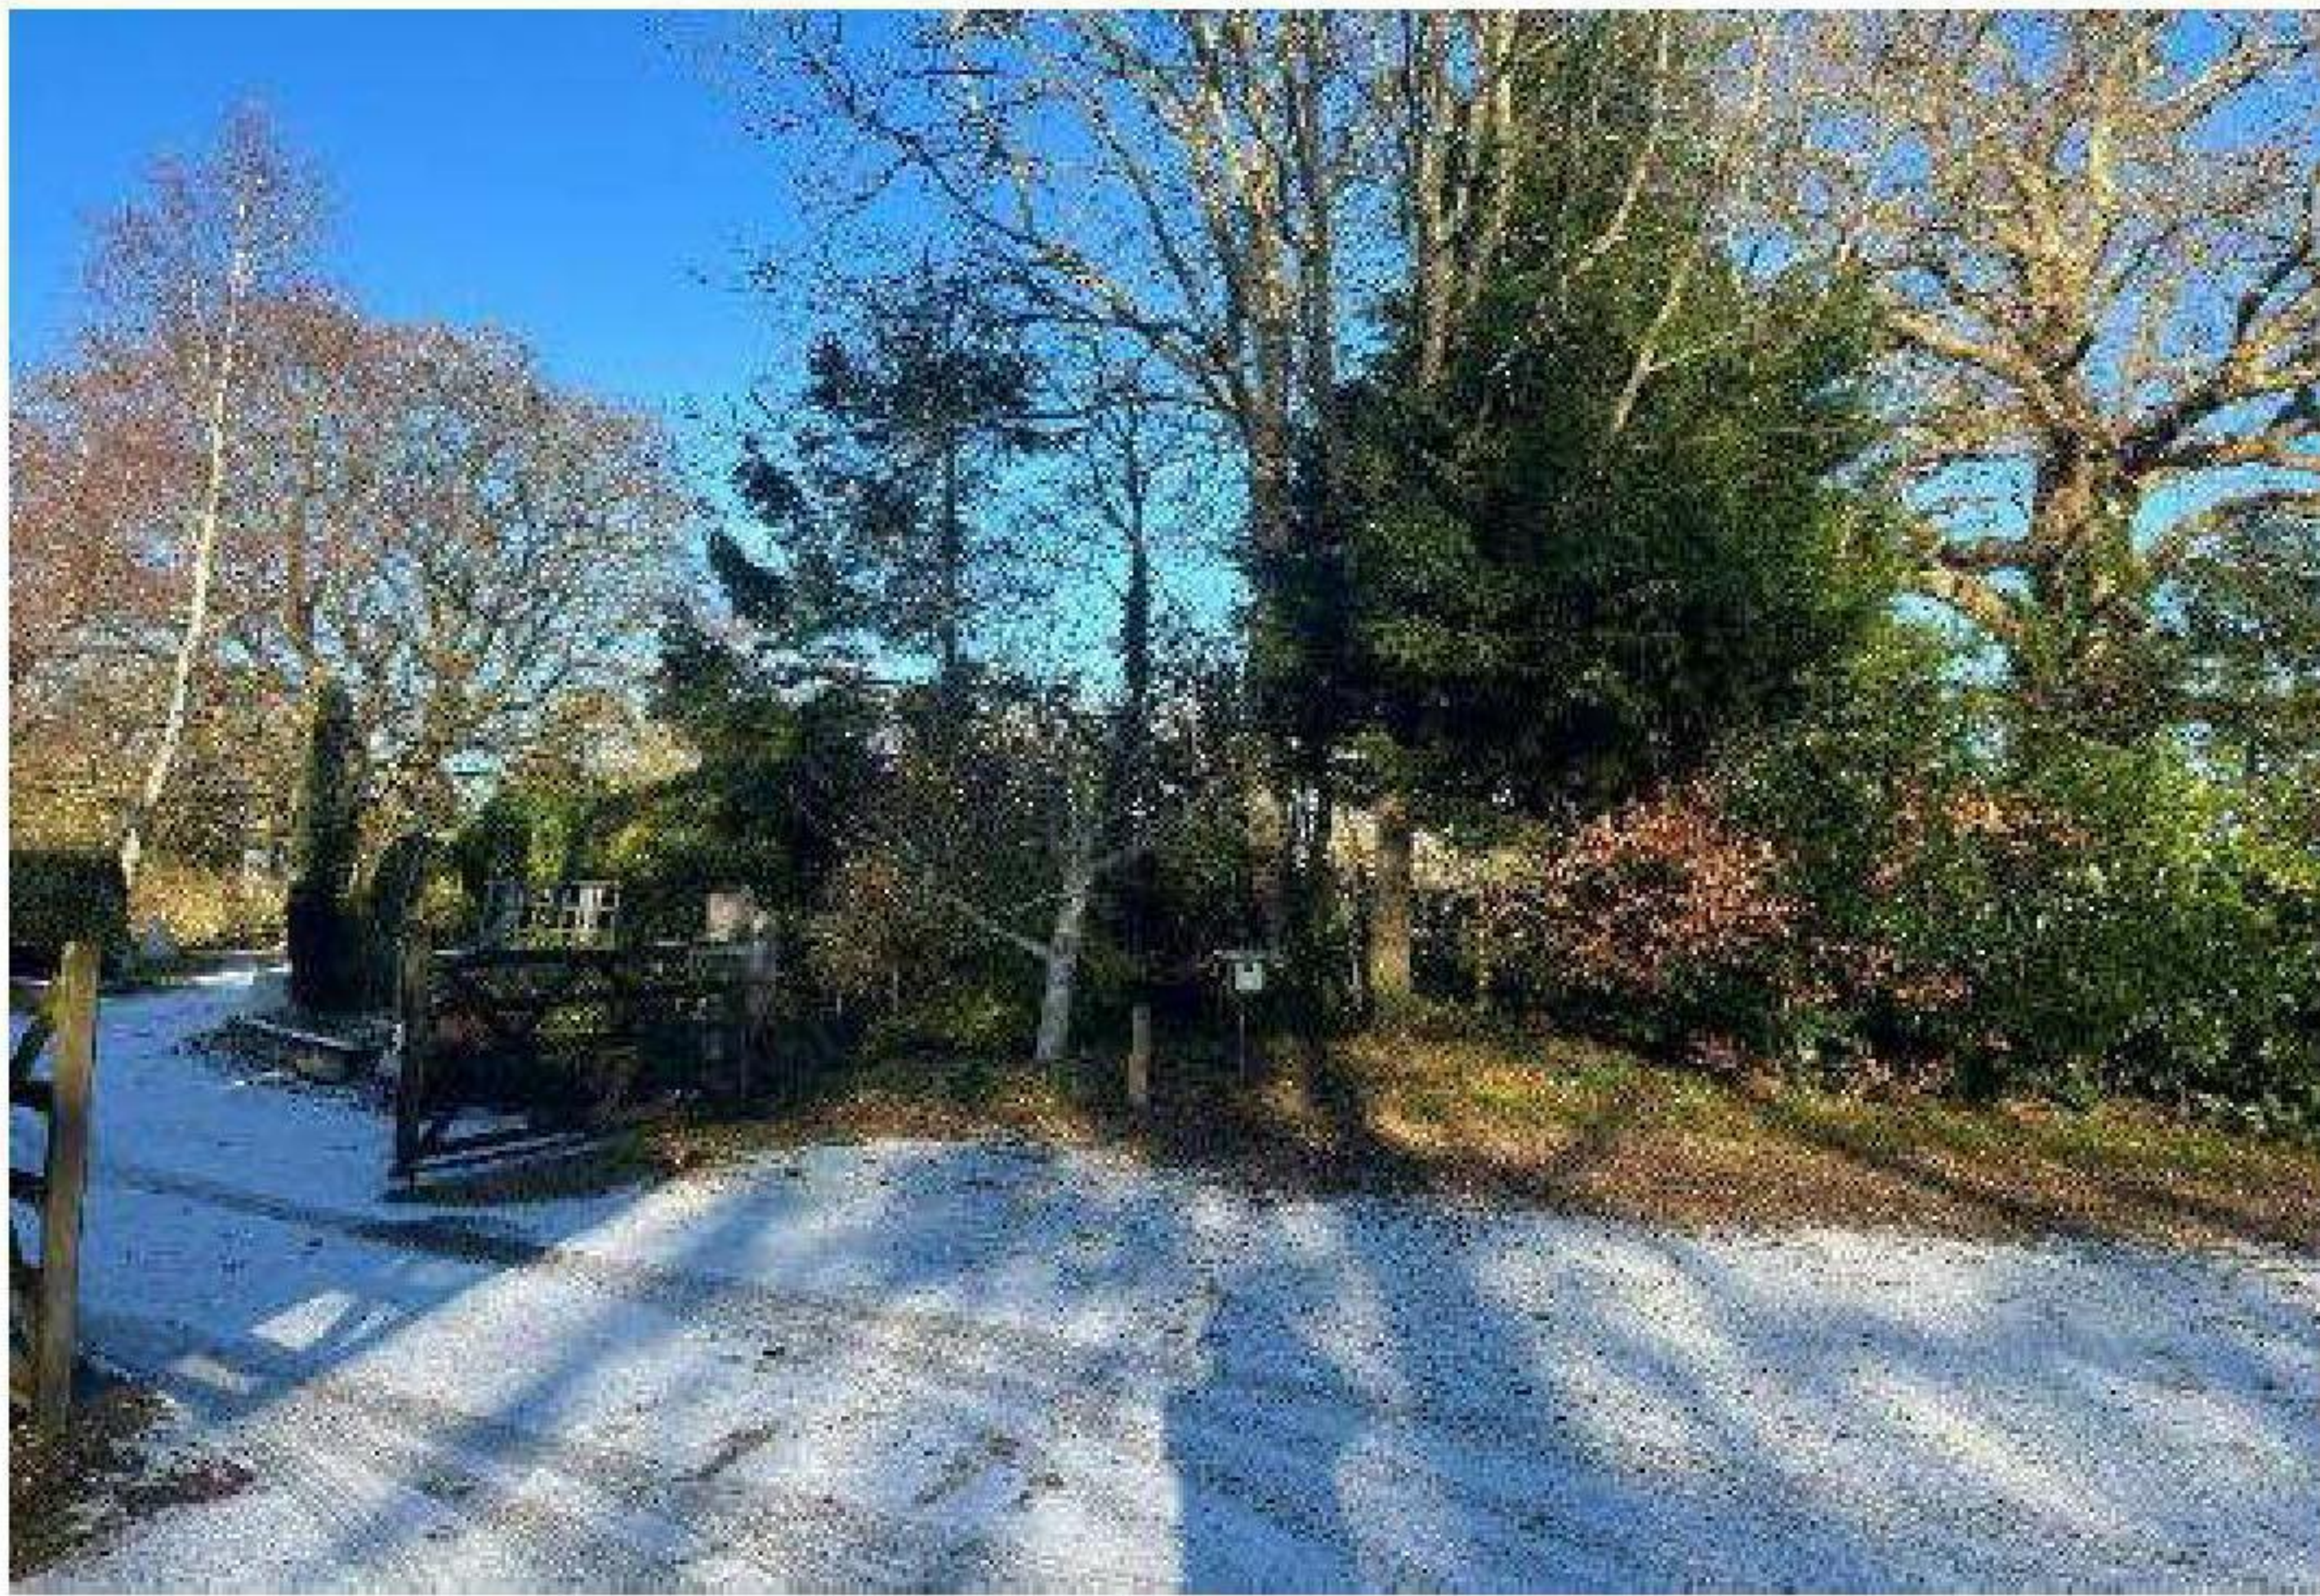
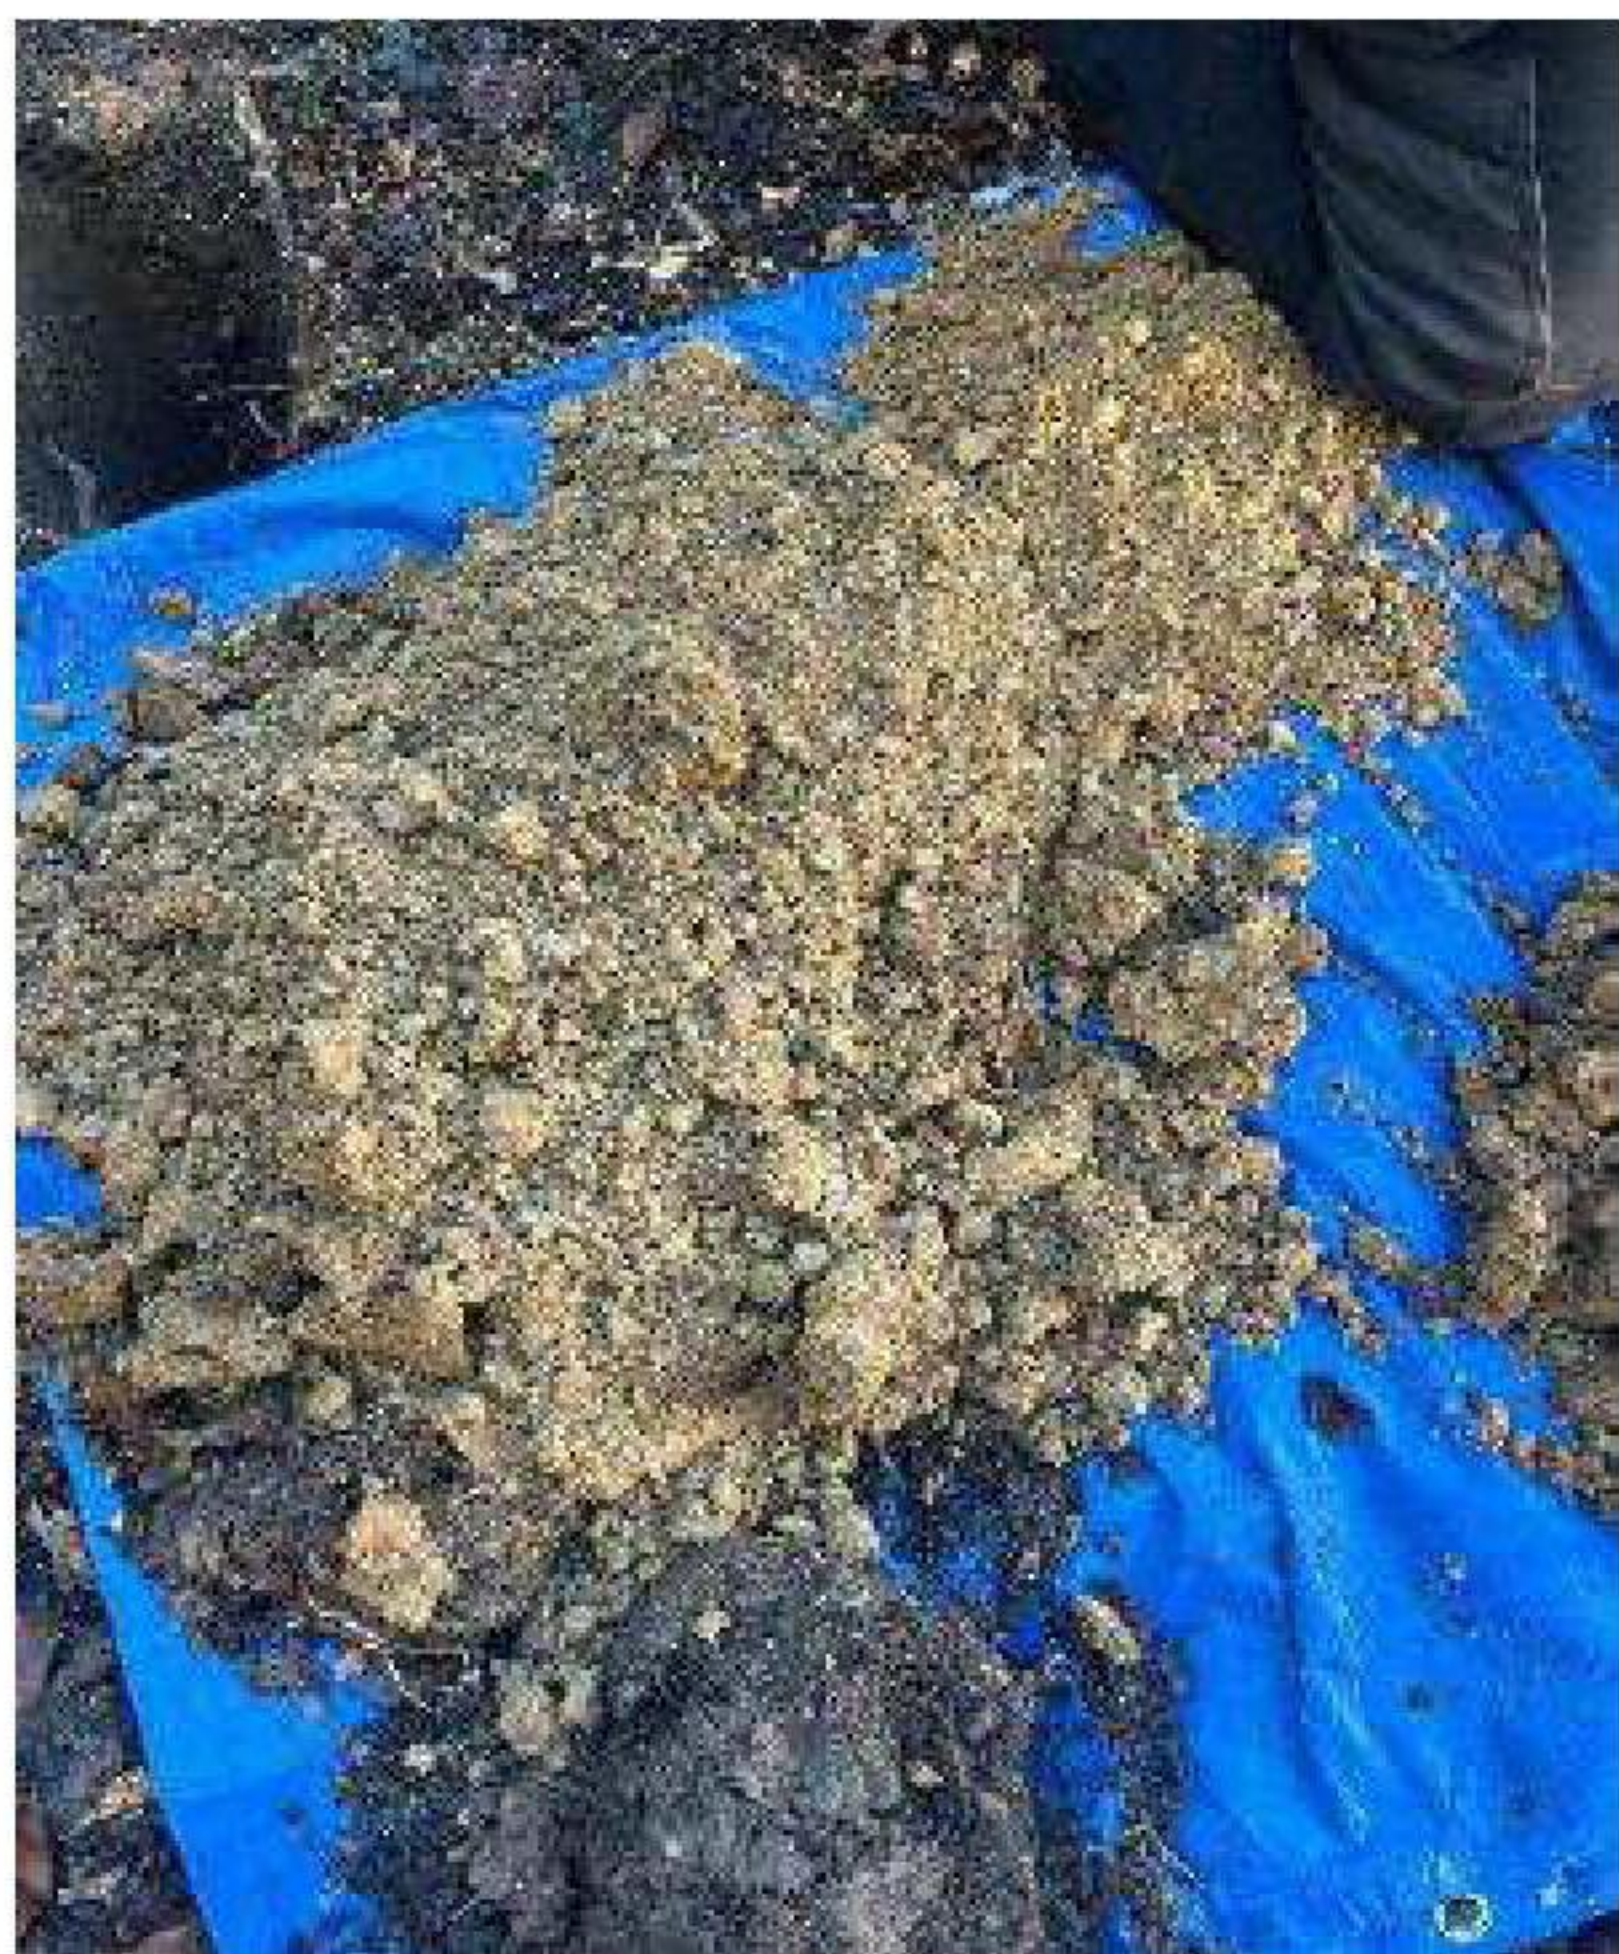
At TP01 the Made Ground was initially dark brown becoming brown slightly sandy silty CLAY with occasional gravel including organic material, ironstones, wood, brick, ash and concrete. At TP04, the Made Ground was comprised a surface layer of Pea Gravel over compacted sand and gravel. Gravels comprised abundant limestone, brick, concrete, rope, plastics and a fragment of presumed Asbestos Containing Materials (pACM). Occasional concrete cobbles were also noted.

- Complete removal of the Made Ground in the vicinity of TP01 and reinstating with topsoil/subsoil as required by the landscape designer (minimum 150mm thickness of Topsoil).
- Excavating and disposing of contaminated soils and replacement with a capping system.
- Provision of upgraded or protected water supply pipework to a specification agreed with the local utility.
