**LAND AT BIRCH TREE FARM,  
CUCKFIELD ROAD, ANSTY, RH17 5AG**  
PHASE II CONTAMINATION  
ASSESSMENT  
**BIRCH TREES FARM**  
23<sup>RD</sup> JANUARY 2026  
**LS8990 A**

| Title: | PHASE II CONTAMINATION ASSESSMENT | |
| Project: | RESIDENTIAL DEVELOPMENT | |
| Reference: | LS8990 A | |

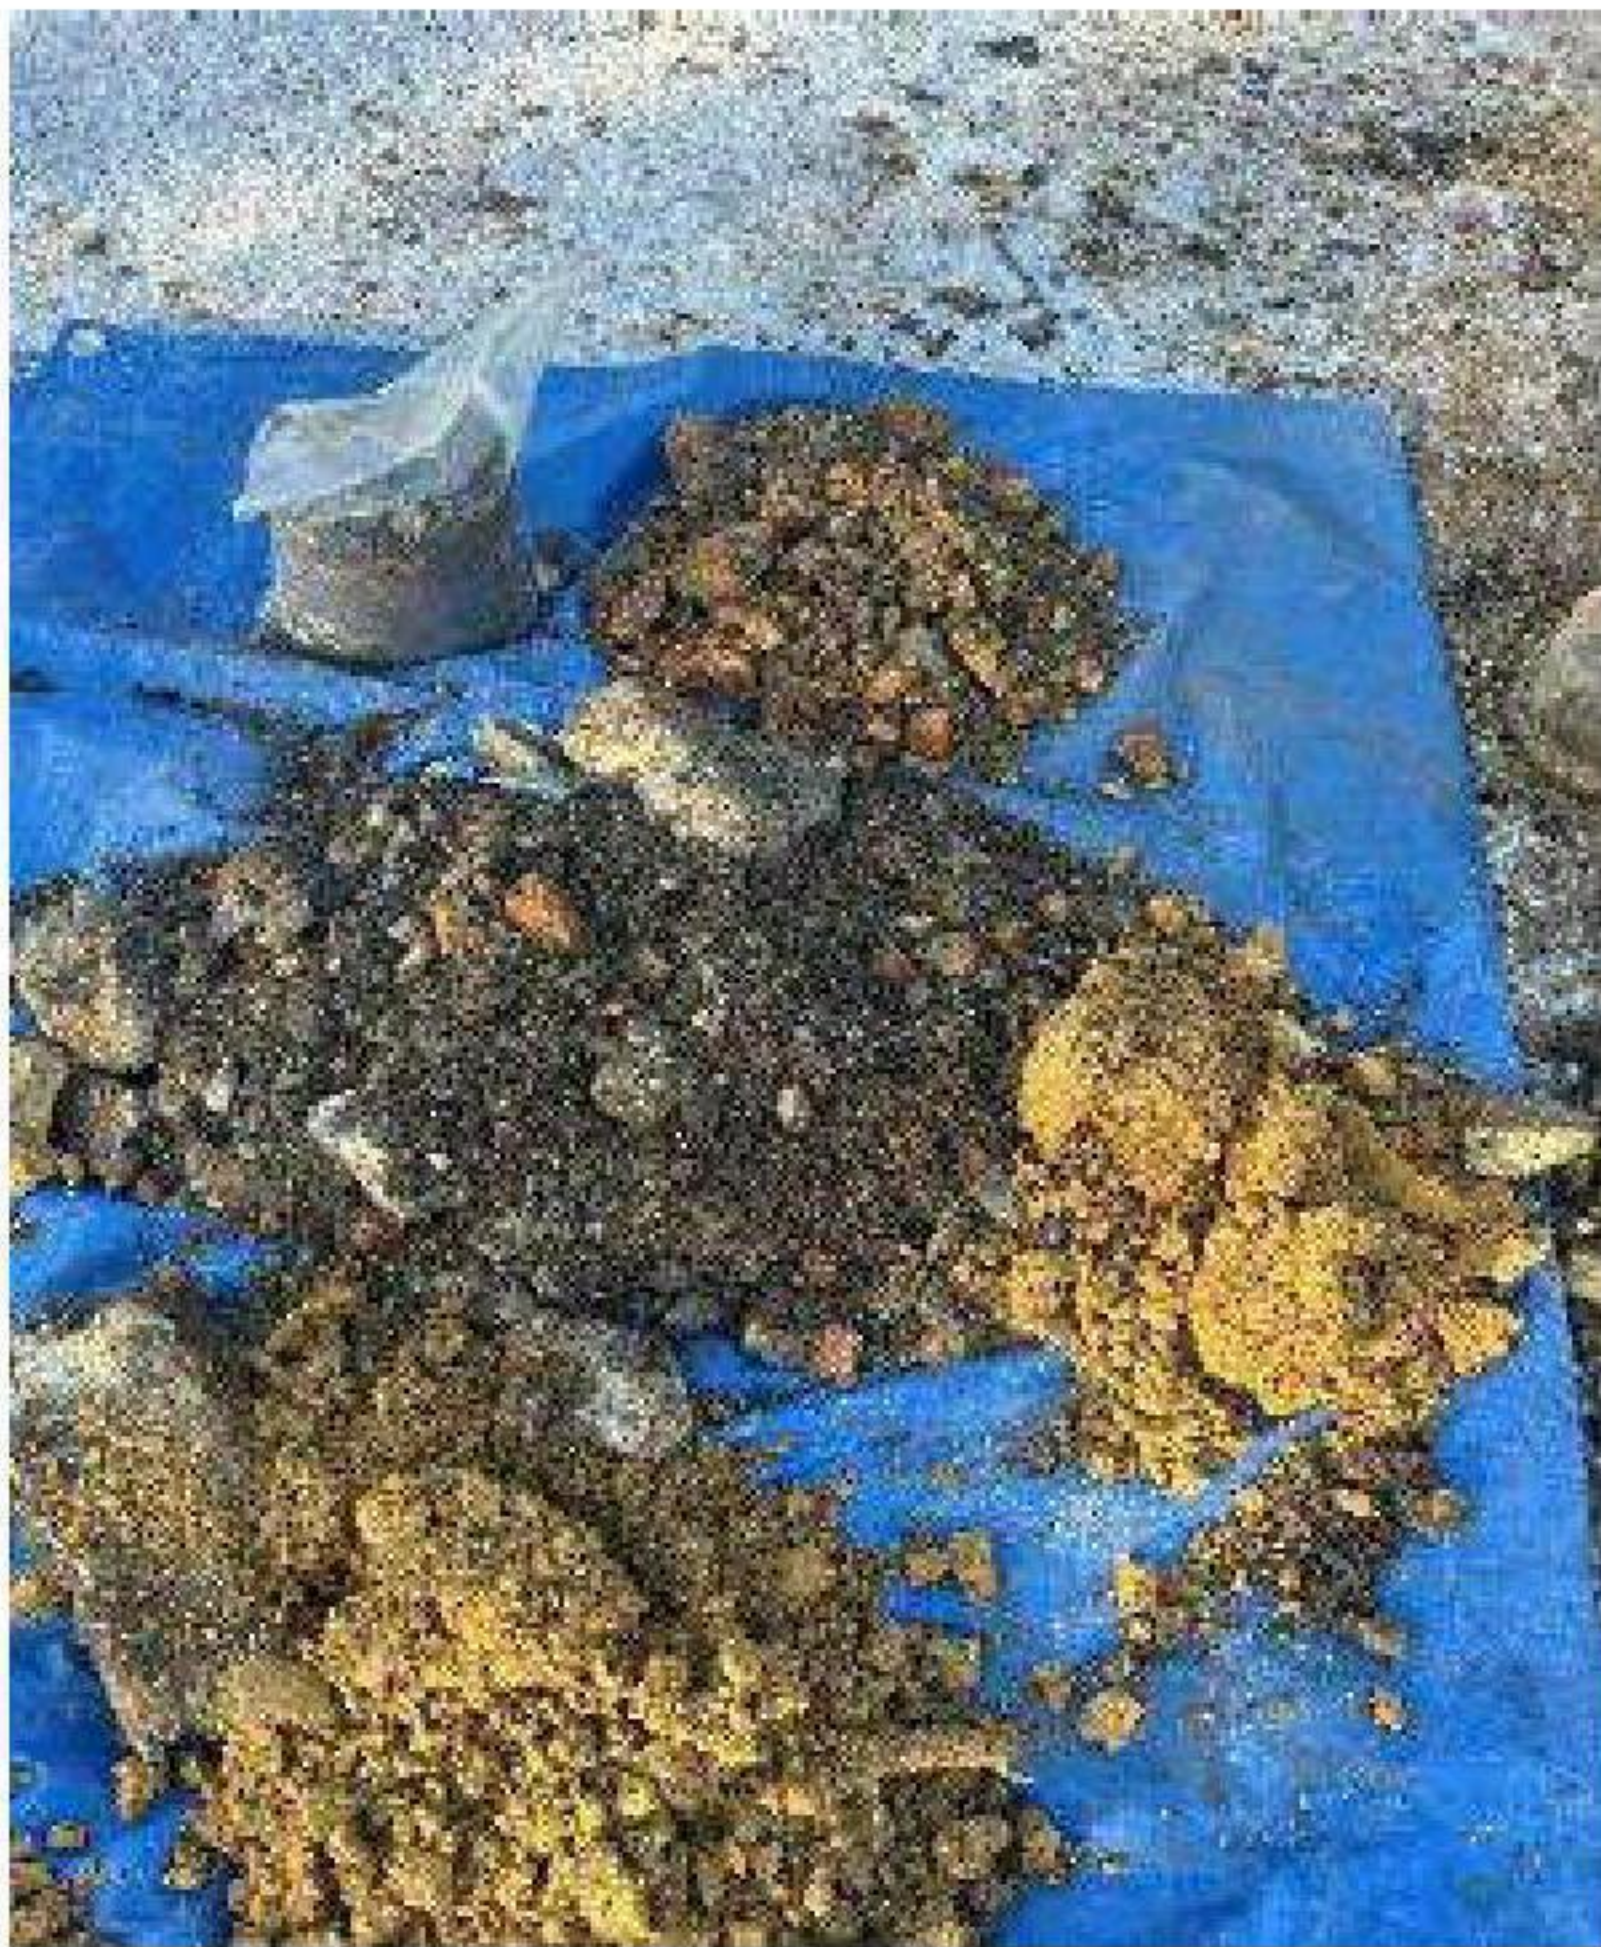
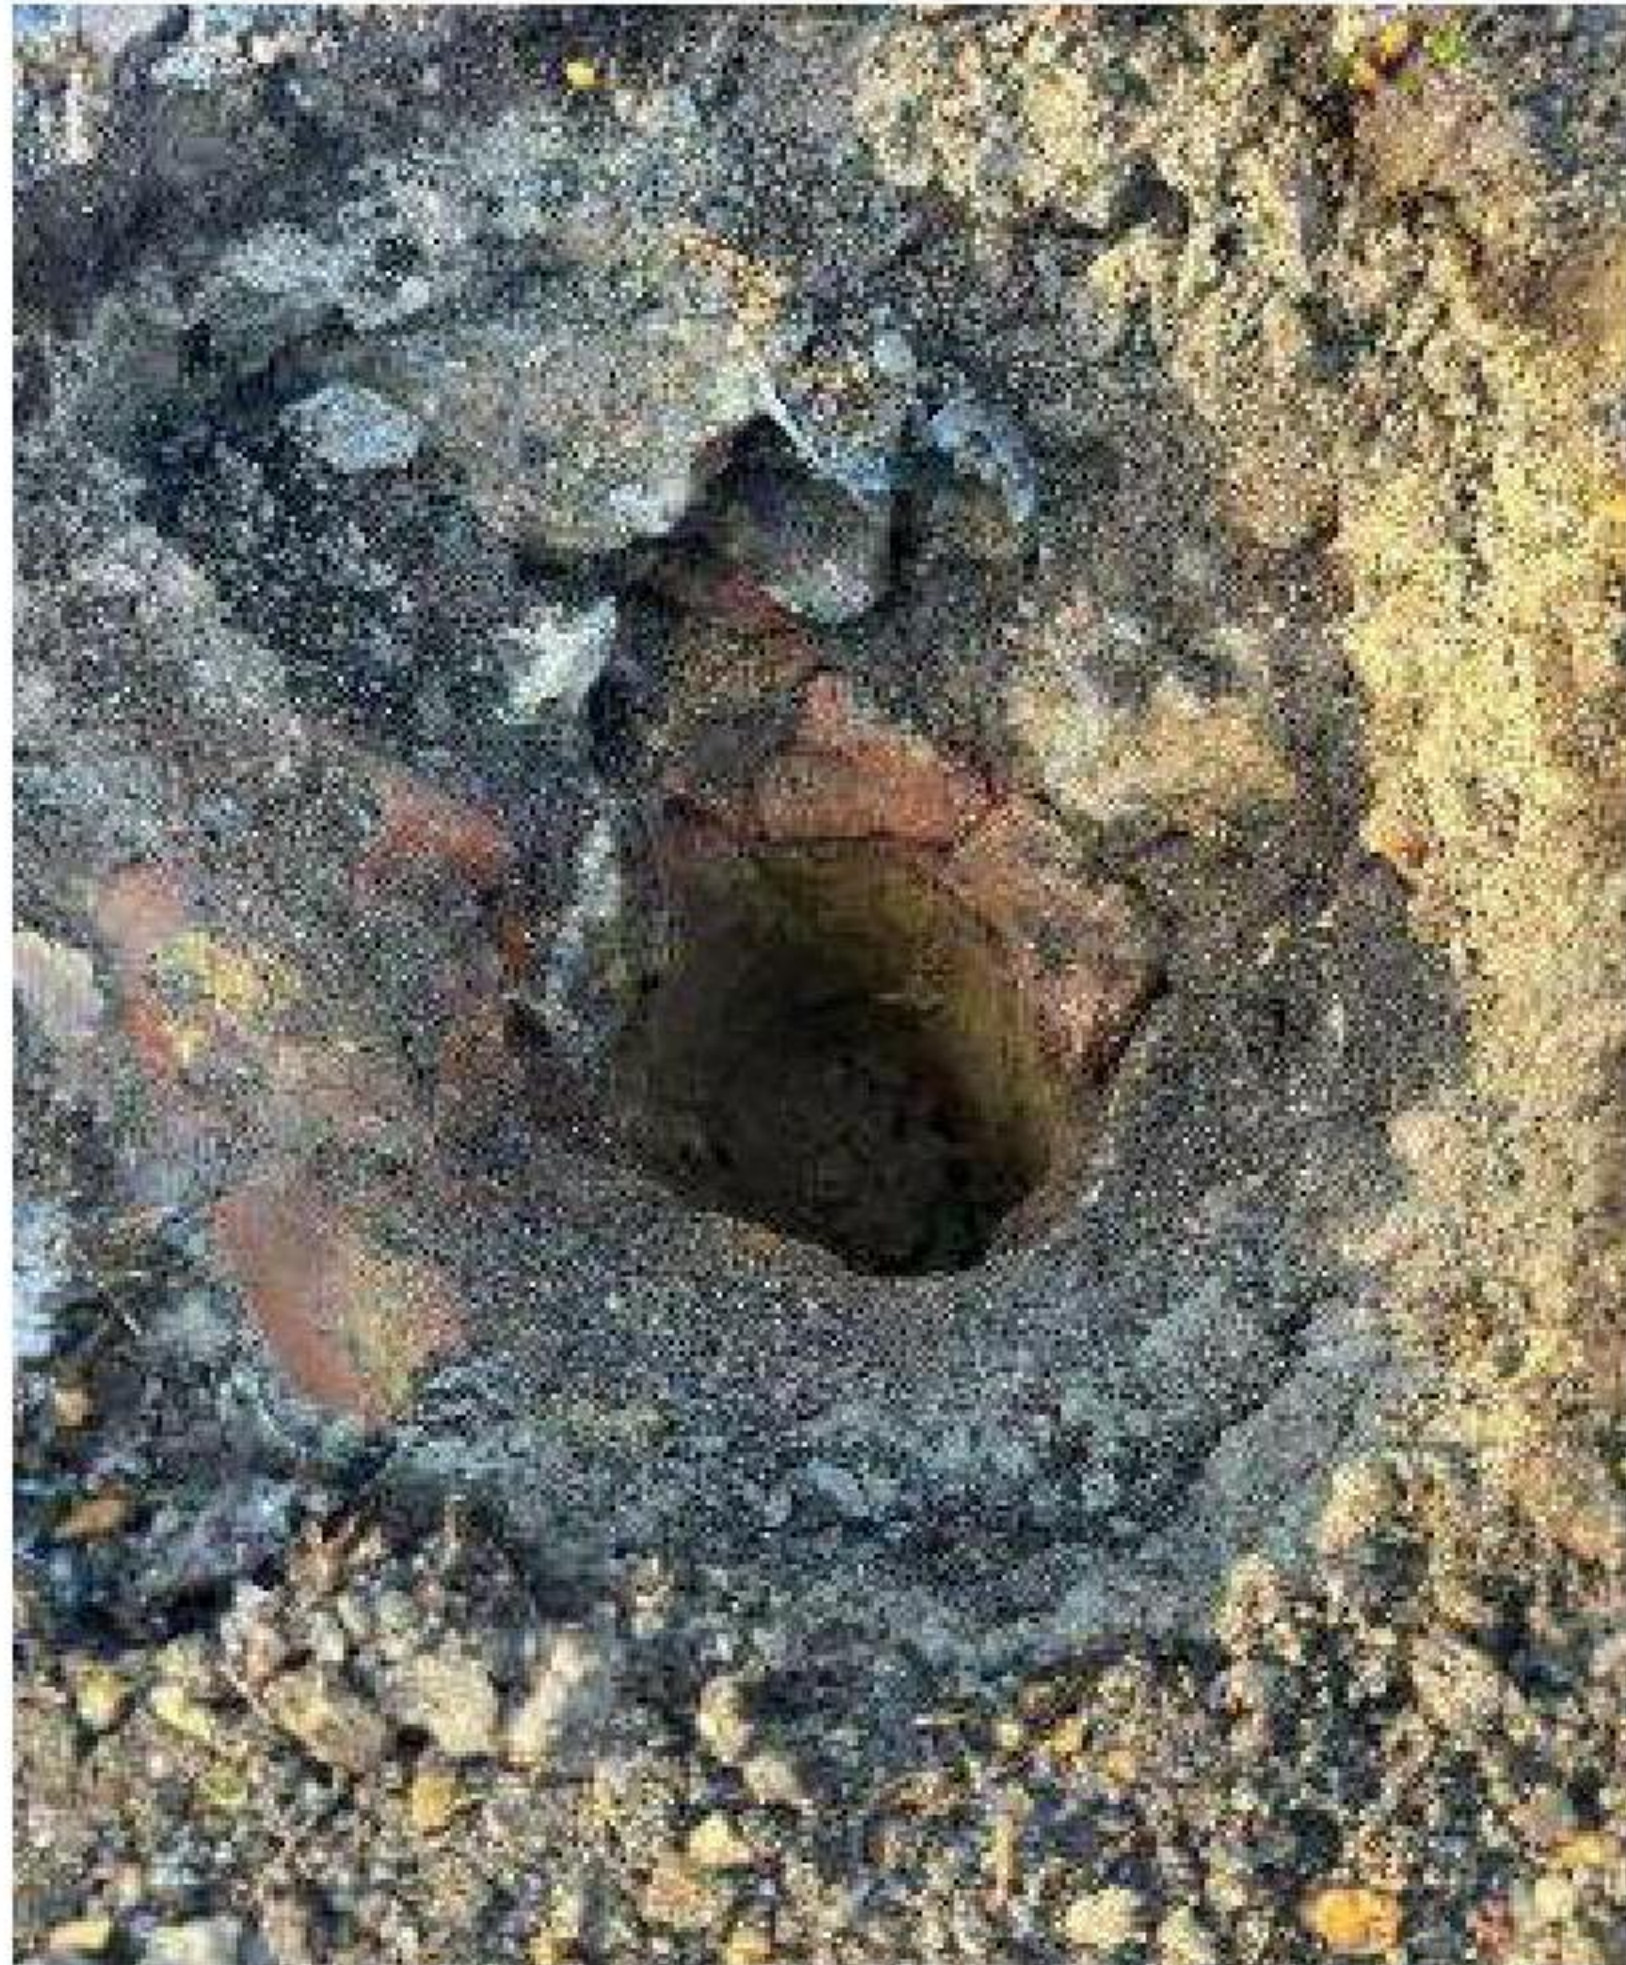
A fragment of potential Asbestos Containing Material (pACM) was identified at TP04 0.30m. No other evidence of possible soil contamination (such as staining, malodours, or brightly coloured soils) was identified in the field.

Asbestos Containing Materials (ACMs) were identified in the Made Ground at TP04 as a fragment of cement bound chrysotile. WM3 states that where waste contains identifiable pieces of asbestos containing material (i.e. any particle of a size that can be identified as potentially containing asbestos by a competent person if examined by the naked eye), then these pieces must be assessed as asbestos. Given that HSE publication HSG264 suggests that there are no ACMs where the typical proportion of asbestos is less than 0.1%, it follows that all soils containing visually identifiable ACMs are hazardous waste (but may still be sub-classified as SNRHW).
