| Contract: | | Client: | | Borehole: | |
| HE Northern Arc, Burgess Hill - Freeks Farm & Link Road GI | | Homes England | | BH103 | |
| 562943 | End: 17.04.19 | 26.33 | E:531153.7 N:120700.4 | 2 of 6 | |

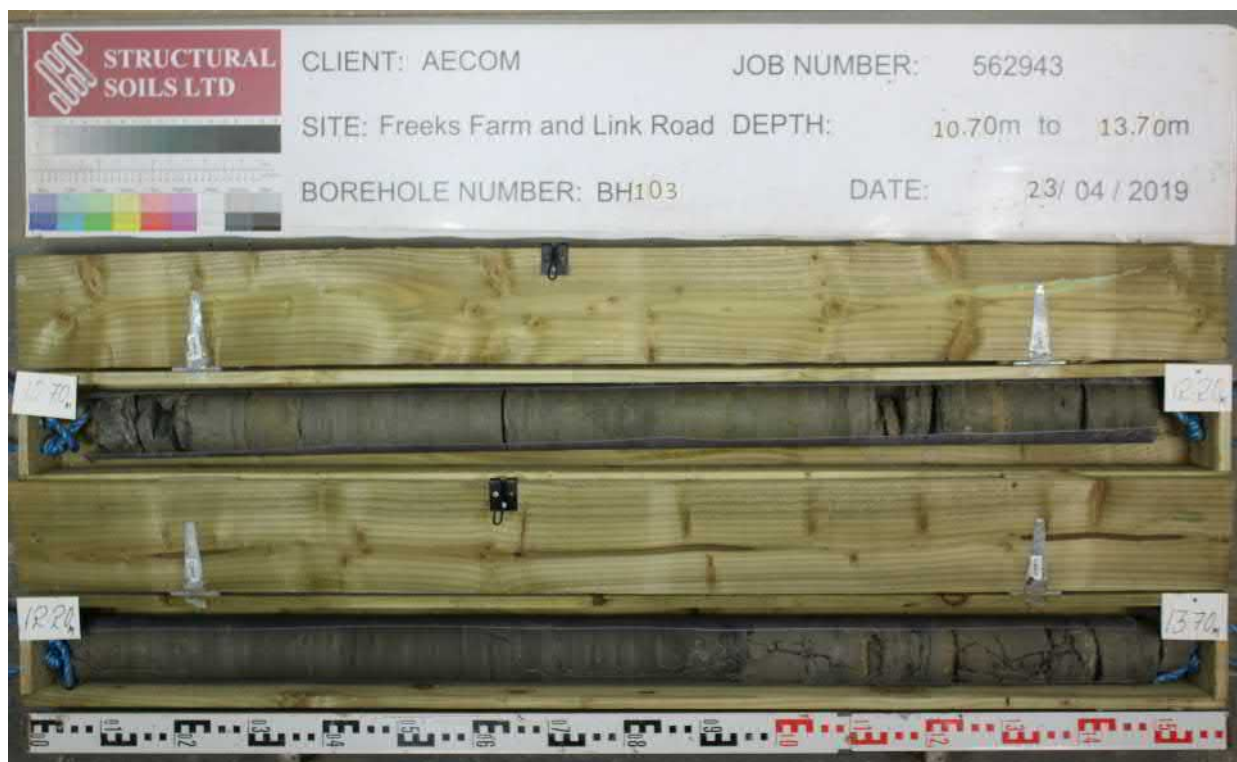
BH103 10.70m-13.70m

| Mechanical Log | | | | Flush Returns & Details | Samples & Testing | | | Backfill & Instrumentation | Water | Description of Strata | Depth (Thickness) | Material Graphic Legend |
|---|---|---|---|---|---|---|---|---|---|---|---|---|
| 10.70-12.20 | ↑ | ↑ | ↑ | | | | | | | Extremely weak to very weak thinly laminated grey MUDSTONE with rare very thin beds of very weak siltstone up to 60mm. Discontinuities are subhorizontal closely to medium spaced undulating rough partly open to open infilled with grey clay or clean. | 12.00 | |
