| Contract:<br>HE Northern Arc, Burgess Hill - Freeks Farm & Link Road GI | | Client:<br>Homes England | | Trial Pit:<br>TP110 |
| Contract Ref:<br>562943 | Start: 15.04.19<br>End: 15.04.19 | Ground Level (m AOD):<br>29.13 | National Grid Co-ordinate:<br>E:531237.8 N:120724.9 | Sheet:<br>2 of 3 |

| Contract: HE Northern Arc, Burgess Hill - Freeks Farm & Link Road GI | | Client: Homes England | | Trial Pit: TP111 |

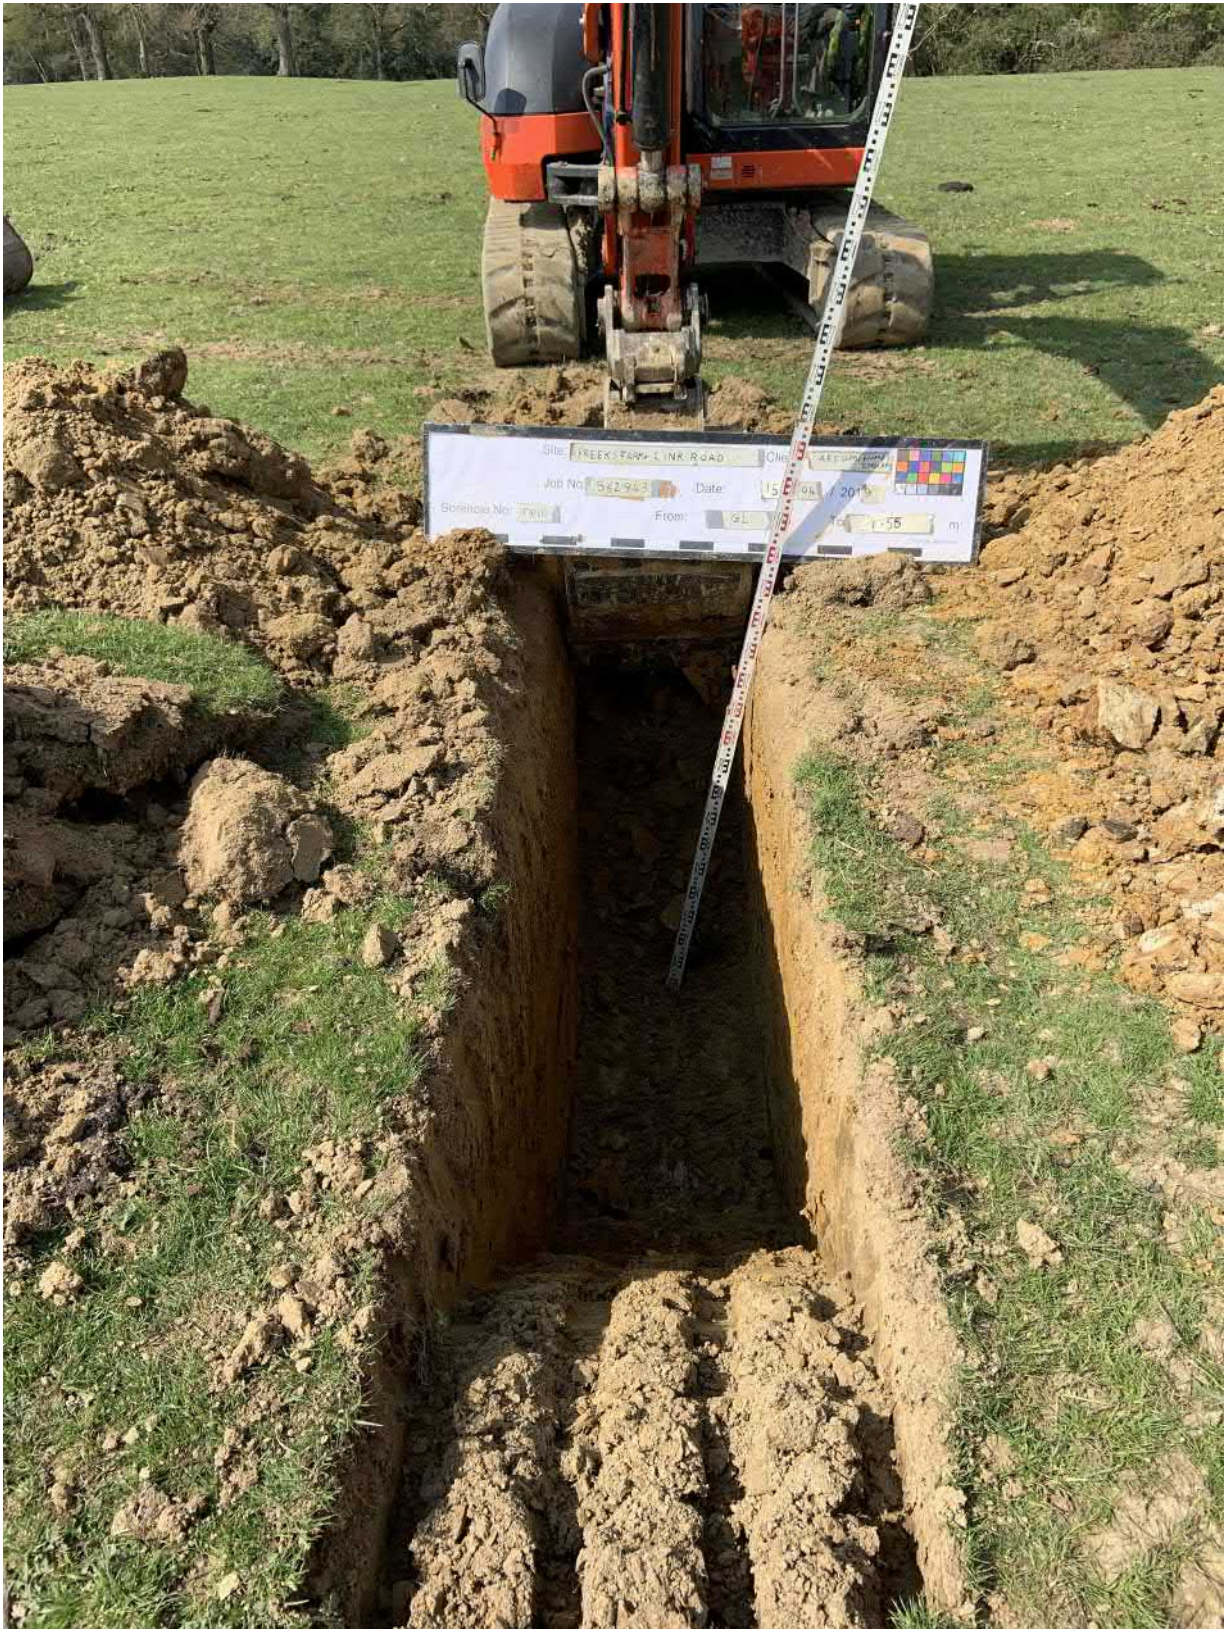
TP111: Pit

| Samples and In-situ Tests | | | | Water | Backfill | Description of Strata | Depth (Thickness) | Material Graphic Legend |
|---|---|---|---|---|---|---|---|---|
| 0.00-0.35 | 1 | B | | | | Grass over soft light brown slightly sandy clayey SILT with frequent roots (<3 x 5mm). Sand is fine to coarse. (TOPSOIL) | (0.35) | |
| 0.40-0.85 | 4 | B | | | | Very soft to soft orangish grey to mottled orangish brown locally stained reddish brown slightly sandy silty CLAY with frequent pockets (up to 40mm) and coarse gravel of weak mudstone. Sand is fine to coarse. (WEALD CLAY FORMATION) | (0.50) | |
| 0.85 | 7 | D | | | | Extremely weak thinly laminated (1-3mm) orangish to greyish stained reddish brown weathered MUDSTONE. (WEALD CLAY FORMATION) | | |
| 1.00-1.10 | 11 | B | | | | Extremely weak to weak thinly laminated greyish brown locally stained reddish brown MUDSTONE. (WEALD CLAY FORMATION) | (0.45) | |
| Trial pit terminated at 1.55m depth due to hard ground condition. | | | | | | | | |

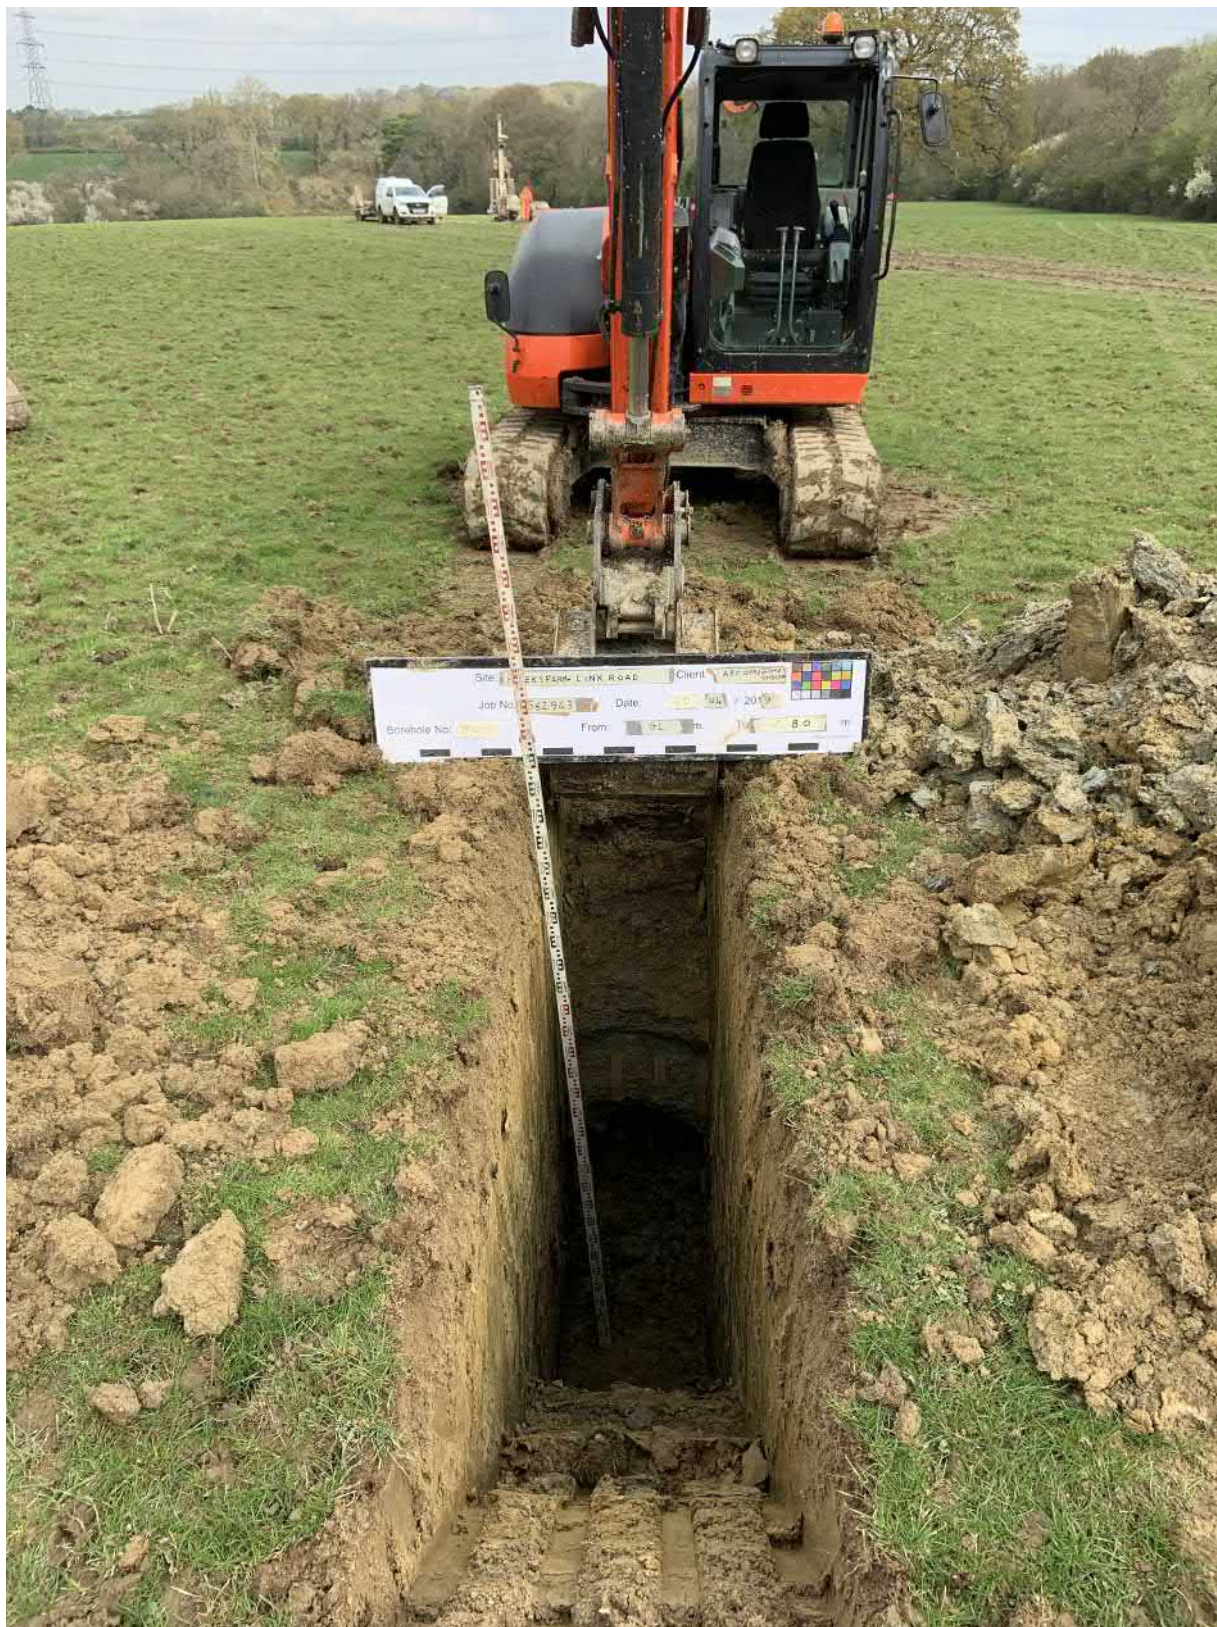
TP112: Pit

| Samples and In-situ Tests | | | | Water | Backfill | Description of Strata | Depth (Thickness) | Material Graphic Legend | | |
|---|---|---|---|---|---|---|---|---|---|--|
| 0.00-0.30 | 1 | B | 1.2ppm | | | Grass over soft to firm greyish brown locally mottled orange and brown clayey SILT with frequent rootlets (8 x 10mm). Sand is fine. (TOPSOIL) | (0.30) | | | |
| 0.20 | 2 | D | | | | Soft to firm greyish brown mottled orange and brown slightly sandy silty CLAY with rare pockets (up to 10mm) organic material. Sand is fine. (WEALD CLAY FORMATION) | 0.30 | | | |
| 0.20-0.30 | 3 | ES | | | | | Firm to stiff greyish brown mottled orange and brown CLAY with occasional pockets (up to 10mm) of reddish brown mudstone. (WEALD CLAY FORMATION) | (1.20) | | |
| 2.00 | | PID | | | | | | Firm thinly laminated greyish blue mottled orangish brown slightly sandy slightly gravelly silty CLAY. Sand is fine to coarse. Gravel is subangular to angular fine to coarse extremely weak mudstone. (WEALD CLAY FORMATION) | (0.90) | |
| 2.80 | 14 | D | | | | Trial pit terminated at 2.80m depth. | | | | |

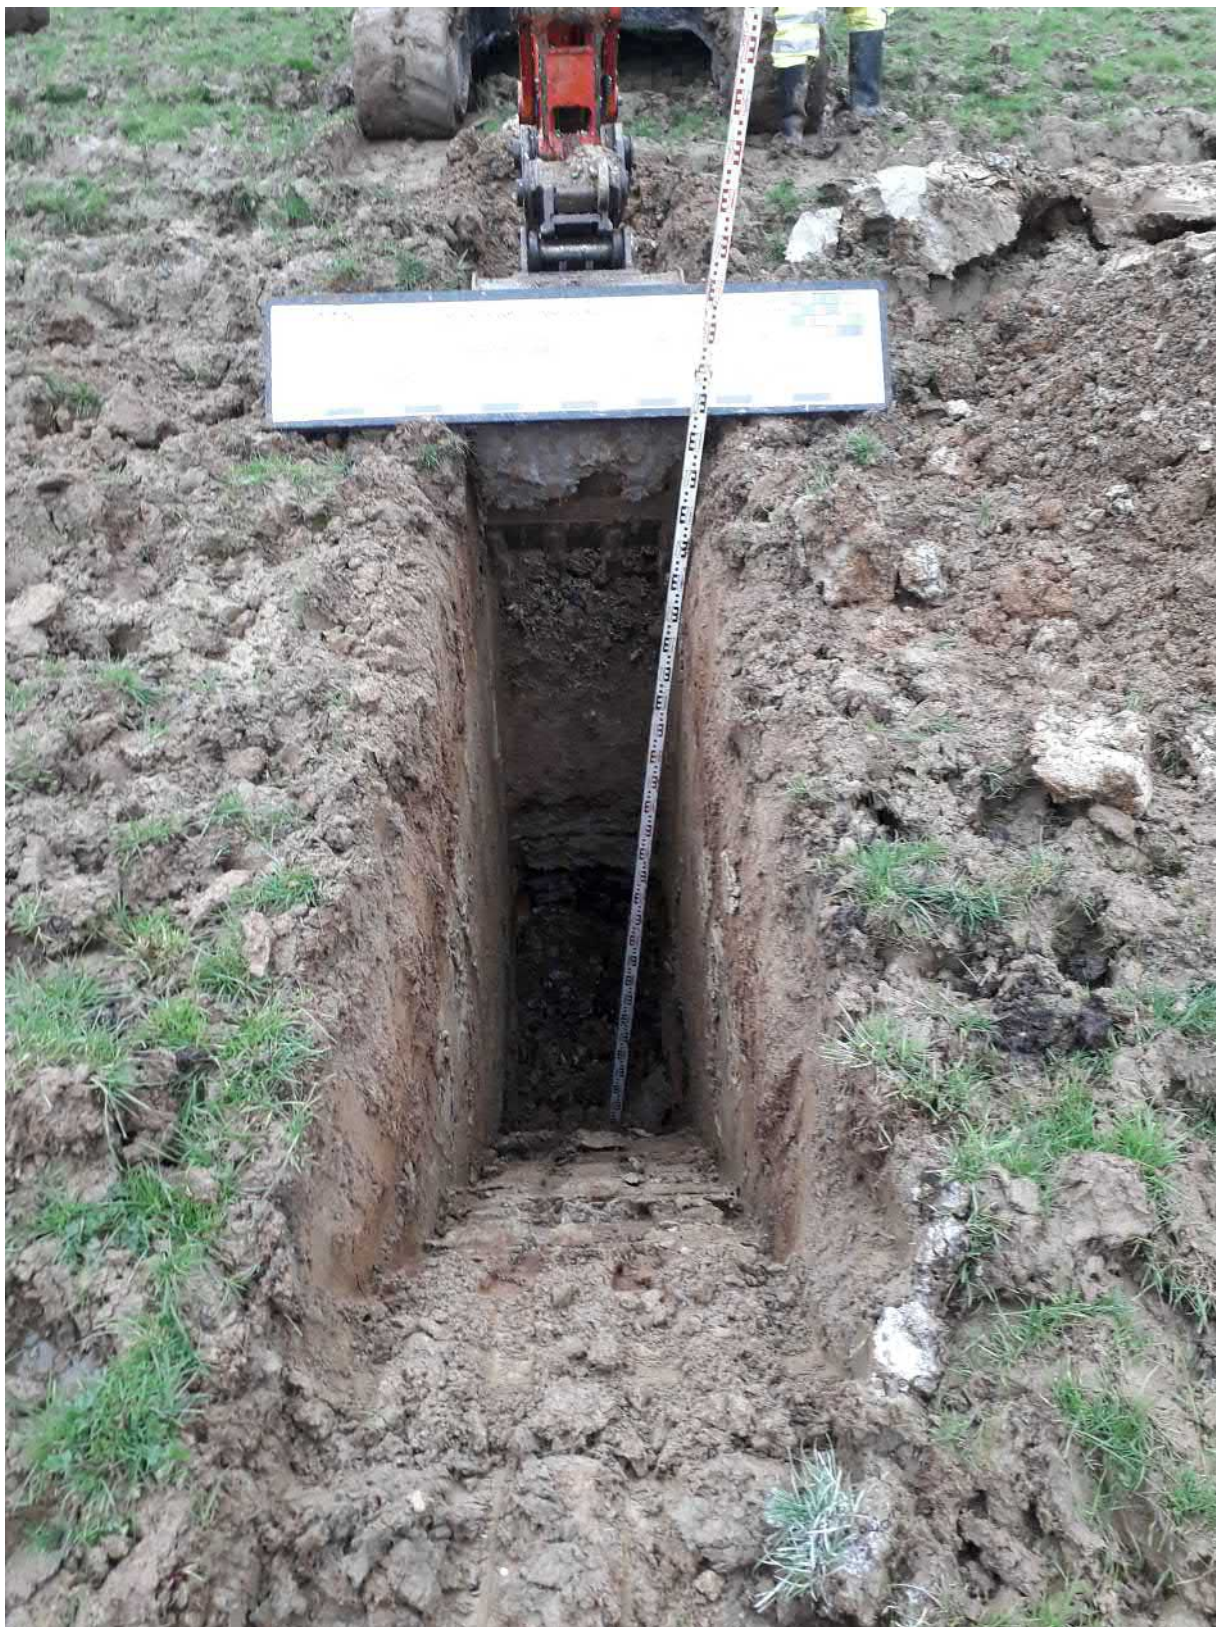
TP113: Pit

| Samples and In-situ Tests | | | | Water | Backfill | Description of Strata | Depth<br>(Thick<br>ness) | Material<br>Graphic<br>Legend | | |
|---|---|---|---|---|---|---|---|---|--|--|
| 0.00-0.50 | 1 | B | 0.1ppm | | | Grass over soft greyish brown locally mottled orange and brown SILT with occasional pockets of firm clay (up to 20mm) and frequent rootlets (<20 x 10mm). (TOPSOIL) | (0.30) | | | |
| 0.20 | 2 | D | | | | Soft greyish brown slightly gravelly CLAY. Gravel is extremely weak angular to subangular fine to medium of mudstone. (WEALD CLAY FORMATION) | 0.30 | | | |
| 0.60-0.70 | 4 | B | 0.1ppm | | | Firm becoming stiff with depth bluish grey mottled orange and brown CLAY. (WEALD CLAY FORMATION) | (0.80) | | | |
| 1.50-2.00 | 10 | B | | | | Soft greyish brown slightly sandy slightly gravelly silty CLAY. Sand is fine to coarse. Gravel is weathered angular to subangular fine to coarse of mudstone. (WEALD CLAY FORMATION) | (0.90) | | | |

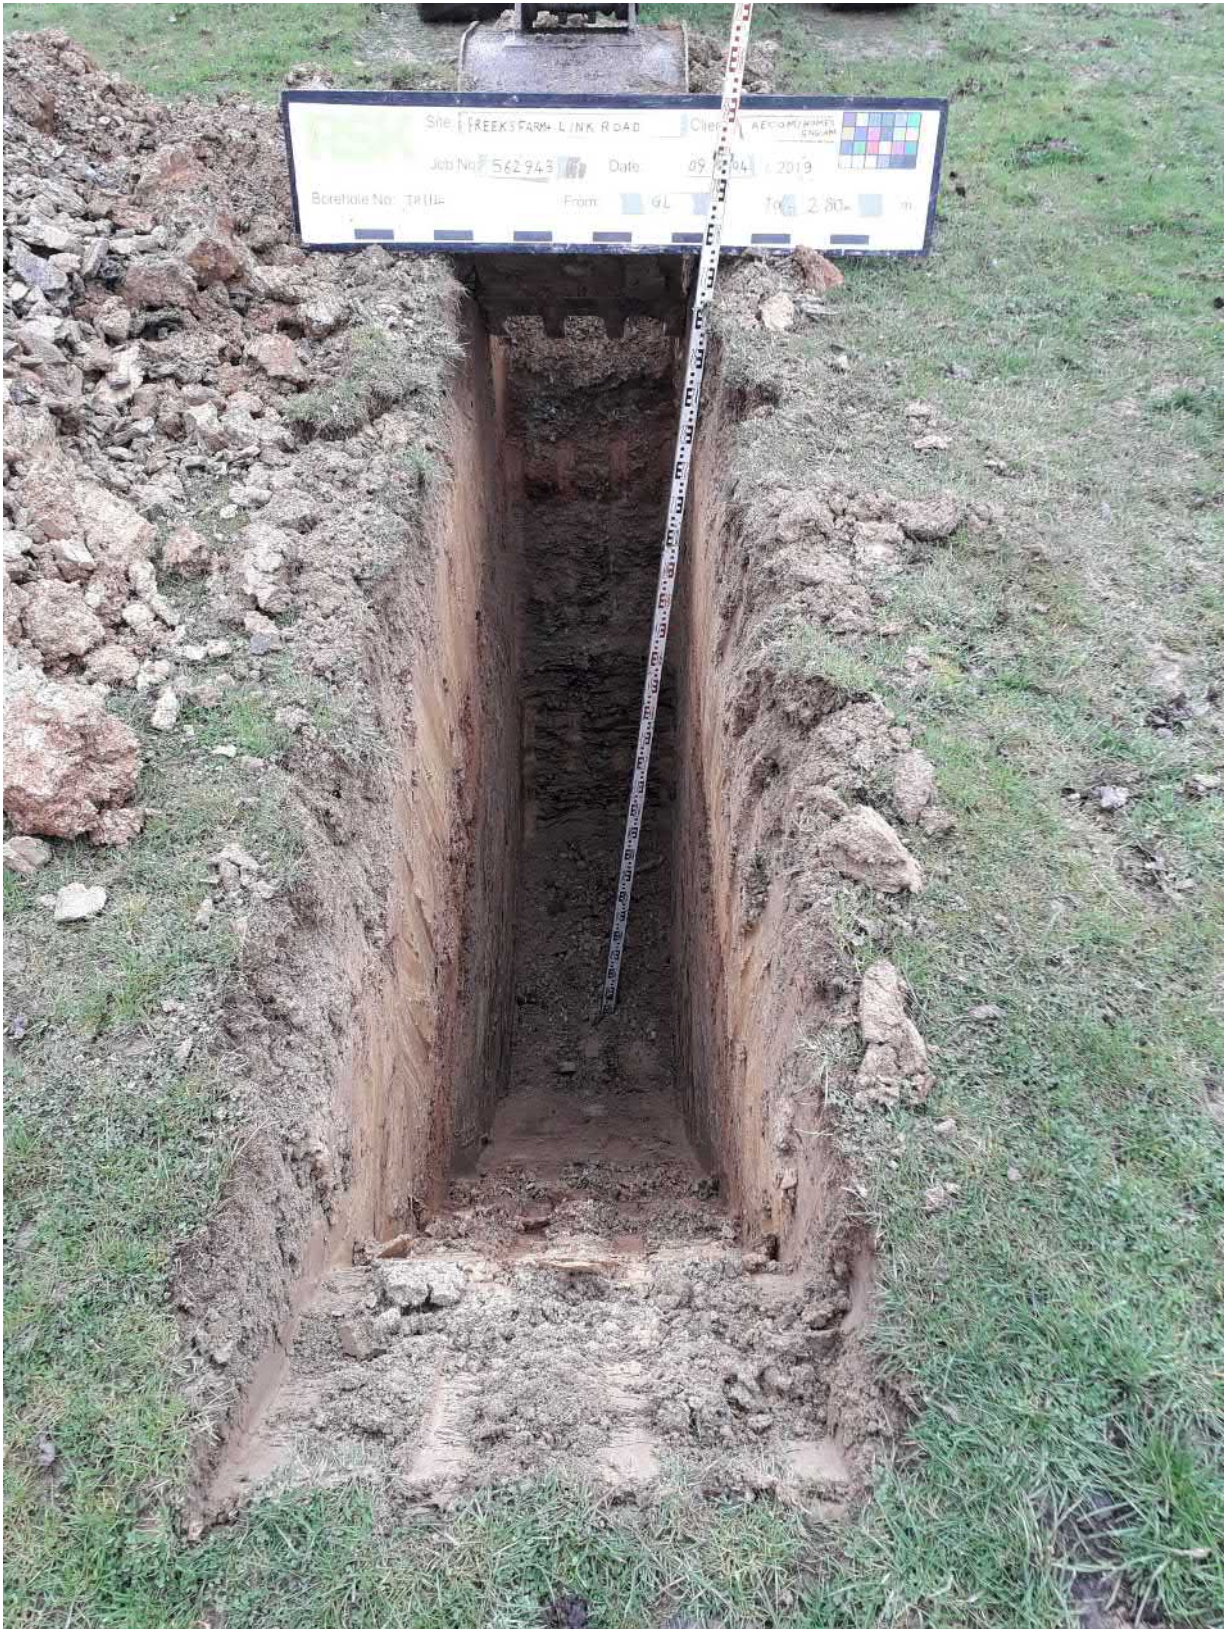
TP114: Pit

| Samples and In-situ Tests | | | | Water | Backfill | Description of Strata | Depth<br>(Thick<br>ness) | Material<br>Graphic<br>Legend |
|---|---|---|---|---|---|---|---|---|
| 0.90-1.40<br>0.90<br>1.00-1.10 | 7<br>8<br>9 | B<br>D<br>ES | | | | Extremely weak grey and brown mottled orange and brown locally stained reddish brown MUDSTONE distinctly weathered to slightly sandy gravelly silty clay. Sand is fine. Gravel is angular to subangular fine to coarse of mudstone.<br>(WEALD CLAY FORMATION) | (0.70) | |
| 1.40<br>1.50-2.00<br>1.50<br>1.60-1.70 | 10<br>11<br>12<br>13 | D<br>B<br>D<br>ES | | | | Extremely weak grey and brown stained reddish brown highly oxidised MUDSTONE.<br>(WEALD CLAY FORMATION) | 1.50<br>(0.70)<br>2.20 | |
| 2.00<br>2.20<br>2.20 | 14<br>15<br>16 | D<br>B<br>D | | | | Extremely weak to weak grey and brown locally stained reddish brown oxidised MUDSTONE.<br>(WEALD CLAY FORMATION) | (0.30)<br>2.50 | |
| | | | | | | Trial pit terminated at 2.50m depth due to hard ground conditions. | | |

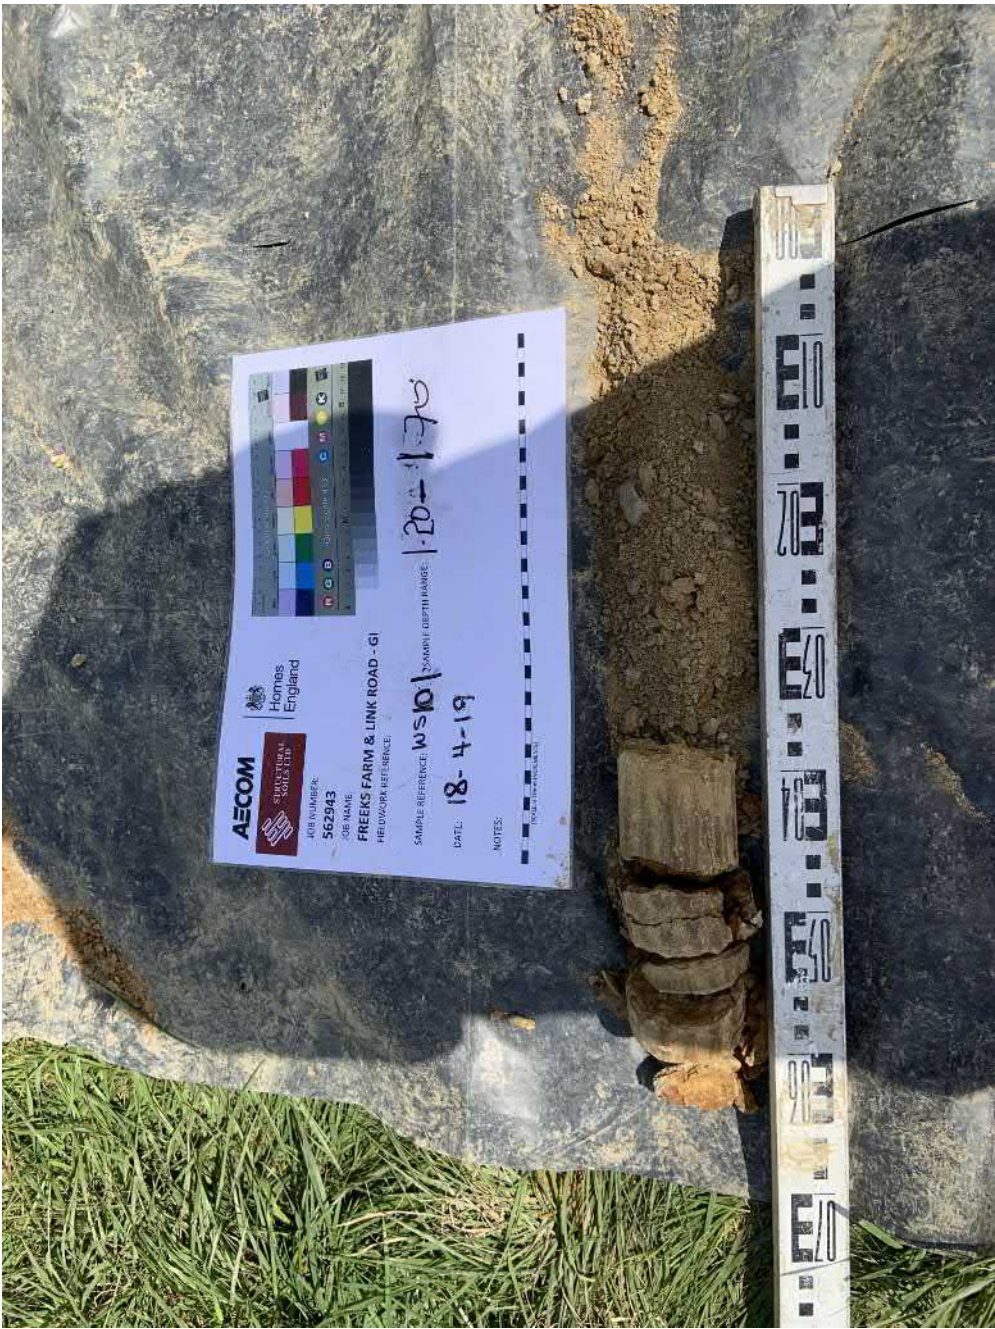
WS101: 1.20m-1.70m

| Progress | | Samples / Tests | | | Water | Backfill | Description of Strata | Depth (Thickness) | Material Graphic Legend |
|---|---|---|---|---|---|---|---|---|---|
| | 1.60-1.70 | 10 | ES | | | | Extremely weak thinly laminated (<3mm) reddish brown locally stained orange and brown oxidised distinctly weathered MUDSTONE. Recovered as slightly sandy gravelly silty stiff friable CLAY. Sand is fine to coarse. Gravel is subangular to angular fine to coarse mudstone. (WEALD CLAY FORMATION) | (0.70) | |

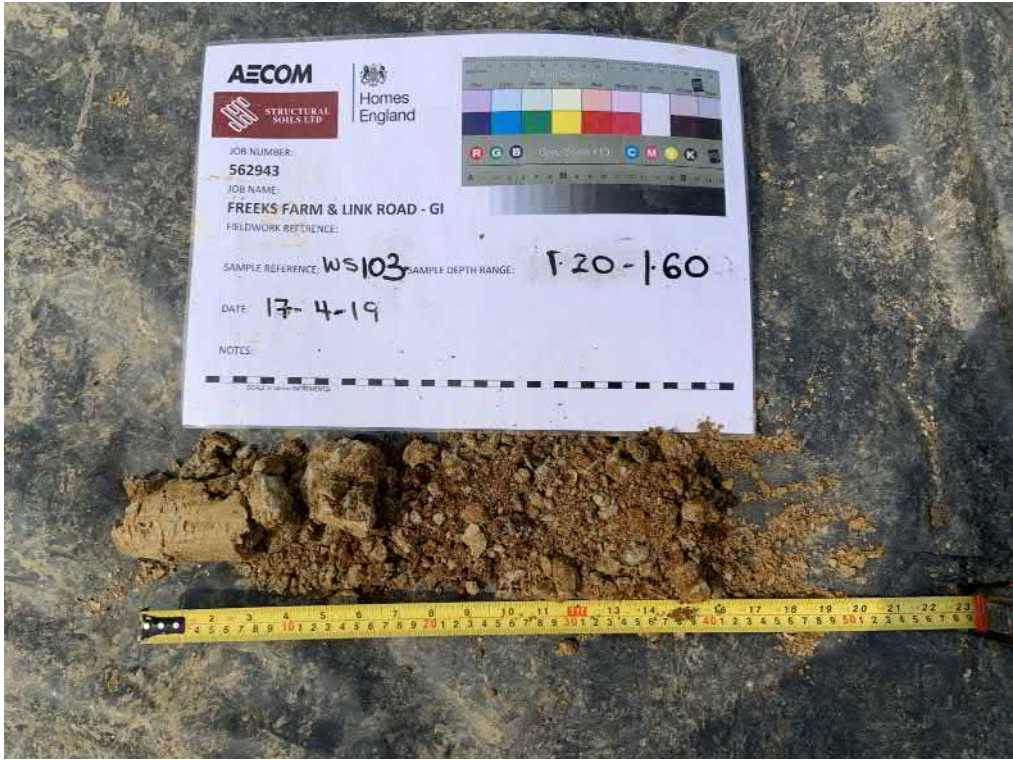
WS103: 1.20m-1.60m

| Progress | | Samples / Tests | | | Water | Backfill | Description of Strata | Depth (Thick<br>ness) | Material<br>Graphic<br>Legend | | | | |
|---|---|---|---|---|---|---|---|---|---|--|--|--|--|
| | 1.90-2.00 | 11 | ES | | | | Extremely weak grey and brown stained reddish brown slightly oxidised destructured MUDSTONE. Recovered as firm to stiff slightly sandy slightly gravelly friable CLAY. Sand is fine to medium. Gravel is angular to subangular fine to coarse mudstone. (WEALD CLAY FORMATION) | (0.75) | | | | | |

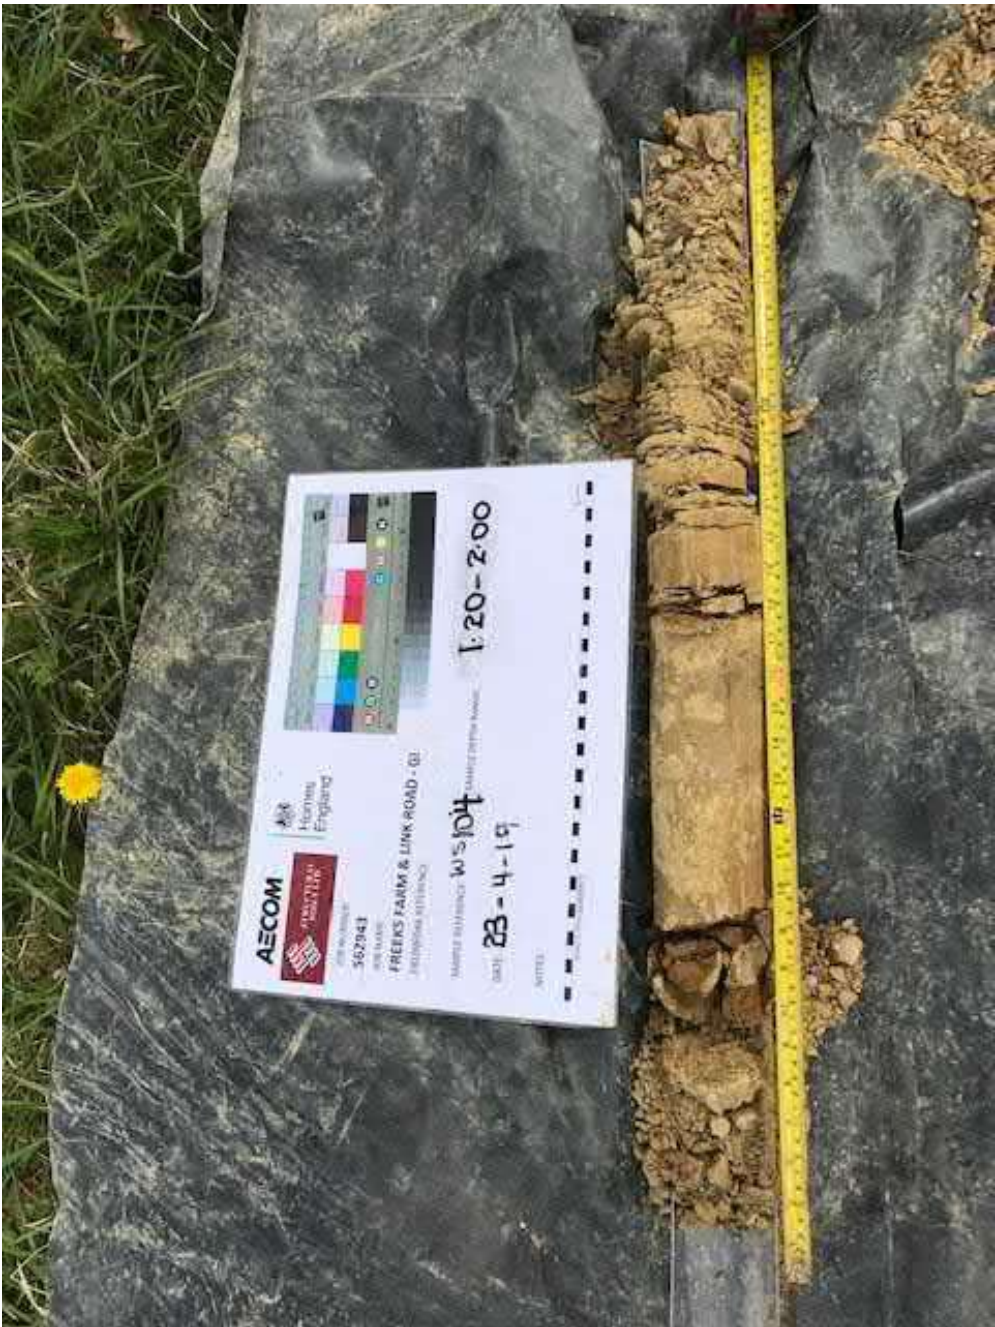
WS104: 1.20m-2.00m

| Progress | | Samples / Tests | | | Water | Backfill & Instrumentation | Description of Strata | Depth (Thickness) | Material Graphic Legend |
|---|---|---|---|---|---|---|---|---|---|
| | 1.70 | 12 | D | | | | Extremely weak thinly laminated orangish brown and grey locally stained reddish brown destructured MUDSTONE recovered as slightly sandy gravelly silty friable CLAY. Sand is fine to coarse. Gravel is angular to subangular fine to coarse of mudstone lithorelics.<br>(WEALD CLAY FORMATION) | 1.65 | |

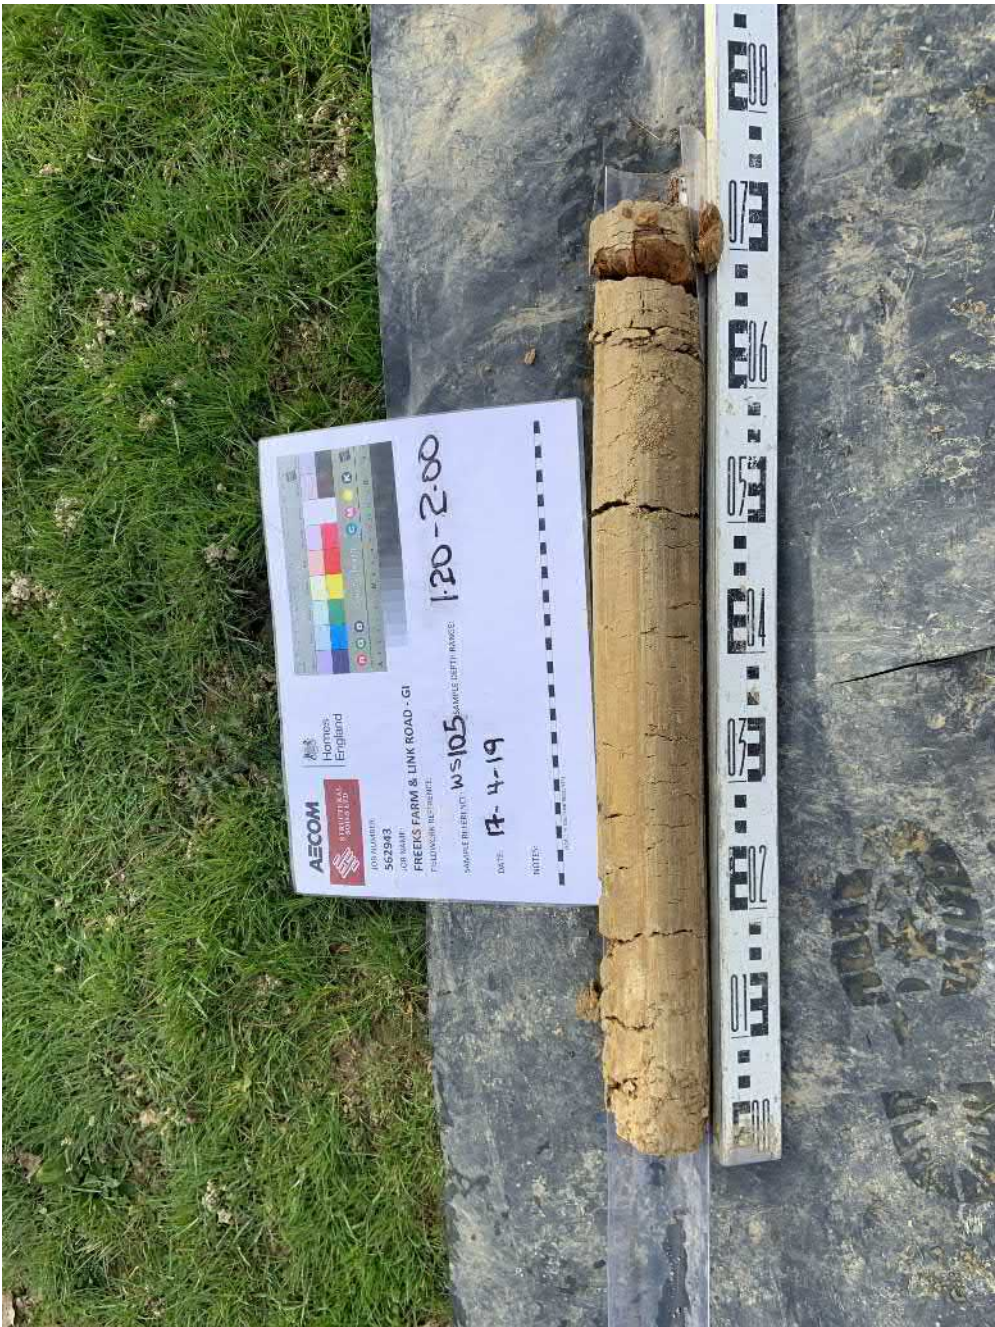
WS105: 1.20m-2.00m

| Progress | Samples / Tests | | | | Water | Backfill | Description of Strata | Depth (Thickness) | Material Graphic Legend | | | | | |
|---|---|---|---|---|---|---|---|---|---|---|---|---|---|--|
| 1.40 | 12 | D | 0.0ppm | | | Extremely weak thinly laminated (3 mm) orangish to greyish brown locally stained reddish brown slightly oxidized MUDSTONE. Recovered as slightly gravelly slightly sandy silty CLAY. Sand is fine to coarse. Gravel is angular to subangular fine to coarse of friable mudstone. (WEALD CLAY FORMATION) | (0.92) | | | | | | | |

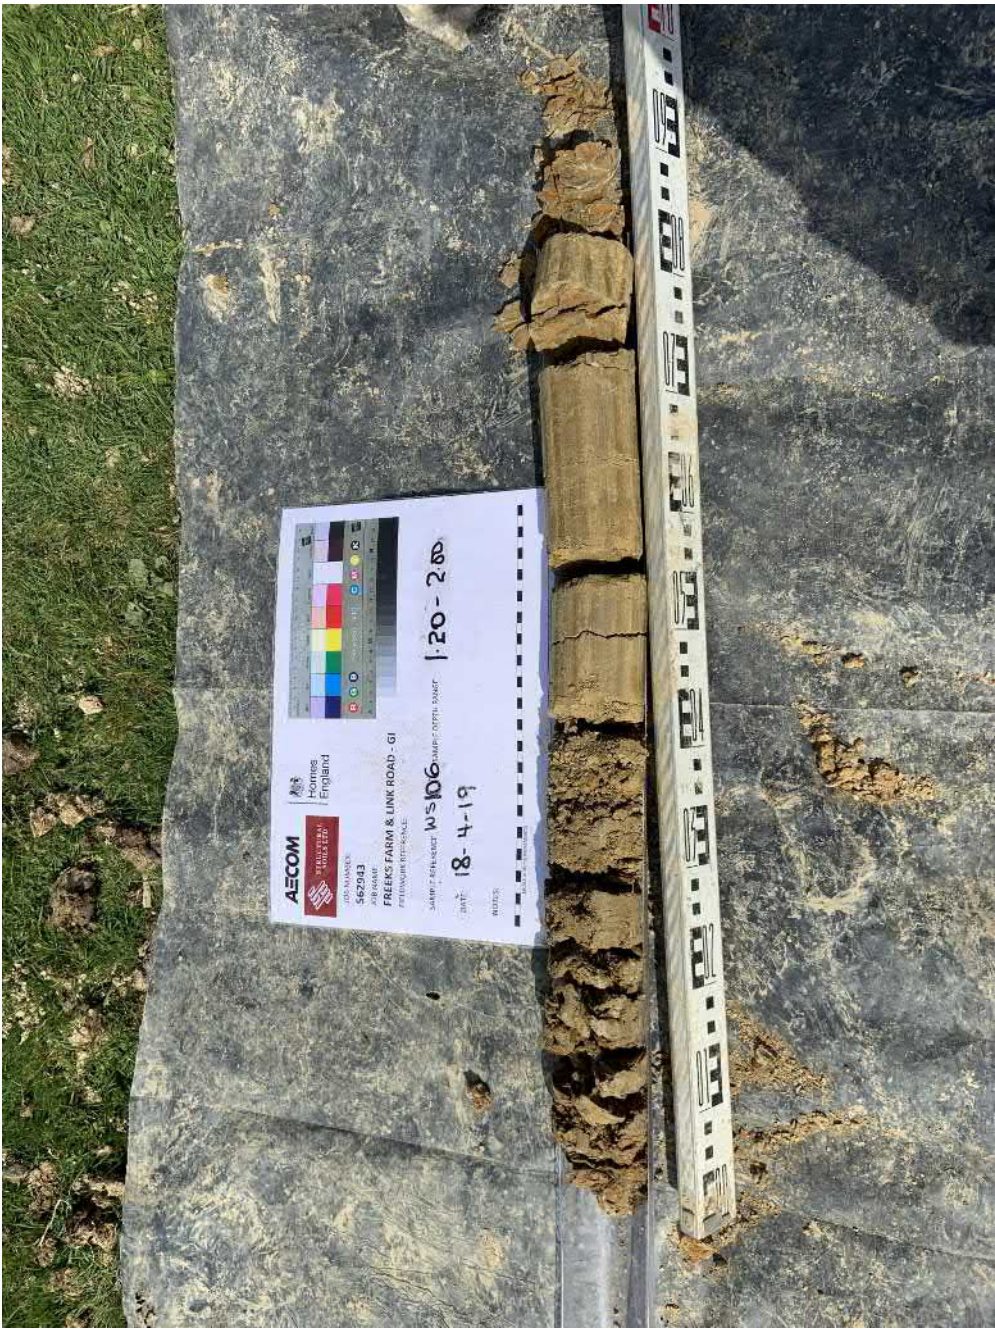
WS106: 1.20m-2.00m

| Progress | Samples / Tests | | | | Water | Backfill | Description of Strata | Depth (Thick-<br>ness) | Material<br>Graphic<br>Legend | | | |
|---|---|---|---|---|---|---|---|---|---|--|--|--|
| | 1.10-1.20 | 9 | ES | Extremely weak thinly laminated orangish brown locally stained reddish brown and grey oxidised MUDSTONE. Recovered as stiff slightly sandy slightly gravelly silty friable CLAY. Sand is fine to coarse. Gravel is subangular to angular fine to coarse of mudstone. (WEALD CLAY FORMATION) | | | (0.40) | | | | | |
| | 1.20-1.65 | 10 | D | 7,20/21,20,35 for 75mm | | | Orangish brown and grey locally stained reddish brown slightly silty clayey subangular to angular fine to coarse GRAVEL of extremely weak mudstone. (WEALD CLAY FORMATION) | | | | | |
