Saint Hill – Site 2,  
Marquee area  
Saint Hill Road,  
East Grinstead, West Sussex, RH19 4JY  
Flood Risk Assessment & Surface Water Drainage  
Strategy

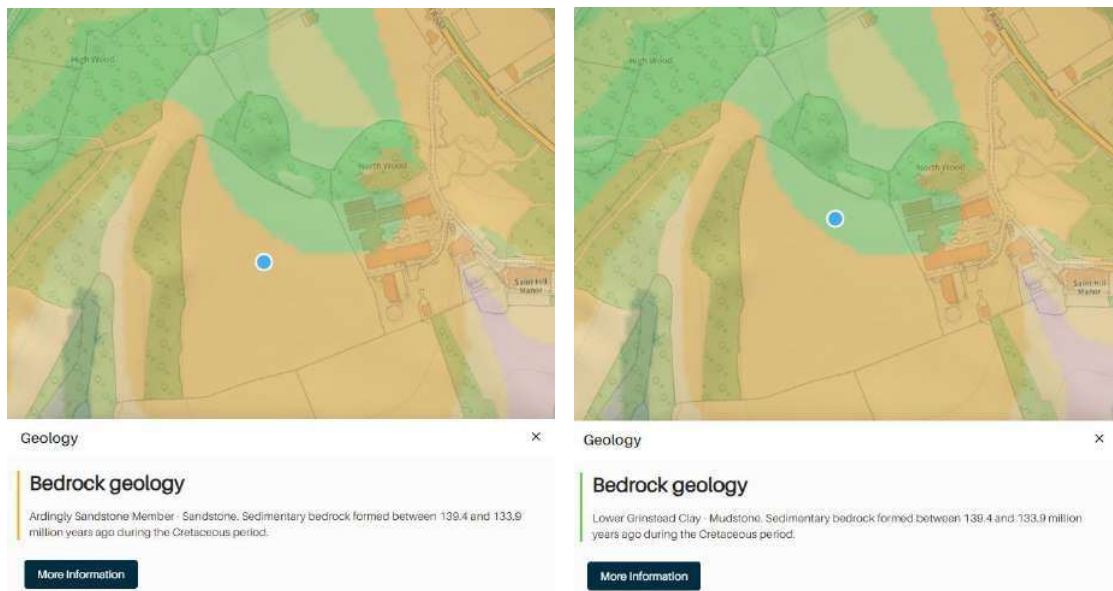
Figure 5: BGS geology map extracts

The British Geological Survey (BGS) Geology of Britain Viewer indicates that the bedrock underlying the majority of the site is Ardingly Sandstone Member – Sandstone. The northern boundary of the site contains bedrock geology consisting of Lower Grinstead Clay - Mudstone (Source: BGS). There are no superficial deposits underlying the site. Initial infiltration testing has been undertaken and is shown not to be a feasible method of discharge for all surface water; however, the sub-base attenuation is to be unlined (Type B) to promote infiltration as much as possible.

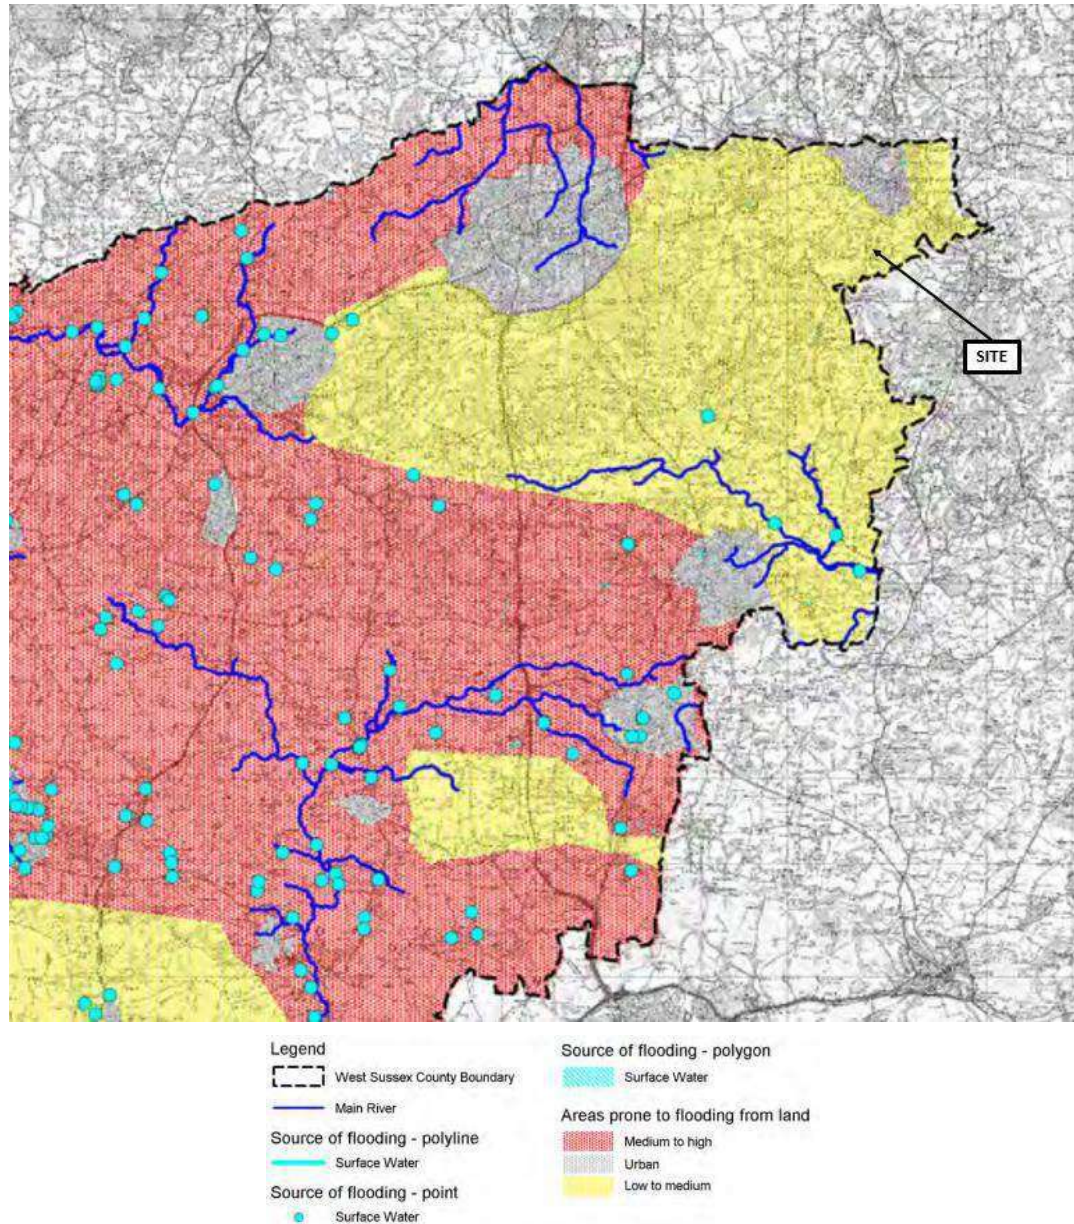
Figure 17: West Sussex County Council SFRA – Areas Prone to Flooding from the Land map extract

Mapping published within the West Sussex County Council SFRA shows the site to be located in an area with low to medium proneness to flooding from the land. There are no recorded surface water flooding events recorded on or near to the development site.

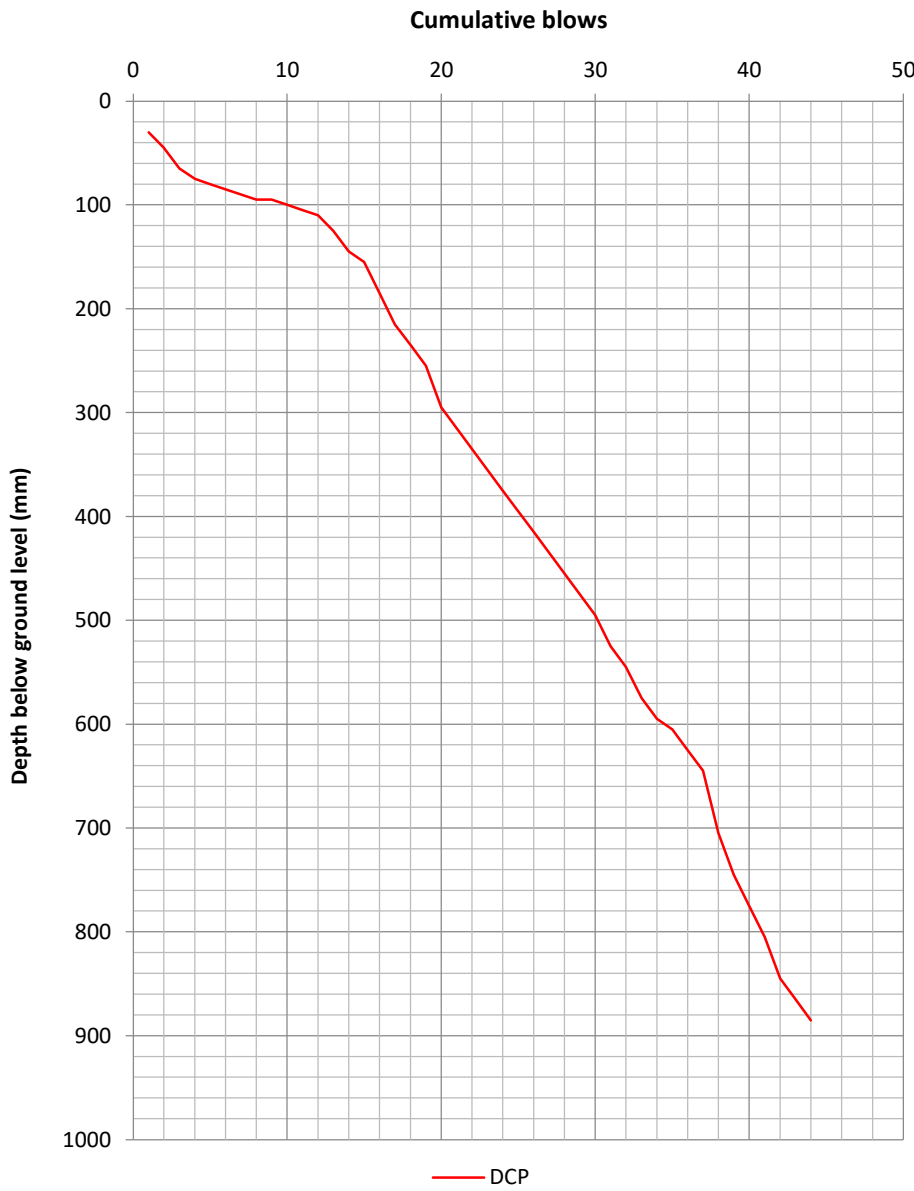
Plot showing number of blows against depth

1. Test procedure following Highways England Document CS229 Data for Pavement Assessment.
