## Preliminary Ecological Appraisal & Preliminary Roost Assessment

Wick Farm House, Truslers Hill Lane, Albourne, Hassocks BN69DU

This report is prepared to inform a planning application with Mid Sussex District Council. This proposal can be described as "Change of use and refurbishment of existing barn"

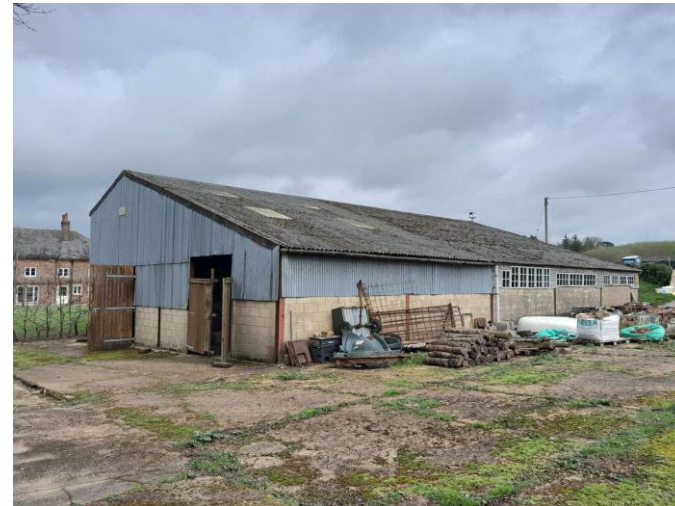
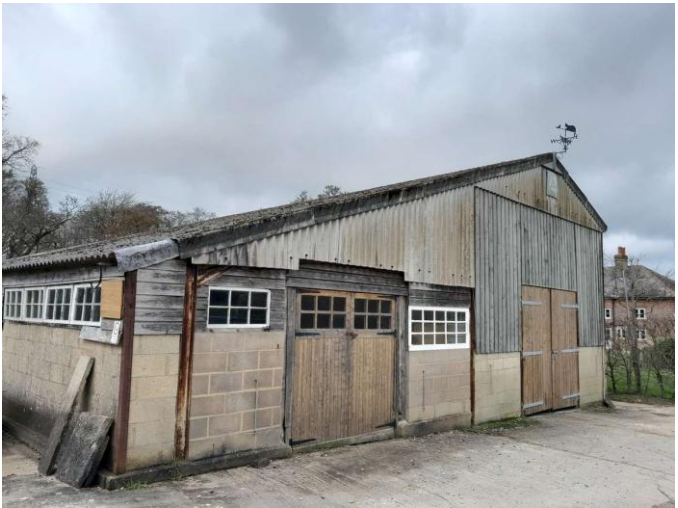
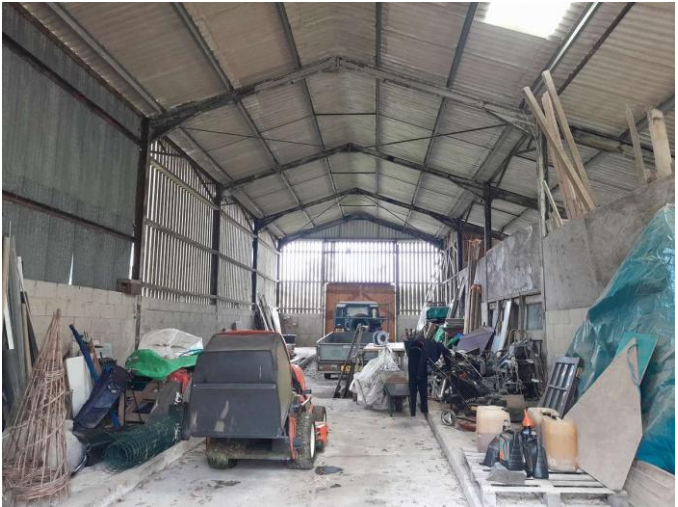
B1 is a single-storey, detached, metal-framed, block-built out-building. The pitched roof is constructed of corrugated asbestos. There is a vaulted ceiling, and the interior is used for storage. The blocks appear in good condition, with no suitable roosting features. The building contains broken windows and various small gaps which would allow bats entry to the interior. The ground, walls and objects within the building were thoroughly searched for bat evidence. No bat evidence was recorded. The building's gaps allow light ingress and the interior is susceptible to temperature and humidity fluctuations, thus reducing suitability for bats.

The building appears in the same material condition as during the 2022 Preliminary Roost Assessment survey.

In line with Good Practice Guidelines (Collins, J (Ed) 2023), B1 is assessed to have negligible habitat value for roosting bats due to a lack of suitable roosting features.

The following precautionary working methods will further reduce the risk to bats, to an acceptably low level:

- The works will be timed to take place when bats are least likely to be present; November to March. As the building is unsuitable for hibernation due to unstable temperature and humidity regimes, this means that the likelihood of disturbing a bat is extremely low.
- In the unlikely event that a bat is found, work will stop and the ecologist will advise on how to proceed.
