**DESIGN AND ACCESS STATEMENT**  
**HERITAGE STATEMENT WITH IMPACT ASSESSMENT**

**APPLICATION FOR**  
**LISTED BUILDING CONSENT FOR ALTERATIONS,**  
**EXTENSION OR DEMOLITION OF A LISTED BUILDING:**  
**REPLACEMENT OF FRONT DOOR.**

**THE OLD BAKERY**  
**65 – 65A HIGH STREET**  
**LINDFIELD**  
**WEST SUSSEX**  
**RH16 2HN**

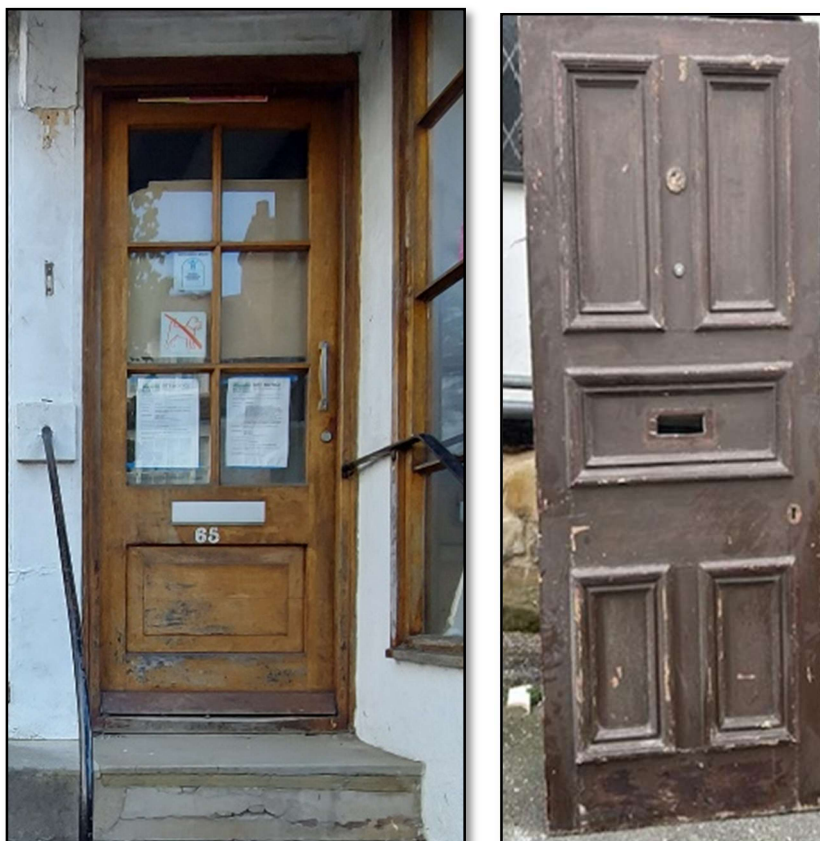
- LEFT: EXISTING DOOR TO BE REPLACED. RIGHT: SALVAGED FRONT DOOR TO BE REINSTATED.

- 2.1.1 Current owner would like to reinstate the timber door that was salvaged from within the property itself, and which the previous owner noted to be the 'earlier' door that was replaced at some point in the past with the existing glazed door.

- 2.1.2 Both doors are not 'Original' but do represent part of the continuous change and adaptation of the building to its adopted use. The glazed door served to promote the use of the building as a bakery allowing for customers to see into the shop, to view goods and gauge the flow of pedestrian traffic over the stepped threshold. Therefore, it acted as a safety measure, as is required for commercial doors to prevent accidents. Whilst the current use of the building as a single-family dwelling, privacy is paramount and sought after, especially taking into consideration its location on a busy road, with a constant flow of pedestrian and vehicular traffic. The replacement of the glazed door with a solid timber door will contribute to providing some privacy and reducing sound transmission.

- 2.1.3 In terms of aesthetics, the use of a solid door would echo the existing adjacent solid door that is currently fixed shut and will not detract from the overall reading of the building. This is as the shopfront with the cantilevered flat roof and signage presents the dominant feature and not the door itself, which is set back within the main elevation.

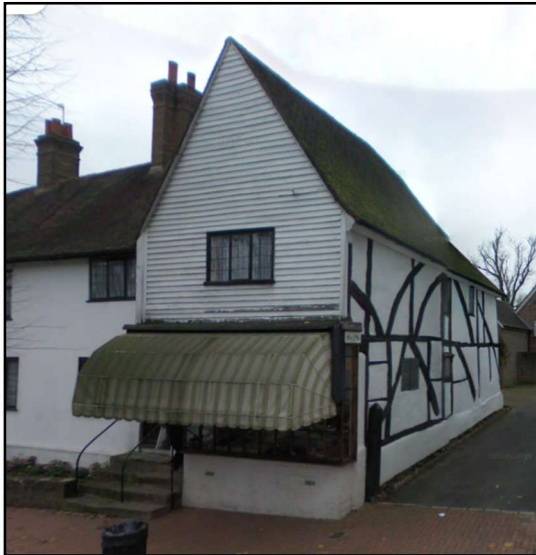
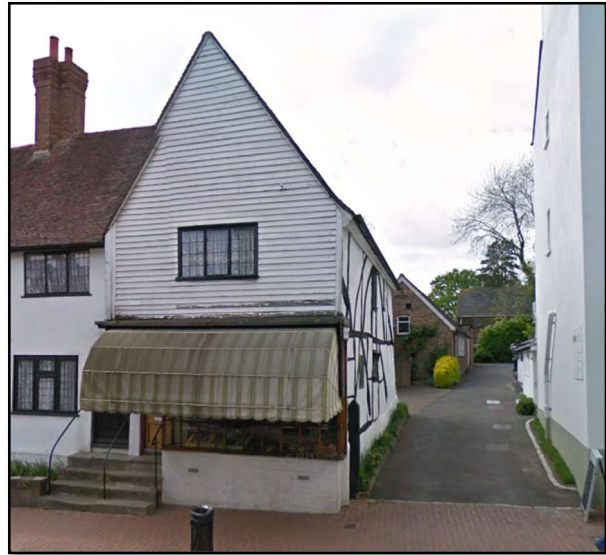
- GOOGLE STREET VIEW: LEFT 2008 & RIGHT 2009

- 2.1.4 The door itself was never meant to be a feature and was almost always concealed by the fabric canopy that was used when the bakery was in operation, and that shielded staff and goods from the glare and heat of the sun. As can be seen from the images below extracted from historic images from Google Street Views.

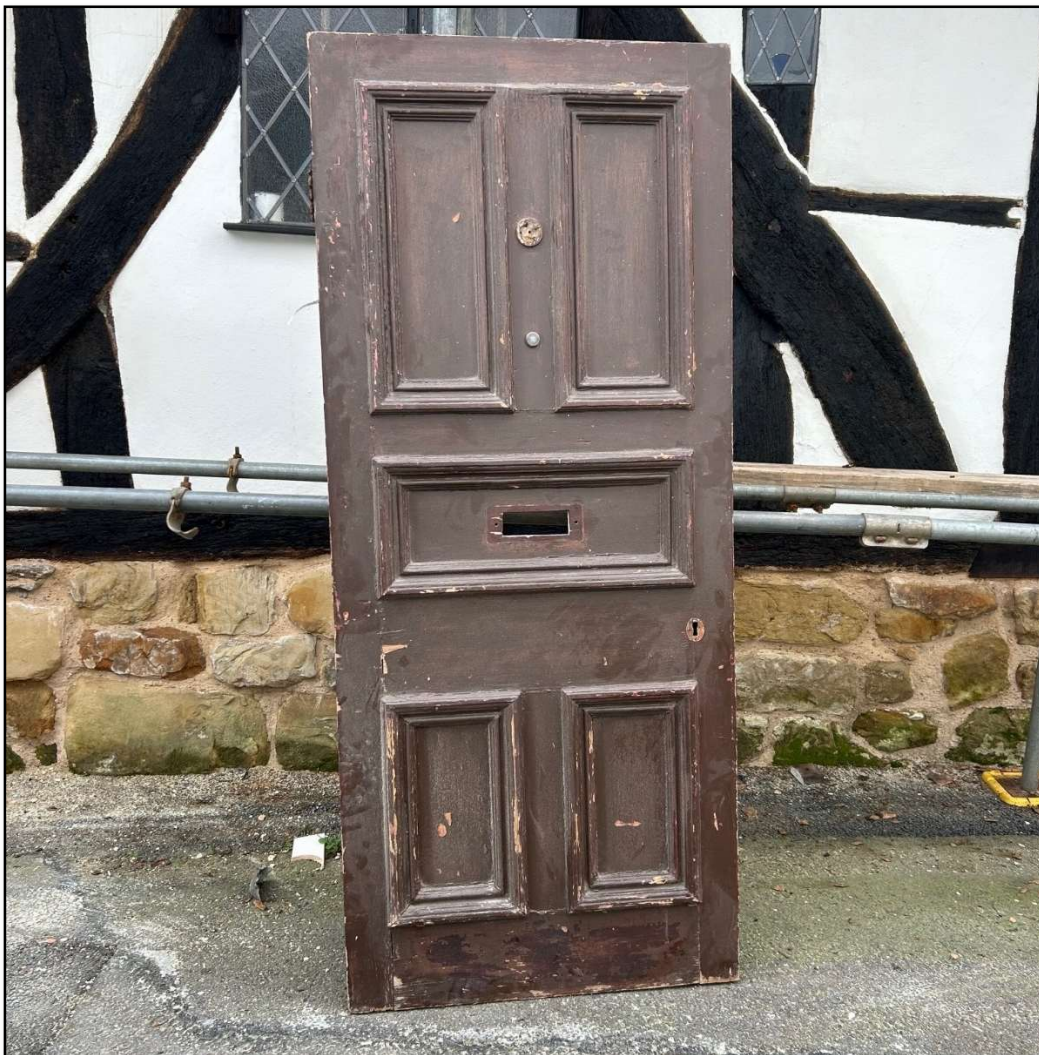
- PHOTO OF THE DOOR RECOVERED FROM THE ANCILLARY RANGE AT THE OLD BAKERY : PHOTO PROVIDED BY THE CLIENT

It is proposed that the front door to the bakery is reinstated to an earlier version. Mrs Kim Wyles the daughter of the previous owner and baker Mr. Wyles has been in touch with the present owner. Mrs Wyles has confirmed that the door salvaged that was initially at the entrance to the bakery in the cross-wing of the building may have been stored with other timber in the ancillary building to the rear of the street front-range. A robust timber door with five moulded panels, the central panel extending across the width of the door and including a letter-box has since been recovered from the ancillary range. Mrs Wyles has supplied photographs, unfortunately they are too pixelated to make out much of the detail other than that the door was certainly to a different form than it is at present, lacking the extent of glazing of the existing modern door as shown on the photos provided above.

The recovered door is stylistically commensurate with a Georgian origin. As the present door is a mid to late 20<sup>th</sup> century addition to the building, its replacement with a more historic alternative will not result in the loss of significant fixtures for this building. The reuse of the robust timber door recovered from the ancillary range will make good use of a salvaged historic fixture of a style that will sit well with the Georgian-style frontage of this important mid-14<sup>th</sup> century cross-wing.

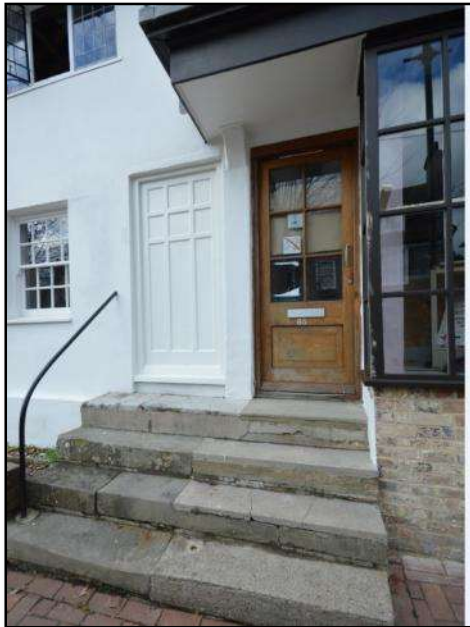
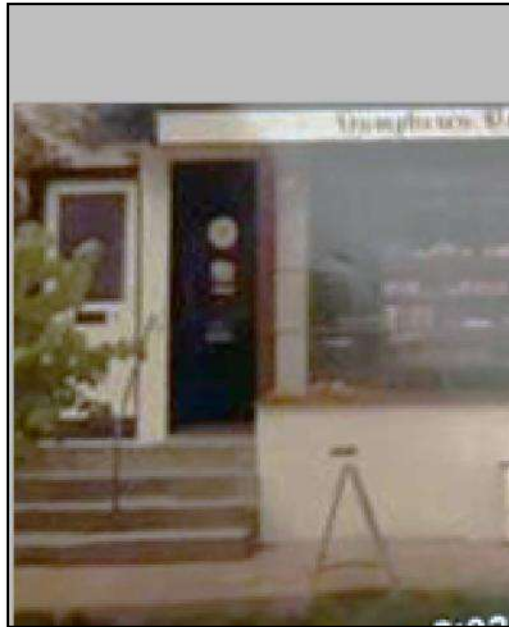
- COMPARISON OF THE EXISTING FRONT DOOR AND ITS PREDECESSOR [PROVIDED BY MRS K.WYLES]
