| Rebuild of fire damaged barn<br>Kenwards Farm<br>Snow Hill<br>Crawley Down<br>RH10 3EG | |
| Floor plans, section and elevations | |
| <b>Dwg No.</b> 2540/03 | <b>Rev</b> |

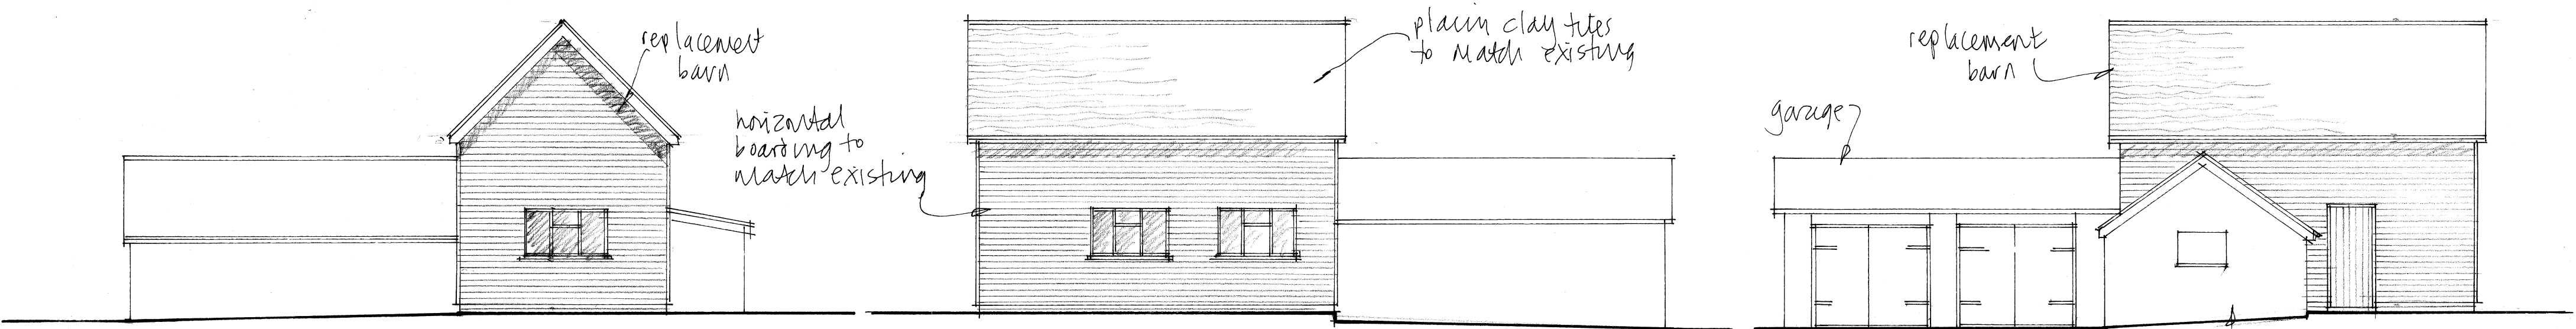
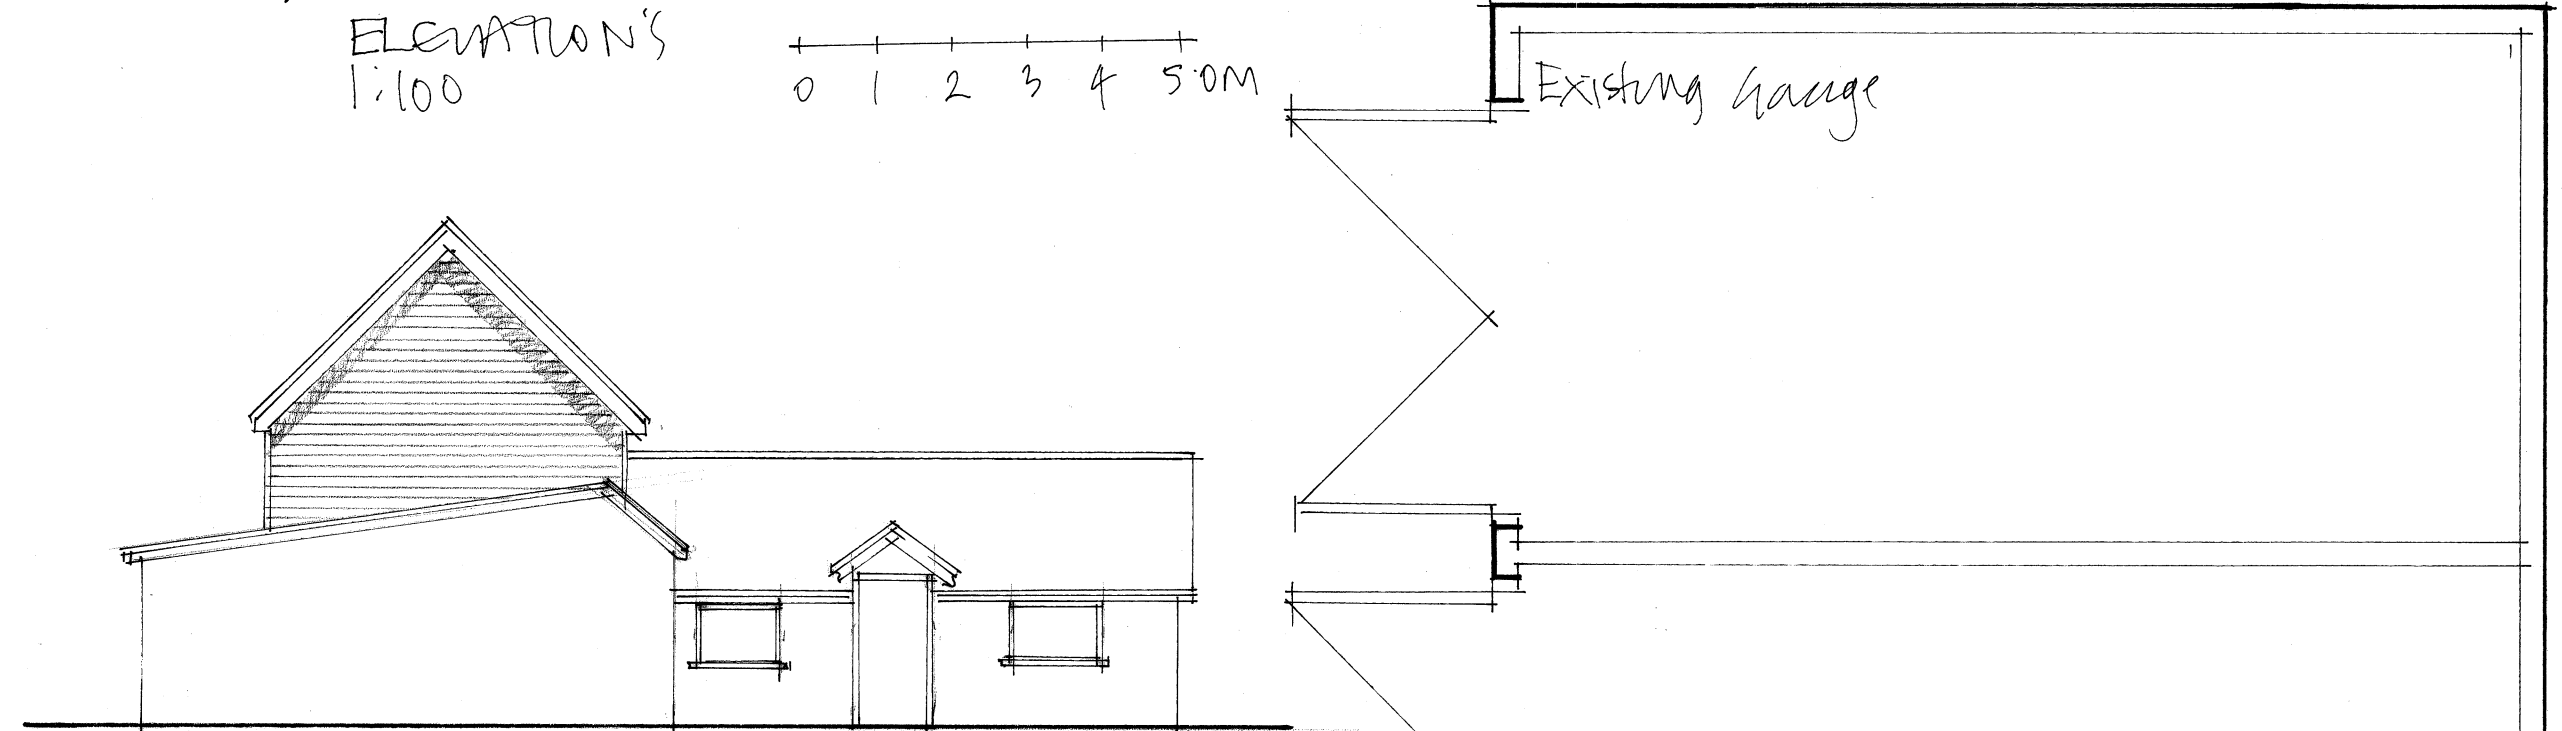
EAST  
ELEVATIONS  
1:100

horizontal boarding  
- dark stained

repair brick plinth

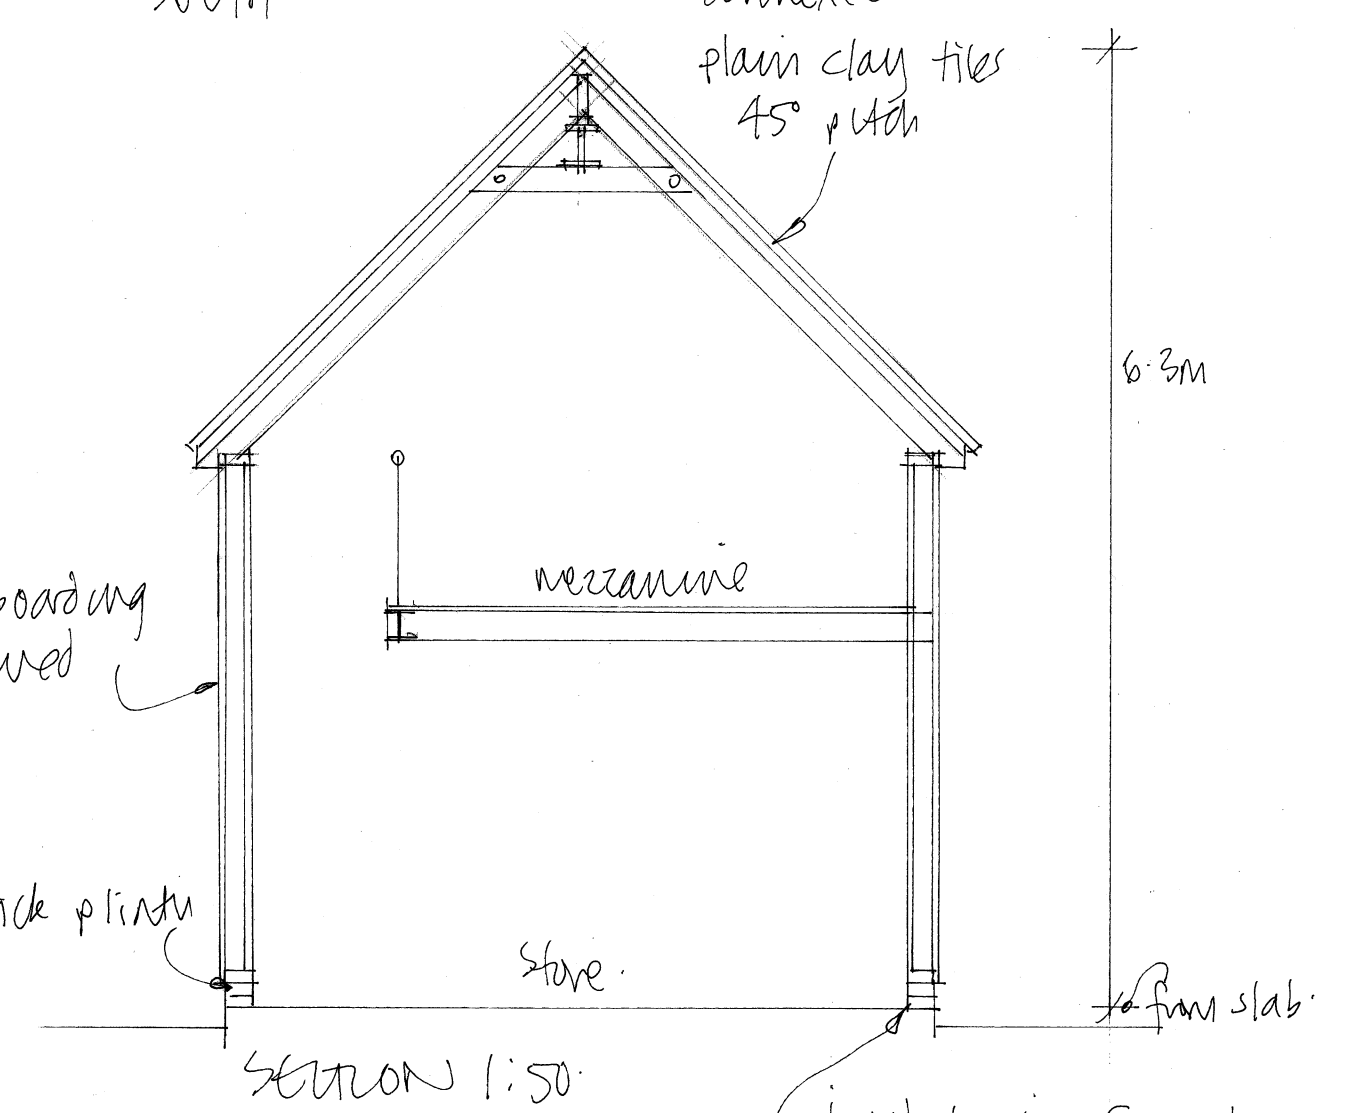
SECTION 1:50

rebuild timber framed  
walls off existing  
slab / brick plinth

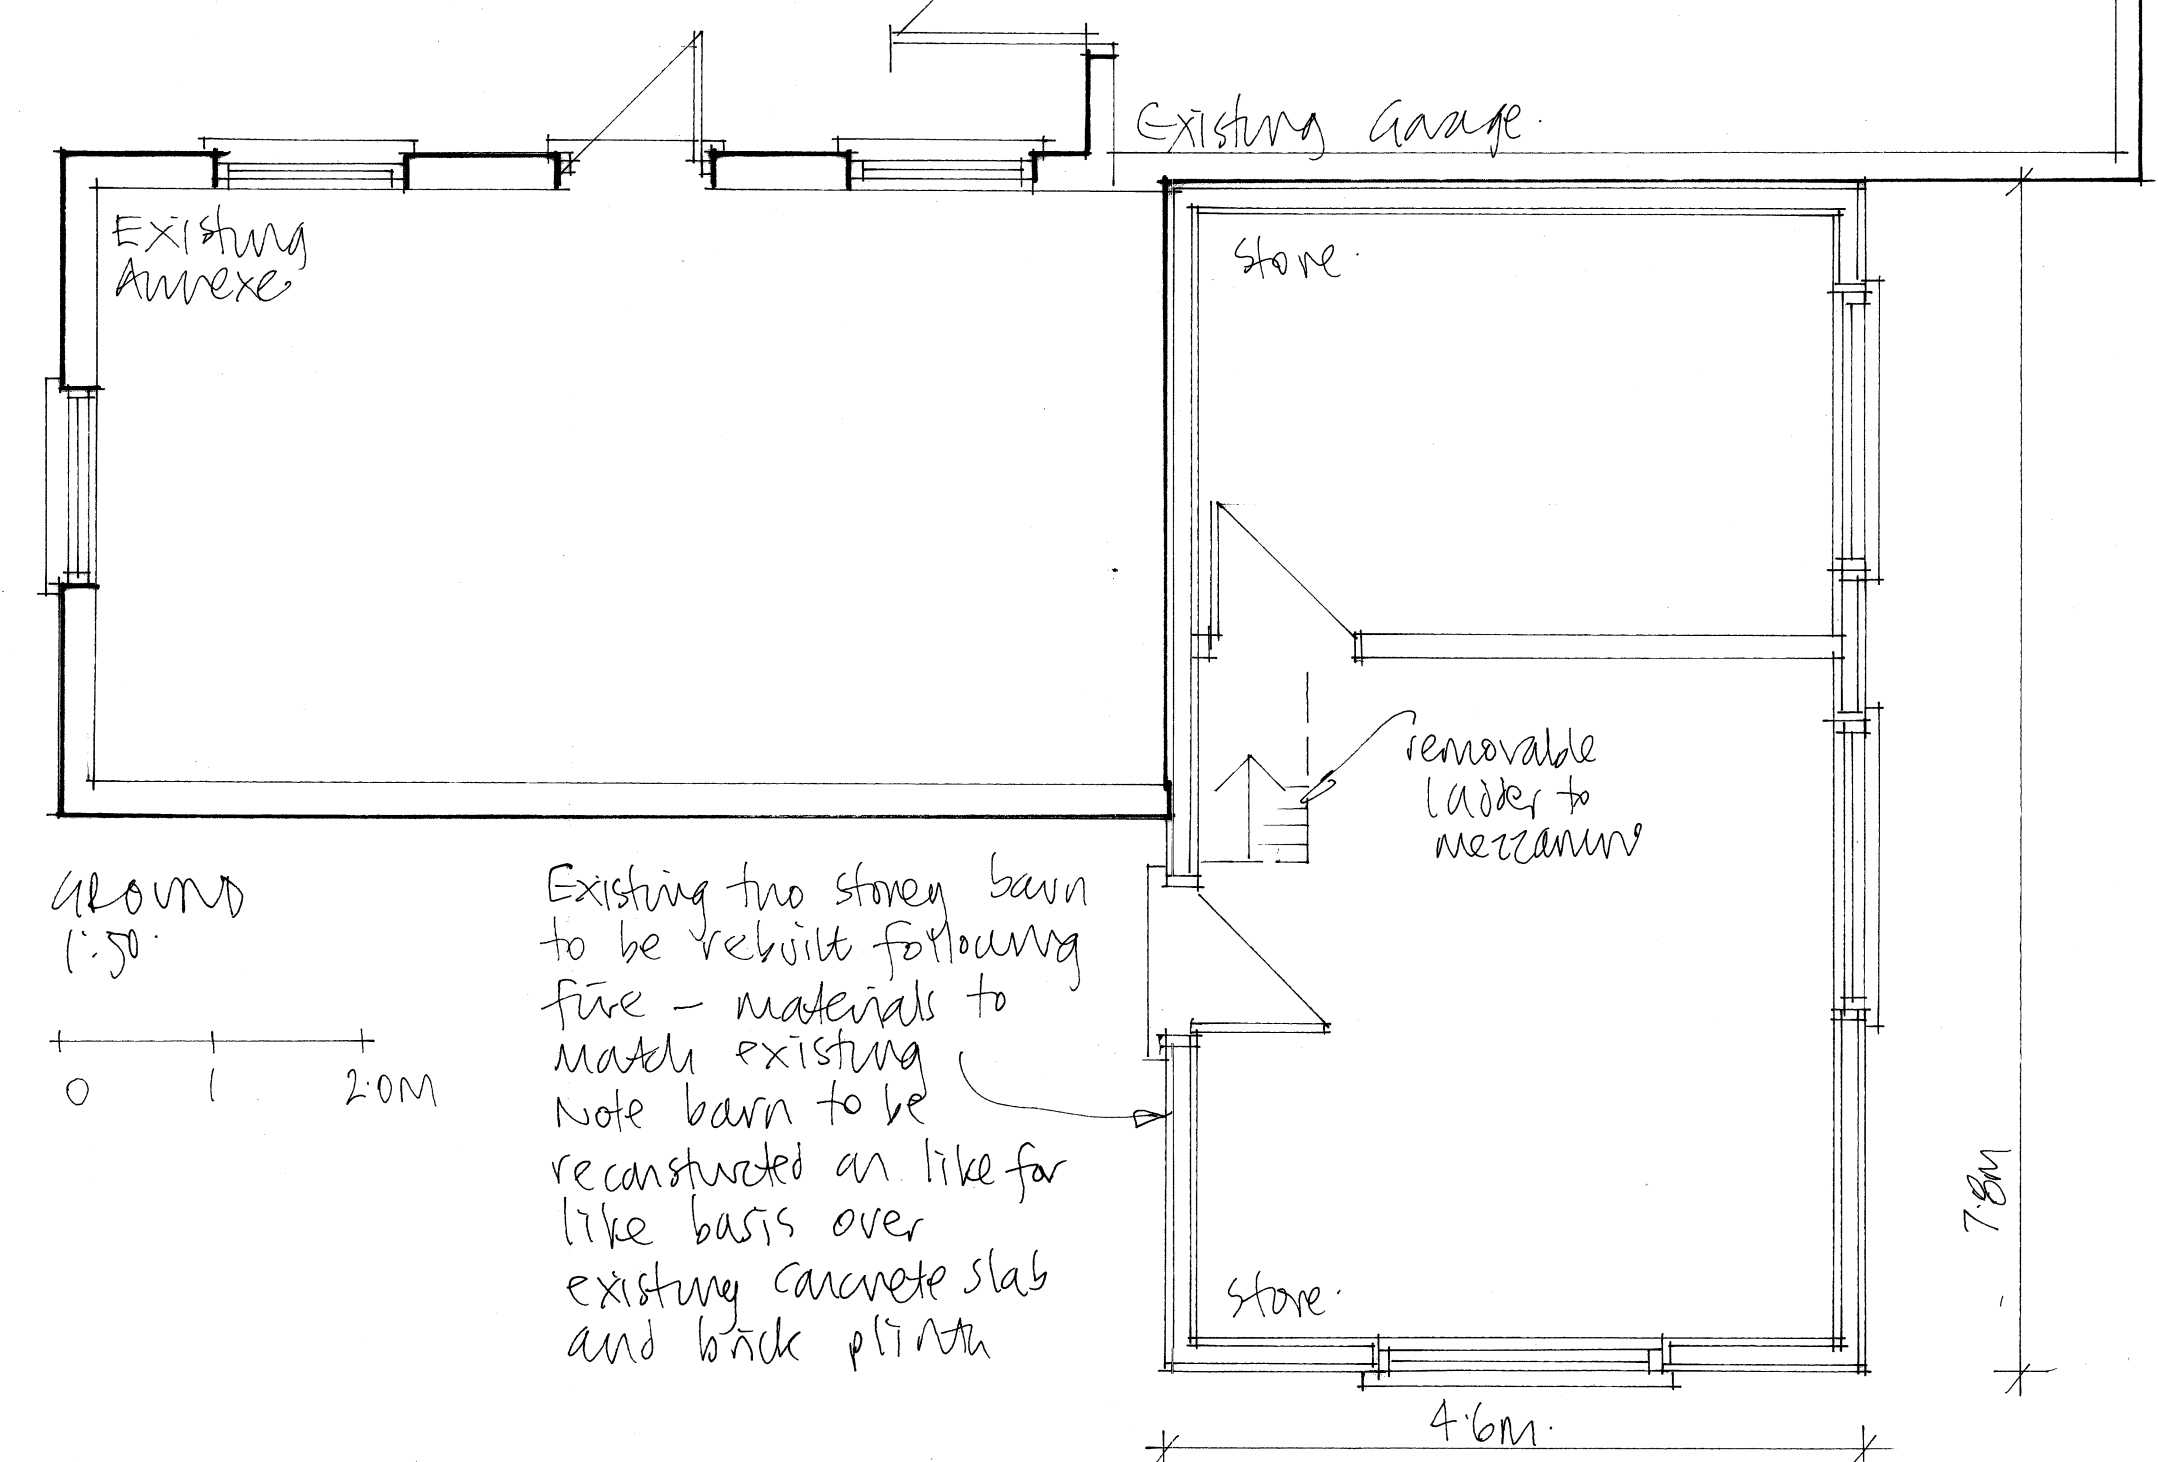
GROUND  
1:50

Existing two storey barn  
to be rebuilt following  
fire - materials to  
match existing  
Note barn to be  
reconstructed on like for  
like basis over  
existing concrete slab  
and brick plinth
