## Desk Study and Preliminary Site Investigation Report

Site: Hamsland, Horsted Keynes, Haywards Heath, RH17 7DS

Client: Rydon Homes Ltd

Project Reference: J14075

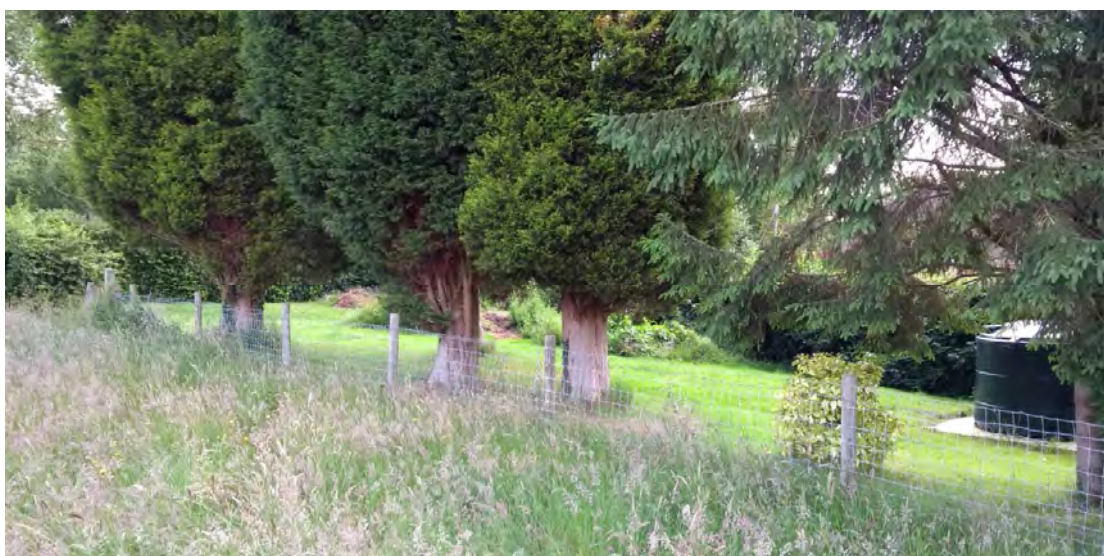
Plate 2 – Above ground storage tank within north-east parcel of adjoining land (18/06/19)

An above ground tank was noted, within the eastern part of the north-east parcel of adjoining land, approximately 5m to the south of the site. The tank appears to be of plastic construction and is located on a concrete base. A short-section of the delivery pipe, leading from the tank, can be seen to be laid away from the site towards the nearby house. The tank appears to be most likely to be used for storing heating oil, for the nearby property.

and concrete base, and with no oil observed dripping from the tank or ponding, the risk of petroleum hydrocarbons leaking from the tank and leaching into the ground is considered to be Low. As such this source is deemed to present a Moderate risk to the site.

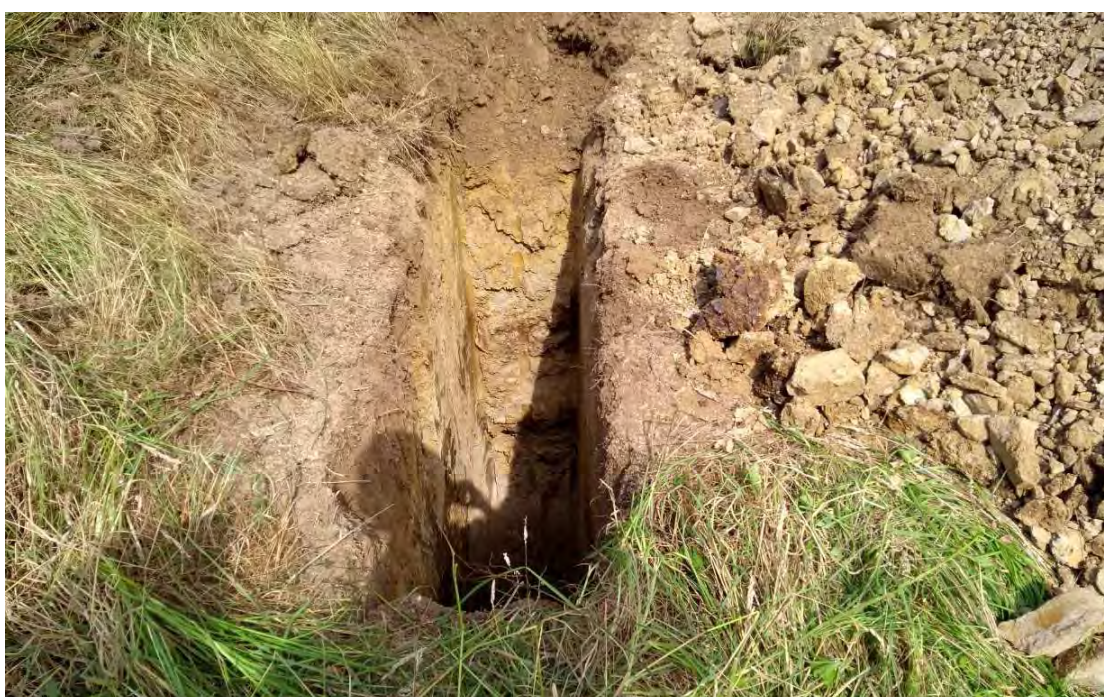
Plate 3 – Typical Trial Pit (TP105) with arisings (02/07/19)
