## DRAINAGE DESIGN VALIDATION REPORT

DOWNLANDS PARK  
BOLNORE FARM LANE  
HAYWARDS HEATH  
RH16 4BQ

21279-SYM-XX-XX-RP-C-0100

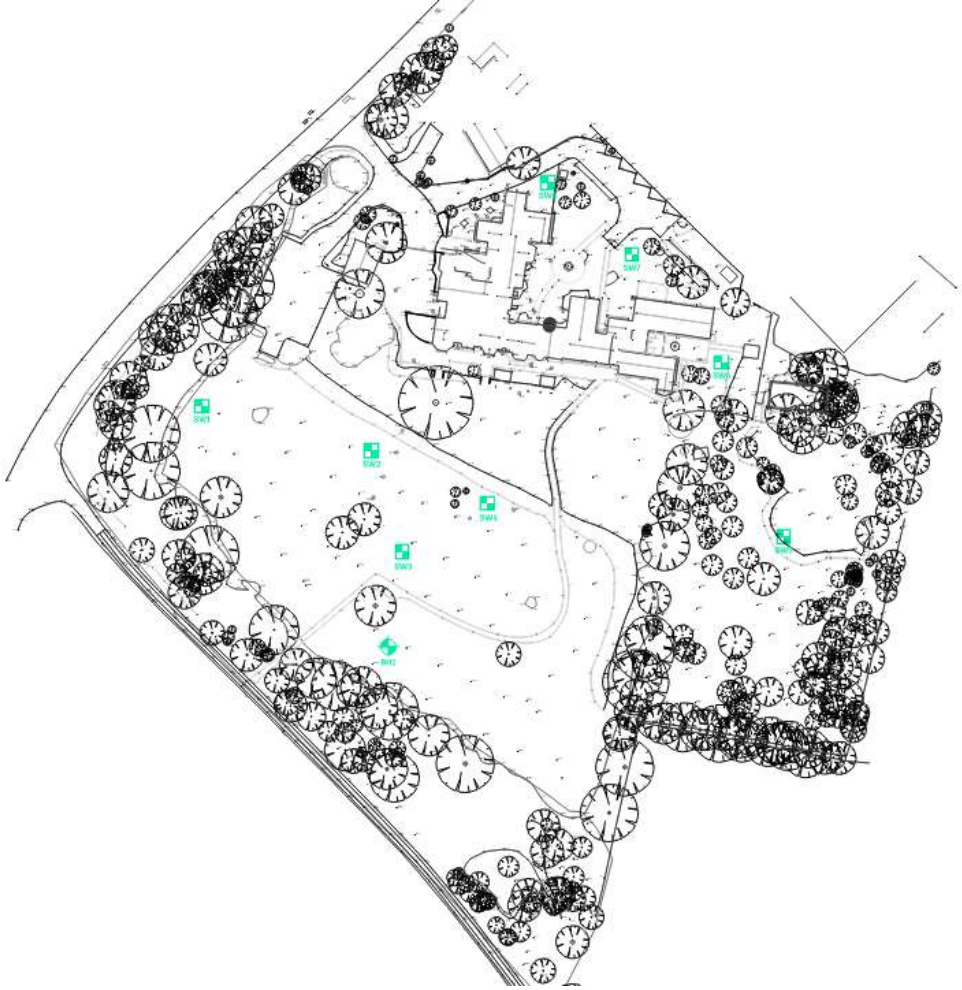
Figure 3: Site Investigation Plan – LMB Geosolutions

3.4.9 Figure 3 below shows the locations of the exploratory holes referenced.

3.4.10 Review of results indicates that SW7 has the most suitable infiltration rate at 1.15x10<sup>-5</sup>. Note that the majority of these tests were carried out within the sandstone strata.

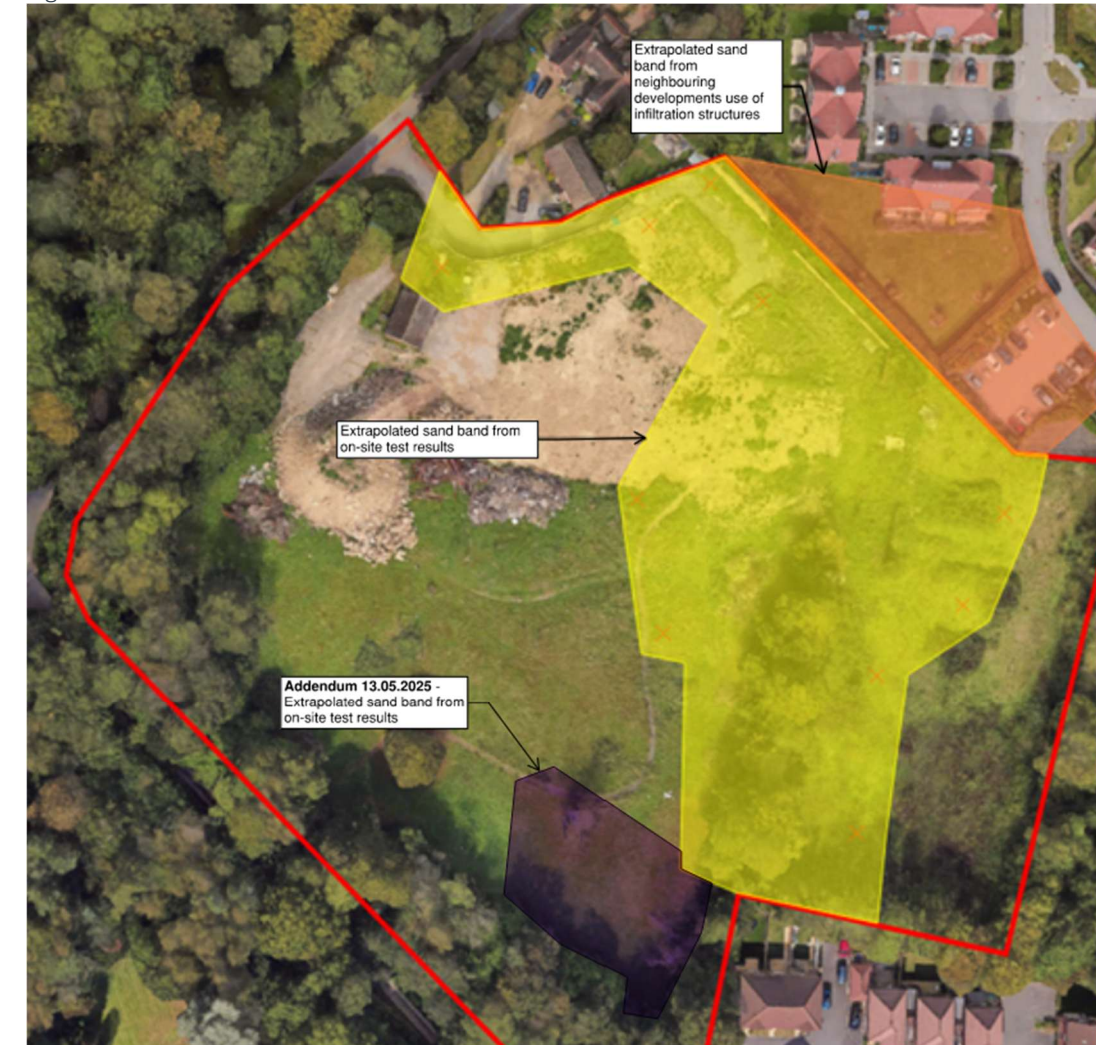
Figure 6: Estimated Sand Band

- 5.1 Figure 6 has been updated to show the extension of the likely sand band, following further on-site tests, more specifically in the location of the proposed basin.
- 5.2 Figure 6 provides an estimated outline of a sand band within both the site and the neighbouring site to the north, based on the observed sand strata from on-site exploratory hole results.
- 5.3 The top layer of sandy soil was largely excluded due to its minimal depth (generally less than 500mm from ground level).

- 5.7 Figure 6 has been updated to show the extension of the likely sand band, following further on-site tests, more specifically in the location of the proposed basin.
