| Project LAND TO THE SOUTH OF REEDS LANE,<br>SAYERS COMMON | | |
| DISCOUNTED VIEWPOINTS | | |

## **Appendix 8 Preliminary Ecological Appraisal**

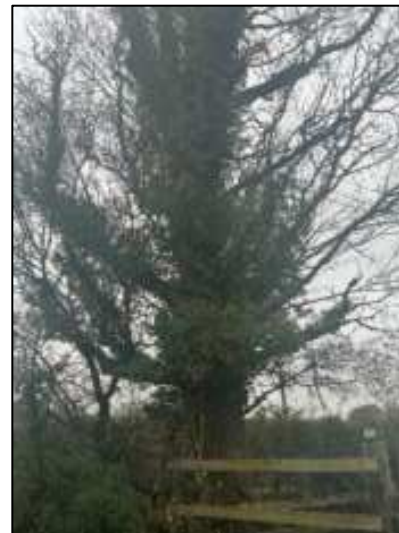
| Tree Ref | Species/Age class | Location | Features | Category | Photograph |
|---|---|---|---|---|---|
| T98 | Field Maple<br>Semi-mature | Scattered tree along the southern boundary, within the southeast corner. | Ivy cladding, split limbs and broken limbs | Low | |

multiple semi-mature oak trees, two crab apple trees, and one mature field maple. The field maple exhibits low bat roosting potential due to features such as ivy cladding, split limbs, and broken limbs. One of the oak trees is mature, with medium bat roosting potential, displaying features like knot holes, broken limbs, tear-outs, and split limbs. A wet ditch runs along the inside of the hedgerow, supporting vegetation such as soft rush, moss, bullrush, and young willow. The hedgerow is well-maintained on the roadside but left unmanaged on the field side, which has led to the development of successional scrub.

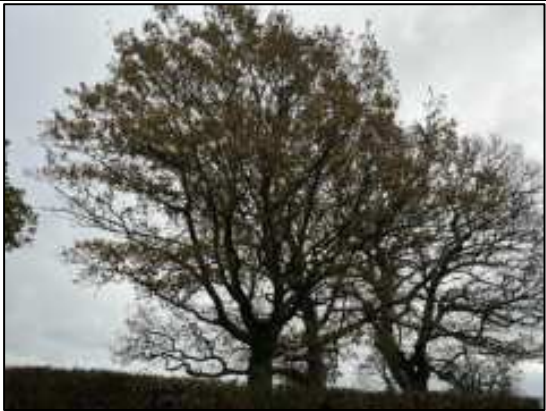
| Tree Ref | Species/Age class | Location | Features | Category | Photograph |
|---|---|---|---|---|---|
| T8/T9 | A pair of oak<br>Semi-mature | Eastern boundary | Ivy cladding, broken branches, cavities and split limbs. | Low | |

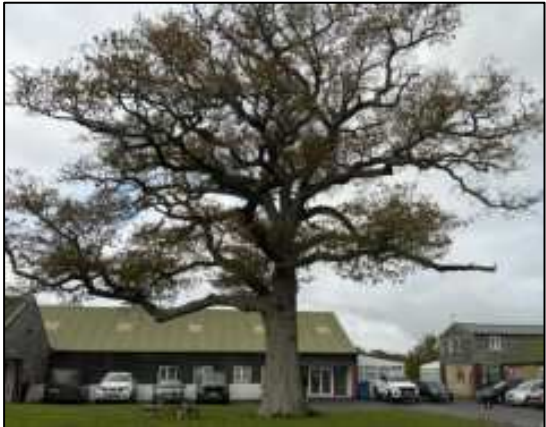
| Tree Ref | Species/Age class | Location | Features | Category | Photograph |
|---|---|---|---|---|---|
| T39 | Very Large<br>Mature oak | Within the centre of Parcel B within a field of modified grassland | Small knot holes and broken limbs present.<br>It could not be determined if these led to a cavity, nor was it possible to fully inspect this feature.<br>No evidence was found to suggest use by bats. | Low | |

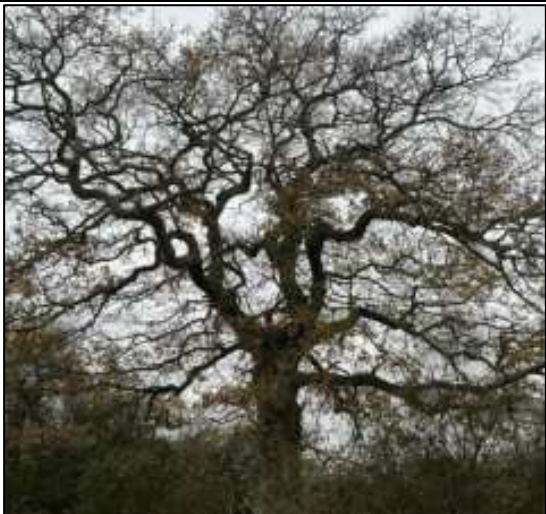
| Tree Ref | Species/Age class | Location | Features | Category | Photograph |
|---|---|---|---|---|---|
| T14 | Very large mature Oak | Species rich hedgerow with trees along the northwestern boundary of Parcel C (L7) | Small knot holes present.<br>It could not be determined if these led to a cavity, nor was it possible to fully inspect this feature.<br>No evidence was found to suggest use by bats. | Low | |

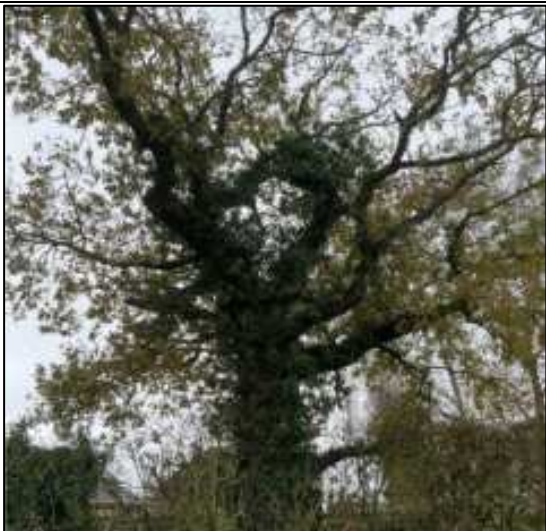
| Tree Ref | Species/Age class | Location | Features | Category | Photograph |
|---|---|---|---|---|---|
| T20 | Very large mature Oak | Native hedgerow associated with ditch on southern boundary of Parcel C (L4) | Small knot holes, ivy cladding and broken limbs present.<br>It could not be determined if these led to a cavity, nor was it possible to fully inspect this feature.<br>No evidence was found to suggest use by bats. | Low | |

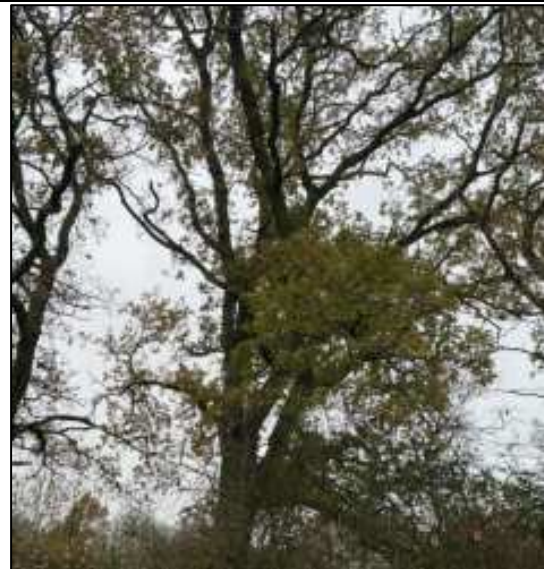
| Tree Ref | Species/Age class | Location | Features | Category | Photograph |
|---|---|---|---|---|---|
| T29 | Large mature Oak | Species rich hedgerow with trees along the northwestern boundary of Parcel C (L7) | Small knot holes and split bark present.<br>It could not be determined if these led to a cavity, nor was it possible to fully inspect this feature.<br>No evidence was found to suggest use by bats. | Low | |

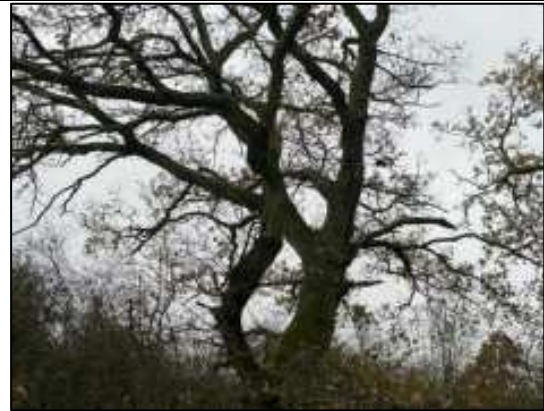
| Tree Ref | Species/Age class | Location | Features | Category | Photograph |
|---|---|---|---|---|---|
| T30 | Large mature Oak | Species rich hedgerow with trees along the northwestern boundary of Parcel C (L7) | Small knot holes and broken limbs present.<br>It could not be determined if these led to a cavity, nor was it possible to fully inspect this feature.<br>No evidence was found to suggest use by bats. | Low | |

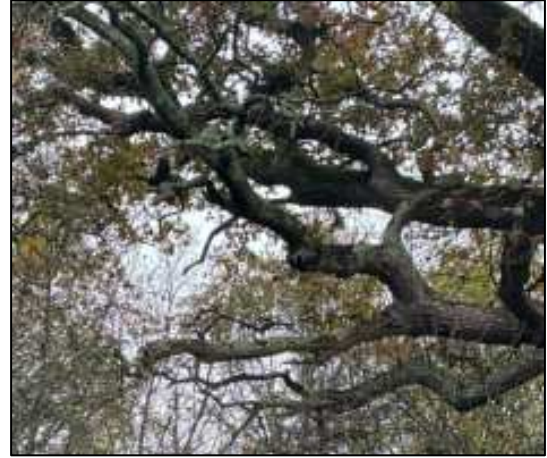
| Tree Ref | Species/Age class | Location | Features | Category | Photograph |
|---|---|---|---|---|---|
| T31 | Very large mature Oak | Species rich hedgerow with trees along the northwestern boundary of Parcel C (L7) | Small knot holes, split bark and broken limbs present. It could not be determined if these led to a cavity, nor was it possible to fully inspect this feature. No evidence was found to suggest use by bats. | Low | |

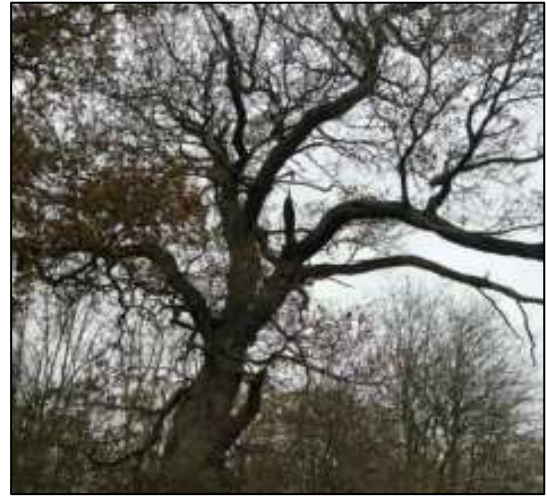
| Tree Ref | Species/Age class | Location | Features | Category | Photograph |
|---|---|---|---|---|---|
| T32 | Very large mature Oak | Species rich hedgerow with trees along the northwestern boundary of Parcel C (L7) | Small knot holes, split bark and broken limbs present. It could not be determined if these led to a cavity, nor was it possible to fully inspect this feature. No evidence was found to suggest use by bats. | Low | |

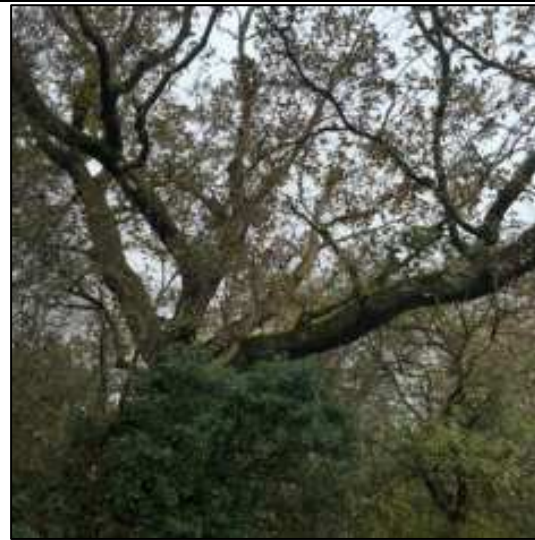
| Tree Ref | Species/Age class | Location | Features | Category | Photograph |
|---|---|---|---|---|---|
| T36 | Very large mature Oak | Species rich hedgerow with trees along the northwestern boundary of Parcel C (L7) | Small knot holes, split bark and broken limbs present. It could not be determined if these led to a cavity, nor was it possible to fully inspect this feature. No evidence was found to suggest use by bats. | Low | |

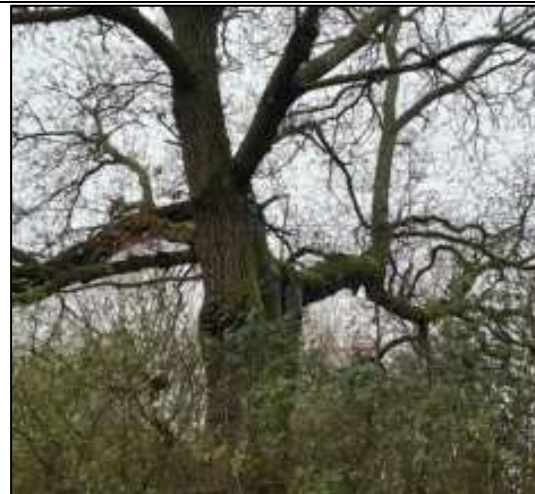
| Tree Ref | Species/Age class | Location | Features | Category | Photograph |
|---|---|---|---|---|---|
| T37 | Large mature Oak | Species rich hedgerow with trees along the northwestern boundary of Parcel C (L7) | Small knot holes, split bark and broken limbs present. It could not be determined if these led to a cavity, nor was it possible to fully inspect this feature. No evidence was found to suggest use by bats. | Low | |

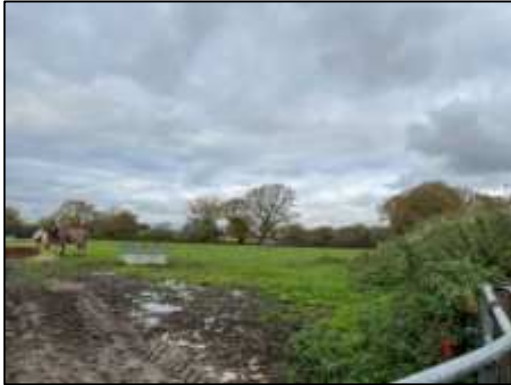
***Photograph 1: Modified grassland grazing paddocks throughout Parcel A.***

3.2.9 A large amount of the Site comprises parcels of grazed modified grassland paddocks (photograph 1). These parcels are present surrounding the equestrian centre. There is also a modified grassland parcel in the northeast corner of the Site. The grassland parcels are all the same and are dominated by perennial ryegrass, with creeping cinquefoil, bristly oxtongue, doves foot cranesbill and broadleaved dock. White clover is found in abundance and creeping buttercup; dandelion and daisy were also identified. The grassland is used for grazing and is therefore short sward and highly disturbed and is lacking in species diversity, hence its assessment of poor condition.

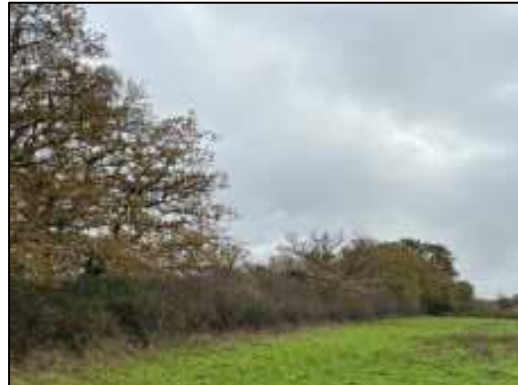
***Photograph 2: Native hedgerow with trees on the western boundary.***

- 3.2.13 Numerous well-maintained native hedgerows with trees are present throughout Parcel A of the Site (Photograph 2). These hedgerows are broadly similar in composition and structure across the parcel and are in good condition due to their strong structure, continuous canopy, undisturbed ground, and healthy trees. The absence of non-native invasive species further supports their ecological value. The hedgerows are dominated by native tree species such as hawthorn, holly, blackthorn, oak, field maple, willow, hazel, wild cherry, ash, and bramble. The ground layer is rich with species such as bramble, cleavers, curly dock, and dogwood.

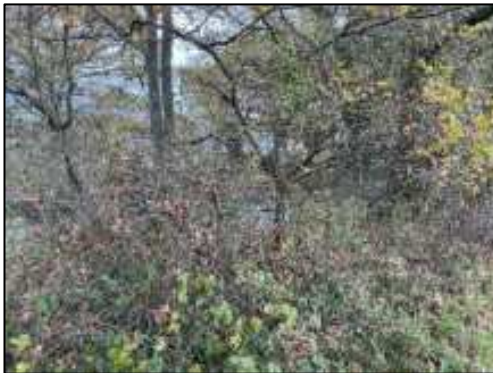
***Photograph 3: Broadleaved woodland (TN 64) within Parcel A***

- 3.2.18 The third woodland block is located in the central-north part of the Site surrounding a pond (photograph 3) (TN A-64). The trees within this woodland include elder, crab apple, willow, holly, oak, hazel, and hawthorn, with an understory of hawthorn, ivy, holly, and bramble. This woodland is of moderate condition, with a mixture of tree ages, species, and good tree health. It is free from grazing damage and invasive species, with a good amount of open space. However, like the other blocks, it lacks both deadwood and veteran trees, as well as significant diversity in ground flora.

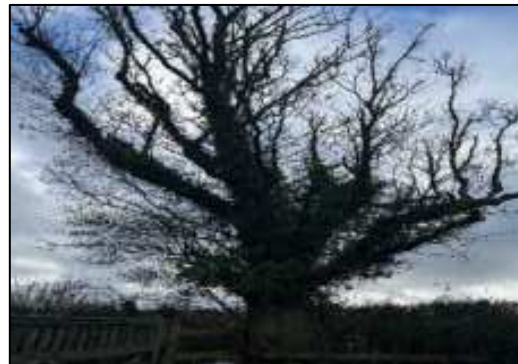
***Photograph 4: Example of scattered tree within Parcel A.***

- 3.2.20 There are also a substantial number of scattered trees of good condition. They range from small to very large in size, and species include oak, field maple (photograph 4), ash, willow, wild cherry and hawthorn. The trees are native and have a full canopy but are not mature. Many of the trees display ecological niches including knot holes or creviced bark, which provide low roosting potential for individual bats. Trees are scattered throughout the Site, near hedgerows and field margins.

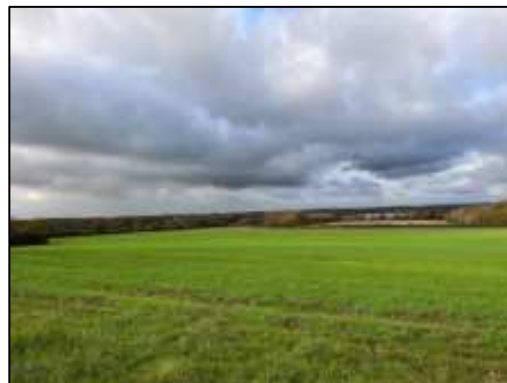
***Photograph 5: Mixed scrub of poor condition within Parcel A.***

- 3.2.21 Within Parcel A of the Site, there are four parcels of mixed scrub in poor condition: three parcels are located in the east, and one parcel is in the west. The first parcel is a long strip of scrub, situated adjacent to horse muck heaps and paddocks (photograph 5). The species present in this area include elder, bramble, hawthorn, field maple, and blackthorn. A second, smaller parcel lies nearby, consisting of bramble, hawthorn, blackthorn, elder, and willow. A third small parcel is located to the south of the previous one, adjacent to the road, and is made up of bramble, blackthorn, and dogwood. The fourth parcel, in the west, is another long strip of scrub, dominated by bramble, oak, blackthorn, and hawthorn. All four parcels are classified as being in poor condition due to a lack of age structure, the absence of a well-developed edge, and the lack of clearings or rides.

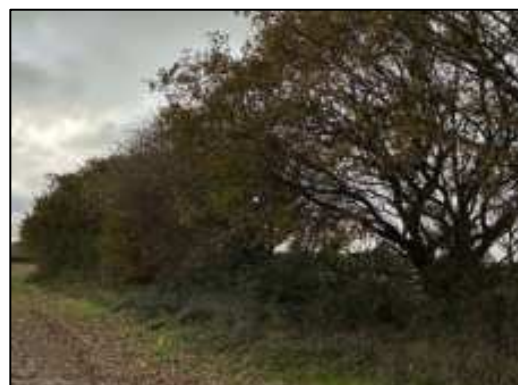
***Photograph 11: Native hedgerow of good condition within Parcel A.***

- 3.2.33 Numerous native hedgerows of good condition are present throughout Parcel A of the Site (photograph 11). These hedgerows comprise a diverse mix of native species, including oak, dog

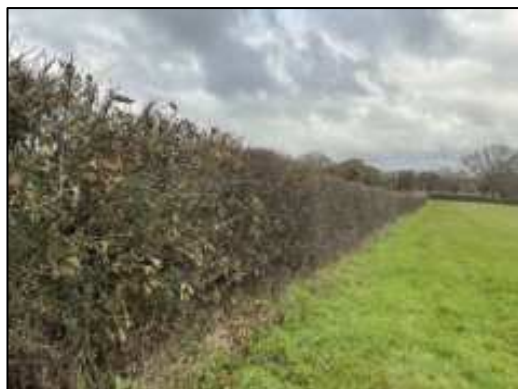
***Photograph 16: Plantation woodland within Parcel B in poor condition.***

Other broadleaved woodland (w1g) (TN B-6)– poor condition - Photograph 16

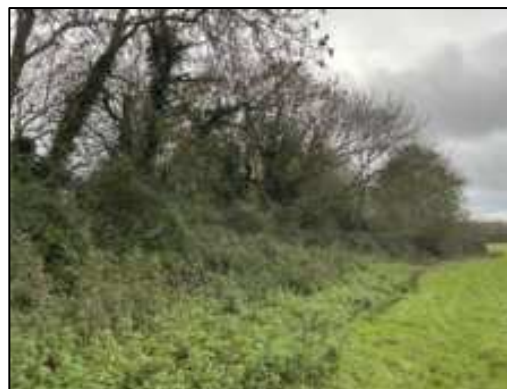
***Photograph 17: Example of a native hedgerow within Parcel B.***

- 3.2.57 Another native hedgerow of moderate condition is present within parcel B (L3). Species composition includes a mix of mature hawthorn and blackthorn and bramble (Photograph 17). Ground flora is limited, with cleavers and common nettle being the dominant herbaceous species suggesting that these hedgerows are subject to higher levels of nutrient enrichment. However, this hedgerow is less defunct and provides better cover and connectivity for protected species such as small nesting birds and mammals.

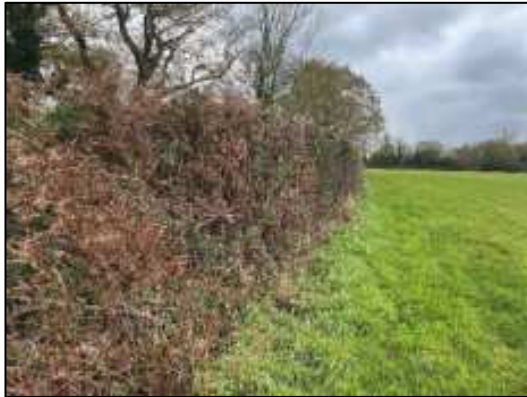
***Photograph 18: Native hedgerow with trees in good condition within Parcel B.***

- 3.2.60 The other native hedgerow with trees is in good condition (L5) (photograph 18). This hedgerow is approximately 3-5 m height and 3-4 m in width, with a continuous canopy. Hedgerow species include predominantly hawthorn and bramble, with tree species including both semi-mature and mature ash and oak. Ground flora comprises red campion, bramble, cleavers, ivy, dove's-foot crane's-bill, daisy, selfheal, white clover and perennial rye grass. There are areas of successional scrub growing out from the hedgerow, providing an undisturbed vegetated strip around the hedgerow on its northern side, and although there are some species indicative of nutrient enrichment present, including cleavers, these do not dominate the area or exceed 20% coverage. As a result, this hedgerow provides better cover and connectivity for protected species such as small nesting birds, reptiles and mammals.

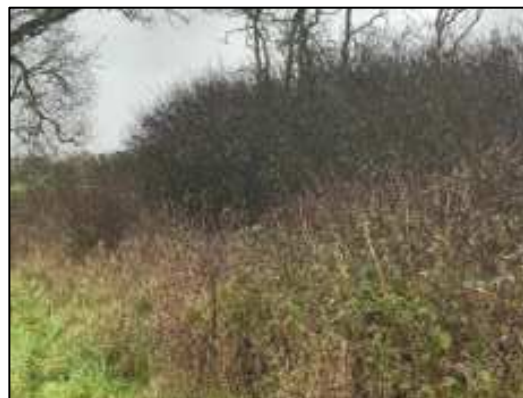
***Photograph 23: Native hedgerow of moderate condition within Parcel C.***

- 3.2.73 Two native hedgerows (C-L2, L3 and L9) within Parcel C are considered to be in moderate condition. These lie along the southern boundary and through the centre of Parcel C, with species composition including a mix of mature hawthorn, wild privet, blackthorn and bramble (Photograph 23). Ground flora is limited, with cleavers and common nettle being the dominant herbaceous species suggesting that these hedgerows are subject to higher levels of nutrient enrichment. However, these hedgerows have continuous canopies with no significant gaps, providing better cover and connectivity for protected species such as small nesting birds and mammals.

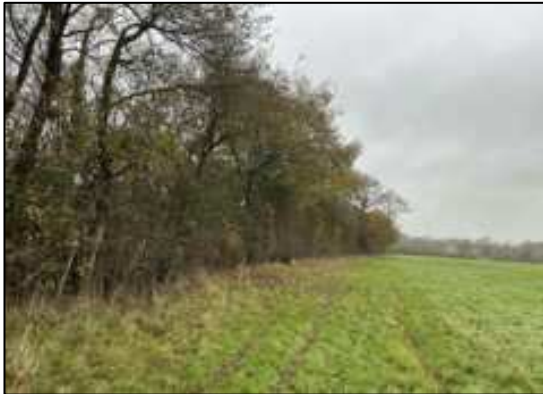
***Photograph 24: Native hedgerow of good condition within Parcel C.***

- 3.2.74 One native hedgerow within Parcel C is in good condition (C-L16). This hedgerow comprises a mix of goat willow, blackthorn and bramble (Photograph 24), with a continuous canopy cover, providing better cover and connectivity for protected species such as small nesting birds and

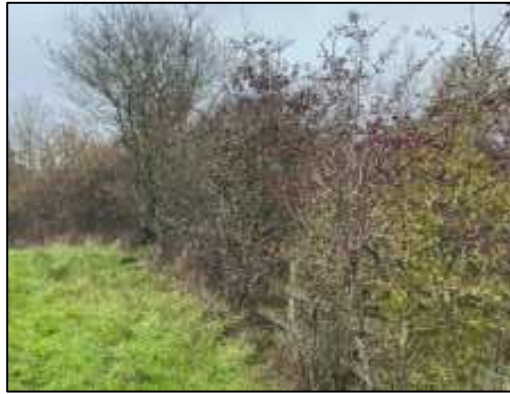
***Photograph 25: Species rich native hedgerow with trees within Parcel C***

- 3.2.75 One species rich native hedgerow with trees in moderate condition lies along the western boundary within Parcel C. Species composition includes a mix of mature hawthorn and blackthorn, ivy and bramble, with trees comprising semi-mature and mature species including oak, field elm and field maple (Photograph 25). Ground flora is limited, with cleavers and common nettle being the dominant herbaceous species suggesting that these hedgerows are subject to higher levels of nutrient enrichment. However, this hedgerow has a continuous canopy with heights and widths of over 1.5 m, and so they provide cover and connectivity to adjacent woodland for protected species such as small nesting birds and mammals.

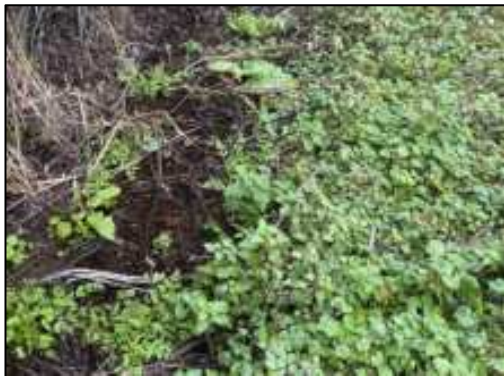
***Photograph 26: Line of trees example within Parcel C.***

Line of trees (33) (C- L8, L13, L14, L15, L17, L18 and L19) – Photograph 26

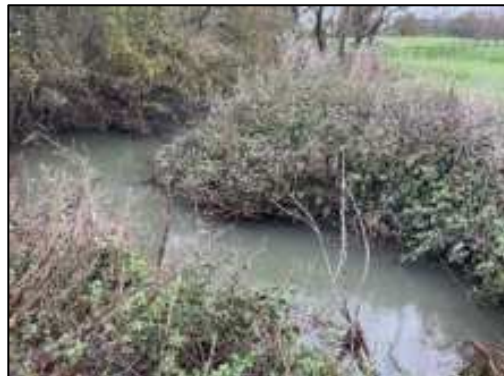
***Photograph 27: Wet ditch within Parcel C.***

Ditch (50) (C- L1) – Photograph 27

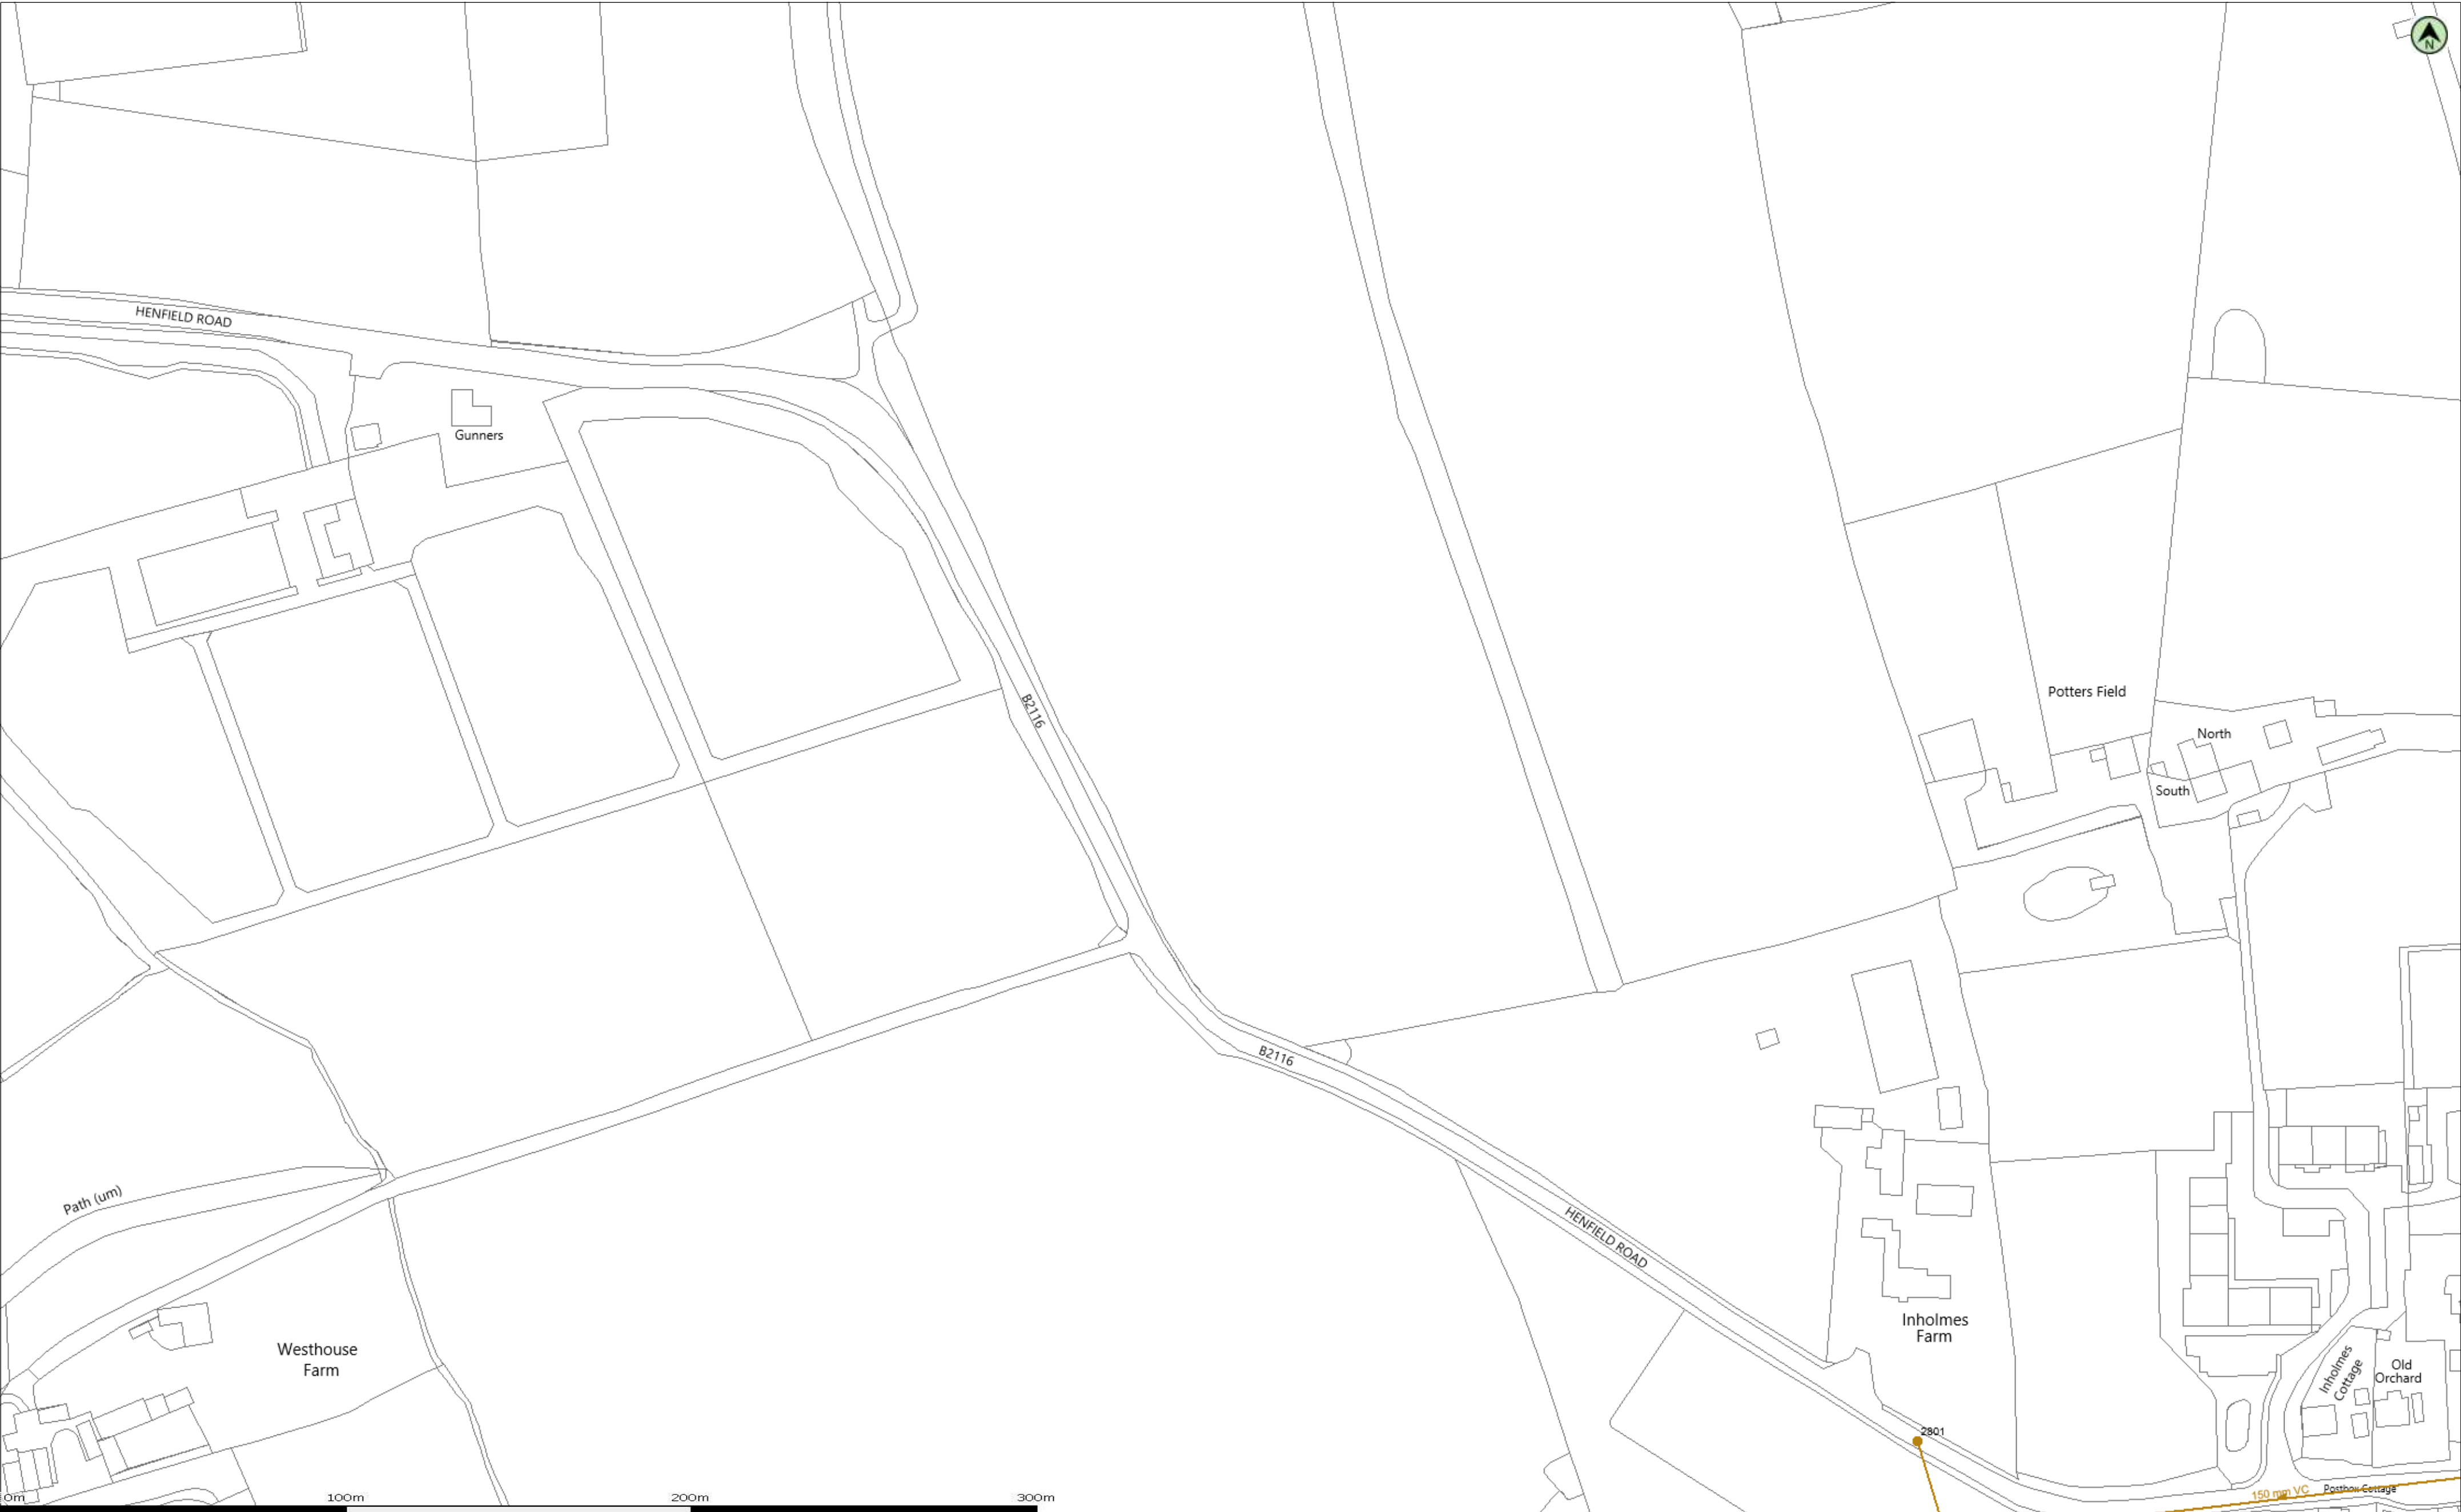
(c) Crown copyright and database rights 2025 Ordnance Survey AC0000808122      Date: 19/12/25      Scale: 1:1250      Map Centre: 526078,117067      Data updated: 24/11/25      Our Ref: 1975692 - 4      Wastewater Plan A2  
Powered by digdat

The positions of pipes shown on this plan are believed to be correct, but Southern Water Services Ltd accept no responsibility in the event of inaccuracy. The actual positions should be determined on site. This plan is produced by Southern Water Services Ltd (c) Crown copyright and database rights 2025 Ordnance Survey AC0000808122. This map is to be used for the purposes of viewing the location of Southern Water plant only. Any other uses of the map data or further copies is not permitted.

WARNING: BAC pipes are constructed of Bonded Asbestos Cement.  
WARNING: Unknown (UNK) materials may include Bonded Asbestos Cement.
