## 2.4

### The Site

## Existing Plan

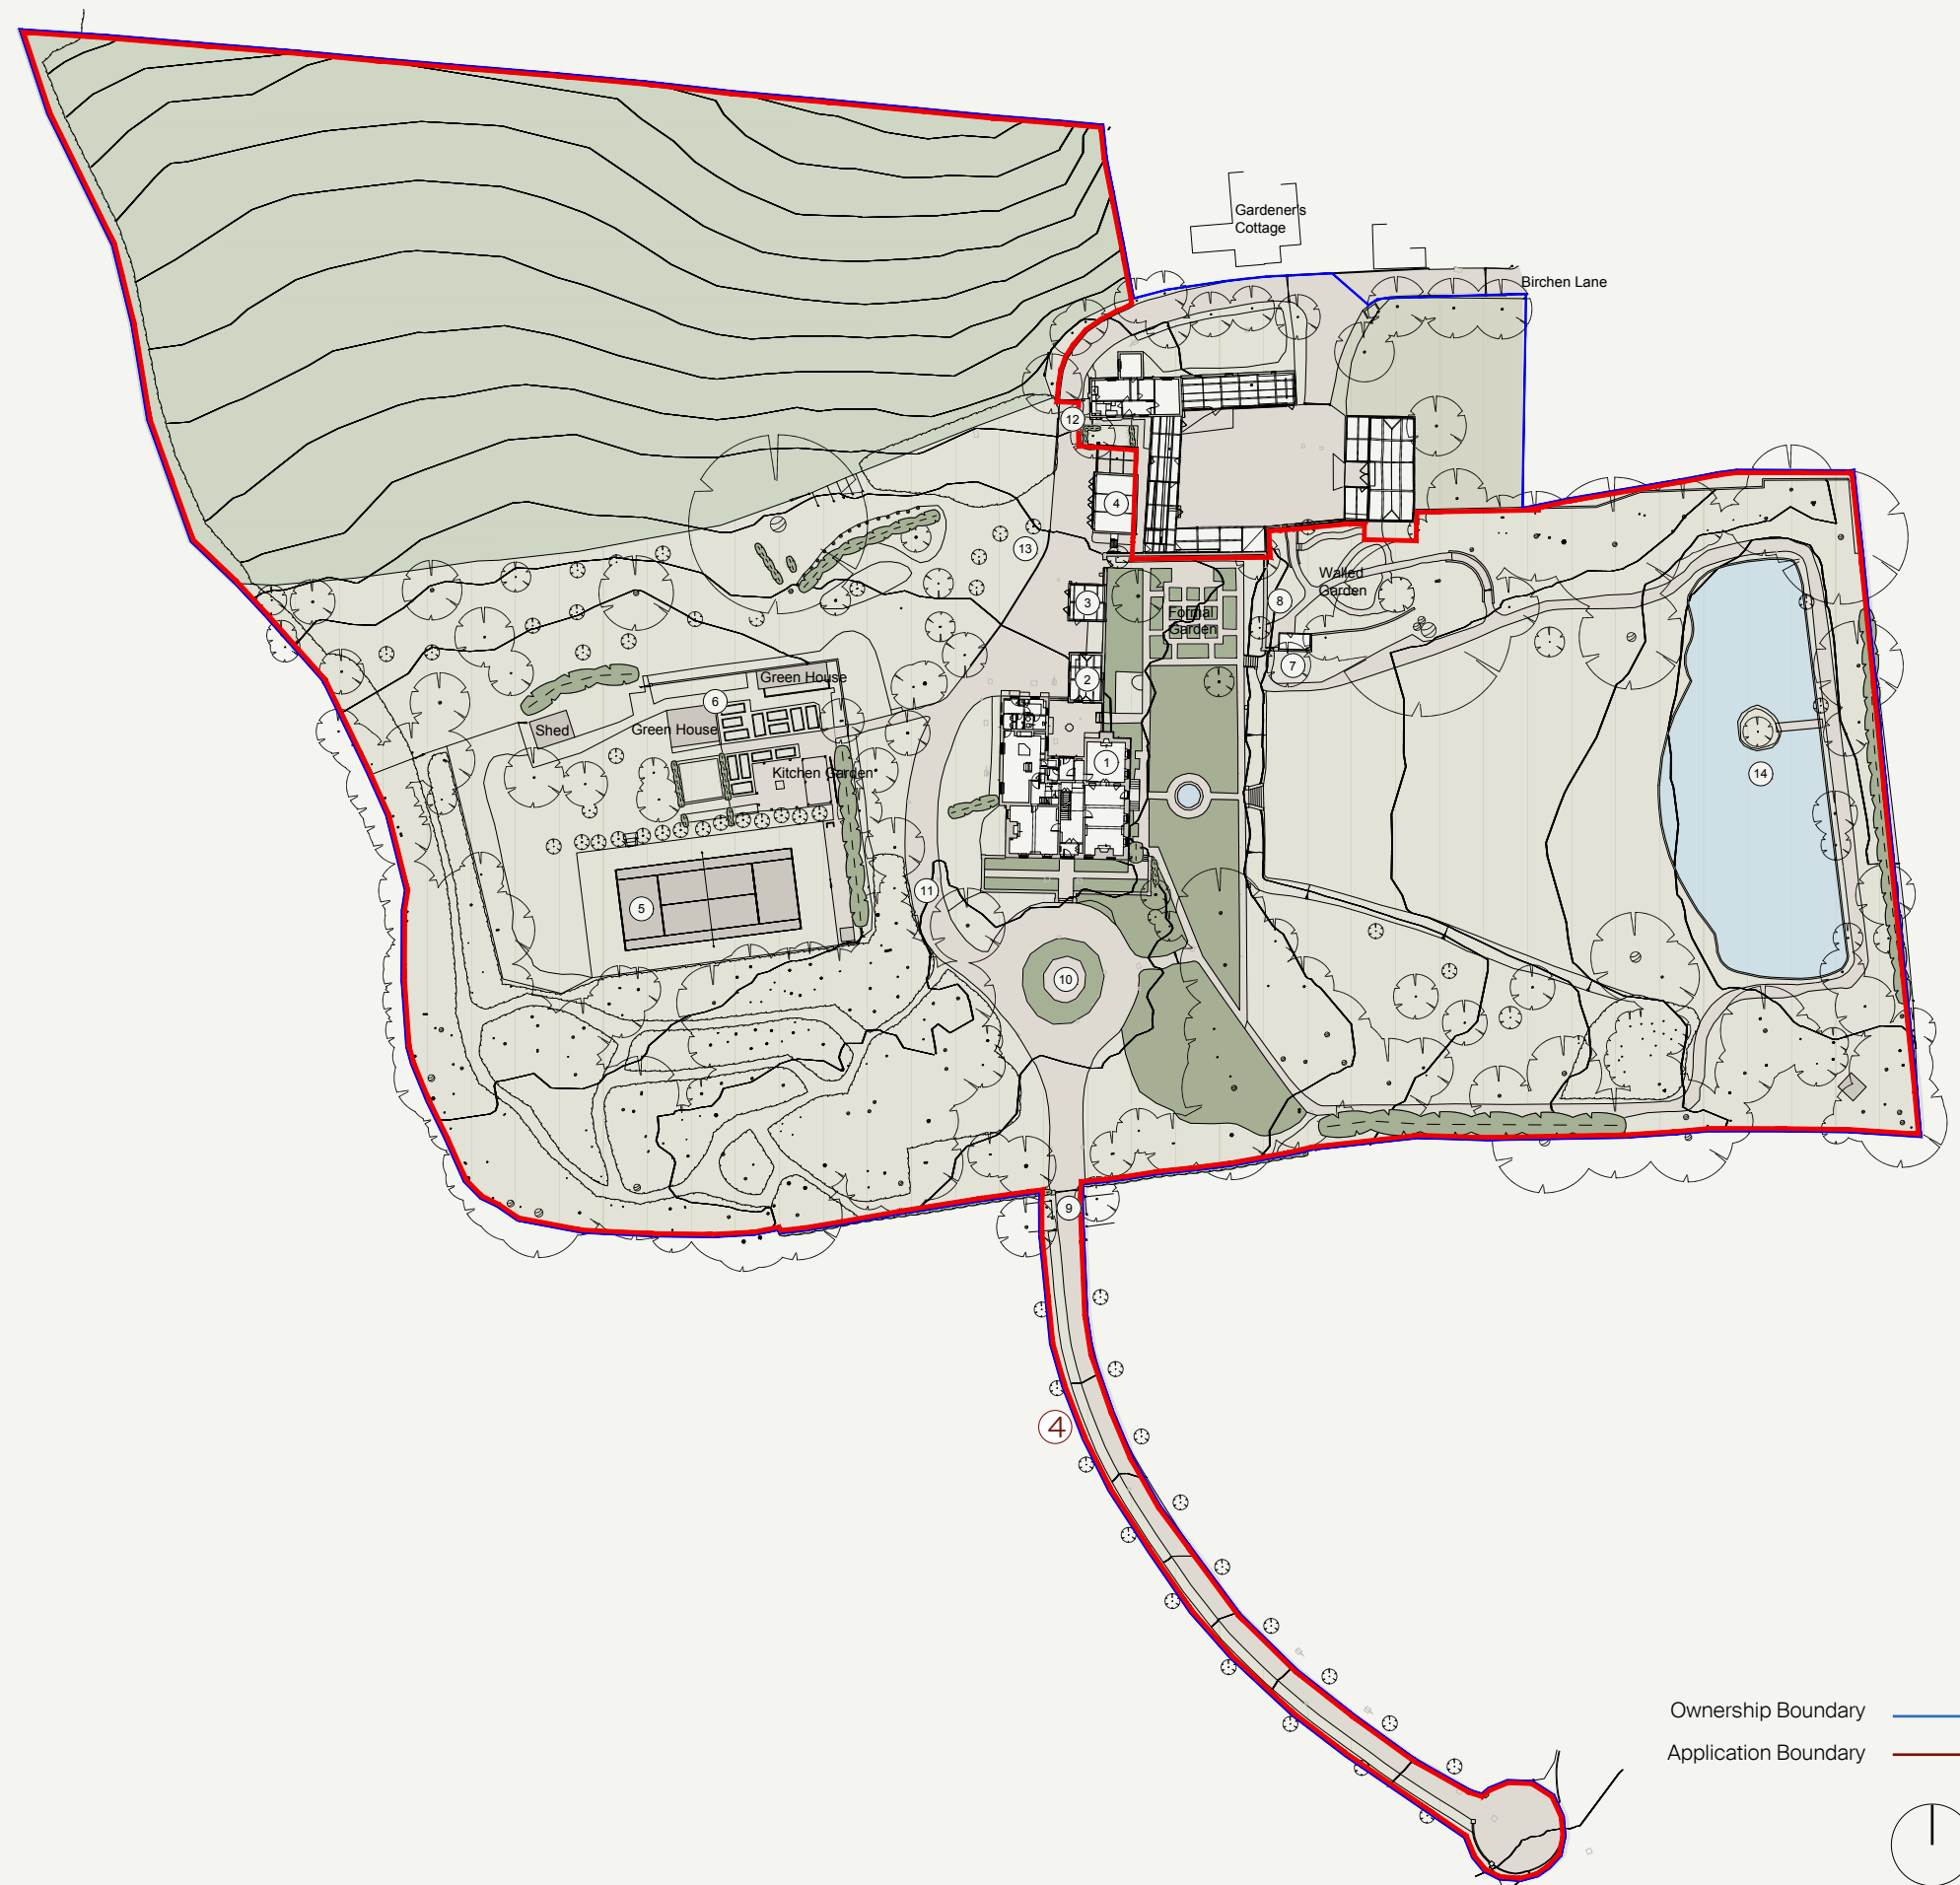
The adjacent plan reflects the existing site extents and proposed application boundary.

- 1 Sunte House - Grade II\*
- 2 Dairy
- 3 Tool-Shed
- 4 Garage
- 5 Tennis Court
- 6 Proposed Pool-house
- 7 Garden Store - Grade II
- 8 Garden Wall - Grade II
- 9 Entrance Gate
- 10 Turning Circle
- 11 Driveway
- 12 Rear Entrance
- 13 Proposed Parking Area
- 14 Lake

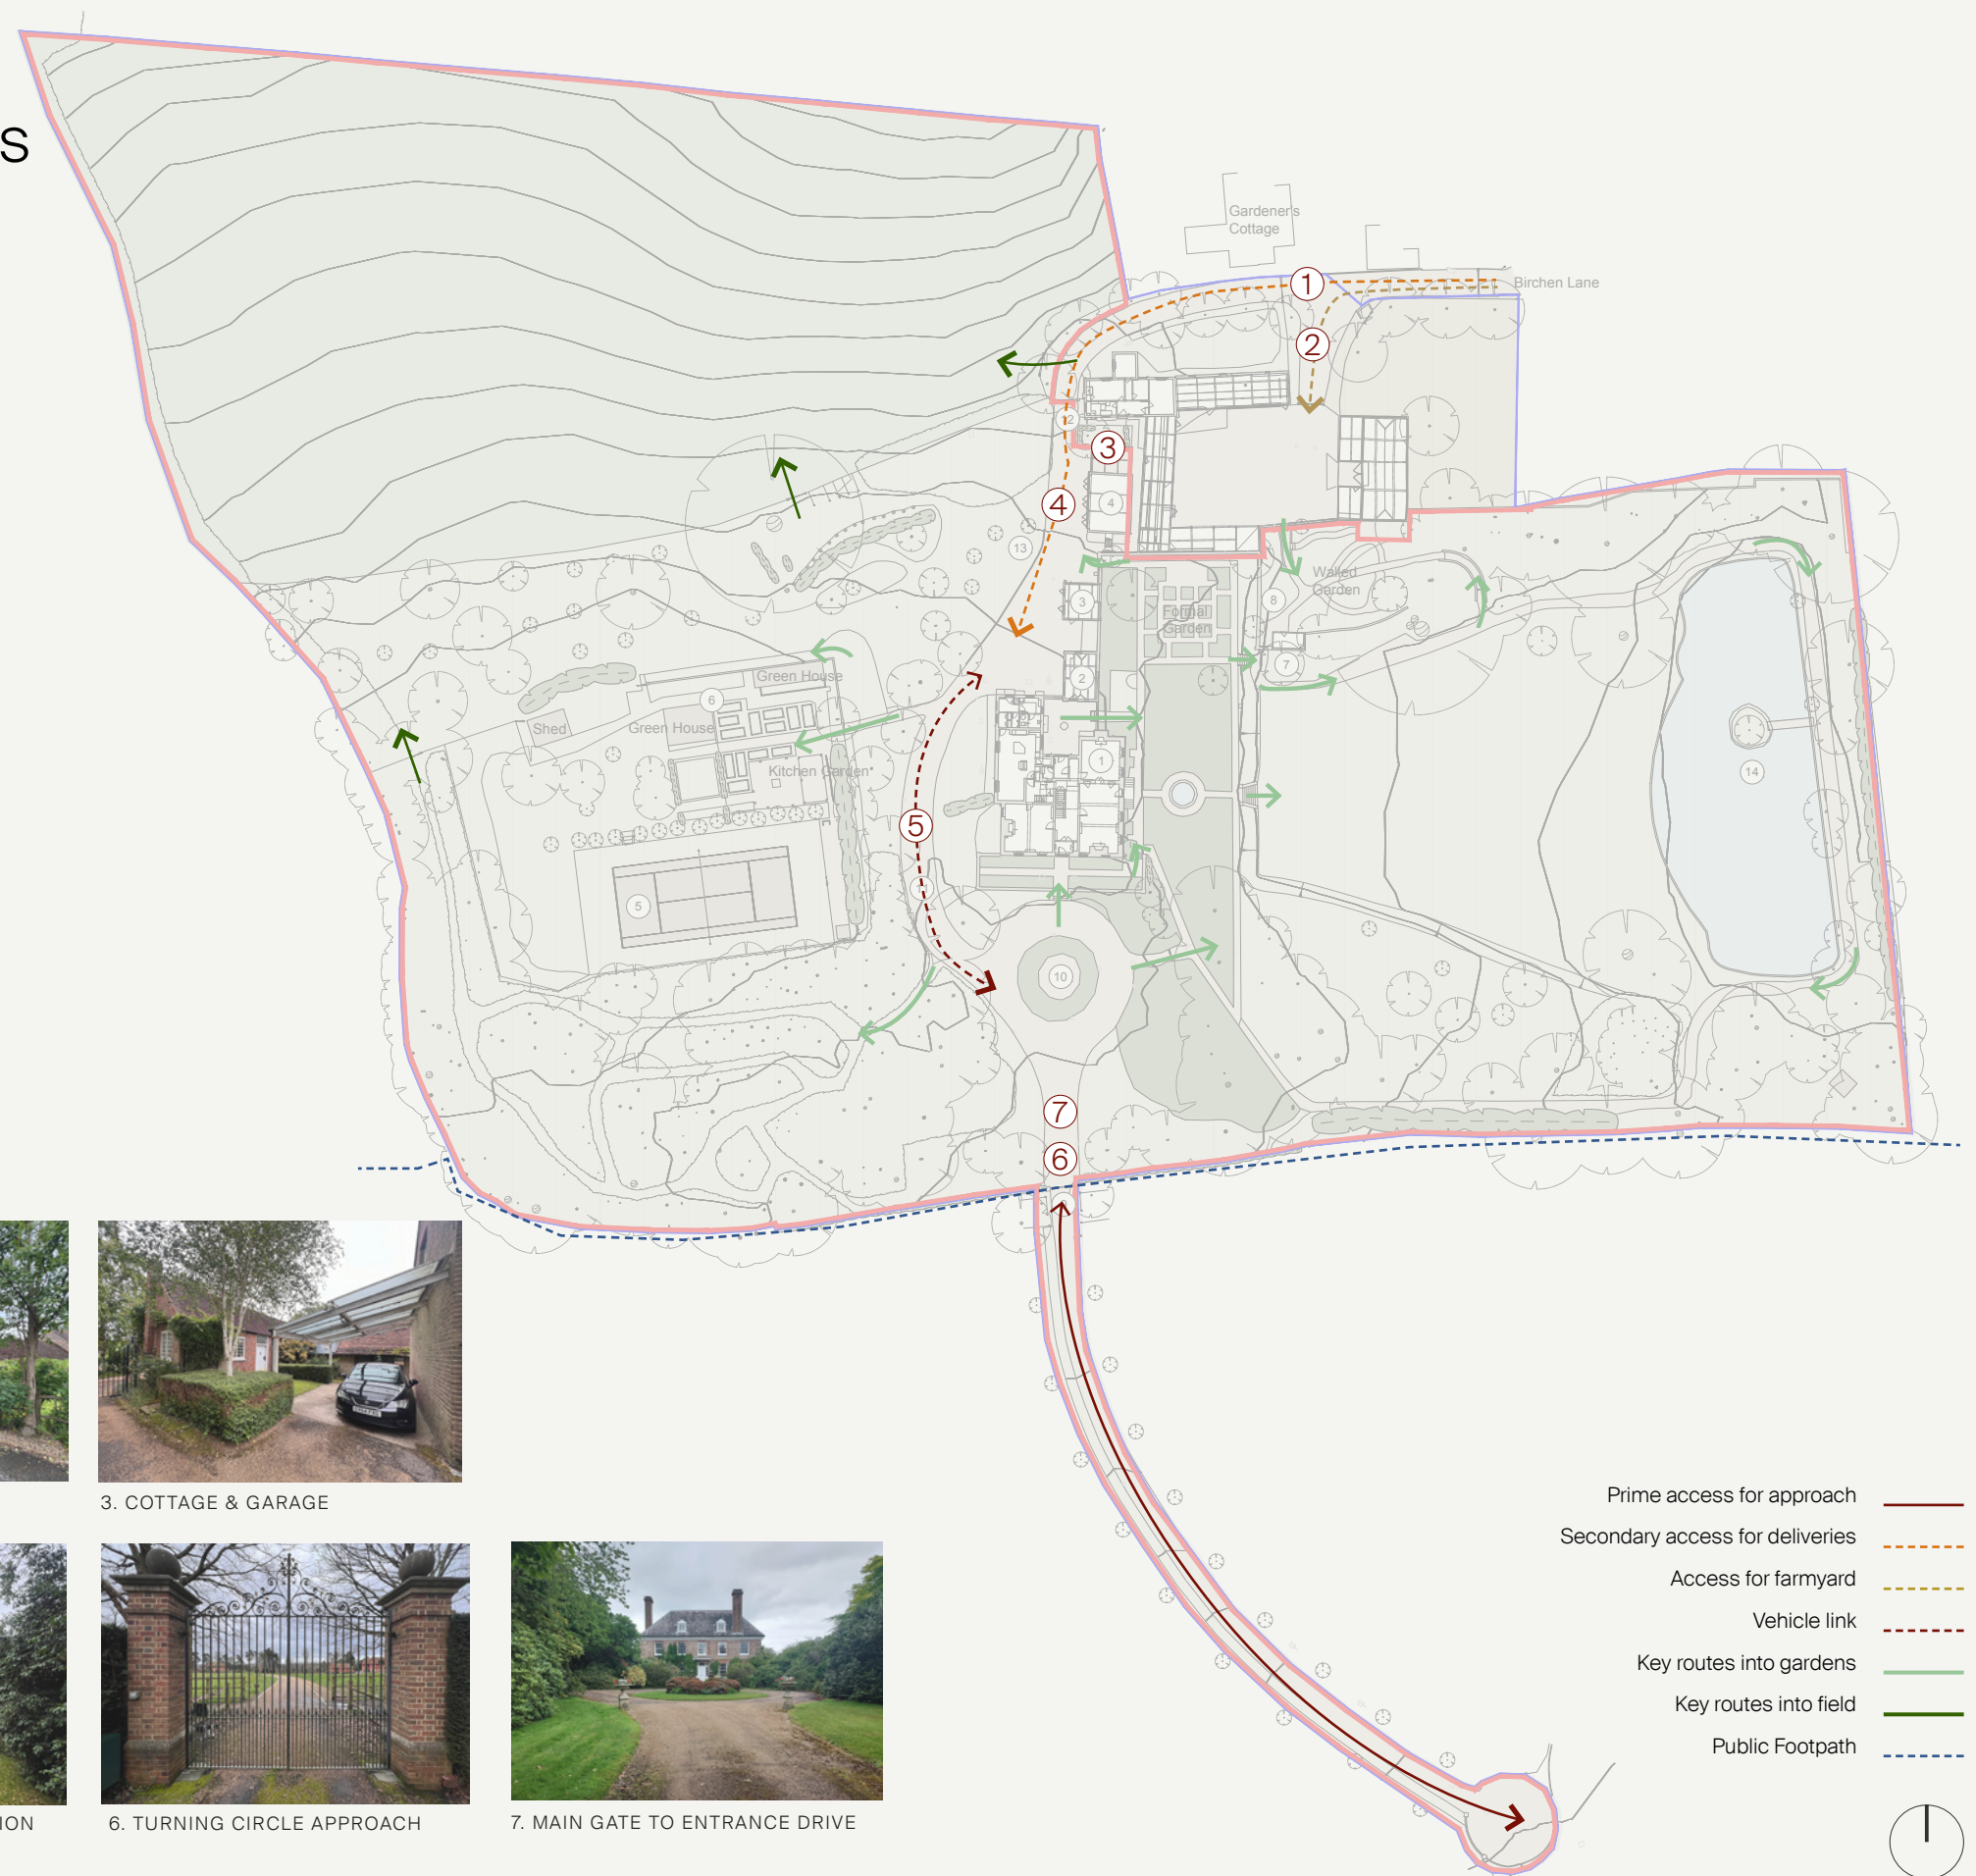
The southern access from Gander Green forms the historic and formal access to the house, primarily used by the residents. To the North, Birchen Lane provides secondary access to the House via a private driveway (1), and an independent spur into the farmyard (2). Typically, these are used for deliveries, servicing and informal access.

Running east west along the southern boundary is a public footpath that connects to a wider network of roads and pedestrian routes.

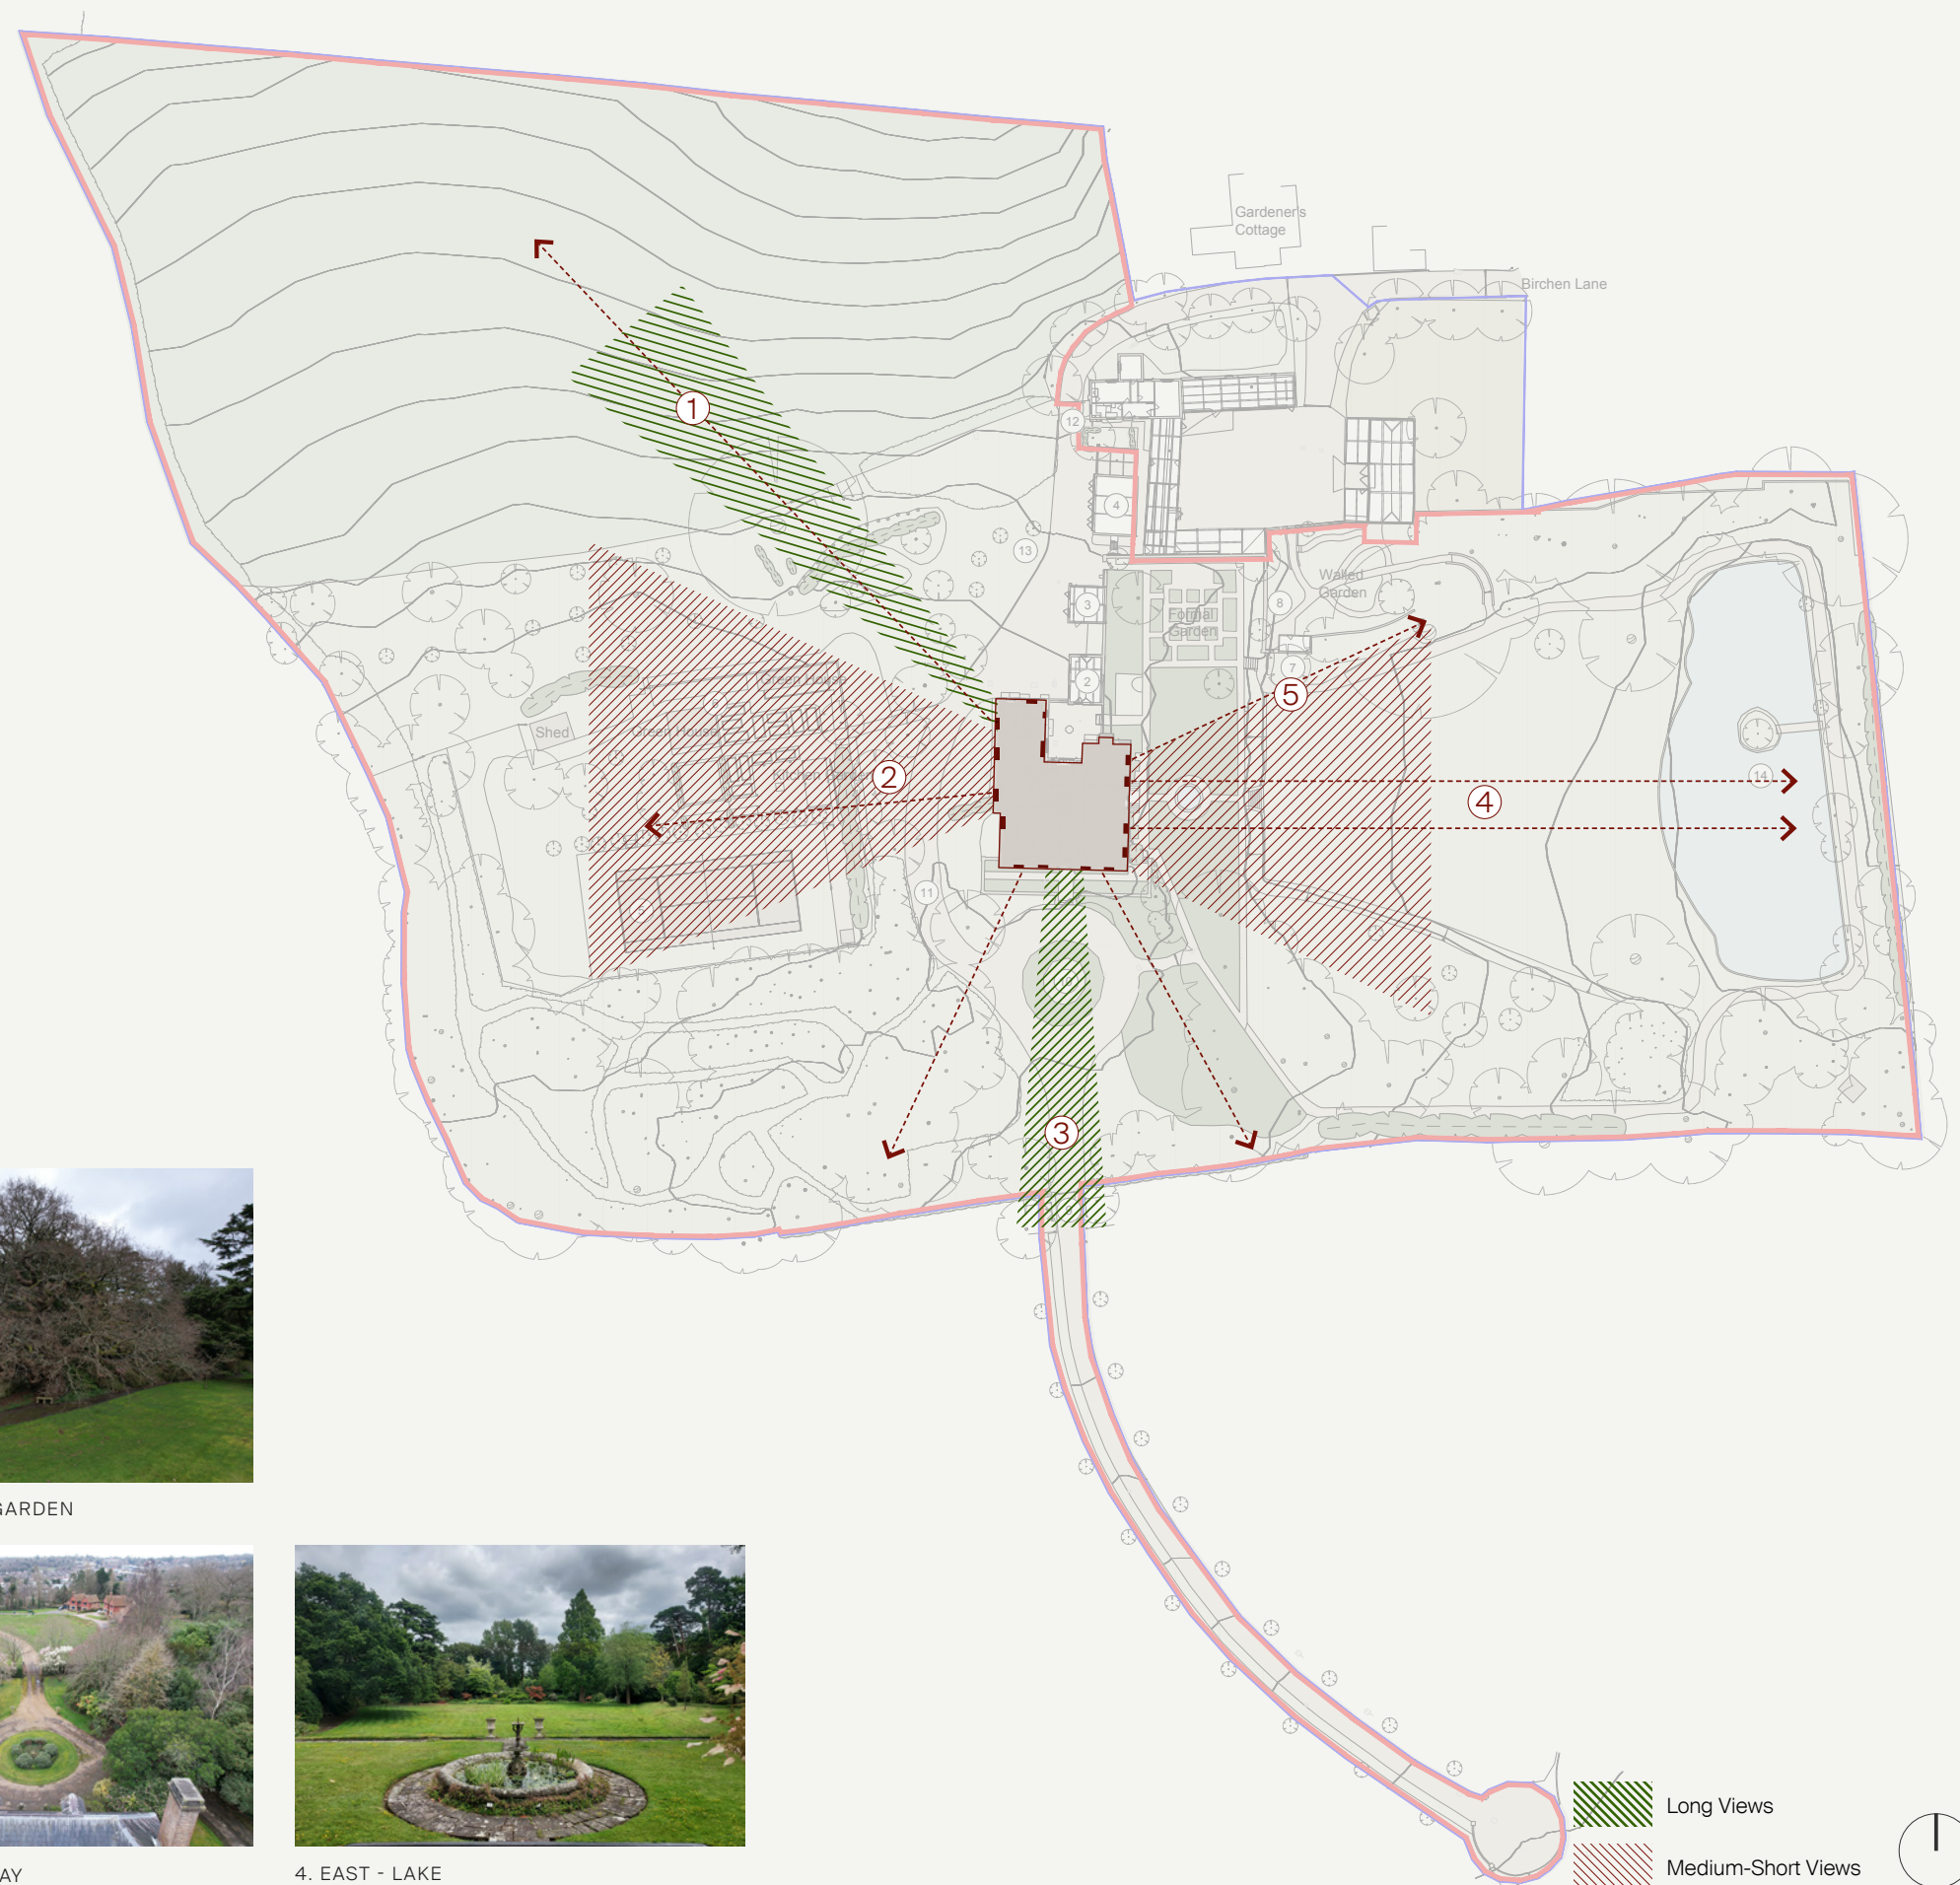
The site benefits from a verdant, almost entirely consistent perimeter of mature planting. There is a wide variety of significant tree species that provides dense crowns and privacy to the estate, minimising long range views from wider settlements to the Main house and outbuildings. The exception to this is to the South gated entrance where there is a permeable vista.

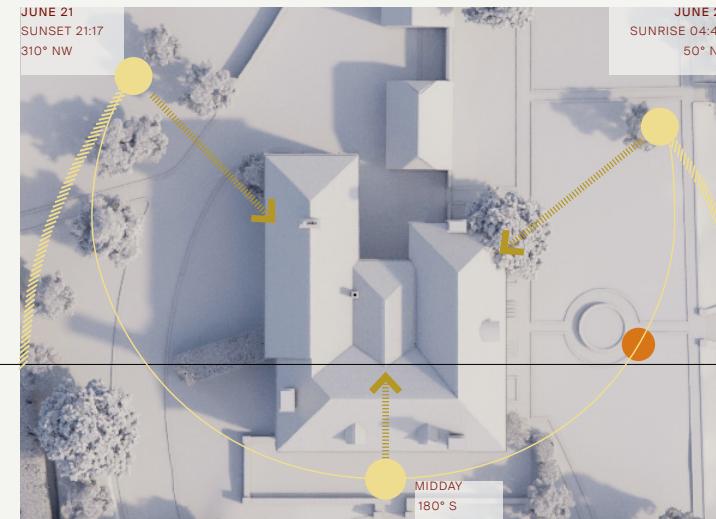
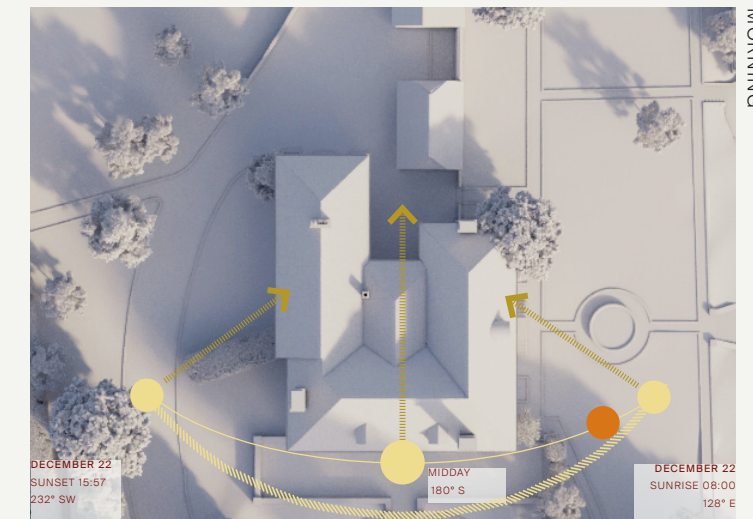
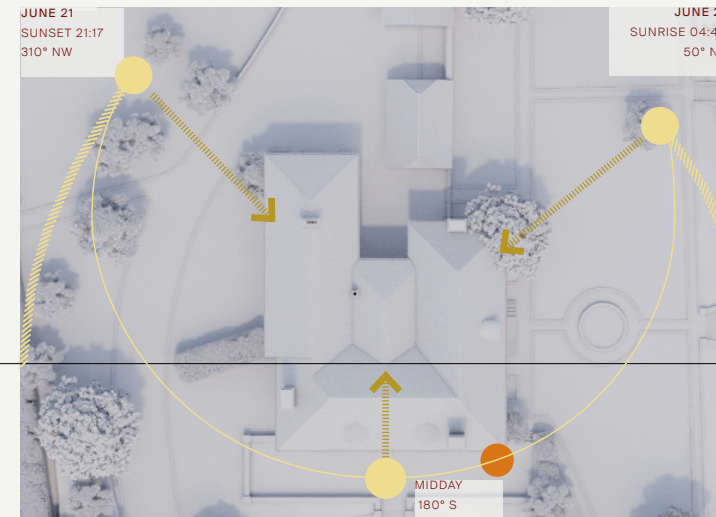
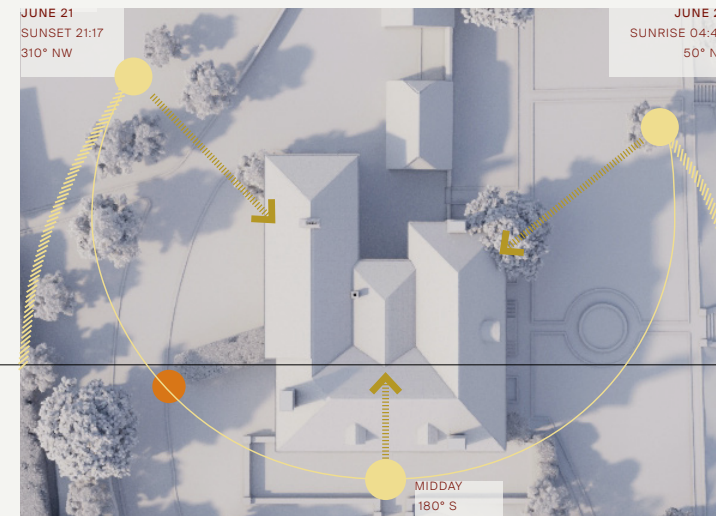
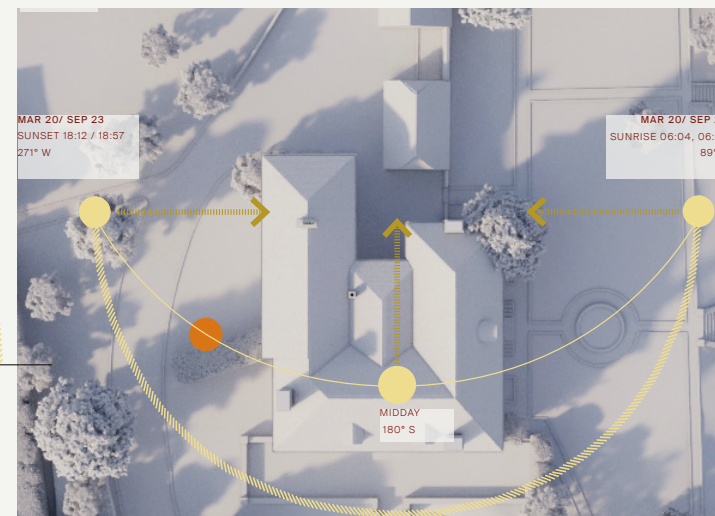
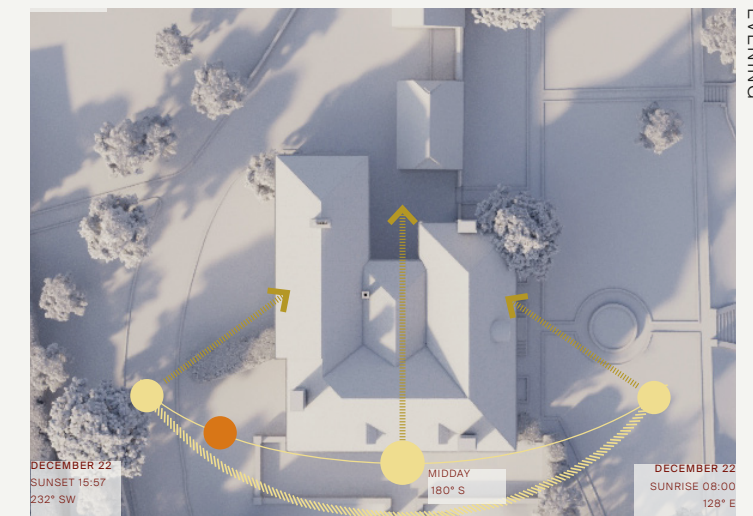
To inform the proposals, in depth solar analysis has taken place to understand aspect, daylighting and overheating. The house sits on a true North - South axis with all primary elevations exposed to long hours of solar exposure. Whilst the north courtyard between the house and dairy is in shade during the winter months, it benefits from morning and evening light between the equinoxes.

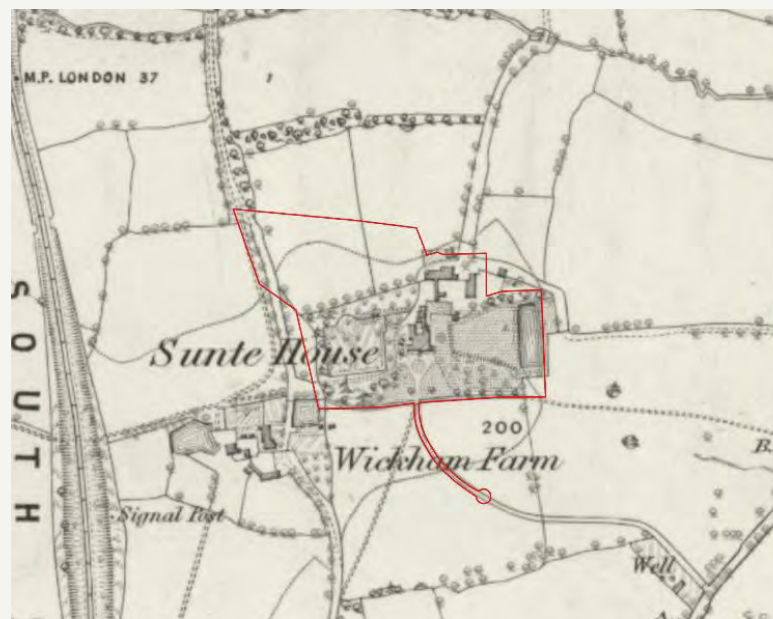
Historic Map 1879

OS Sussex Sheet XXVI: The North west extension to the Main House seems to be completed, along with the Byre and a reconfiguration / extension to the Barn.
