## 2.10 The Site Heritage Chronology

## 3.0 Existing Building Character

## Sunte House - Exterior

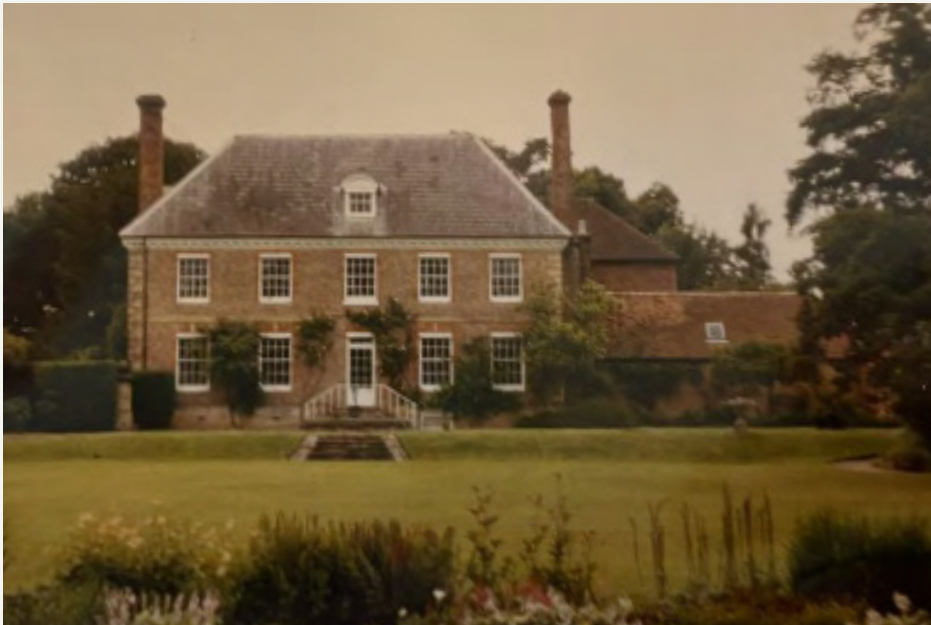
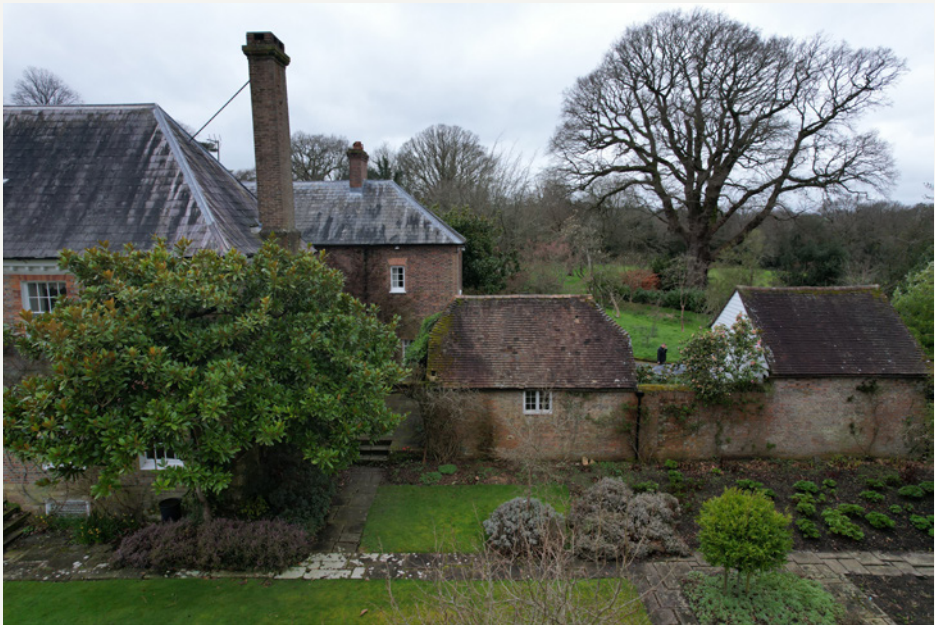
LISTED BUILDING CONSENT CIRCA 1988 FOR REMOVAL OF PORTIONS OF DAIRY OUTBUILDING

Some of the most notable adjustments across the historic fabric of the main house occurred following the permitted 1987 works. This included partial demolition of the interlinking dairy to the main house, and skylights introduced to the roof (among other works). The adjacent imagery depicts a before and after comparison.

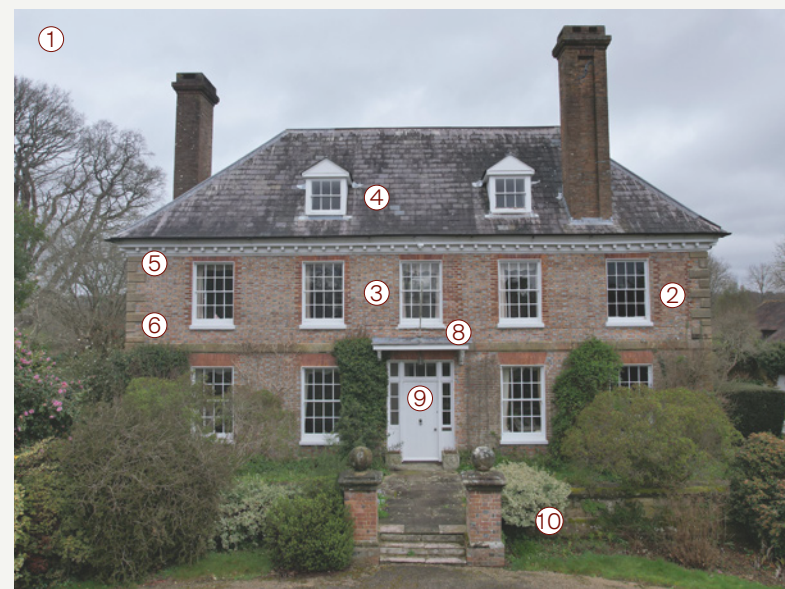
South Elevation

1. Sunte House 10.9.51 GV II\* Large House. **L-shaped building of 1700** having 2 principal elevations with C18 service wing to north east and C19 extension to north west in similar style.

2. 2 storeys and attics, 5 windows to each principal elevation.
3. **Diaper pattern red brick and grey headers** on cemented plinth.
4. Steeply pitched **slate roof** with 2 **pedimented dormers**.

5. Deep wooden modillion eaves cornice.
6. **Stone quoins and moulded stone band** between floors.
7. **16 pane sashes** with rubbed brick arches and scalloped blind boxes.

8. Central doorcase to south elevation with **flat wooden hood on enriched scrolled wooden brackets**.
9. Double door with rectangular fanlight flanked by sidelights.

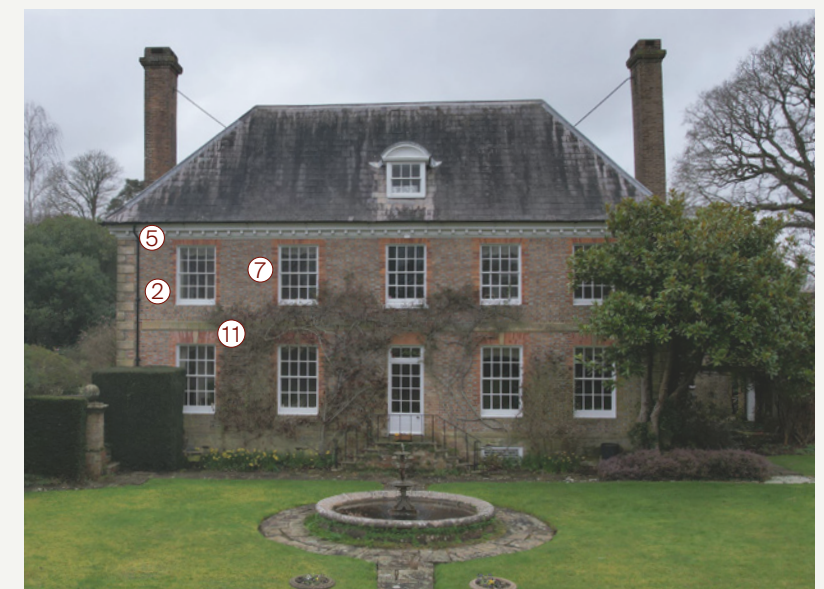
East Elevation

10. Attached to south is **forecourt wall** of 2 courses of sandstone blocks with brick piers with moulded tops and ball caps.
11. East or garden elevation has windows with **stone keystones** and doorcase has flight of steps with ramped iron handrail.

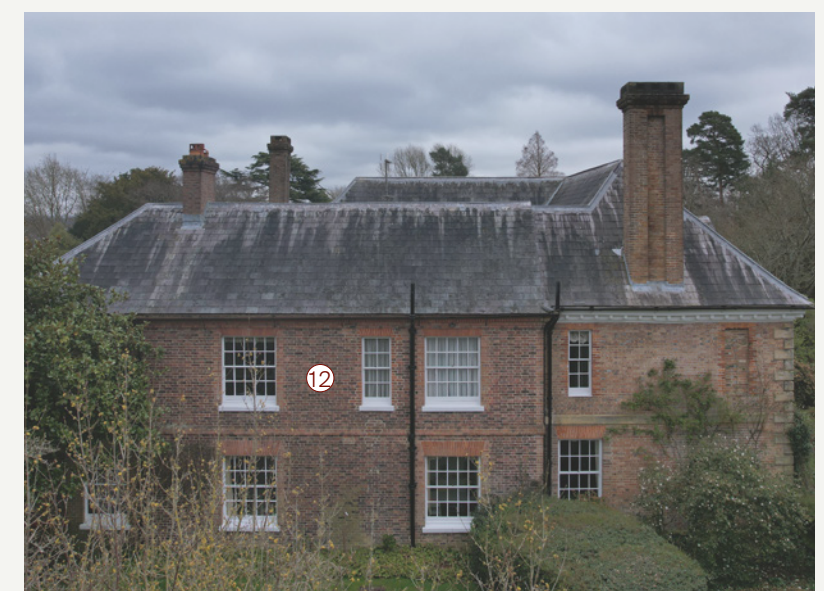
West Elevation

12. **West elevation is largely C19** but in matching style.
13. North east extension is an **C18 extension of 1 storey** referred to as the dairy, with red brick and mixed material roof, consisting of Horsham Stone and clay tile.

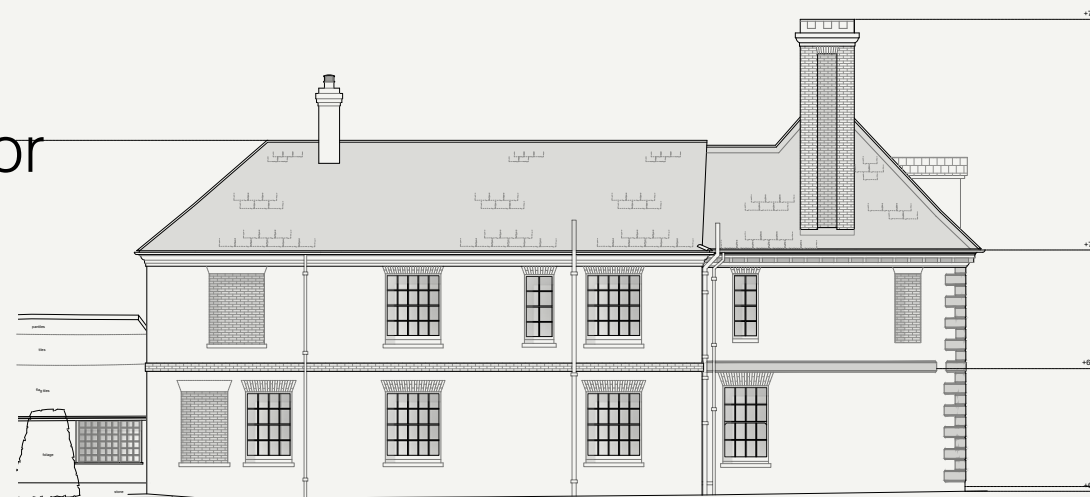
WEST ELEVATION

- Grade II\* Listed Structure
- Red Brick Masonry across entire facade
- Portions of handmade brick in flemish bond
- Feature Quoin Corners
- Deep wooden modillions eaves cornice
- Brick Lintels
- Pitched Slate roof
- Timber sash Windows
- Lead flashing and Ridge caps

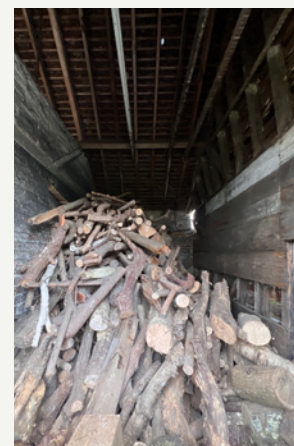
- Curtilage listed single storey building
- Primarily brick masonry (Sand Palette)
- White timber clad South Facade
- Queen Post timber truss

TOOL SHED INTERIOR

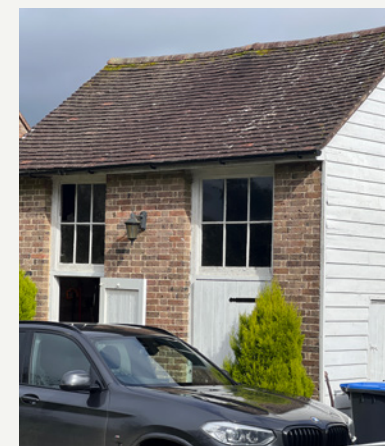
TOOL SHED ENTRANCES

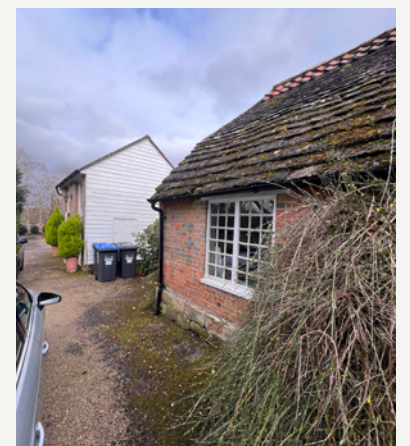
TOOL SHED AND DAIRY
