Tree Survey

Preliminary Arboricultural Impact Assessment and Method Statement

Highfields
West Hill
East Grinstead
RH19 4DL

Job Ref	Version	Author	Agent	Client	Date
AAS/0511	Rev 02	RR	Westbournes	-	20/10/2025

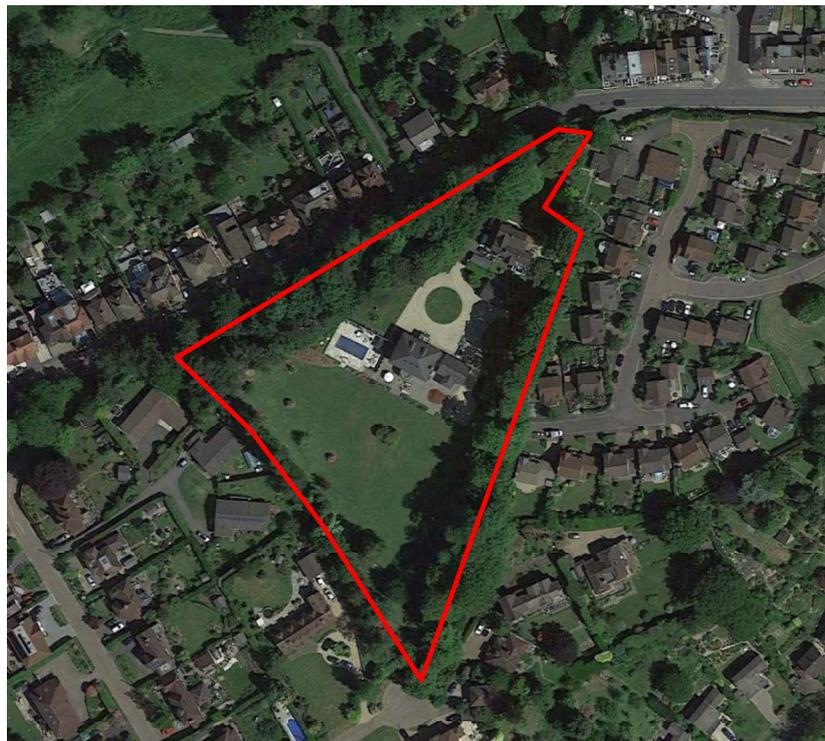
Figure 2 – Google Earth screen shot of Highfields

6.1 Highfields is a detached property occupying approximately 1.3 ha accessed from the north.

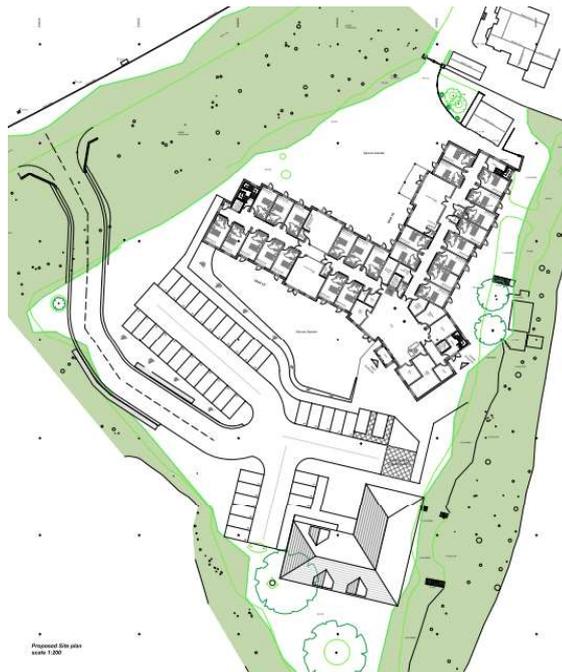
Figure 4 – Proposed layout

6.2 The proposed project seeks to demolish the existing dwelling and construct a care home and create a new access from the western boundary off West Hill.

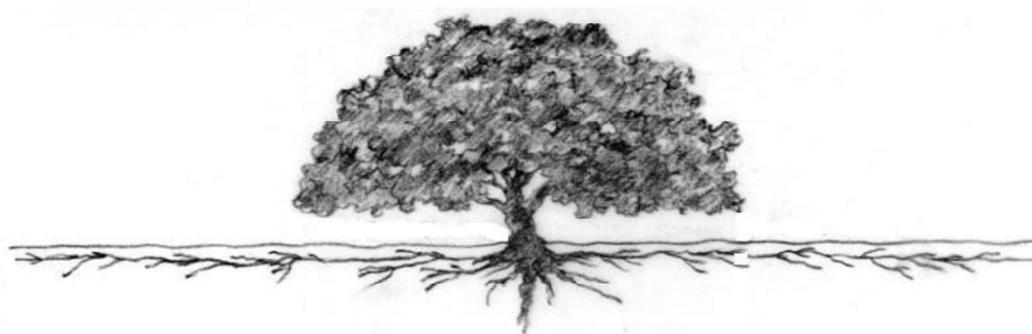
Figure 5 - Diagram showing typical root morphology of a mature tree growing in homogenous ground conditions.

The root systems of retained trees represent the most critical constraint, albeit an invisible one under normal circumstances. The most valuable part of the root systems for maintaining health and structural anchorage of trees is mostly located in the upper 600 millimetres of a soil profile.

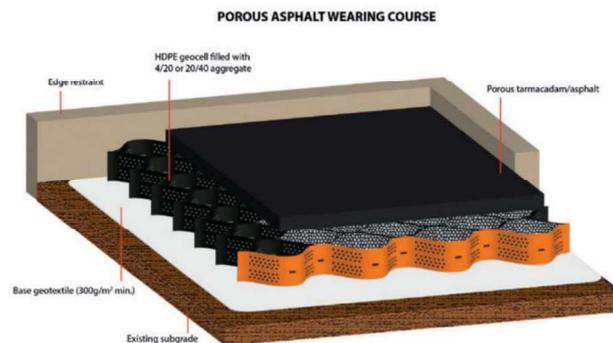
Figure 6 – Illustrative specification for 'no-dig' surfacing for an asphalt surface

Working off suitable ground protection the existing hard surface will be removed by hand
Any roots exposed during excavations should immediately be wrapped or covered in damp hessian to prevent desiccation and to protect them from rapid temperature changes. Any wrapping should be removed prior to backfilling, which should take place as soon as possible. Prior to backfilling, retained roots should be surrounded with topsoil or un-compacted sharp sand (builders' sand should not be used because of its high salt content, which is toxic to tree roots), or other loose inert granular fill, before soil or other suitable material is replaced.

8.3.7 **Installation of cellular load bearing system**– for the area(s) highlighted on the tree protection plan ref AAS/0511 TPP Rev 02 October 2025 a cellular system is required for the load bearing requirements.

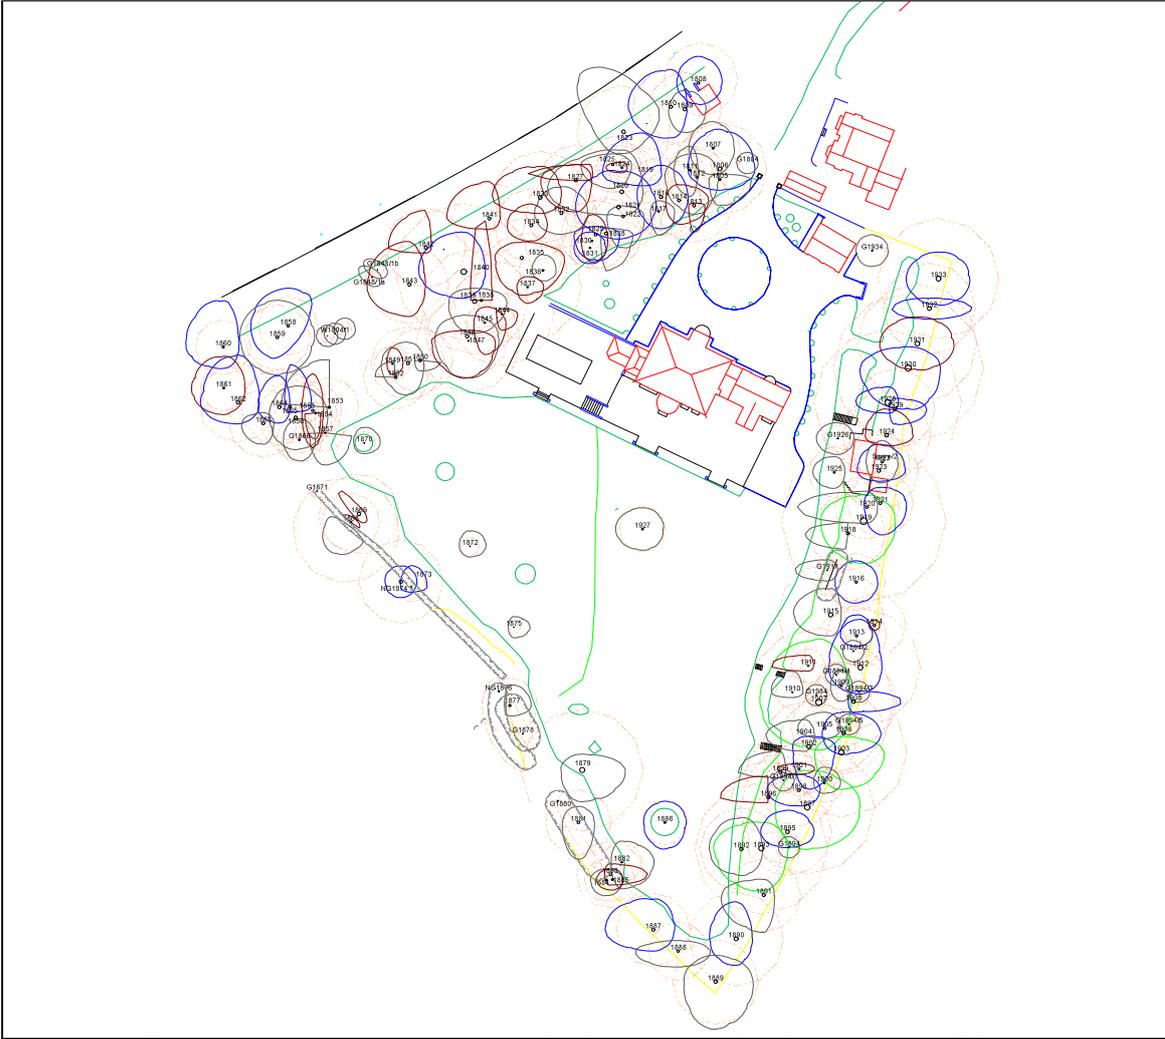
(AAS/0511 Drainage Plan Rev 01 October 2025)

Drainage Plan – 01

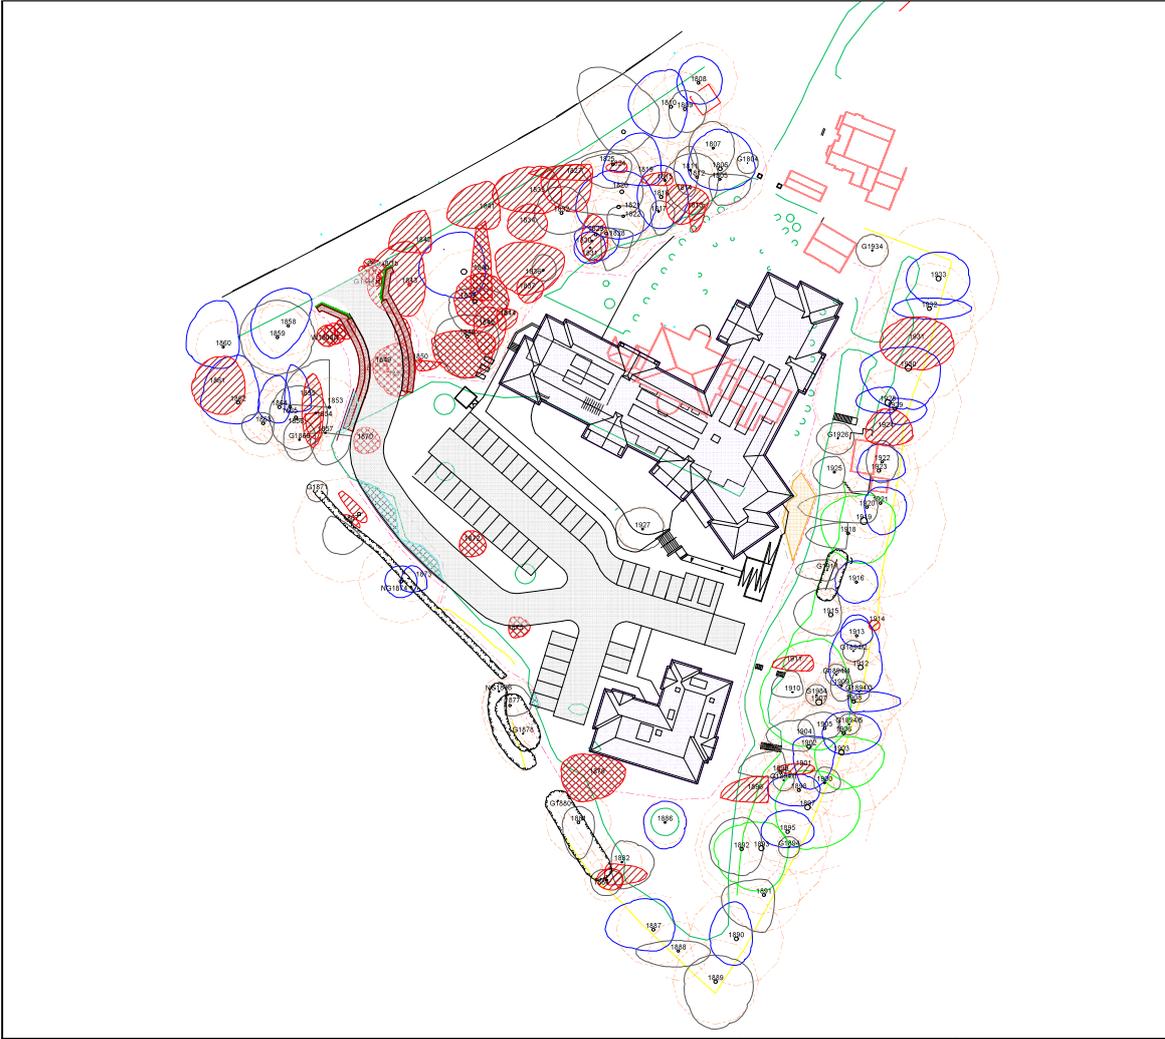
SCALE: 1 : 500 @ A2 DATE: 20/10/2025
AAS/0511 TPP - Rev 03 October 2025

**Highfields, East Grinstead
Tree Protection Plan - Proposed Layout**

- New access and parking
- Ground Protection
- Encroachment into RPA
- Manual excavation/root pruning
- Tree Protection Fencing
- Care home footprint
- Gabbions
- Temporary Fencing

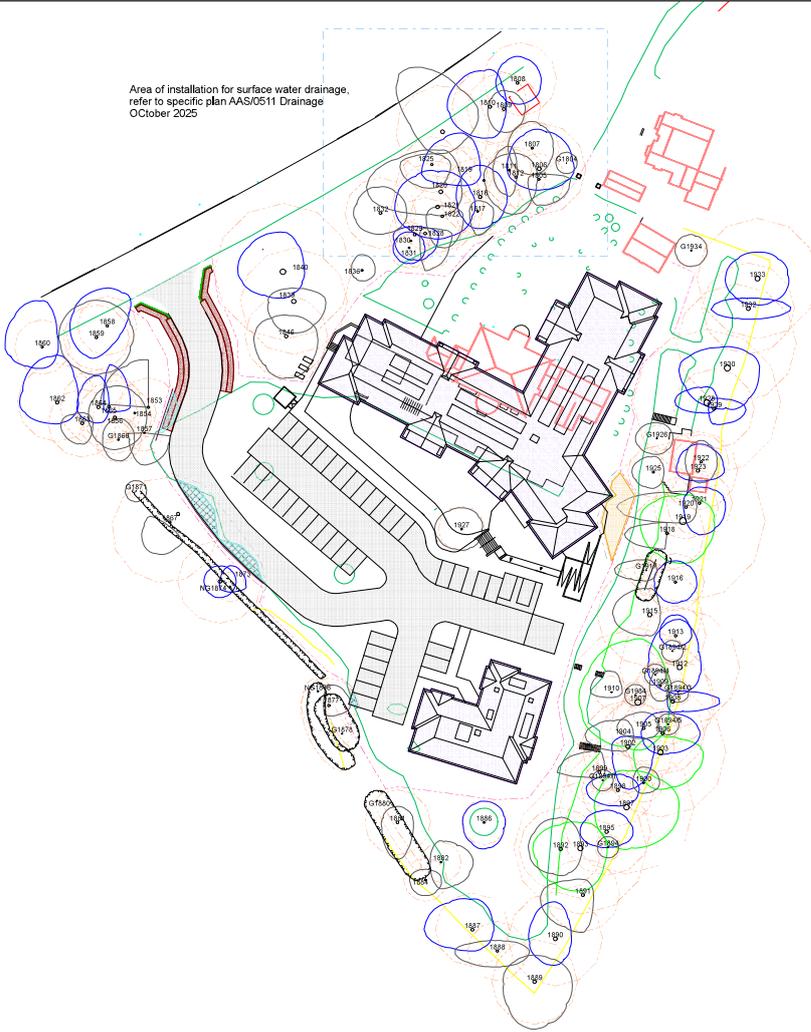
SCALE: 1:500 @ A2 DATE: 20/10/2025

**Highfields, East Grinstead
Tree Protection Plan - Proposed Layout Trees Removed**

- New access and parking
- Ground Protection
- Encroachment into RPA
- Manual excavation/foot pruning
- Tree Protection Fencing
- Care home footprint
- Gabions
- Temporary Fencing

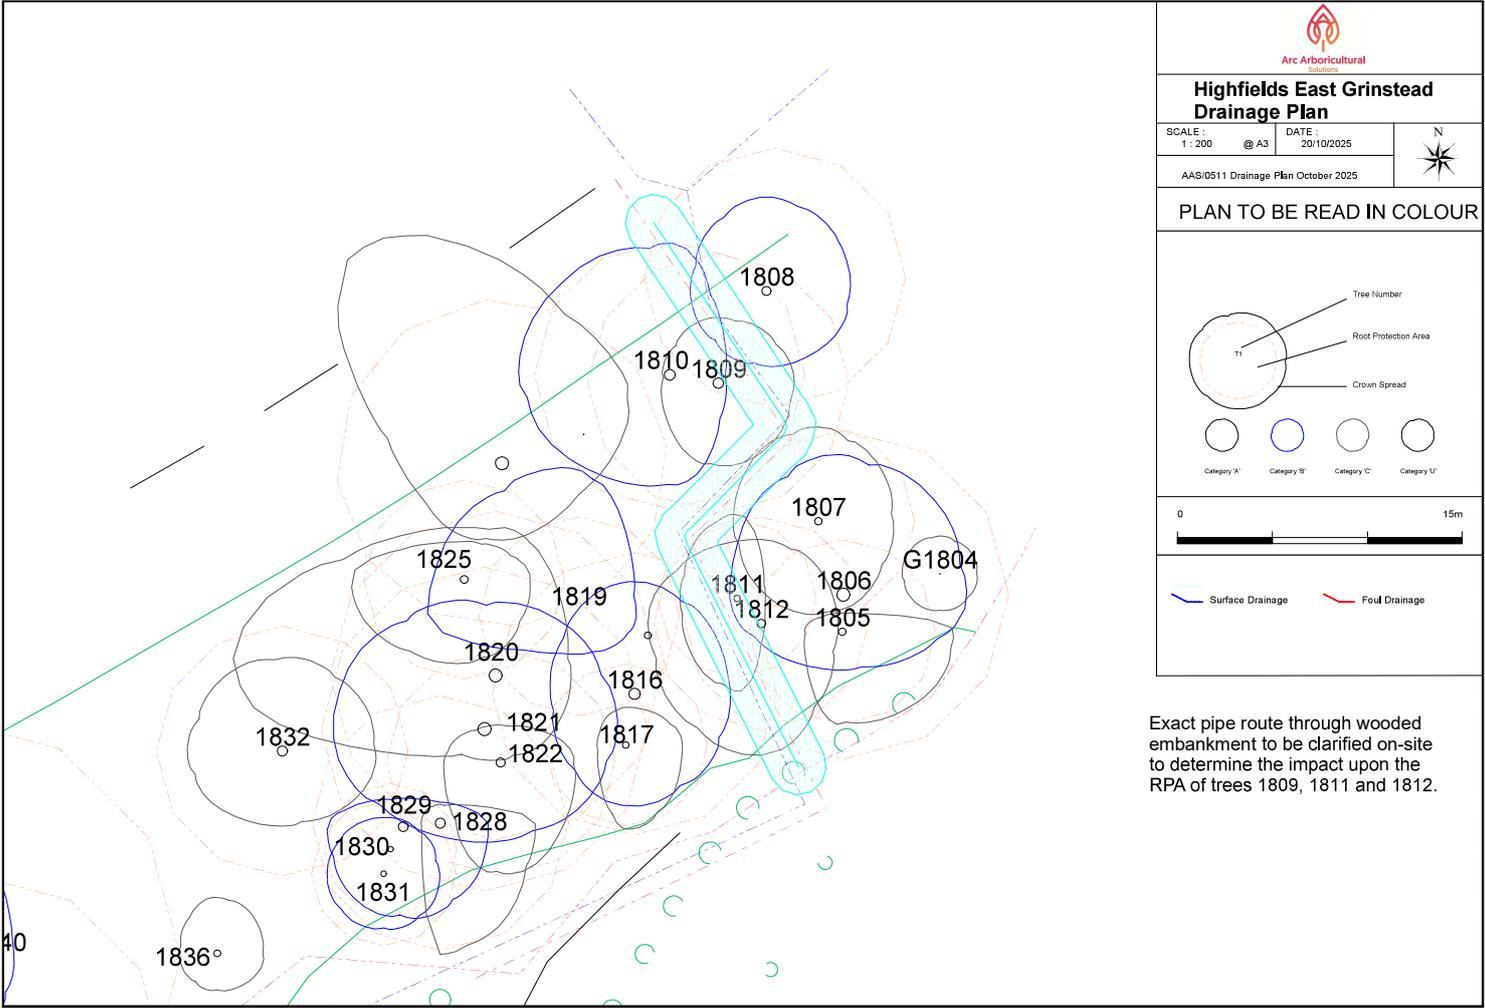
SCALE: 1:200 @ A3 DATE: 20/10/2025
 AAS/0511 Drainage Plan October 2025

Area of installation for surface water drainage, refer to specific plan AAS/0511 Drainage October 2025

Highfields East Grinstead Drainage Plan

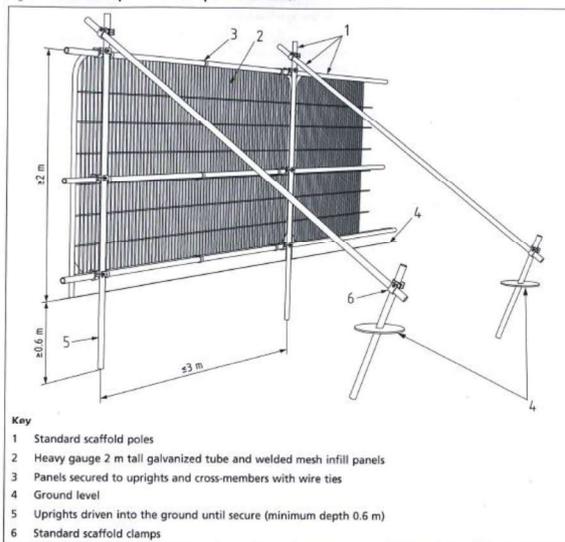
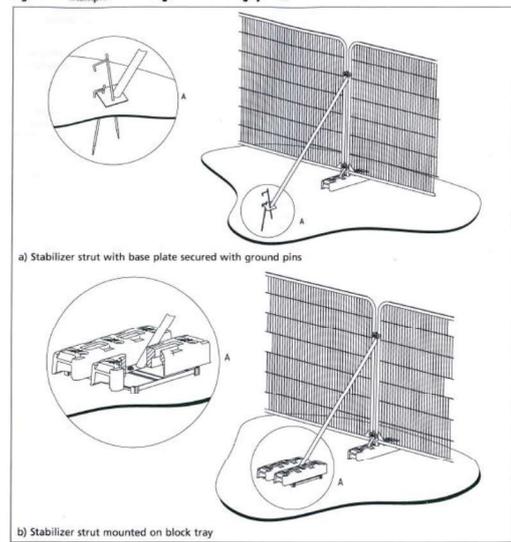
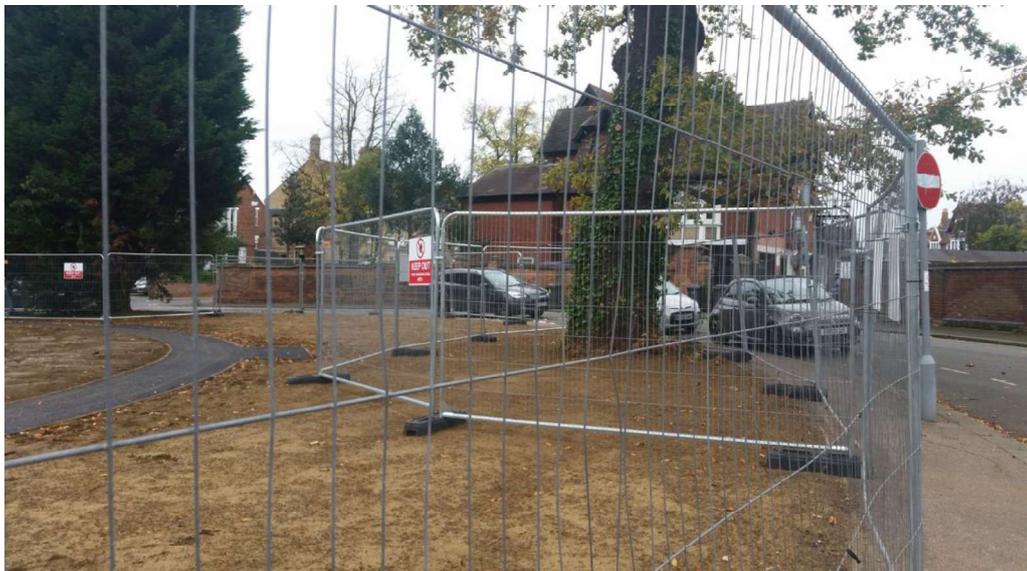
BS 5837:2012 Specification for protective barrier

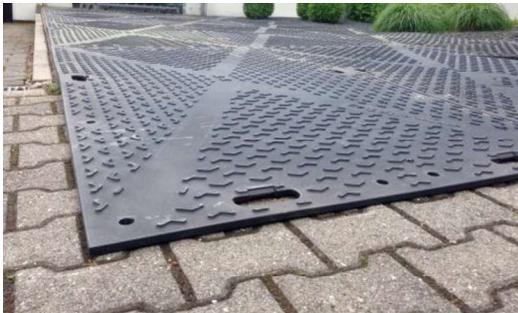
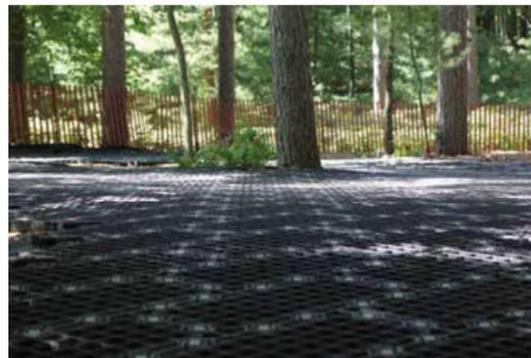
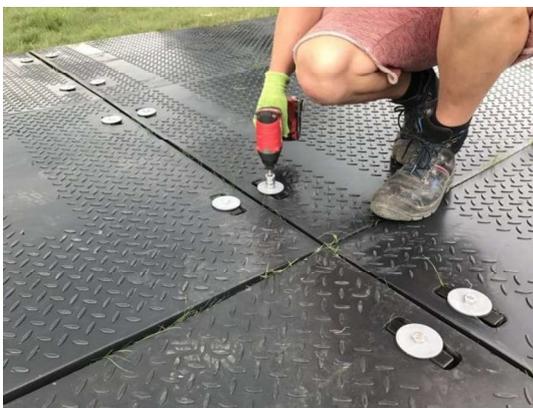
Types of Ground Protection

There are various proprietary ground protection mats on the market which provide a secure and stable solution to preventing compaction within the Root Protection Area of a tree.

Ground protection should be laid over an impermeable geo-textile to prevent leakage of any toxic materials into the soil beneath

Ground Protection – the use of a proprietary ground protection is desirable to accommodate the likely load. Alternatives may be used if agreed and proven not to distort or cause compaction to the underlying soil. Where only light vehicles are operating e.g. barrows, trolleys, thick wooden boards or scaffold planks can be used. These should be placed over a minimum of 150mm of compressible woodchip placed over a membrane for ease of removing and to prevent integration with the existing ground conditions.

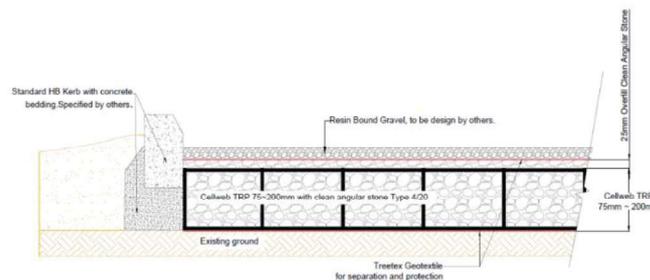
Generic no-dig load bearing construction

Generic Method Statement for No-Dig Construction
