## Bat Emergence and Re-Entry Surveys (BERS)

The Granary at North Hall, Staplefield, West Sussex, RH17 6AS

This report is prepared to inform a planning application for the proposal described as: The conversion of an existing outbuilding to ancillary uses to the main dwelling and for other ancillary works to the building at North Hall Mallions Lane Staplefield.

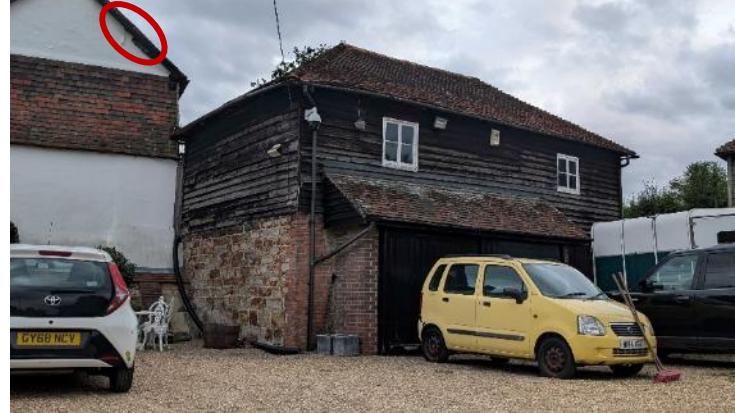
Surveyor 2	<p><b>Roost 1: Common pipistrelle day roost</b></p> <p>Number: 2</p> <p>Time(s): 21:09, 21:14</p> <p>Location of access point(s): Damaged eaves at the northern gable end of B2</p> <p>Direction(s) of travel on emergence: South over B1</p> <p>Species ID was confirmed by the surveyor on site</p> <p>Summary of general activity:</p> <p>Species – Common pipistrelle, brown long eared</p> <p>Flight paths – North to south over B1</p> <p>Foraging areas – Northern garden</p> <p>The first activity was a common pipistrelle passing over B1 heading south at 21:01. <b>Two emergences from the eaves of B2 occurred at 21:08 and 21:14, both common pipistrelles.</b> From then until 22:02, common pipistrelles were intermittently heard not seen. A brown long eared was heard not seen at 22:03. From then until 22:36, brown long eared were intermittently heard and/or seen, with regular foraging activity within the northern garden.</p>	<p>Surveyor 2 elevation photo, emergence location circled</p>

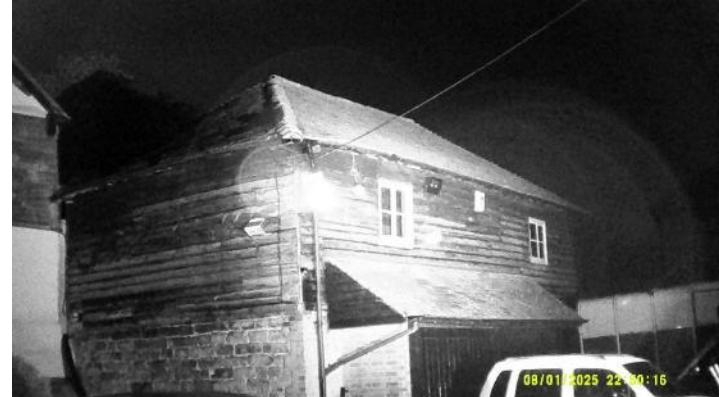
<i>IR position 2</i> <i>Nightfox Whisker</i> <i>Nightfox XB5 850nm IR</i>	<p>Camera position: observing northeast elevation of B1 and B2</p> <p>Emergences observed: Yes</p> <p>One of the two emergences from B2 was captured on the IR footage, the second emergences was out of the cameras field of view. Otherwise, the footage was in line with the observations of surveyor 2 with no additional activity.</p>	<p>Surveyor 1 darkest point photo</p>

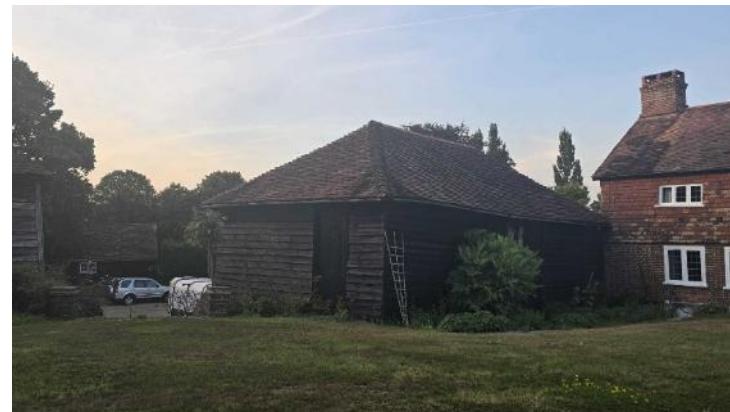
Surveyor observations		
Surveyor 1	<p><b>Roost 1: Common pipistrelle day roost</b></p> <p>Number: 2</p> <p>Time(s): 20:14</p> <p>Location of access point(s): Hanging tile on the southern gable end of B2</p> <p>Direction(s) of travel on emergence: South</p> <p>Species ID was confirmed by the surveyor on site</p> <p>Summary of general activity:</p> <p>Species – Common pipistrelle, brown long eared</p> <p>Flight paths – North to south past and over B1</p> <p>Foraging areas – Western garden</p> <p>The first activity was two common pipistrelles emerging from hanging tiles on the southern elevation of B2 at 20:14 before commuting south. A common pipistrelle was seen flying from north to south, towards the rear garden at 20:15. A common pipistrelle was seen entering B3 at 20:20 to forage. Between then and the end of the survey, common pipistrelles were intermittently heard and/or seen with regular passes from north to south. From 20:59 until the end of the survey, there was constant activity from brown long-eared. The majority of activity was heard not seen, with intermittent foraging within the garden activity to the southwest of B1.</p>	<p>Surveyor 1 elevation photo, emergence location outside of field of view</p>

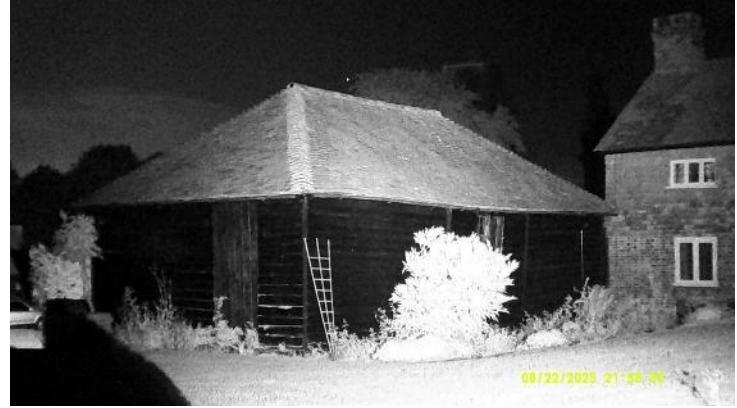
<p><i>IR position 1</i>  <i>Nightfox Whisker</i>  <i>Nightfox XB5 850nm IR</i></p>	<p>Camera position: observing southwest elevation of B1 and B2  Emergences observed: No</p> <p>The emergences observed on site were out of the field of view of the IR. Otherwise, the footage was in line with the observations of surveyor 1 with no additional activity.</p>	<p>Surveyor 1 darkest point photo</p>

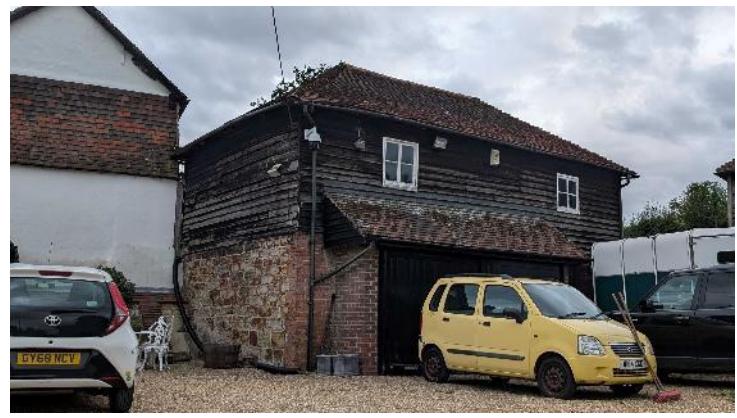
<p>08/02/2020 21:58:39</p>
<p><b>Surveyor 2</b></p>	<p><b>Summary of general activity:</b>  Species – Common pipistrelle, brown long eared  Flight paths – North to south over B1  Foraging areas – Western garden</p> <p>The first activity of the night was a heard not seen common pipistrelle at 20:20, with regular passes north to south between then and 20:34. From then until the end of the survey, common pipistrelles were intermittently heard not seen. From 21:00 until the end of the survey, there was near constant brown long eared activity, with near constant heard not seen activity between and occasional foraging to the west of B1.</p>	<p>Surveyor 2 elevation photo</p>

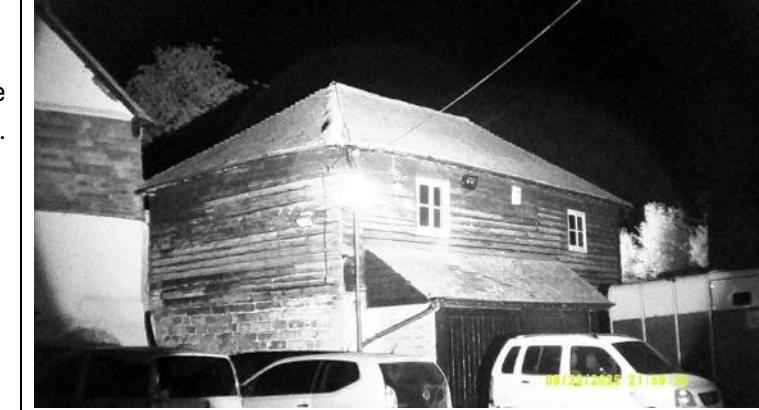
<i>IR position 2</i> <i>Nightfox Whisker</i> <i>Nightfox XB5 850nm IR</i>	<p>Camera position: observing northeast elevation of B1 and B2</p> <p>Emergences observed: No</p> <p>No emergences were observed and the footage was in line with the observations of surveyor 2 with no additional activity.</p>	<p>Surveyor 2 darkest point photo</p>

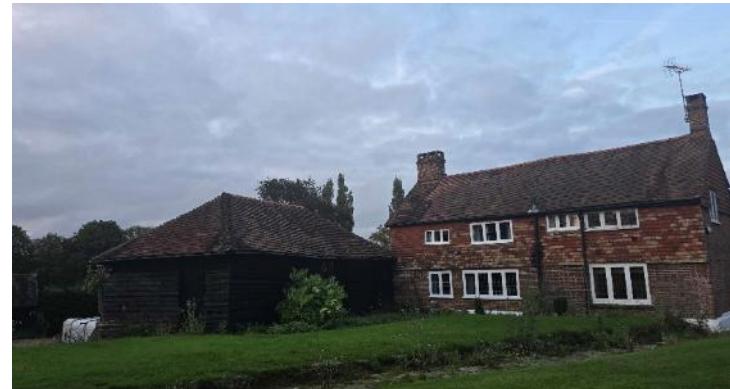
<p>Surveyor 1 elevation photo</p>

Magenta Electronics	Magenta Bat4	2		
	Two Way Radio	BAOFENG	FV-88E	2		
<b>Results</b>						
<b>Date of survey</b>			<b>Sunset; Start - End</b>			
18/09/2025			Sunset 19:07; 18:52 – 20:37			
Roost reference	Species and numbers	Roost type	Structure reference	Roost location	Access point	Dimensions (for lofts/internal voids)
2	4x common pipistrelle	Day	B2	Hanging tiles on the southern gable end of B2	Lifted hanging tile	N/A
3	1x common pipistrelle	Day	B2	Hanging tiles on the southern elevation of B2	Lifted hanging tile	N/A
4	1x common pipistrelle	Day	B2	Hanging tiles on the northern portion of the western elevation of B2	Lifted hanging tile	N/A
5	2x common pipistrelle	Day	B2	Hanging tiles on the southern portion of the western elevation of B2	Lifted hanging tile	N/A
<b>Surveyor observations</b>						
Surveyor 1	<p>Summary of general activity:</p> <p>Species – Common pipistrelle, brown long eared, noctule, soprano pipistrelle</p> <p>Flight paths – North to south over B1</p> <p>Foraging areas – Western garden</p> <p>The first activity was a noctule which was heard not seen intermittently from 19:11 until 19:16. At 19:17, a common pipistrelle was seen commuting north to south past B1. This flight path was utilised twice more by common pipistrelle during the survey. From 19:17 until 20:03, common pipistrelles were intermittently heard not seen. A soprano pipistrelle was heard not seen at 19:40. From 19:41 until 20:03, there was constant heard not seen activity from brown</p>

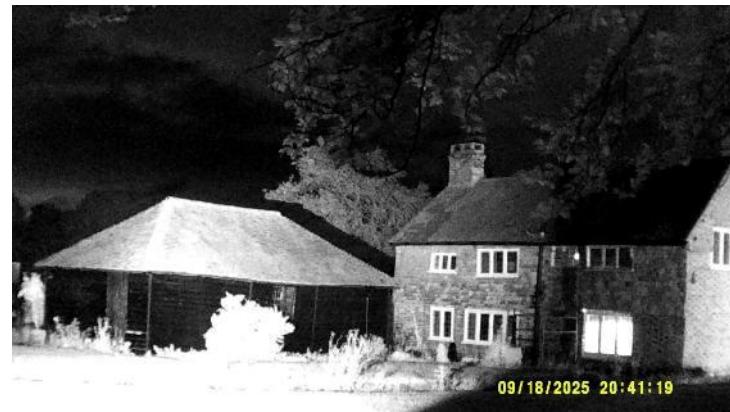
long-eared which then reduced to intermittent until the end of the survey.	
<i>IR position 1</i> <i>Nightfox Whisker</i> <i>Nightfox XB5 850nm IR</i>	<p>Camera position: observing southwest elevation of B1 and B2 Emergences observed: Yes</p> <p><b><u>Roost 2: Common pipistrelle day roost</u></b></p> <p>Number: 2 Time: 19:22, 19:26 Location of access point: hanging tiles on the southern gable end of B2 Direction of travel on emergence: South Species ID was confirmed by surveyor 1 on site</p> <p>In addition to the observations on site, the above two emergence were identified upon IR review. These emergences aligned with heard not seen common pipistrelle calls identified during the survey. These emergences were both also identified upon review of unmanned camera 3. Otherwise, the footage was in line with the observations of surveyor 1 with no additional activity.</p>	<p>Surveyor 1 darkest point photo</p>

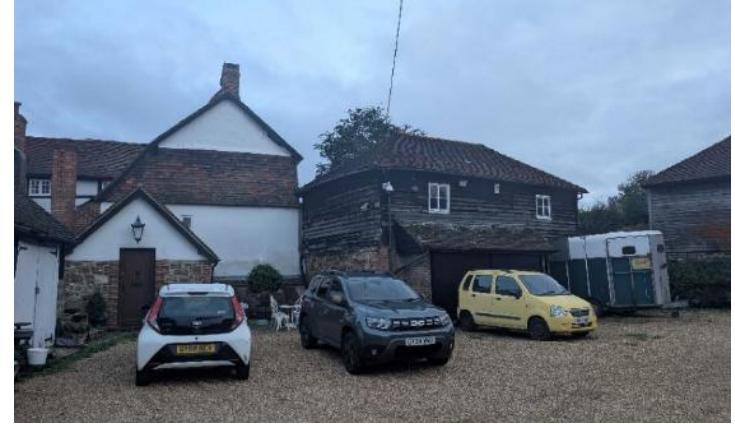
Surveyor 2	<p>Summary of general activity:            Species - Common pipistrelle, brown long eared            Flight paths - None observed            Foraging areas – North of B1</p> <p>The first bat was a common pipistrelle seen foraging to the north of B1 at 19:43. This behaviour continued intermittently throughout the survey. At 19:57, a brown long eared was heard not seen.</p>	<p>Surveyor 2 elevation photo</p>

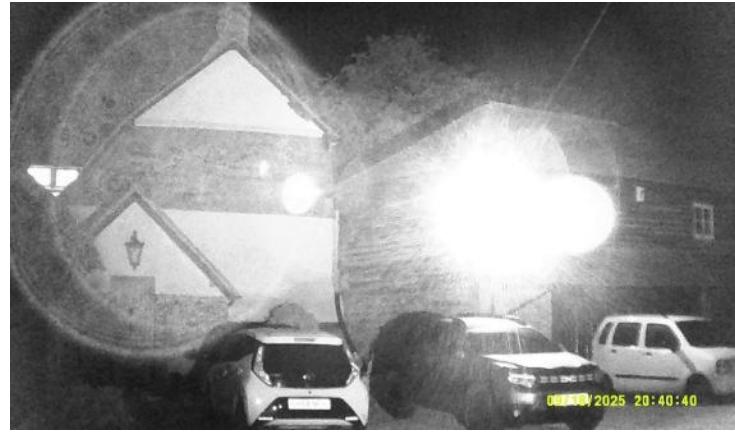
<i>IR position 2</i> <i>Nightfox Whisker</i> <i>Nightfox XB5 850nm IR</i>	<p>Camera position: observing northeast elevation of B1 and B2            Emergences observed: No</p> <p>No emergences were observed and the footage was in line with the observations of surveyor 2 with no additional activity.</p>	<p>Surveyor 2 darkest point photo</p>

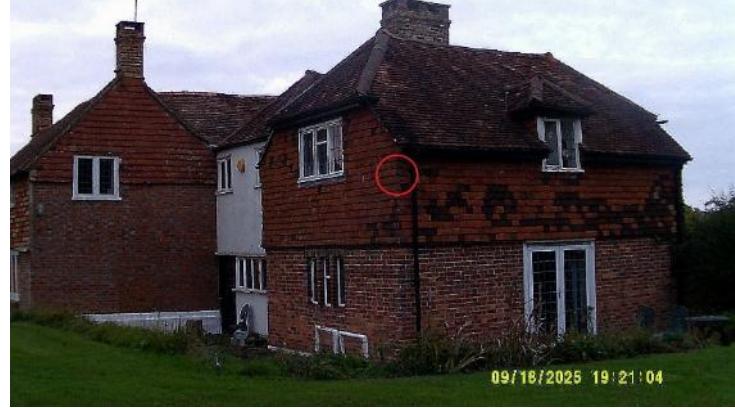
<p>Species ID'd visually prior to the survey during the pre-survey walkover and through DNA analysis</p> <p>The first bat was a common pipistrelle emergence at 19:21 from the southwest corner of B2. Between then at 19:27, there were a further 8 emergences across 4 different roosts as detailed above. From 19:45 until 20:03, up to two brown long eared were seen near constantly foraging to the south of B2. From then until the end of the survey, both common pipistrelles and brown long eared were seen foraging to the south of B1 and passing east to west and west to east intermittently.</p>	<p>Roost 3 emergence location</p>

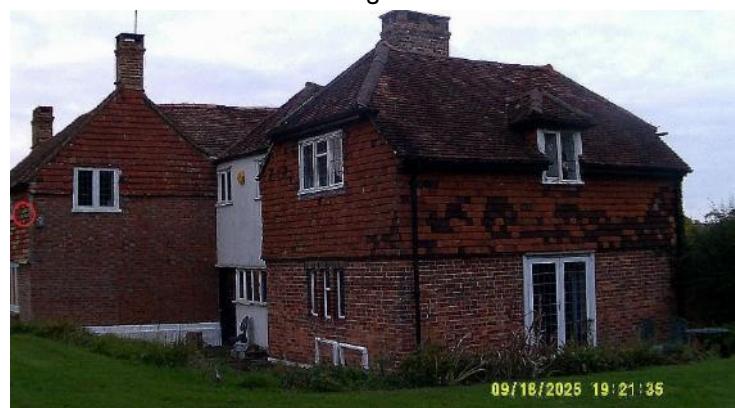
<p>09/18/2025 19:21:04</p> <p>Roost 4 emergence location</p>

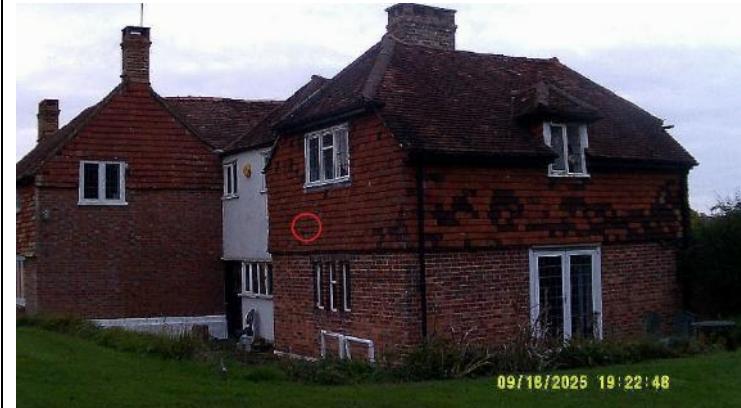
<p>Roost 5 emergence location</p>

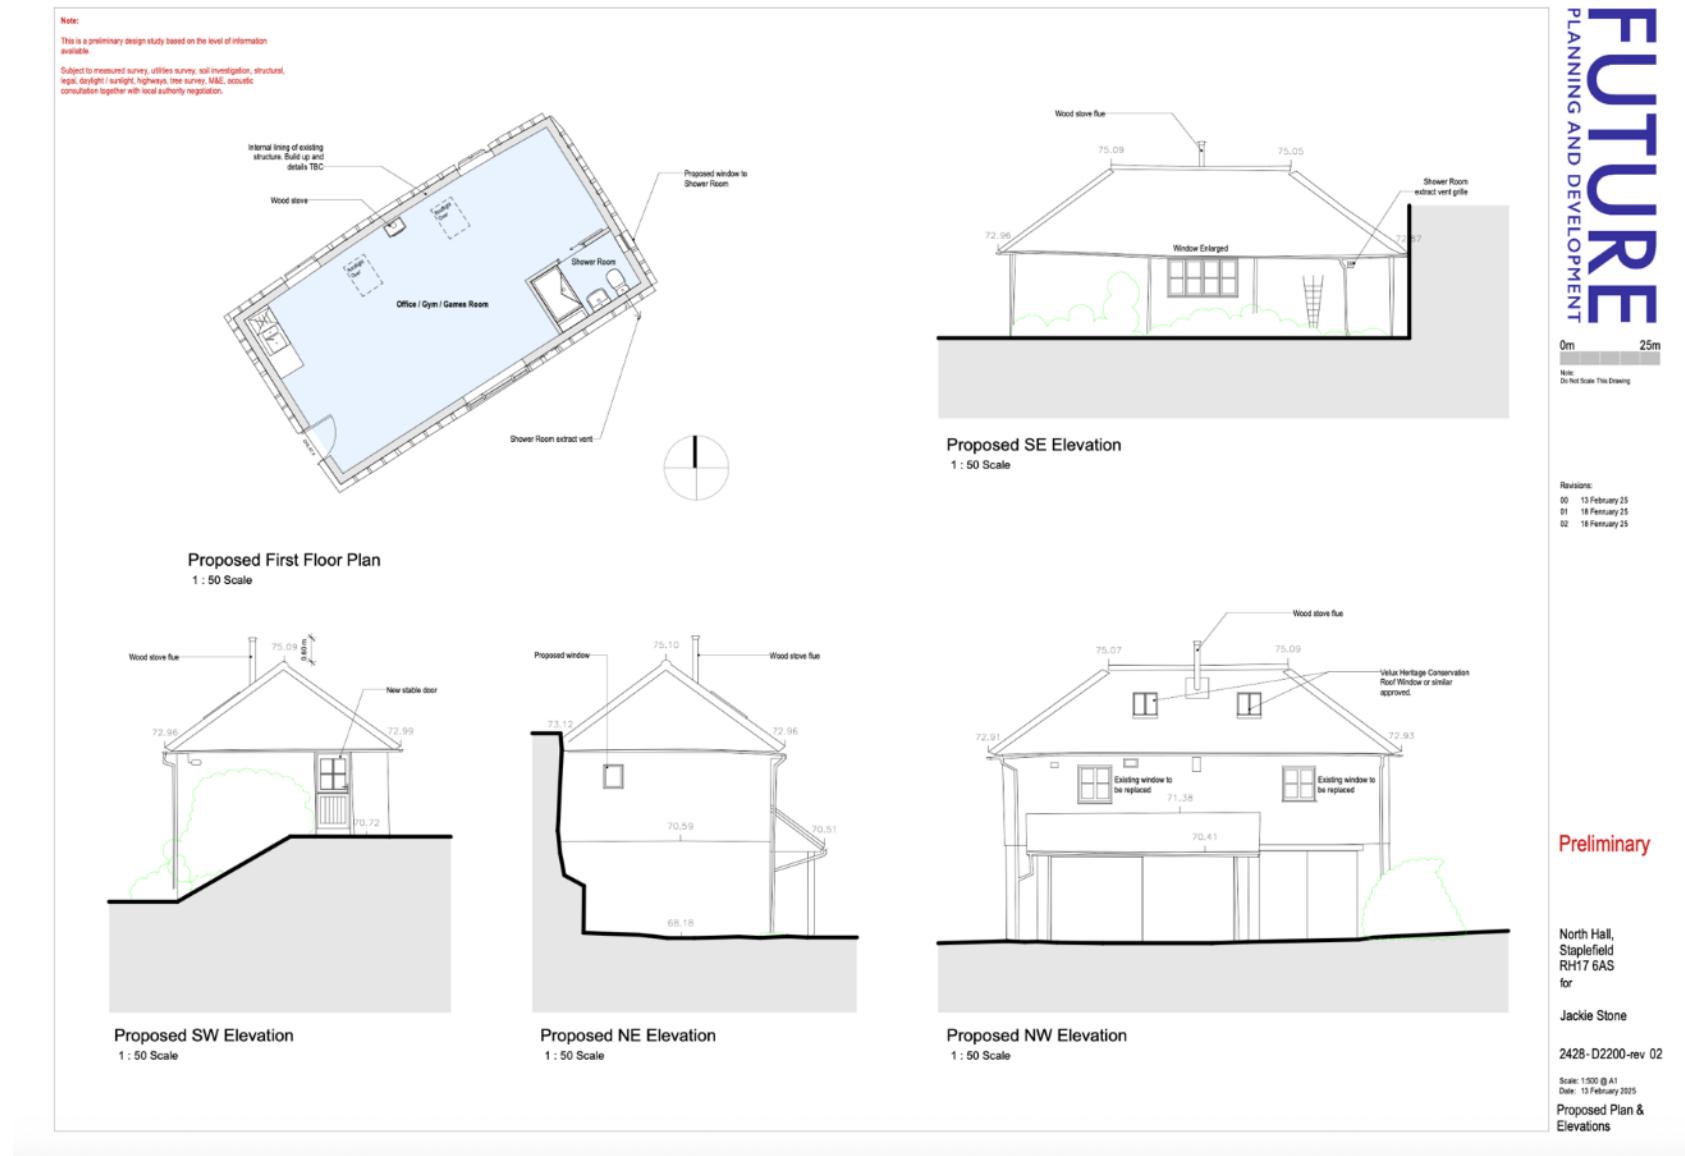
## Appendix 3: Proposed Plans

Structural changes to building – Conversion including installation of shower room and wood stove with associated flue

Cosmetic/repair work – Roof repairs, replacement of windows and doors

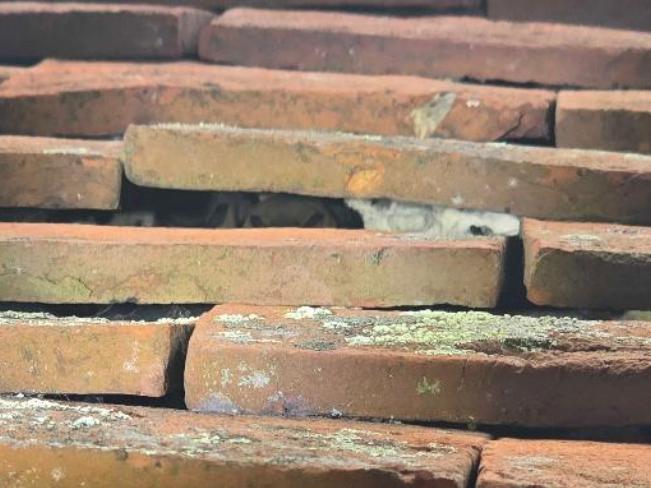
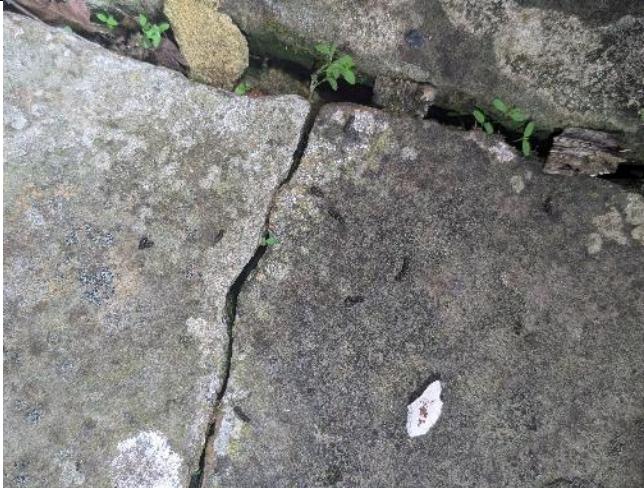
Picture 3: 2x common pipistrelle roosting beneath hanging tiles on the western elevation of B2	Picture 4: Scattered droppings on the floor around B2

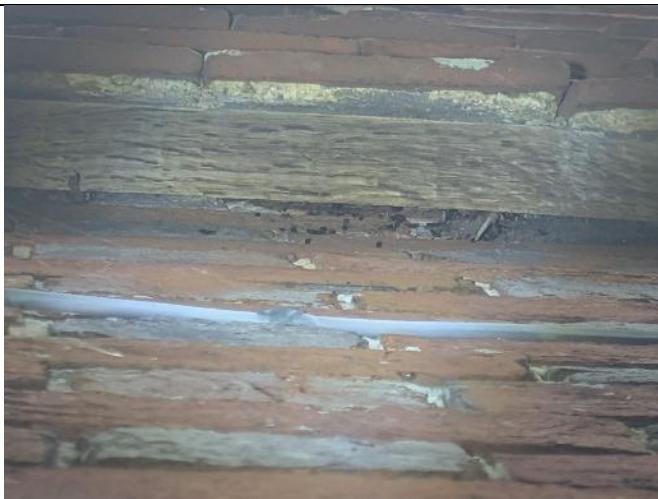
Picture 5: Droppings caught in cobwebs beneath bargeboard on the southern elevation of B2

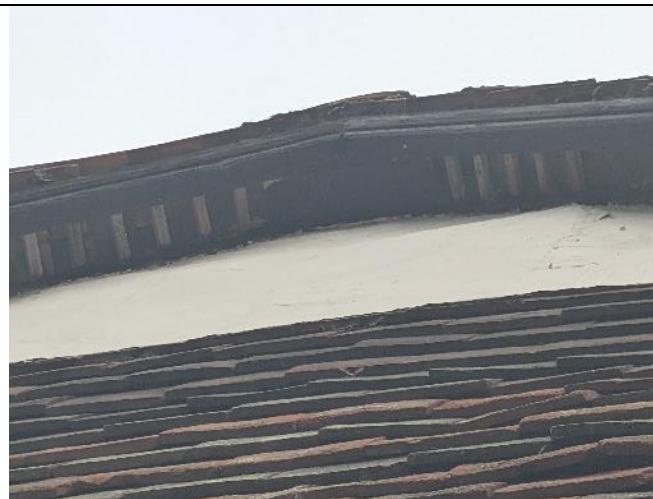
Picture 6: Damaged eaves and lifted hanging tiles on the northern elevation of B2

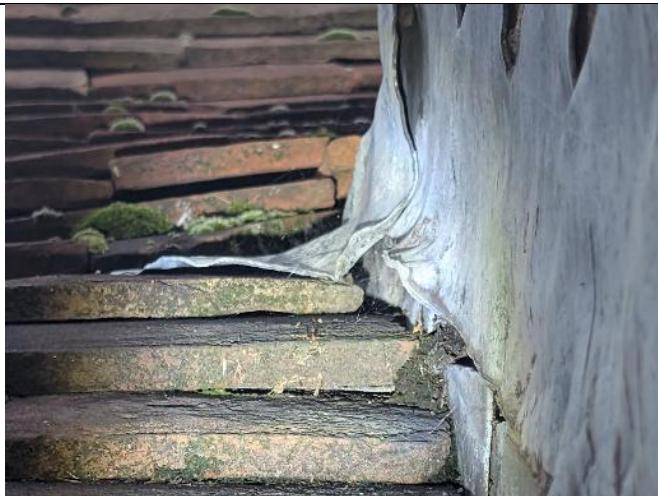
Picture 7: Lifted tiles and lead flashing on B2

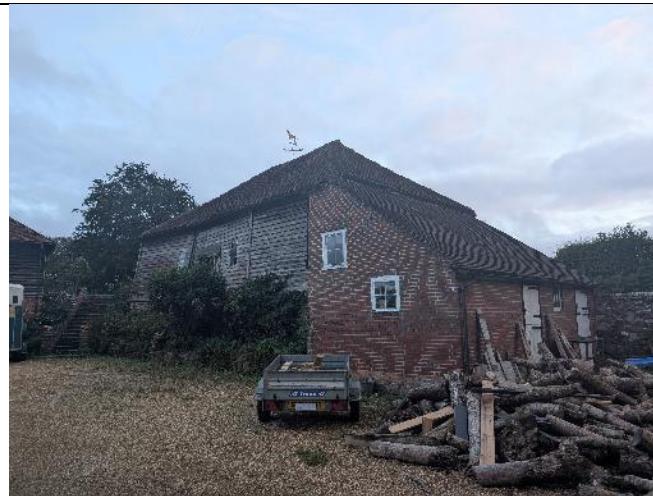
Picture 8: B3 exterior

<i>B3 summary and suitability</i>	B3 is a large barn to the west of B1 which is partially hipped with a pitched extension on the northern elevation. The barn is constructed partly of brick and mortar and partly of timber, with a clay tile clad roof. Roosting features include lifted roof tiles, missing mortar beneath hip tiles, damaged eaves and lifting between timber panels. Access to the interior of B3 is present throughout, with large gaps in the timber walls, gaps at the eaves and broken windows. The internal roof is lined with bitumen

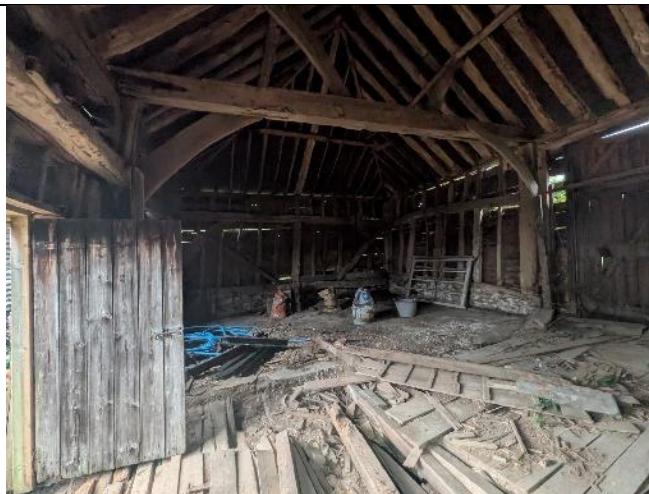
Picture 9: B3 interior

<p>felt, and timber beams throughout the roof structure provide a suitable roosting location for void dwelling bat species. B3 has been assessed to provide <b>high</b> habitat value for roosting bats.</p> <p>Bat droppings were identified scattered throughout B3, with a cluster beneath the join between the ridge and hip beams to the south of B3. ~200 droppings were identified in total, though more may have been missed due to debris on the floor. In amongst the cluster of droppings were ~20 scattered insect wings, suggesting the presence of a feeding roost. Due to the high volume of droppings compared to the volume of insect wings, this is also considered likely to be a day roost of the same species. Droppings were collected and sent for DNA analysis. These were identified as brown long eared (see DNA results in appendix 3).</p>									
<i>B4, B5 summary and suitability</i>	<p>B4 and B5 are both is a small outbuildings to the northeast of B2 which are constructed partially of brick and mortar and partially of timber, with a clay tile clad roof. Roosting features include a small number of lifted roof tiles, gaps in the mortar and gaps around window and door frames. The interior of B4 and B5 could not be accessed, however, due to windows on the norther, southern and western elevation there are likely high levels of light internally which will limit the suitability for roosting bats internally. B4 and B5 have been assessed to provide <b>moderate</b> habitat value for roosting bats. No evidence of roosting bats was identified on or around B4 or B5.</p>

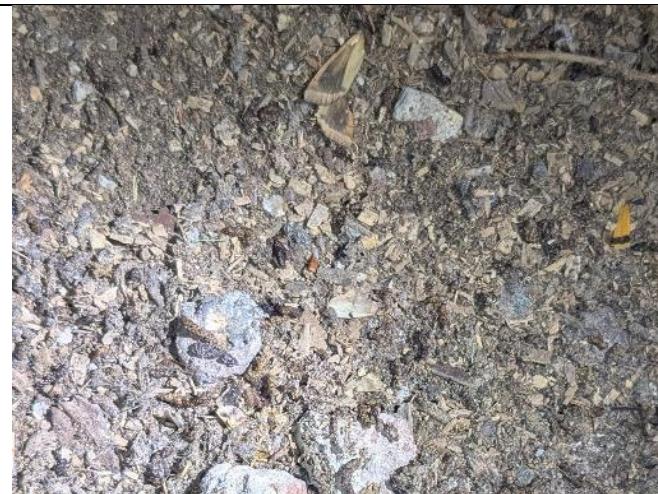
Picture 10: Cluster of bat droppings and discarded wings amongst debris inside B3

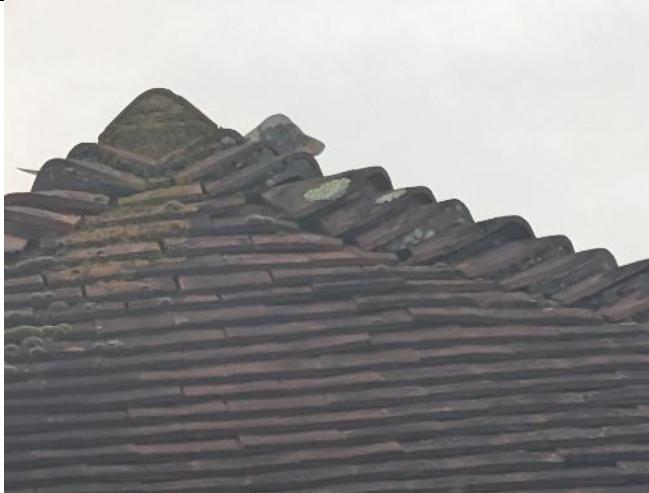
Picture 11: Missing mortar and lifted roof tiles on B3

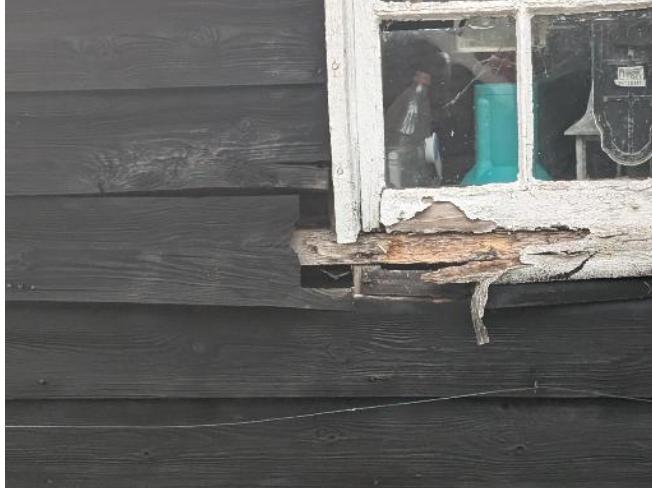
Picture 13: Damage and gaps around window B4	Picture 14: B2, B4 and B5, northwestern elevations
