# **ROWFANT MILL COTTAGE**

## **HERITAGE NOTE**

Ref. JO-594-HS-01-A

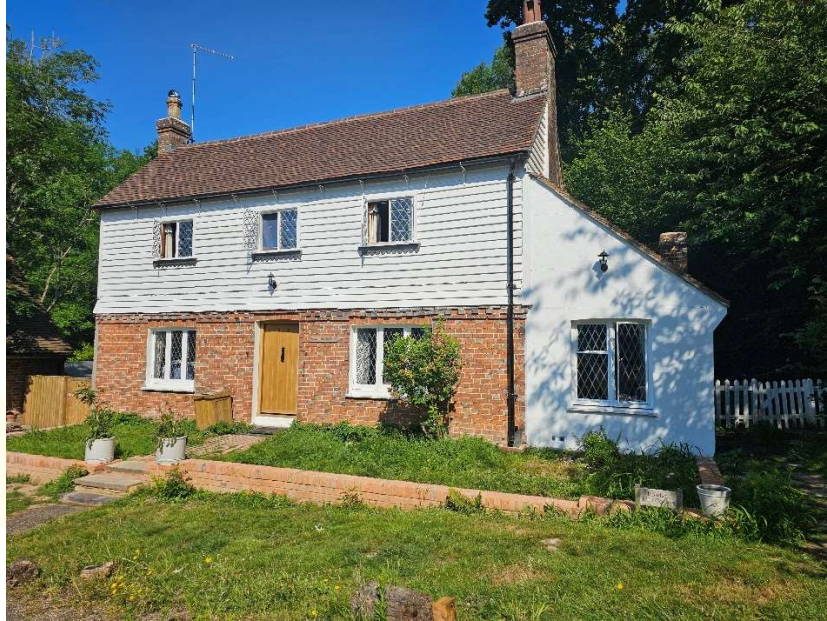
Figure 1: Front elevation of Rowfant Mill Cottage

- 2.1 Rowfant Mill Cottage was added to the statutory *List of Buildings of Architectural or Historic Interest* at Grade II on 10<sup>th</sup> May 1983. The list description reads as follows:

*C18. Two storeys. Three windows. Ground floor red brick, above faced with Weatherboarding. Tiled roof. Casement windows.*

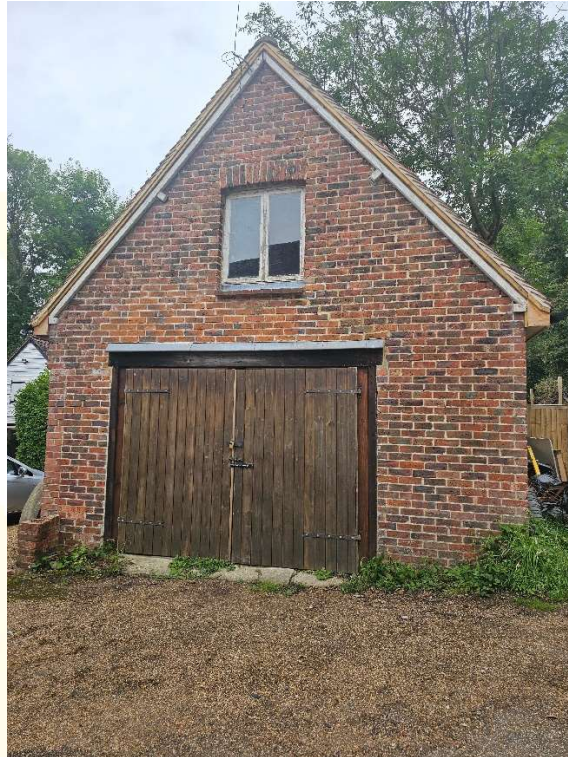
- 2.3 The barn to the south-west of Rowfant Mill Cottage appears to have been built in the late 19<sup>th</sup> century to replace an earlier building in this general location. The barn appears to be historically associated with the function of the mill rather than forming part of the domestic

curtilage of Rowfant Mill Cottage. It is, however, likely that the LPA will regard the barn to be curtilage listed.

Figure 2: Front elevation of the barn to the south-west of Rowfant Mill Cottage

- 3.7 The barn is of late 19<sup>th</sup> century date and of some interest in terms of the historic use of the site as a flour mill, i.e. a storage related use. The front elevation has been altered by the insertion of garage doors. The upper gable window suggests that the barn was originally built with an upper floor on the south-eastern side. The interior includes a brick floor and a relatively recent mezzanine (assumed to have replaced an earlier floor). The roof structure is of machine-made timbers.

- 4.3 There is scope for alterations to the barn to provide ancillary accommodation. There is scope to restore this elevation back to its original appearance or at least back to a historical ratio of openings to void. A new door opening in the side or rear wall would require the loss of a small area of brick walling that should be acceptable. Alterations to the interior could include a mezzanine (there is already a mezzanine) and an appropriately designed stair. Finishes and insulation would need to consider breathable products such as wood fibre boards etc. It will be important to retain a sense of openness and retain the roof as a vaulted feature rather than insert a ceiling.

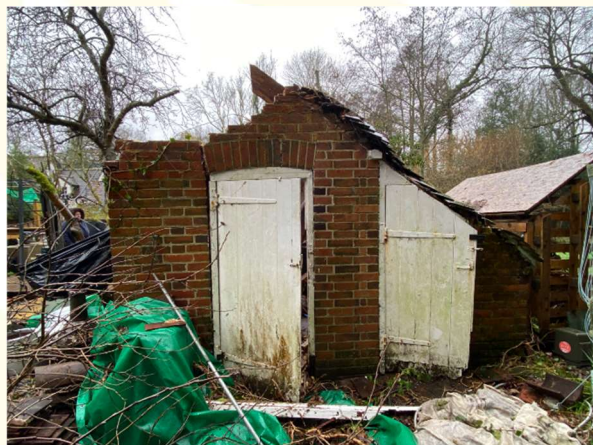
- 2.4 The small outbuildings to the rear of Rowfant Mill Cottage appear to have been built in the 2<sup>nd</sup> or 3<sup>rd</sup> decades of the 20<sup>th</sup> century and the outdoor loo, or privy, built post-1933. As these are pre-1948 structures they are likely to be regarded as curtilage listed buildings.

Figure 3: c. 1920s outbuilding to the rear of Rowfant Mill Cottage

- 3.8 The outbuildings in the rear garden of Rowfant Mill Cottage include a c. 1920s brick-built structure in a ruinous condition and a later outdoor loo of post 1933 date. These structures replaced earlier outbuilding in this location and are considered to be of relatively low heritage value.

- 4.4 The brick outbuildings to the rear of Rowfant Mill Cottage are of 20<sup>th</sup> century date and of relatively low heritage value. As they are likely to be regarded as curtilage listed, LBC will be required and, as such, justification for their demolition will be required. Justification will primarily lie with their condition and whether they are beyond repair. They could be repaired and retained as garden buildings.

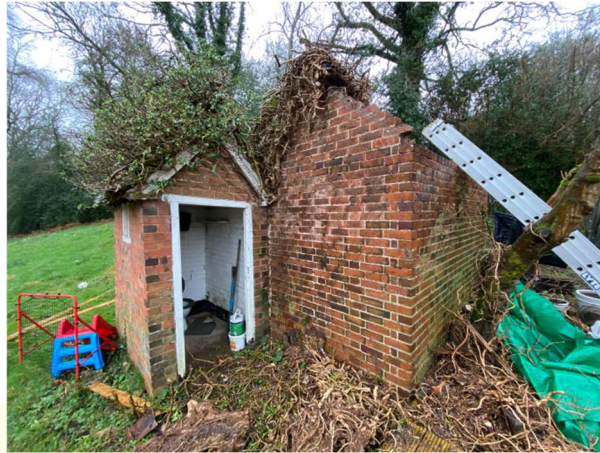
Figure 4: Post-1933 outdoor loo

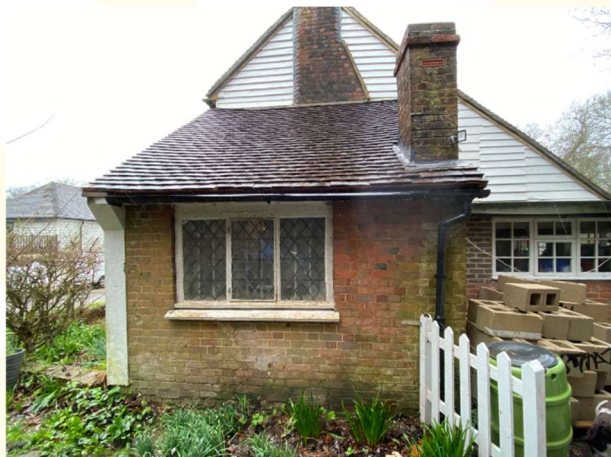
- 3.1 The original cottage has a double-pile plan with principal rooms to the front, originally including a living/kitchen room with an open fireplace and a smaller parlour. The rooms to the rear probably had a service use such as storage and includes a staircase.
- 3.2 The original cottage was extended on the north-east side with a single storey lean-to with a corner fireplace.

Figure 5: 19<sup>th</sup> century lean-to extension

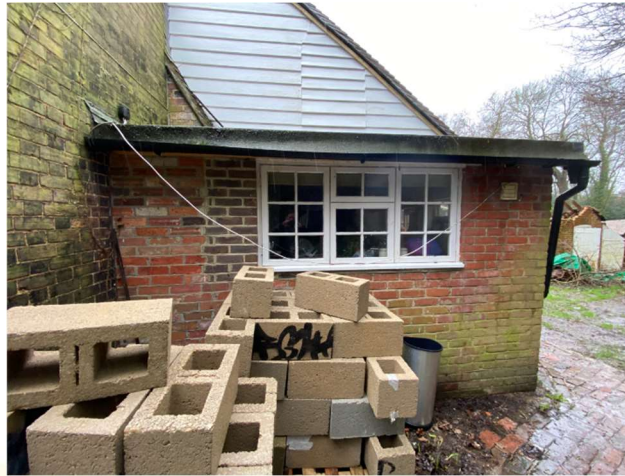
- 3.3 20<sup>th</sup> century changes include the extension of the kitchen on the north-east side, the addition of a rear porch and a conservatory.

Figure 6: Mid-late 20<sup>th</sup> century kitchen extension

- 3.6 The extension on the north-east side of the kitchen, the rear porch and conservatory are of no heritage value and removal or sympathetic alterations to these elements would represent an enhancement.

- 4.2 The remodelling of the kitchen in a manner that would impact on the modern extension and carried out in an appropriate manner scale, form and materials wise should be acceptable and wouldn't impact on historic fabric.

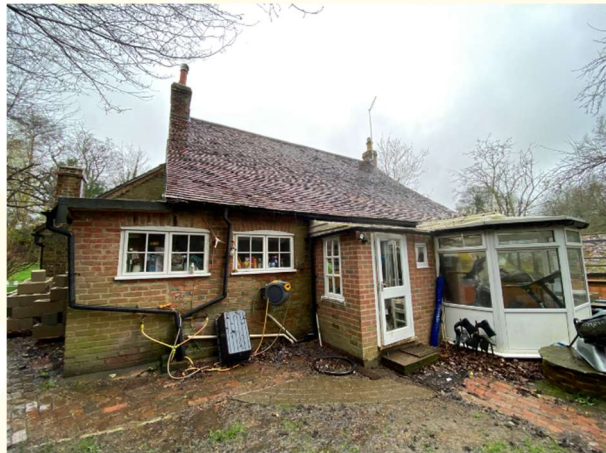
Figure 7: 20<sup>th</sup> century kitchen extension, brick porch and conservatory to the rear of Rowfant Mill Cottage

- 4.1 It is currently unknown when the conservatory and rear porch were built. The character of the Fletton brick plinth of the conservatory suggests a 1970s to early 1980s date. This and the porch sit below the eaves level of the catslide roof of the original house to the rear. As the rear catslide roof form is an important component of the historic design of the original listed building, it should be considered how a replacement extension could be designed to avoid blurring the definition and form of the catslide. Options could be to design a flat roofed replacement extension of appropriate design and use of materials that reference the character of the host building. Another option could be to include a narrow glazed link that sits below the rear eaves level and which would provide an opportunity for a pitched roof single storey replacement extension that would better reflect the historic forms of structures at Rowfant Mill. The existing access from the back hall should ideally be utilised and the rear elevation of the original elevation retained unfinished, as is currently the case, to preserve the legibility of the brickwork and brick arch.

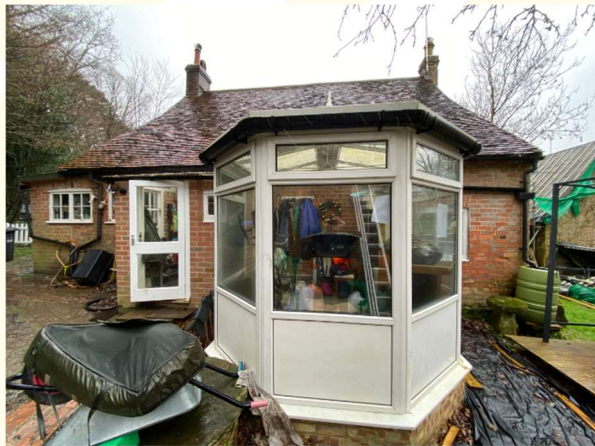
Figure 8: Expressed brickwork of the rear elevation of the original part of the cottage viewed through the modern conservatory
