## Bat Emergence Report

Red House, Staplefield, RH17 6ET

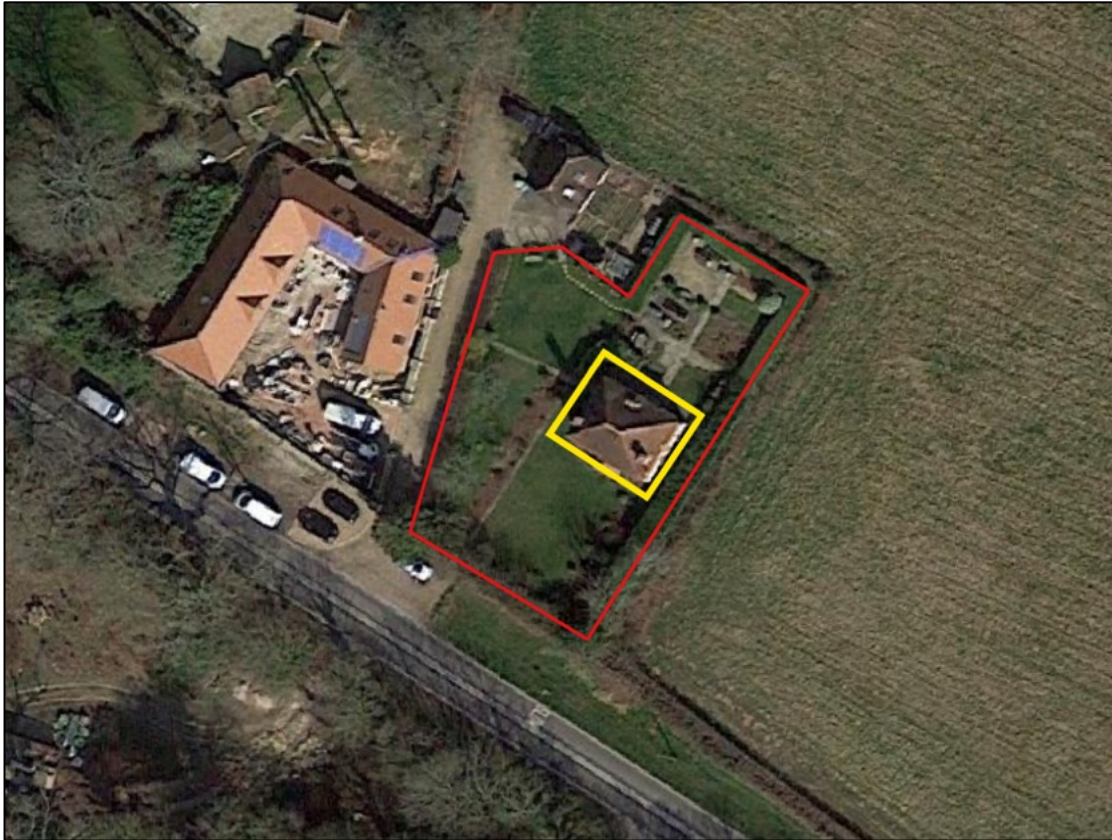
*Figure 1: Site boundary (red), building surveyed (yellow)*

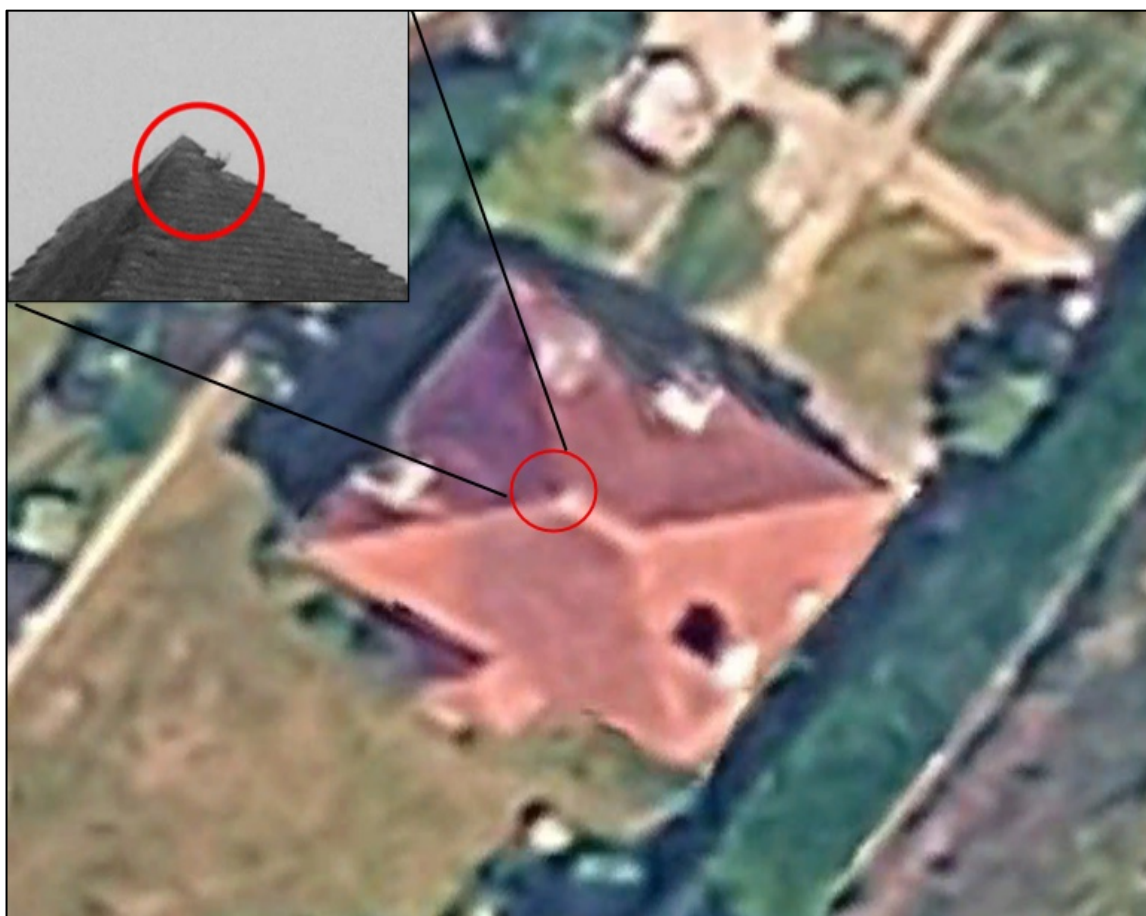
- 3.4 Sunset was at 21:19 with clear skies and no wind. The survey temperature started at 19°C dropping to 18°C at the end of the survey. A single brown-long eared bat was recorded emerging during the survey at 21:53 from the top northwestern ridge of the roof (Figure 4). The direction and position of surveyors during this survey are below (Figure 4). The first bat recorded was at 21:20 and was a noctule commuting east to west over the site. During the survey occasional bat activity by noctules and common pipistrelles were recorded over the house and garden.

*Figure 4: Single emergence of brown long-eared bat at 21:53 on third emergence survey (26/06/24)*

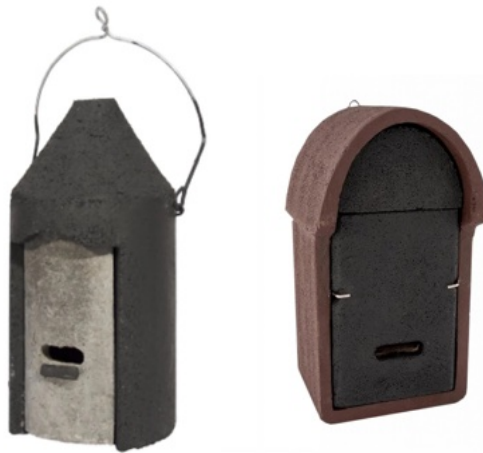
- 2F Schwegler Bat Box – A bat box suitable for cavity-dwelling species such as brown long-eared bats. These can be hung on trees or buildings and provides a stable temperature internally suitable for long-term use.
- Large Multi Chamber WoodStone Bat Box – This is a multipurpose box designed for larger colonies and a range of bat species including pipistrelles, noctules and brown long-eared bats. These should be hung on mature trees around the site.

*Figure 6: 2F Schwegler Bat Box (left) and Large Multi Chamber WoodStone Bat Box (right)*

4.8 It is recommended that three bat boxes are provided as mitigation (Figure 6). This box will be installed on the existing building or on nearby mature trees. A range of boxes can be used which are designed for different bat species, for example;

4.9 Bat boxes can be installed on mature trees or retained buildings and should ideally be positioned to receive maximum sunlight exposure. As such, south and west facing aspects are generally recommended. Boxes should be installed at a minimum height of 3m above ground level to reduce the risk of disturbance and predation.

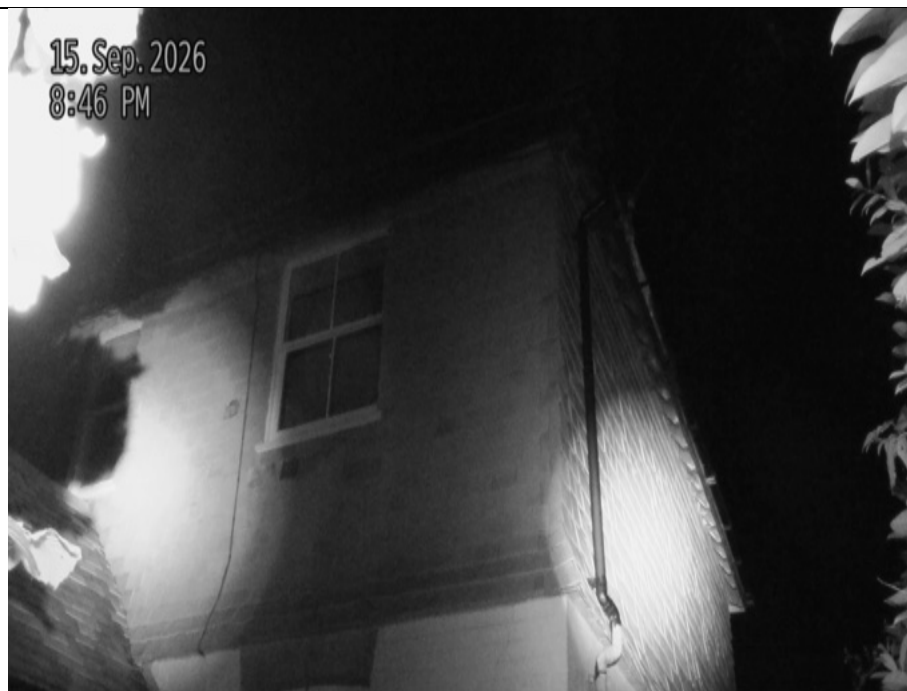
**Photograph 3:**

Southeastern aspect of the building at the darkest point (15/09/26)

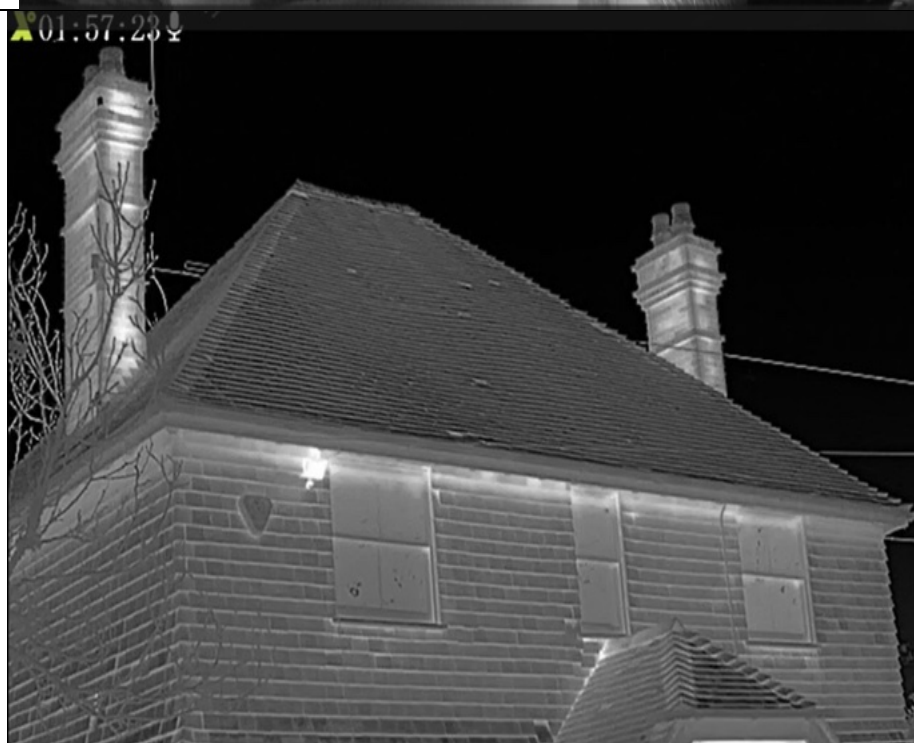
**Photograph 4:**

Southwestern aspect of the building at the darkest point of survey (15/09/26)

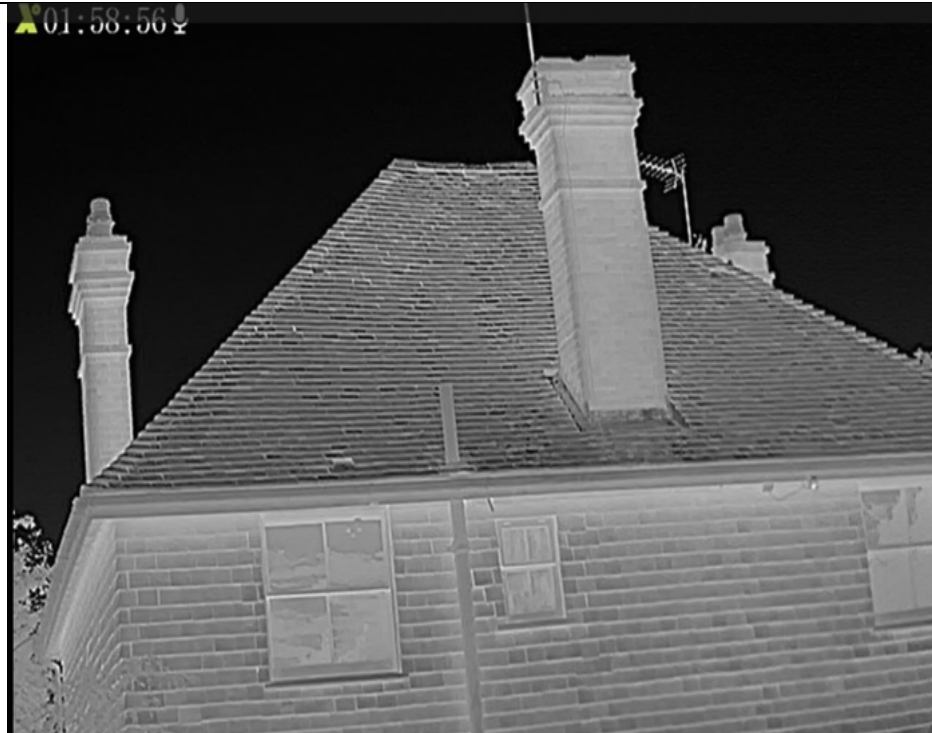
**Photograph****5:**

Northeastern  
aspect of the  
building at  
the darkest  
point of  
survey  
(15/09/26)
