## Condition 7- Ecological Design Strategy

Land at Red House  
Cuckfield Road, Staplefield  
Haywards Heath

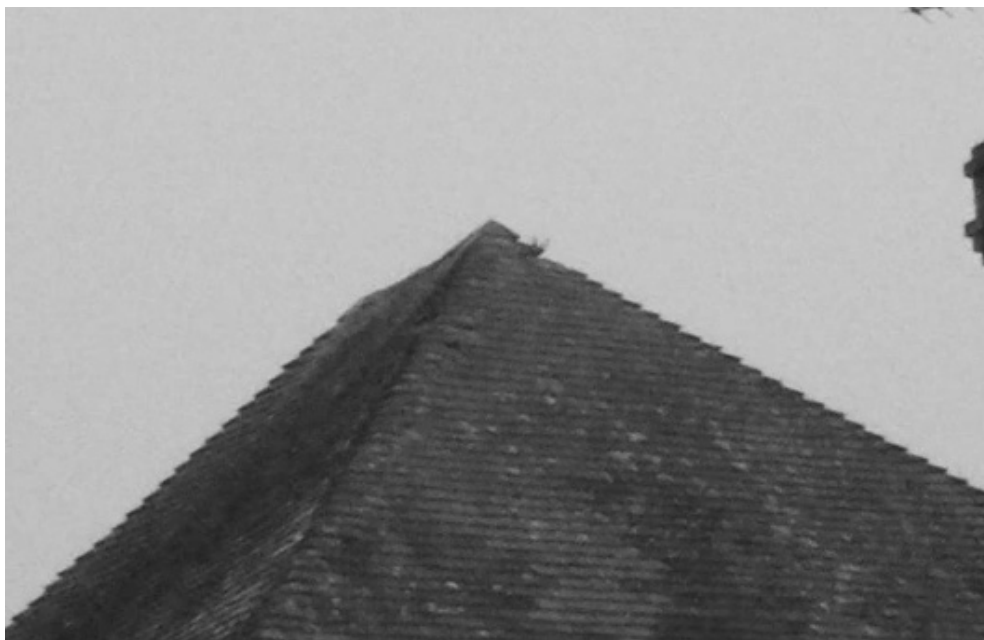
*Figure 2: Emergence at 21.53*

- 2.5 The house was surveyed on the 16<sup>th</sup> May 2024, 5<sup>th</sup> June 2024 and 26<sup>th</sup> June 2024. Surveys identified common and soprano pipistrelles, noctules and brown long eared bats. During the final survey a single brown long eared bat was recorded emerging during the survey at 21.53 from the top northwestern hip of the roof, Figure 2.
- 2.6 No other emergence was recorded from the roof or the hanging tiles around the building. Due to the low numbers of bats recorded, it is considered that the loft void of the house is used as an opportunistic/day roost by a brown long eared bat. As such, the works to the building and loft void must be undertaken under a low-impact licence from Natural England.

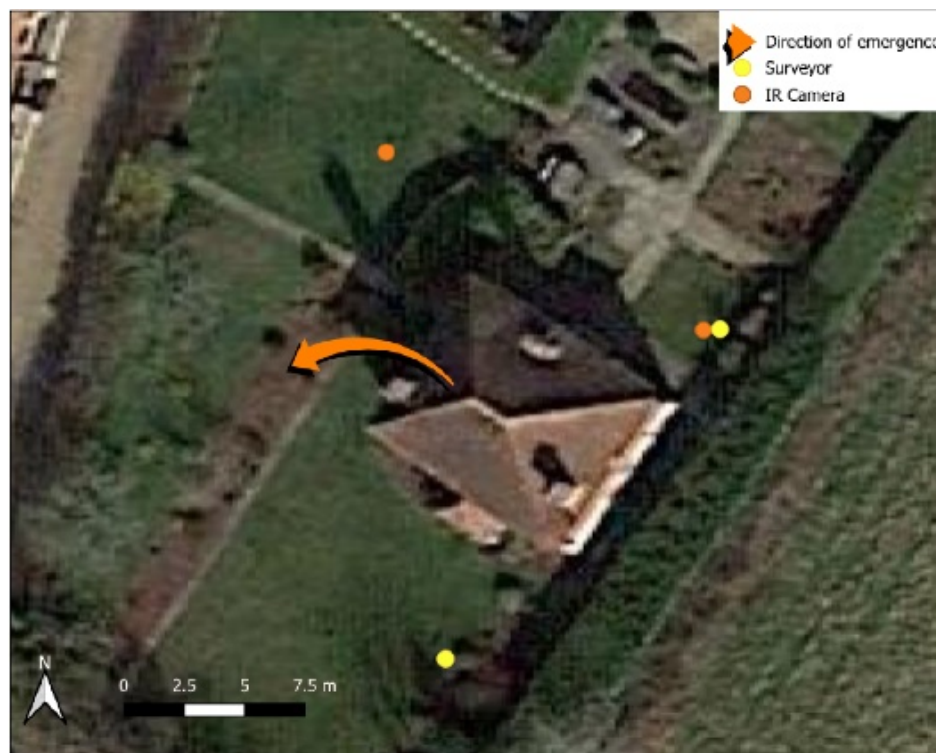
*Figure 3: Emergence and surveyor locations 26<sup>th</sup> June 2024*

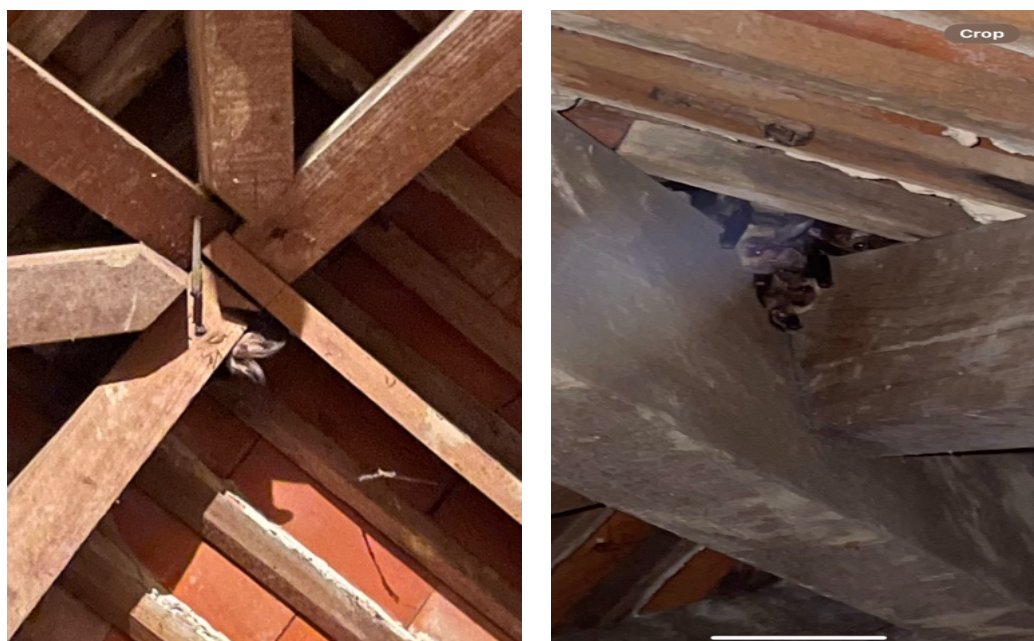
**Figure 5: Brown long eared bats recorded in roof void**

- 2.7 An update internal and external and emergence surveys was conducted on the 15<sup>th</sup> September 2026. Internally a total of 4 brown long eared bats were recorded, Figure 5 below. The roof void was not lined and supported numerous small gaps, making the void airy and cool.

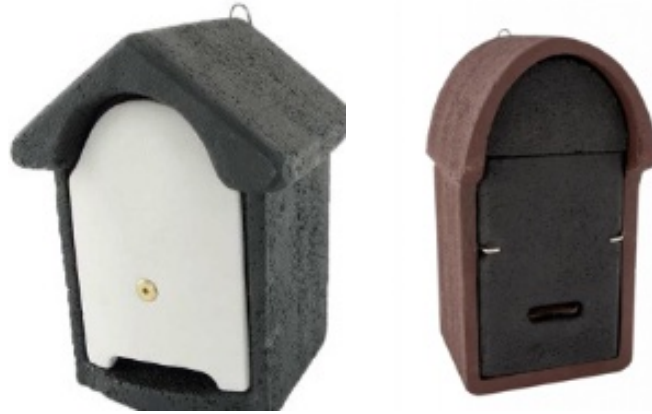
- 5.3
- The three tree mounted bat boxes will consist of Vivara Pro WoodStone Bat Box Large and the Multi Chamber WoodStone Bat Box are both recommended, Figure 8. Please note that the final agreed location for the bat boxes will be determined by the ecologist if these positions require alteration.

*Figure 8: Proposed Tree Mounted Bat Boxes*

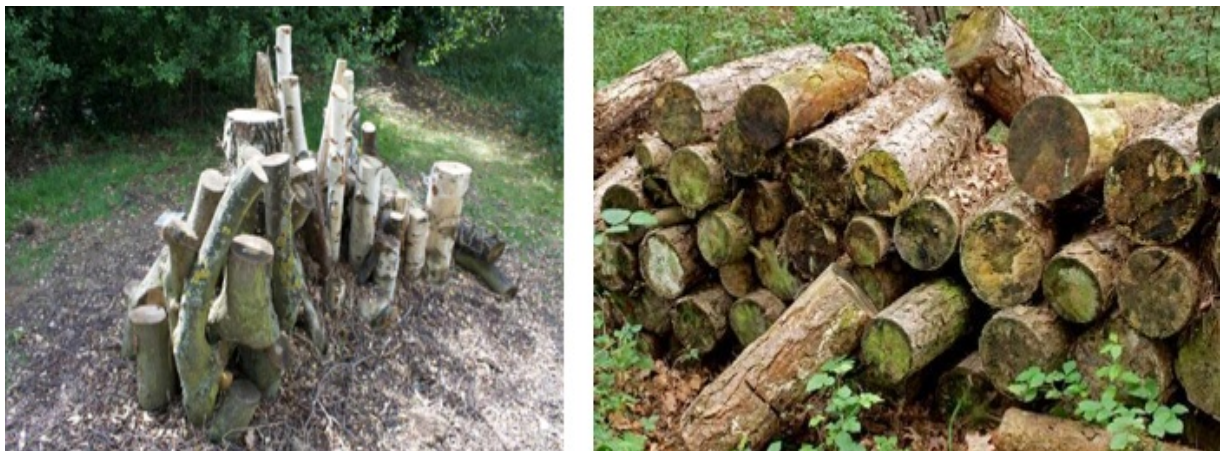
- 5.6 The addition of log piles around the north of the site are to be included within the scheme. These would provide new opportunities for hedgehogs and invertebrates post-development. Log piles can be created using local, native wood where possible (Figure 11).

*Figure 11: Examples of log piles that can be made on site*

- 6.5 Log piles will be retained and managed as habitat for invertebrates, providing shelter, breeding and overwintering opportunities. Logs should be maintained in contact with the ground and comprise a range of sizes and decay stages. Log piles will be left undisturbed wherever practicable, with additional untreated timber added where appropriate.

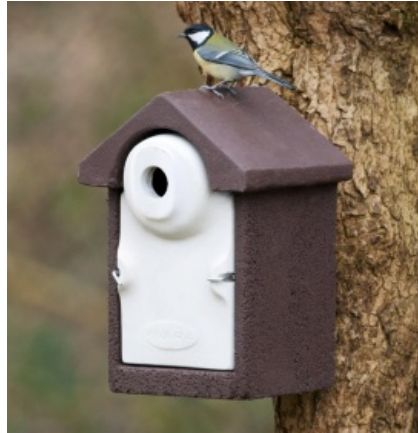
- 5.7 Additional nesting opportunities will be installed on several mature trees in the southern garden area. Hardwearing woodcrete boxes as shown in Figure 12 below. These would cater for species such as house sparrows and wagtails and the smaller garden birds. A total of two boxes will be utilised on the site and will be established on the north eastern aspect of the garage block, Figure 13 below.

*Figure 12: Vivara Pro Seville 32mm WoodStone Nest Box*

- 6.6 The boxes should be checked once a year. Damaged bird boxes should be replaced promptly to maintain safe and suitable nesting conditions, as structural defects can expose birds to weather and predation. Routine maintenance should also ensure that entrance holes remain unobstructed to support ventilation and prevent water ingress. In line with best practice, all old nesting material should be removed during the recommended non-breeding period (typically early autumn) to minimise parasite load and prepare boxes for future occupancy, while ensuring compliance with wildlife protection legislation by avoiding disturbance during active nesting periods.
