**PRELIMINARY ROOST ASSESSMENT
REPORT**

CUCKFIELD COTTAGE HOMES TRUST

CUCKFIELD COTTAGE HOMES
CHURCH PLATT
CUCKFIELD
WEST SUSSEX
RH17 5LA

12TH AUGUST 2025

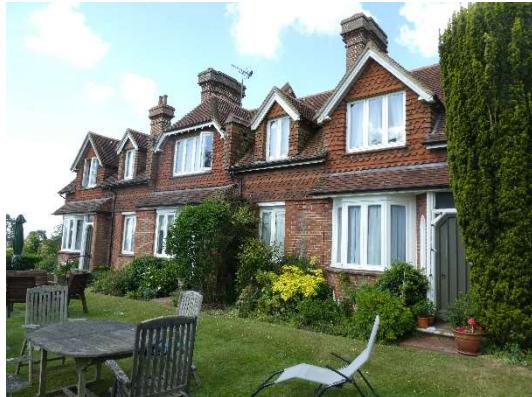
Photograph 1: East elevation of the building with tile hung dormers.

3.7 The building is of brick construction with upper tile hung wall elevations. The hanging tiles were in general good condition, with lifted tiles located at corners (of which there were many). The main roof pitch is half-hipped and faces west to east, with various dormers situated along both roof pitches (see Photographs 1 and 2). Dormers were tile hung, with various lifted tiles associated with the east elevation, and tighter, modern hanging tiles associated with the west elevation. The roof pitches were clad in traditional clay roof tiles which were in moderate condition, with a few raised and lifted tiles across the roof pitches. Dormers associated with the west elevation had felted flat roofs, and ground level flat roof extensions were also felted, all of these areas appeared to be tight fitting with no obvious gaps at the eaves. The eaves across the wider extent of the building consist of the roof pitches abutting the external wall surfaces, and some small gaps were present (see Photographs 3). Some large gaps were noted along the lower eaves of the west elevation (between the flat roof extensions). One small crevice feature was also noted to the southeast corner of the building, associated with the tile verge (see Photograph 4).

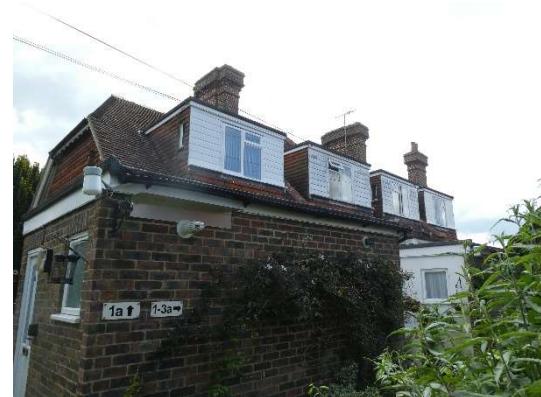
Photograph 2: South and east elevations of the building, with flat roofed dormers.

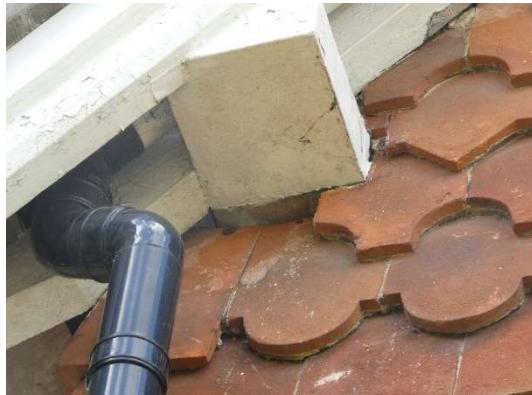
Photograph 3: Gap at the eaves associated with the north elevation.

4.2 The site supports a variety of potential bat roosting features and access opportunities, including a low number of raised roof tiles, lifted hanging tiles and gaps at the eaves.

5.2 To confirm the presence/absence of roosting bats at the site, two bat emergence surveys must be carried out between May and August inclusive. Three experienced bat surveyors will be required, along with one unattended night-vision aid and static detector (a total of 4 survey positions) to fully survey the building.

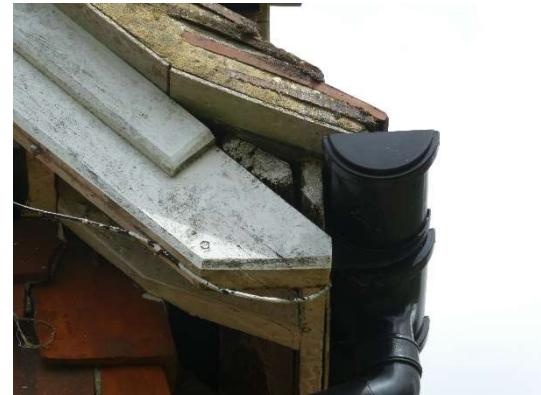
Photograph 4: Missing mortar at south facing tile verge.

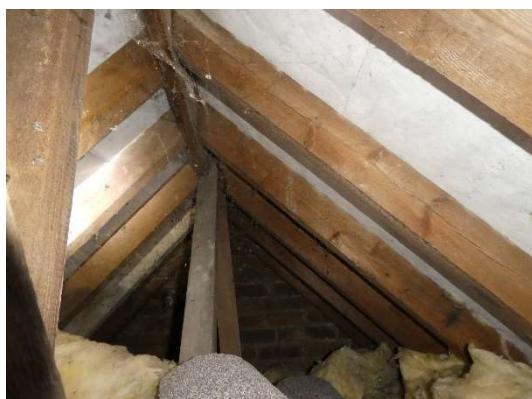
3.9 The roof void measures approximately 2.8m (l) x 1.8m (w) x 1m (h), with thick fibreglass insulation between the joists and the roof pitches were lined with a modern breathable membrane. The roof void was densely cobwebbed.

Photograph 5: View within roof void above 1A.

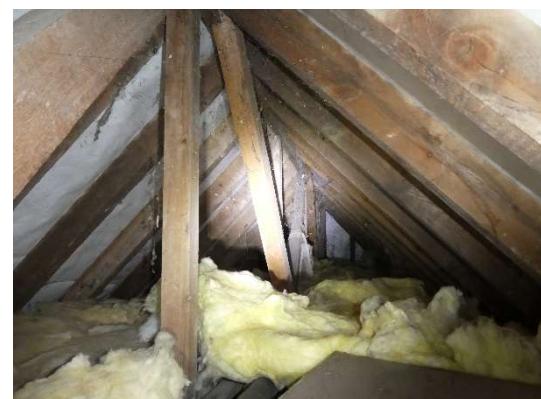
3.11 The roof void measures approximately 7m (l) x 1.8m (w) x 1m (h) with the same materials associated with the spaces in the other roof voids and with cobwebs throughout.

Photograph 6: View within roof void above 3A.
