# Phase I Desk Study Site Reconnaissance & Phase II Site Investigation Report

at Land South of Hanly  
Lane, Cuckfield, Haywards  
Heath, RH17 5HN

for Sigma Homes L

Report Reference LF3210/DSP:

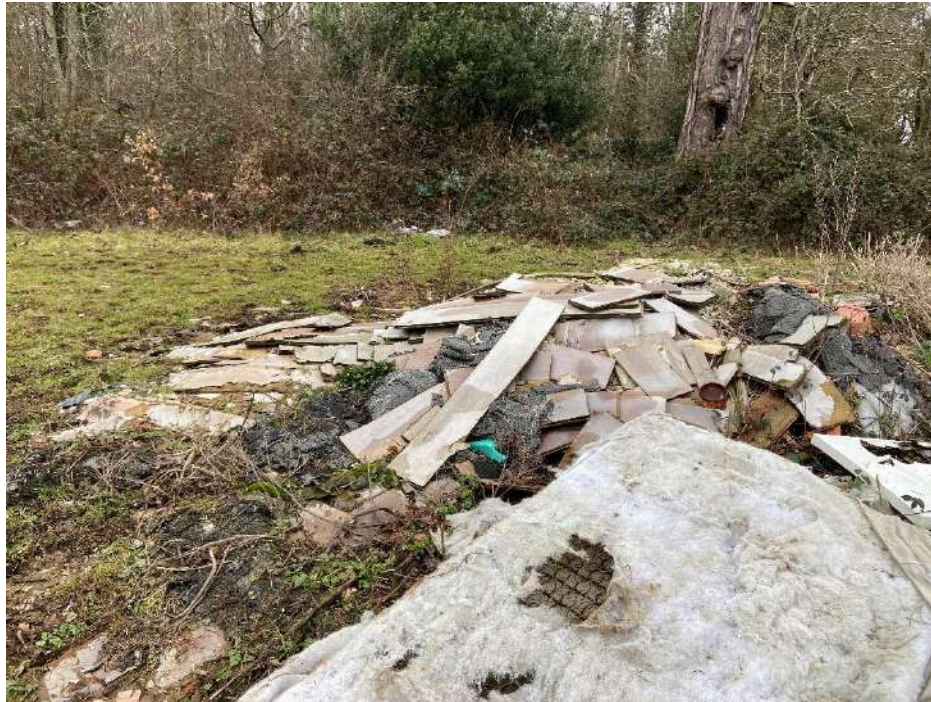
Plate 3: Flytipping in the north of the site.

It should be noted that some fly-tipped waste was present in the northern part of the site, and there may be localised contamination beneath these materials. It is recommended that once they are removed limited further testing is undertaken in the area. Likewise around the small historical tank and structure in the south western part of the site limited further testing is recommended to confirm that the soil is not contaminated.

The fly tipped materials and potential burning of waste on the northern part of the site may have led to localised heavy metal, PAH, petroleum hydrocarbon and asbestos contamination.

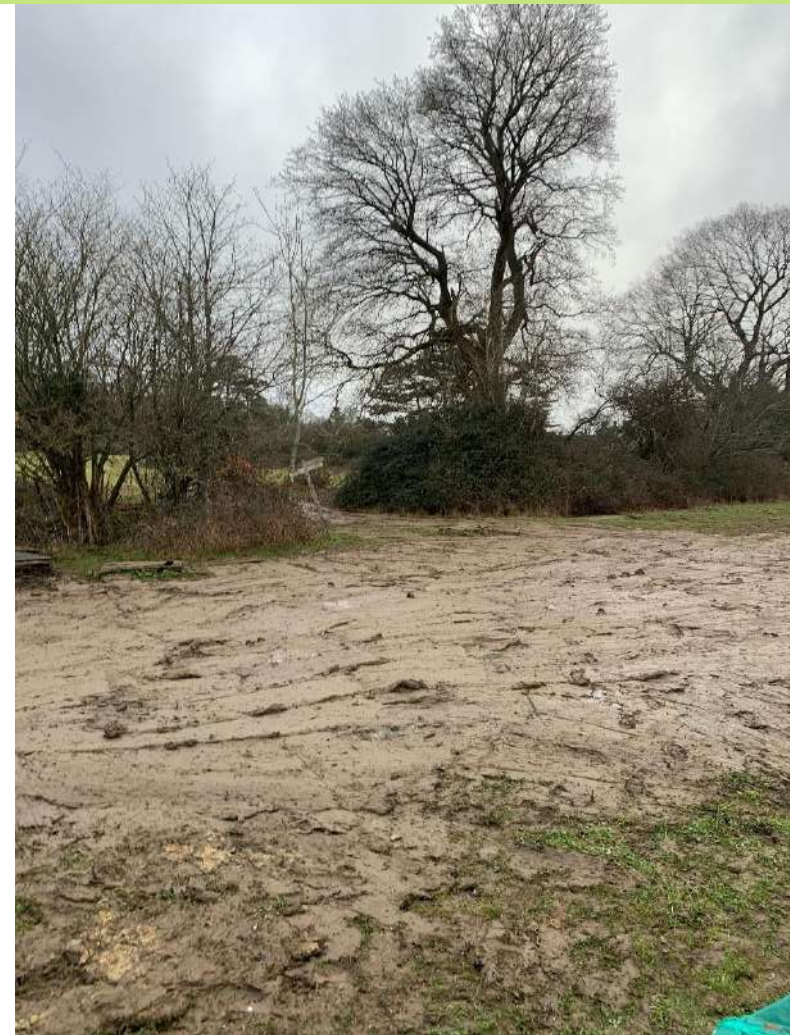
Plate 4: At the entrance of the site.

Access for plant onto and across the site was hampered by the presence of soft ground conditions near the only entrance on the western boundary. Despite the use of track mats, 4x4 water tanker and use of a JCB for towing, the water tanker for the BRE365 tests could not get safely on to site. Because of this the BRE 365 soakage tests were not undertaken, in any pit other than TP9 where 70m+ of hosing was used and water was pumped from the tanker near the entrance. Whilst testing was not able to be carried out in the remaining pits, they were constructed and backfilled with gravel ready for testing at a later date when safe access for plant is more viable.

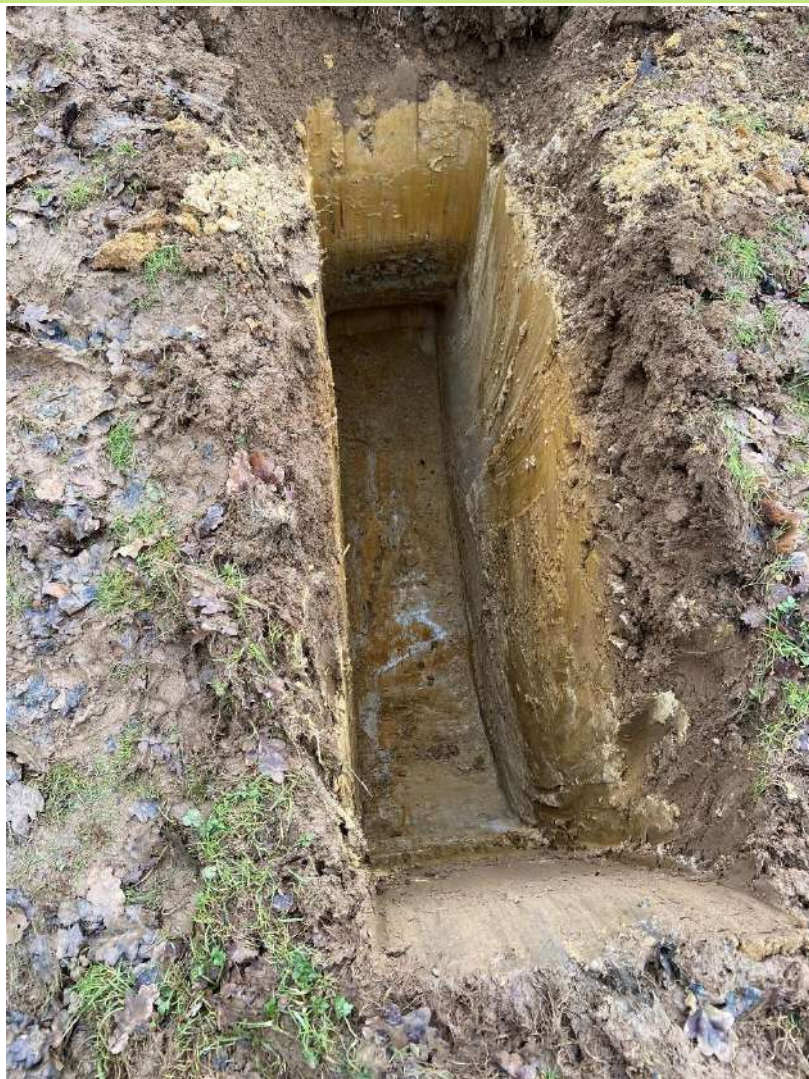
Plate 5: TP1 excavation.

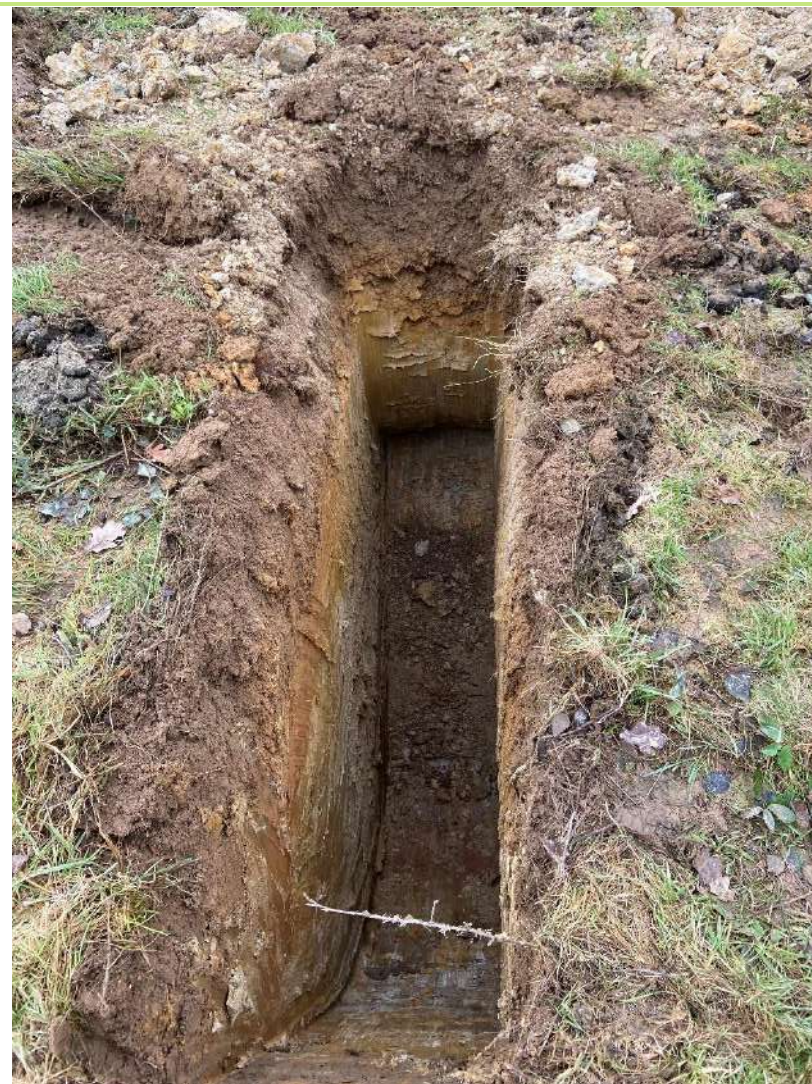
Plate 6: TP3 excavation.

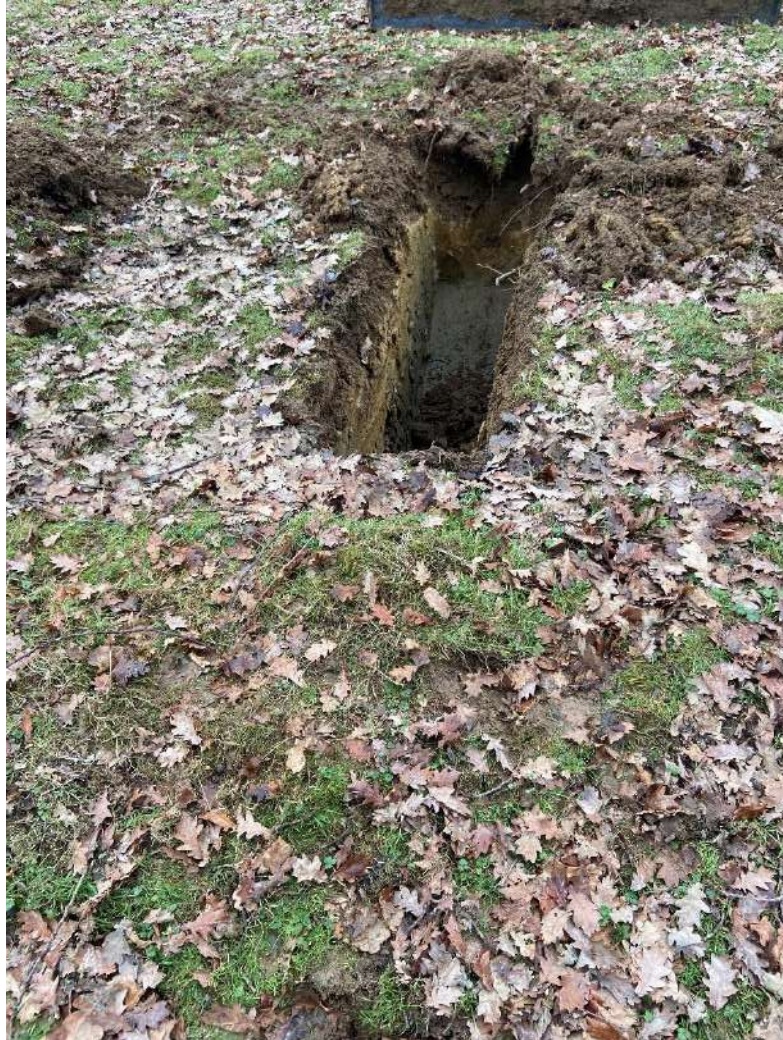
Plate 7: TP5 excavation.

It is noted that shear faces were recorded within the clay TP5 and TP6 located on the eastern half of the site at depths of between 1.2m and 1.6m.

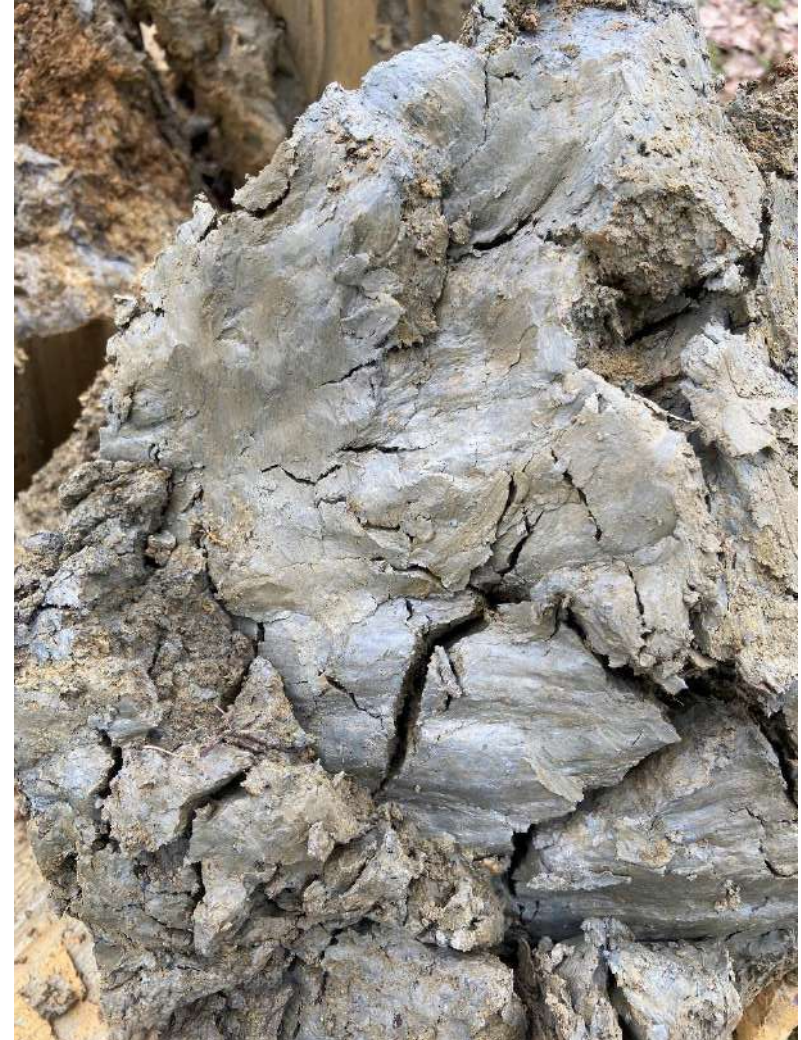
Plate 8: TP5 arisings

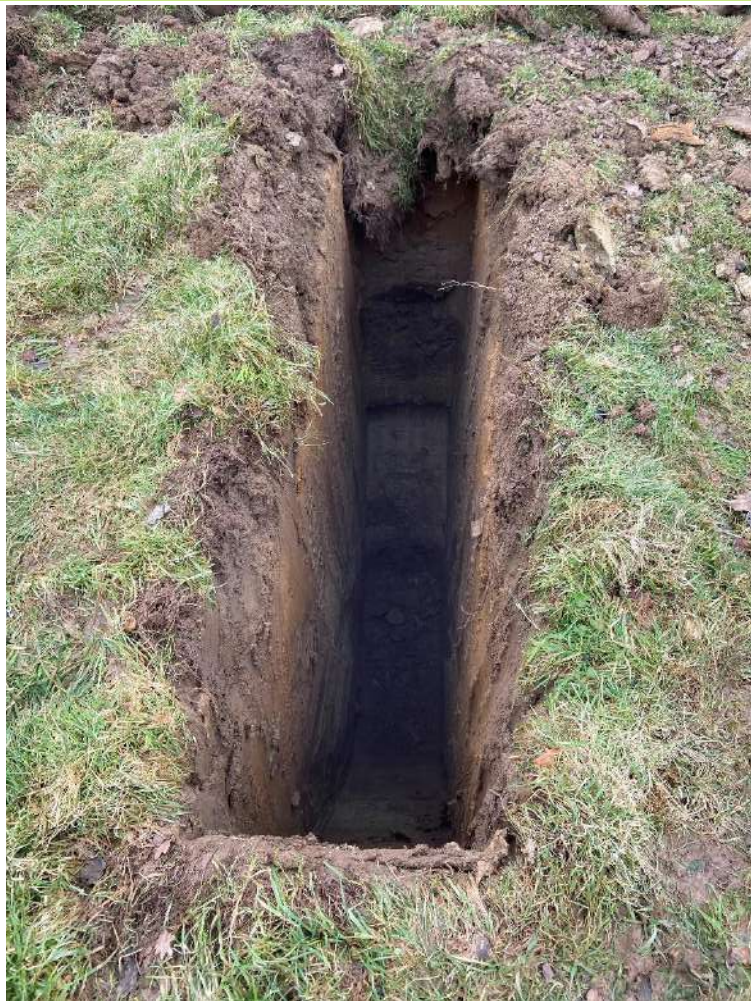
Plate 9: TP6 excavation.

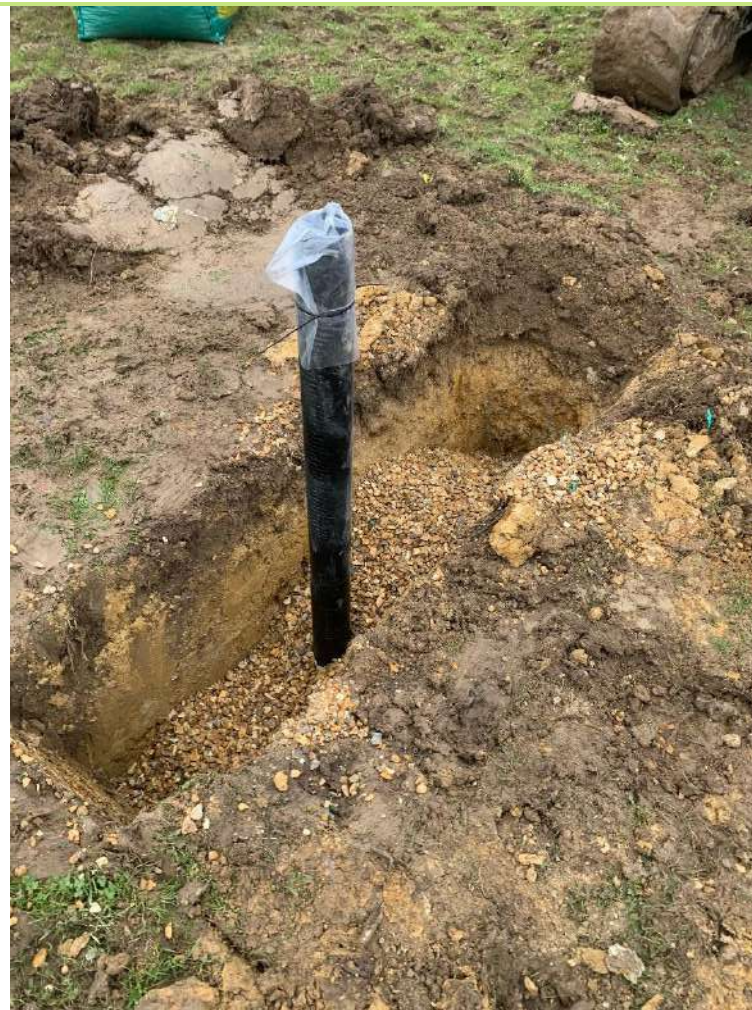
Plate 10: TP7 installation.

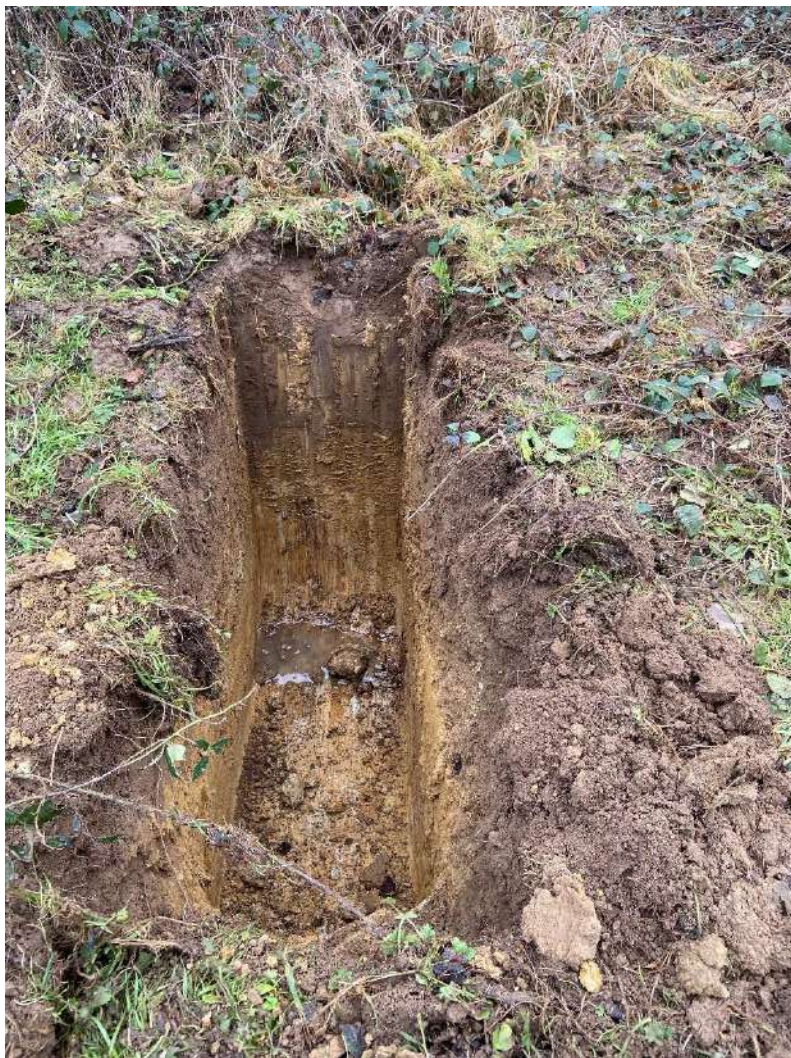
Plate 11: TP9 excavation.

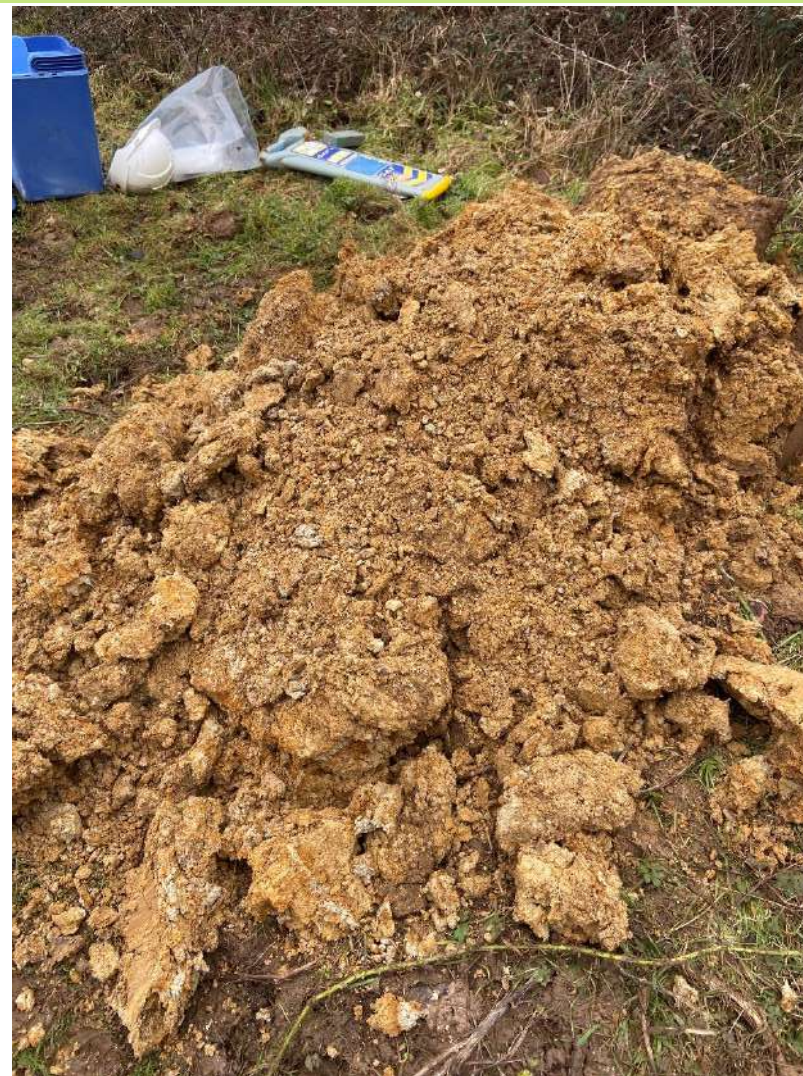
Plate 12: TP9 arisings.

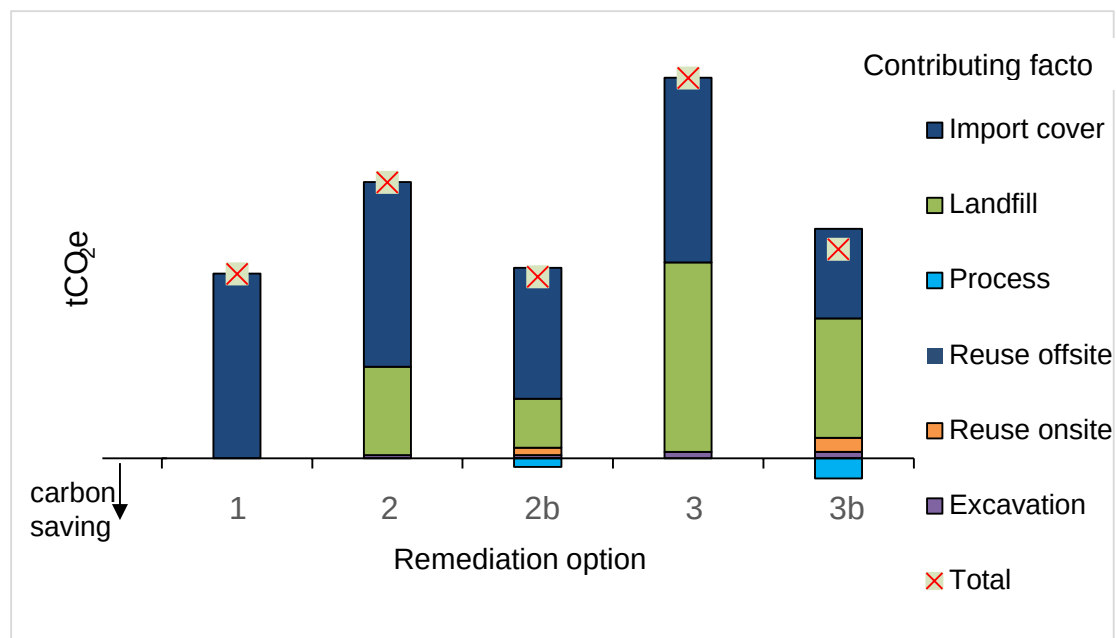
The relative carbon footprint of the remediation options 1-3a is shown below. Reusing material onsite or processing leads to considerable savings in the carbon footprint of the remediation options as shown in options 2b and 3b. Maximum savings are made by focusing on preventing material with a high carbon footprint being sent to landfill. Carbon savings are made if the material is processed leading to a net reduction in carbon emitted.
