**Batchelors Farm,
Keymer Road,
Burgess Hill,
West Sussex
RH15 0BQ**

Phase 2 Geo-Environmental Investigation

On Behalf of SDP Developers

Document Reference: 12531

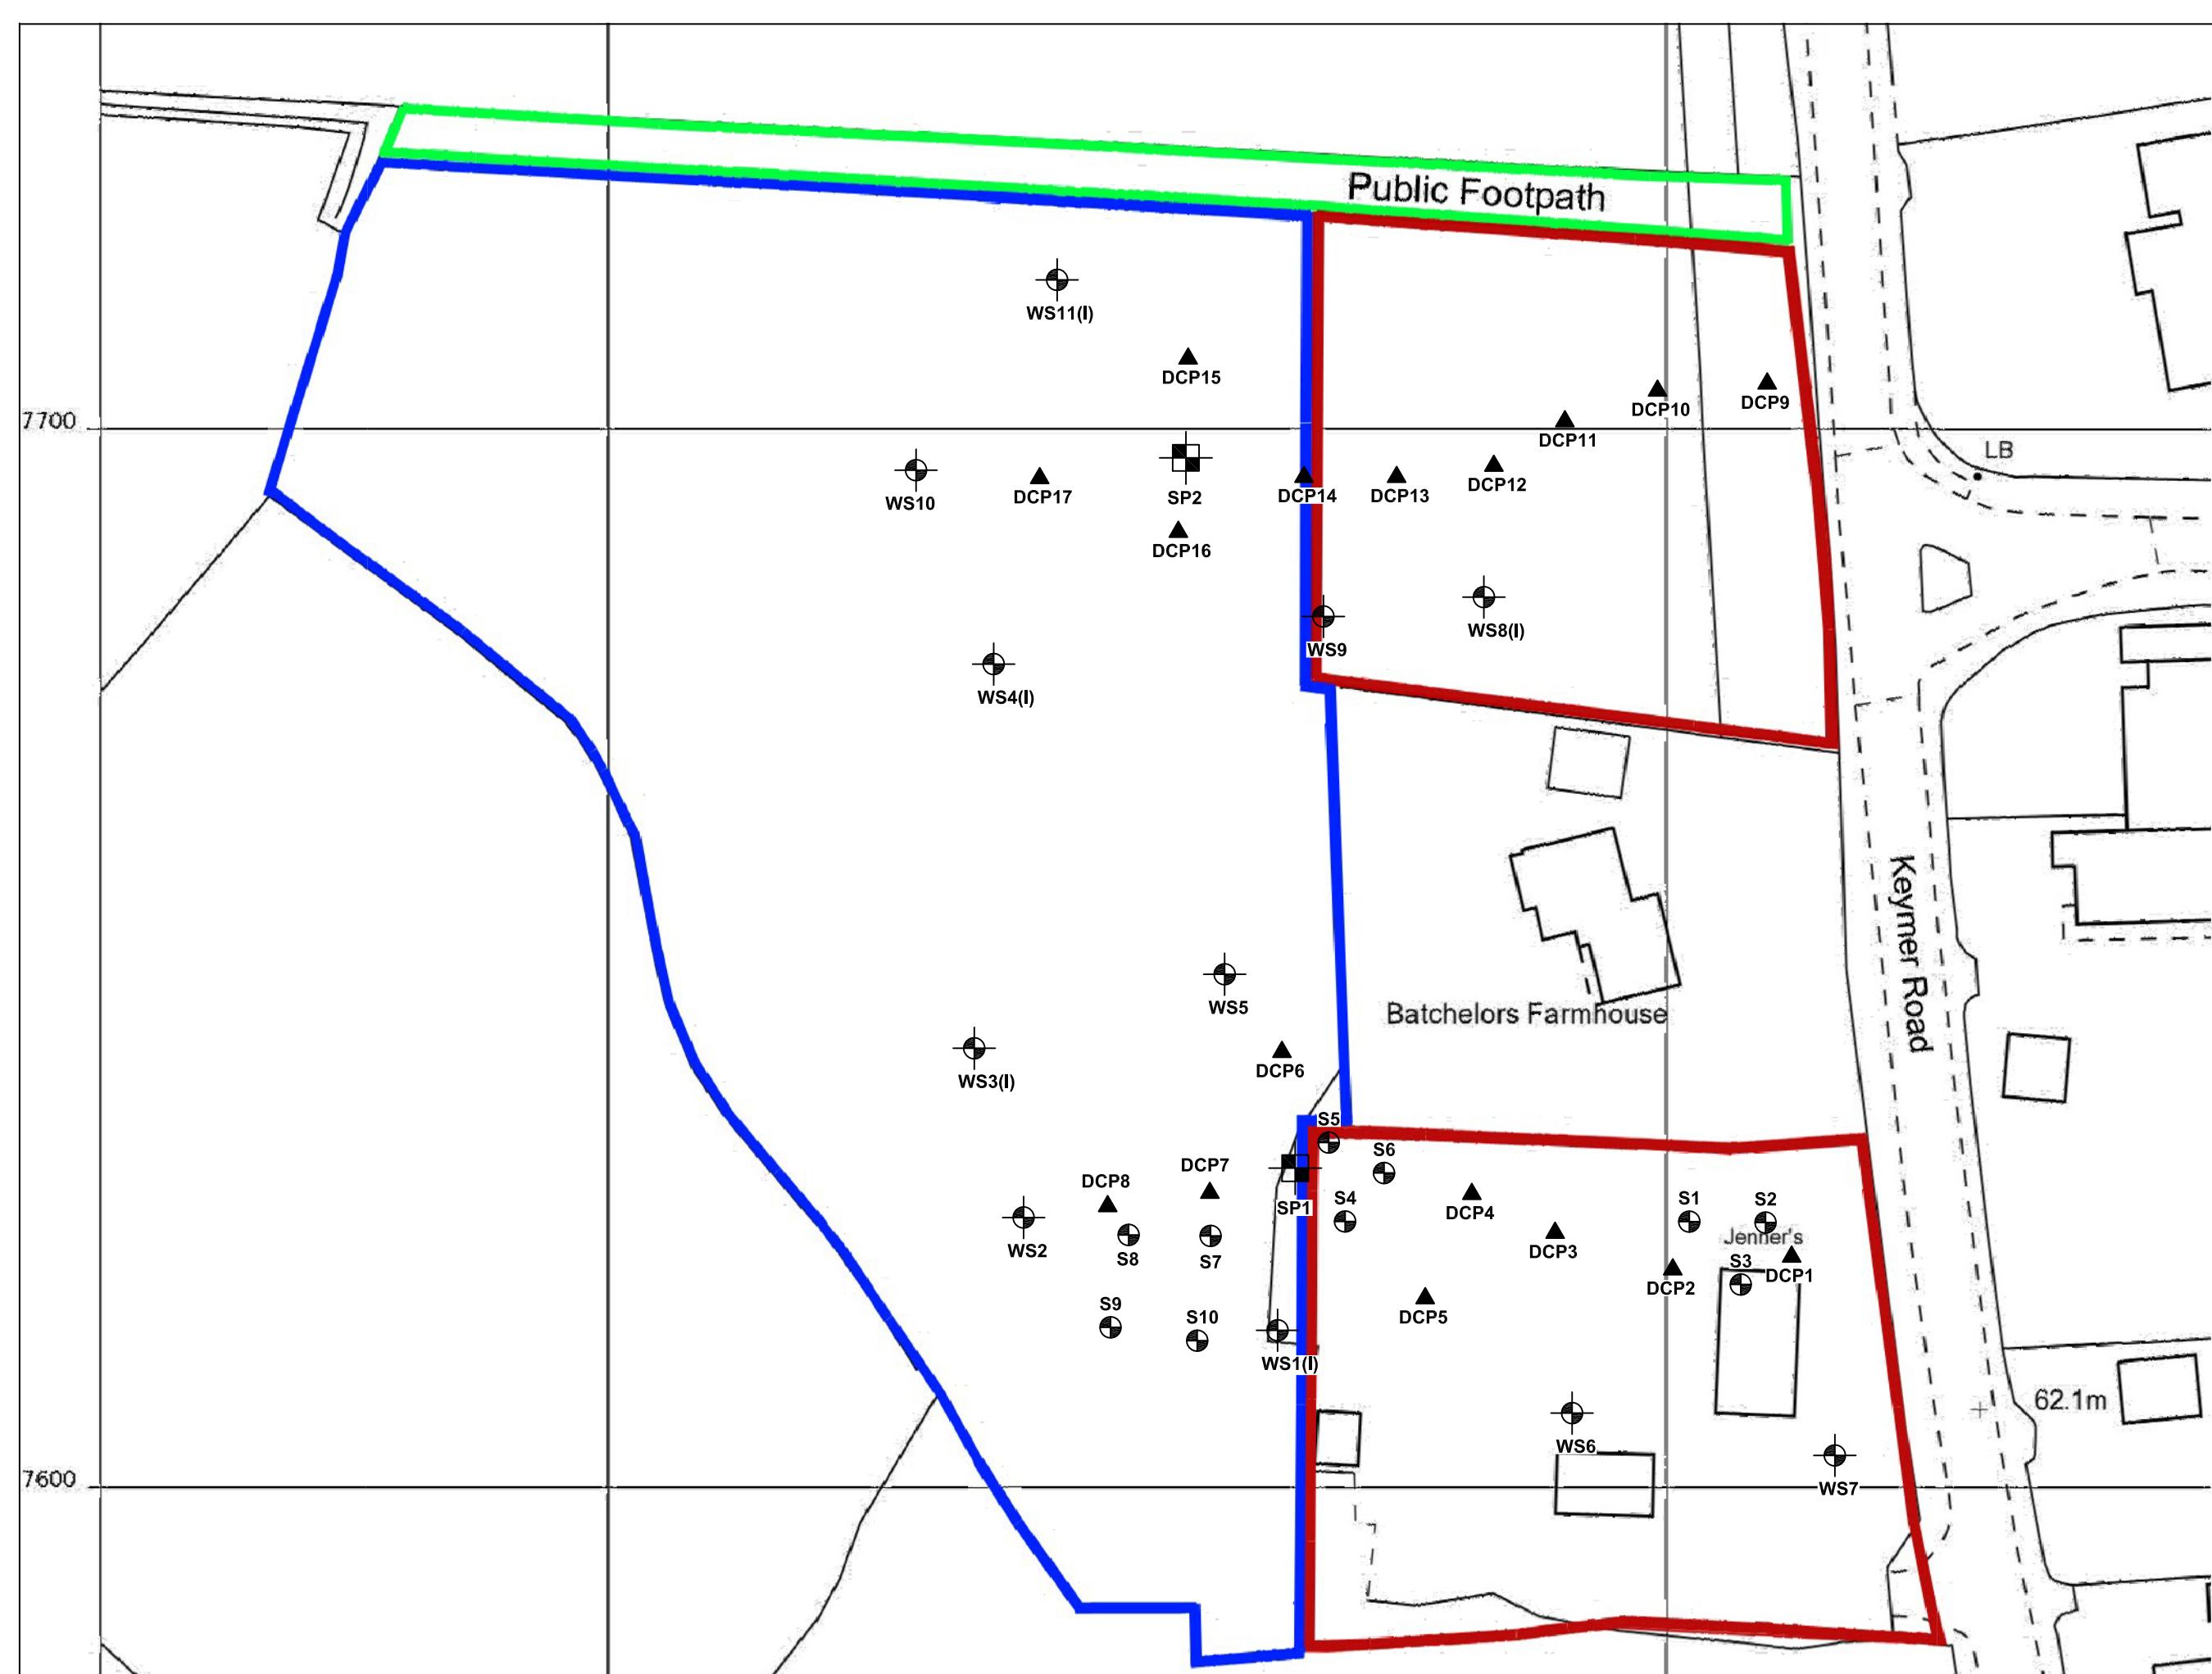
WS - Window Sample
 BH - Borehole
 TP - Trial Pit
 HDTP - Hand Dug Trial Pit
 DCP - Dynamic Cone Penetration Test
 HA - Hand Auger

DP - Dynamic Probe
 GM - Gas Monitoring Standpipe
 SP - Soakage Pit
 PT - Percolation Test
 S - Sample Location

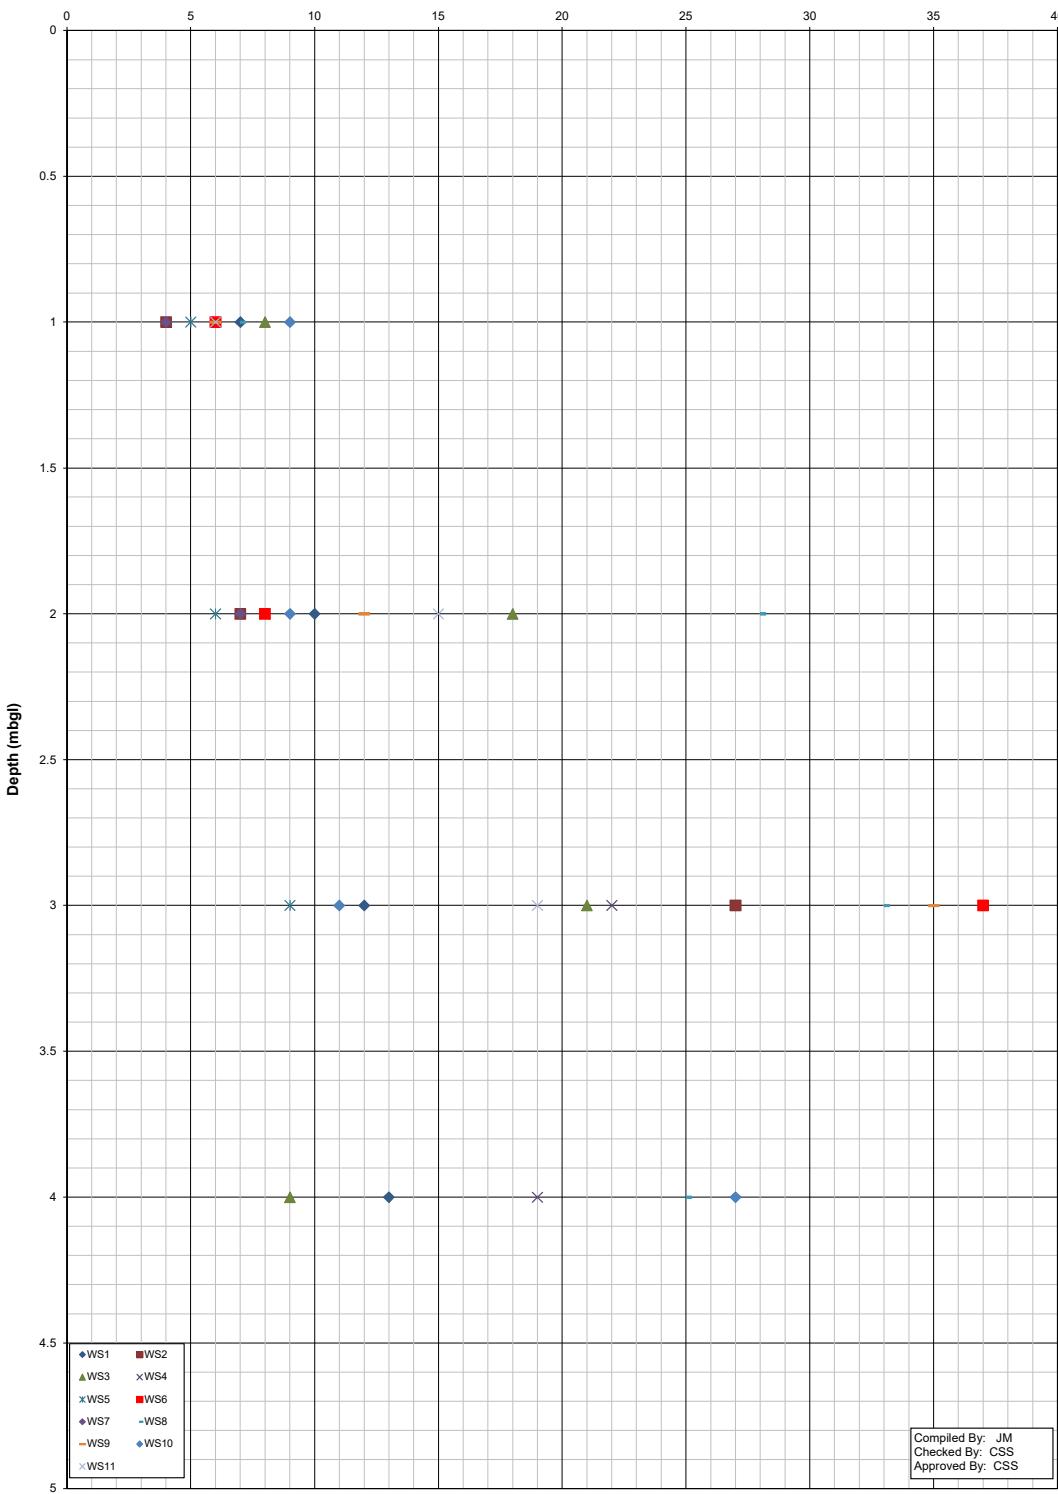
Figure 2: Batchelors Farm, Keymer Road, Burgess Hill RH15 0QB
SPT N-Depth Profile

SPT 'N' value

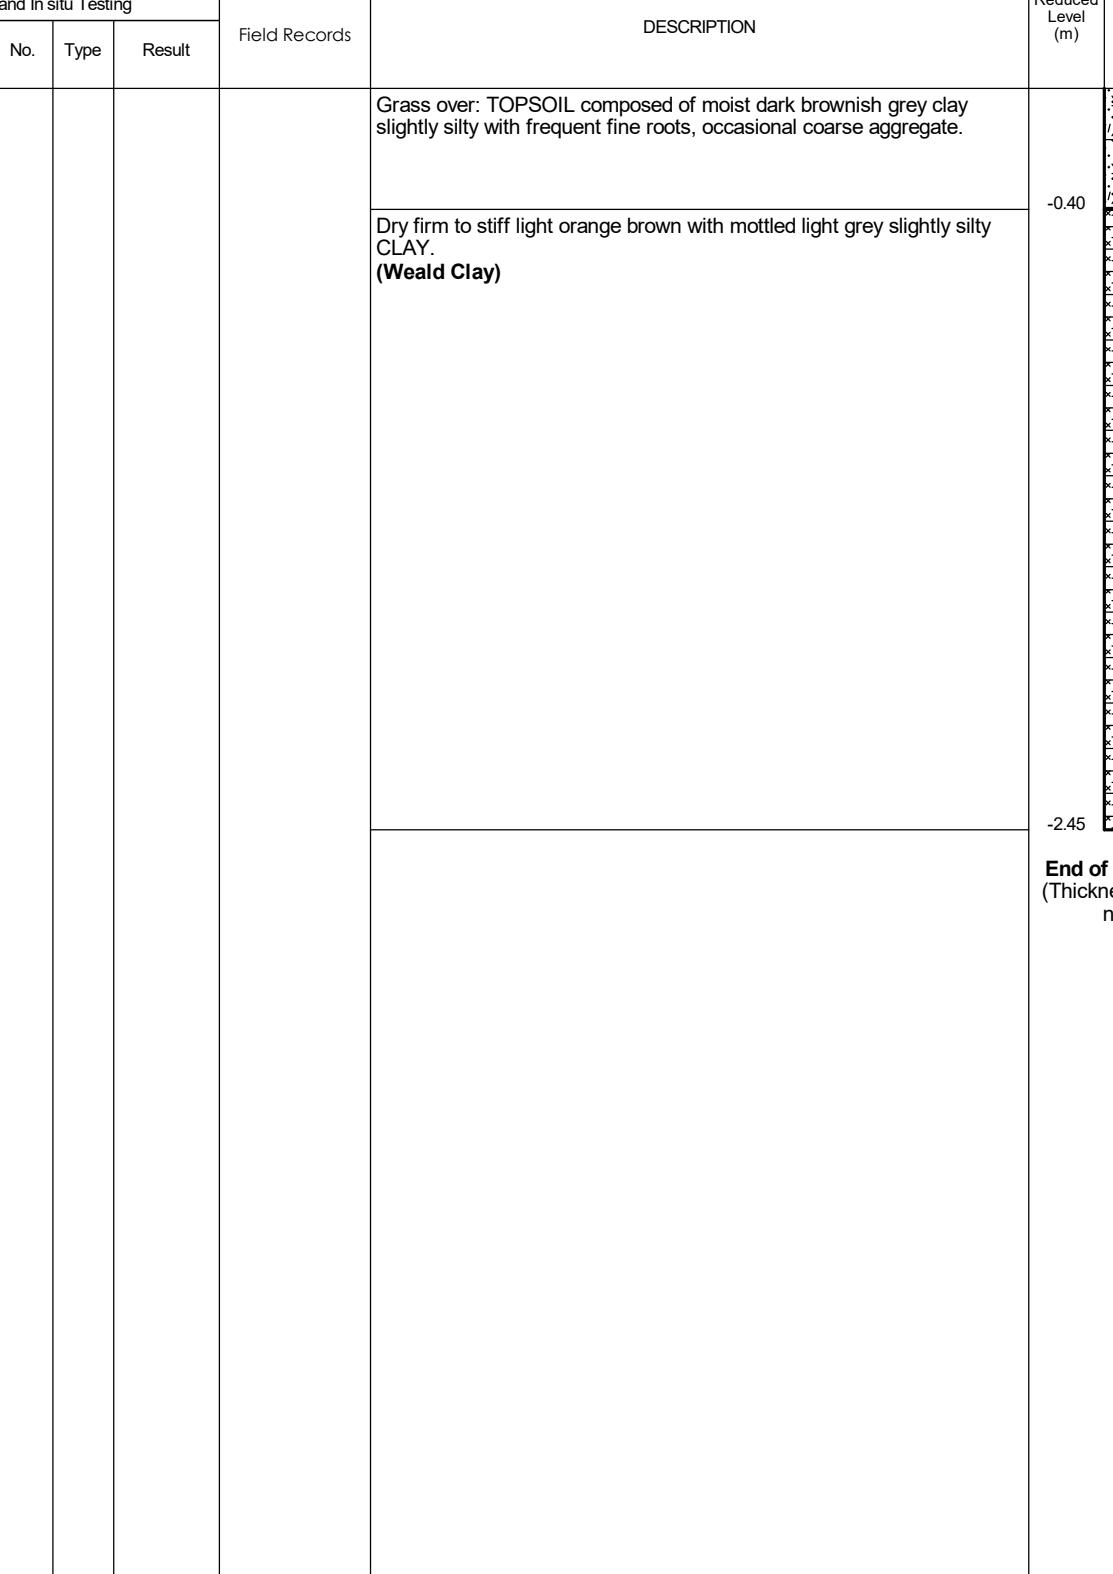
Equipment & Methods: JCB 3CX Support Used:None Backfill: Arisings				Project Name: Batchelors Farm Project Location: Keymer Road, Burgess Hill Client: SDP Developers	Job No: 12531		
Co-ordinates: E: N:			Ground Level (m):		Date Started:04/12/2020 Date Completed:04/12/2020		
Samples and In situ Testing			DESCRIPTION		Reduced Level (m)		
Depth (m)	No.	Type	Result	Field Records	Legend		
				Grass over: TOPSOIL composed of moist dark brownish grey clay slightly silty with frequent fine roots, occasional coarse aggregate.	(0.40)		
				Dry firm to stiff light orange brown with mottled light grey slightly silty CLAY. (Weald Clay)	0.40		
					(2.05)		
					-2.45		
					2.45

<p>End of Trial Pit 2.45 m (Thickness of basal layer not proven)</p>							
<p>Remarks:</p>							
			Logged By:	Checked By:			
			JM	CSS			
			Scale:	Approved By:			
<p>FIG No.</p>							
<p>3</p>

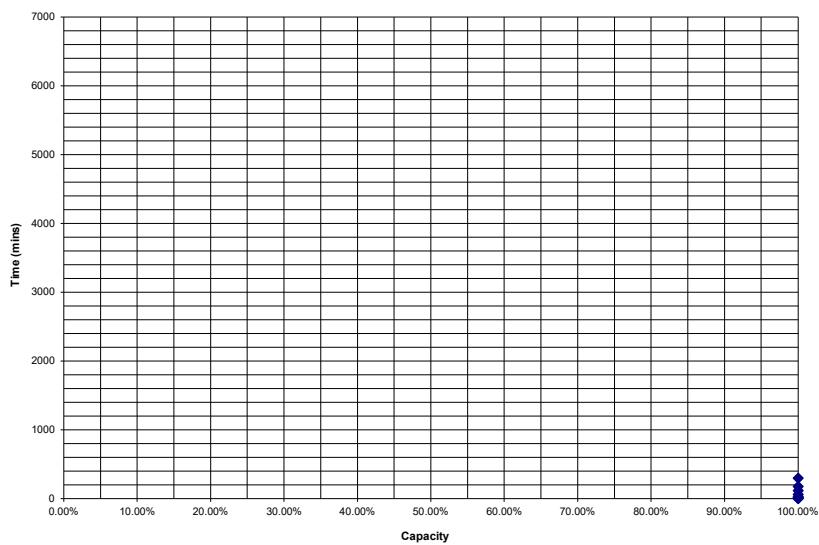
SOAKAGE RESULTS

Depth	(%)	Time
1	100.00%	0
1	100.00%	5
1	100.00%	10
1	100.00%	20
1	100.00%	30
1	100.00%	60
1	100.00%	120
1	100.00%	180
1	100.00%	300

INFILTRATION RATE

Depth (B.G.L) (m)	Infiltration Rate (m/s)
1.0 - 2.45

DG365 Soakage Testing Infiltration testing was carried out in trial pits SP1 and SP2. The test was carried out in accordance with the methodology given in BRE 365 'Soakaway design' and comprised discharging water into a 2.45mbgl (SP1) and 2.5mbgl (SP2) deep excavations up to approximately 1.0mbgl and monitoring the fall in water level against time. Indicative soil infiltration rates have been calculated based on the results obtained. The results have been presented in Appendix 2 and are discussed in Section 7.4 below.

- Suspended ground floor slabs were recommended.
- For preliminary design purposes it is recommended that a CBR value of 4% should be adopted.
- The use of shallow chamber type soakaways would not be viable due to the negligible infiltration achieved.

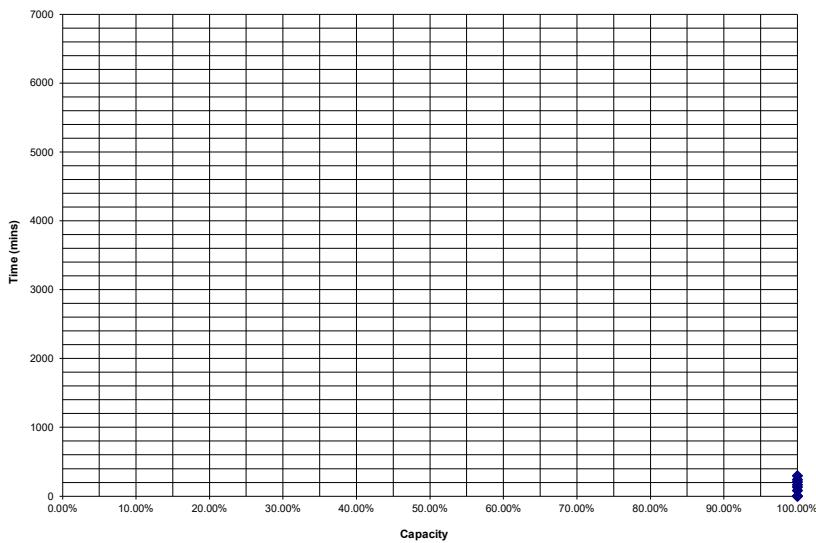
SOAKAGE RESULTS

Depth	(%)	Time
0.9	100.00%	0
0.9	100.00%	4
0.9	100.00%	84
0.9	100.00%	133
0.9	100.00%	170
0.9	100.00%	208
0.9	100.00%	240
0.9	100.00%	300

INFILTRATION RATE

Depth (B.G.L) (m)	Infiltration Rate (m/s)
0.9 - 2.5

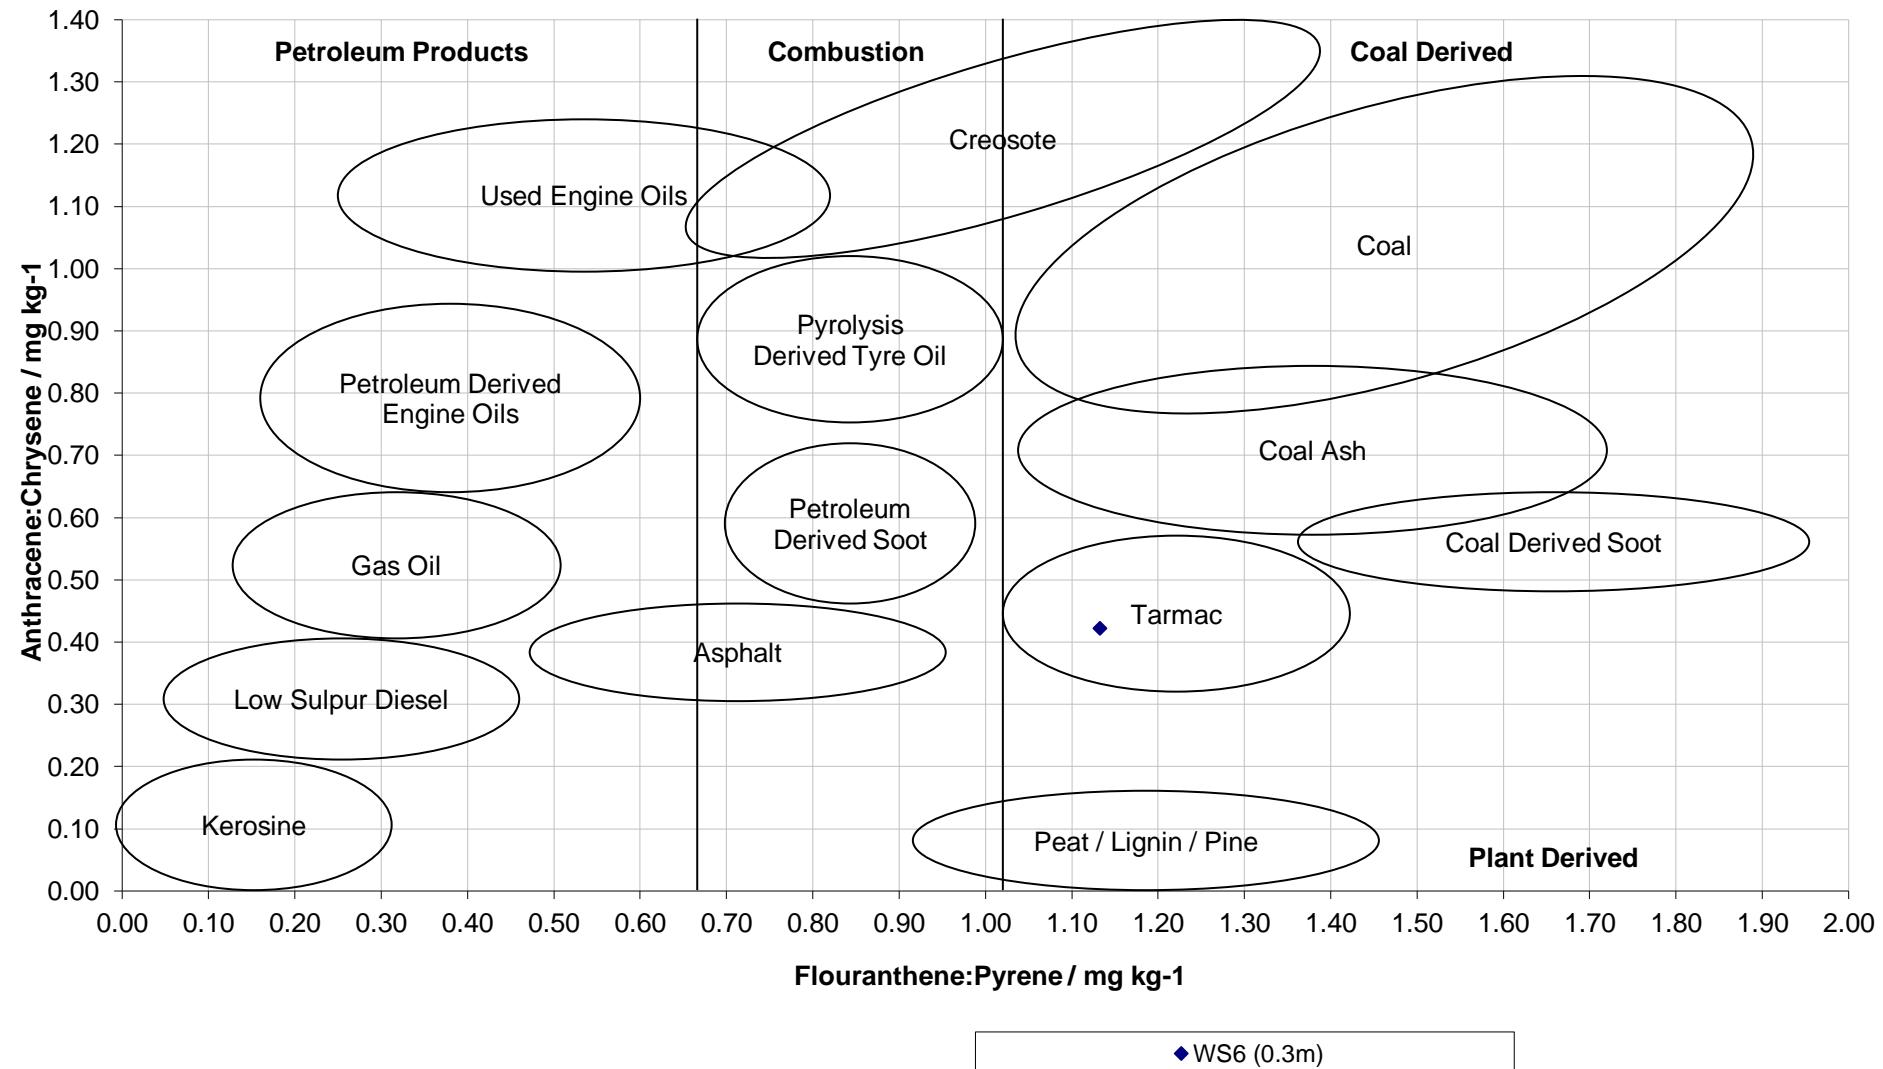
APPENDIX 8
PAH SOURCE RATIO INDICATOR

Potential Sources of PAH Contamination Based on PAH Ratios

Concentrations of PAH were generally low and were found to be below the analytical detection limit of 1.6 mg/kg and therefore the inert waste acceptance criteria of 100 mg/kg as detailed in the EC Landfill Directive 1999/31/EC as applied under the Environmental Permitting (England and Wales) (Amendment) (EU Exit) Regulations 2019 (SI 2019/39) and as defined by the council decision establishing criteria and procedures for the acceptance of waste at landfills pursuant to Article 16 of and Annex II to Directive 1999/31/EC(2003/33/EC), in all of the samples tested, with the exception of the sample retrieved from WS6 (0.3m) which contained a Total PAH concentration of 115 mg/kg.
