**Park Centre, 60 Park Road,  
Burgess Hill, West Sussex RH15 8ET**

**Archaeological Desk-Based Assessment**

**Project No. 240596  
Report No. 2024246**

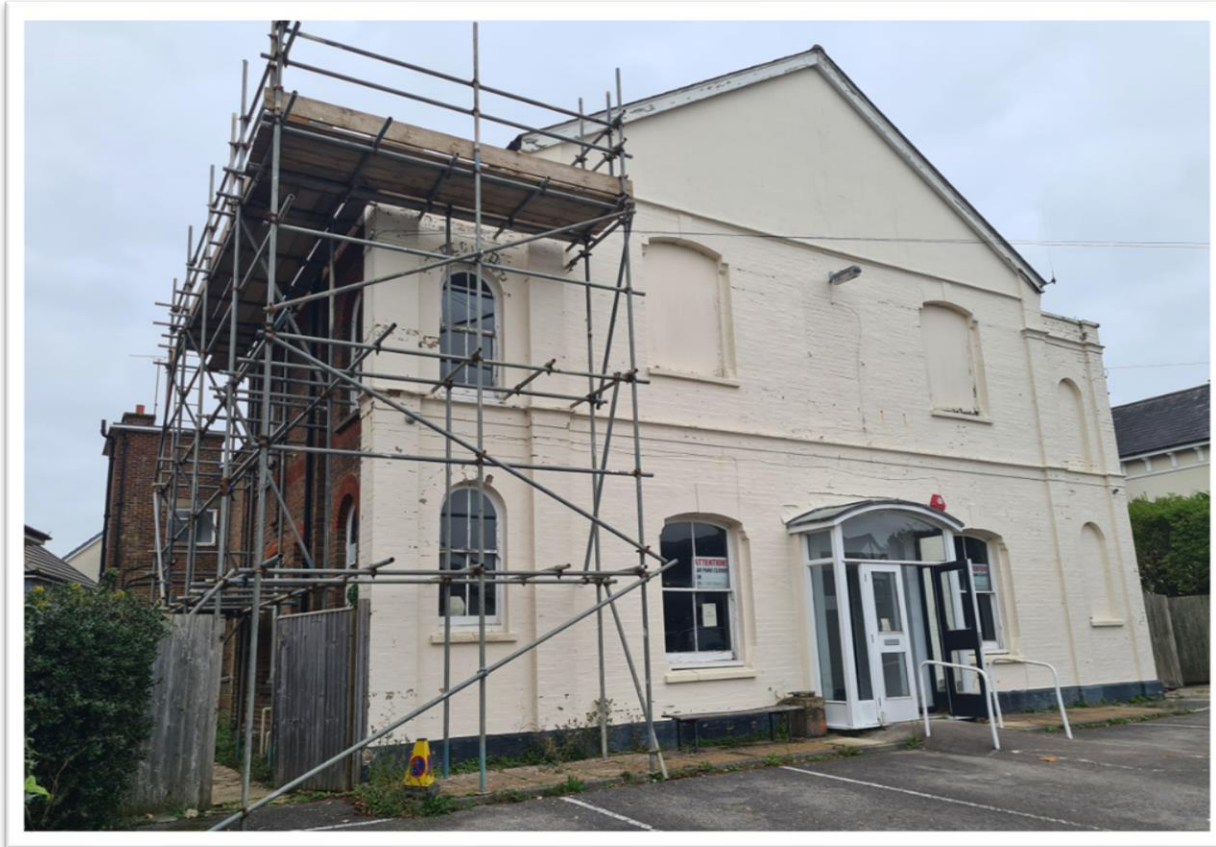
Plate 7.1: View of front of building (Park Centre) from the south-west of the car park (looking north-east)

- 7.3 The building, which was constructed c.1870, stands in a central position on the plot with access through wooden gates to either side (Plate 7.1). There is no external access to the rear garden, which has to be accessed via the building. Various extensions and alterations to the building appear to have taken place since its construction with a more modern two-storey extension to the rear.

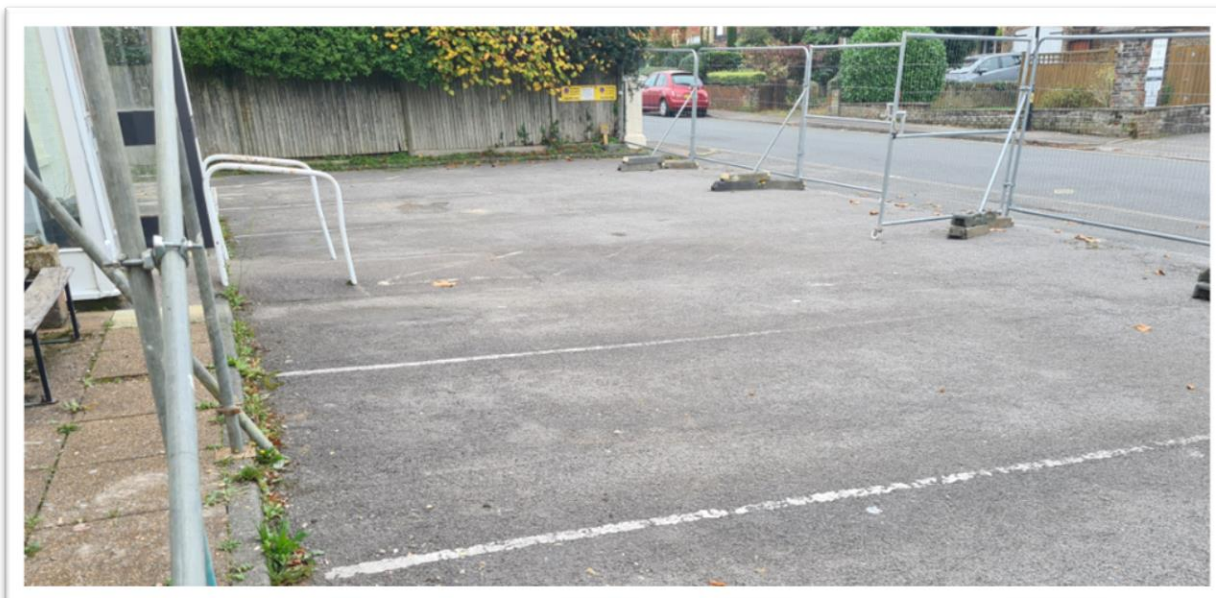
Plate 7.2: View across car park area to the front (south) of the building (looking south-east)

- 7.2 The Site is accessed from Park Road with hard landscaping providing a Tarmac covered car parking area in front of and to the south of the building. This area is generally flat and level with the pavement which runs along the southern boundary (Plates 7.2-4). A couple of manholes were observed within this area which suggests some below drainage exists here (Plates 7.3-4). A small ramp leads to the main central doorway.

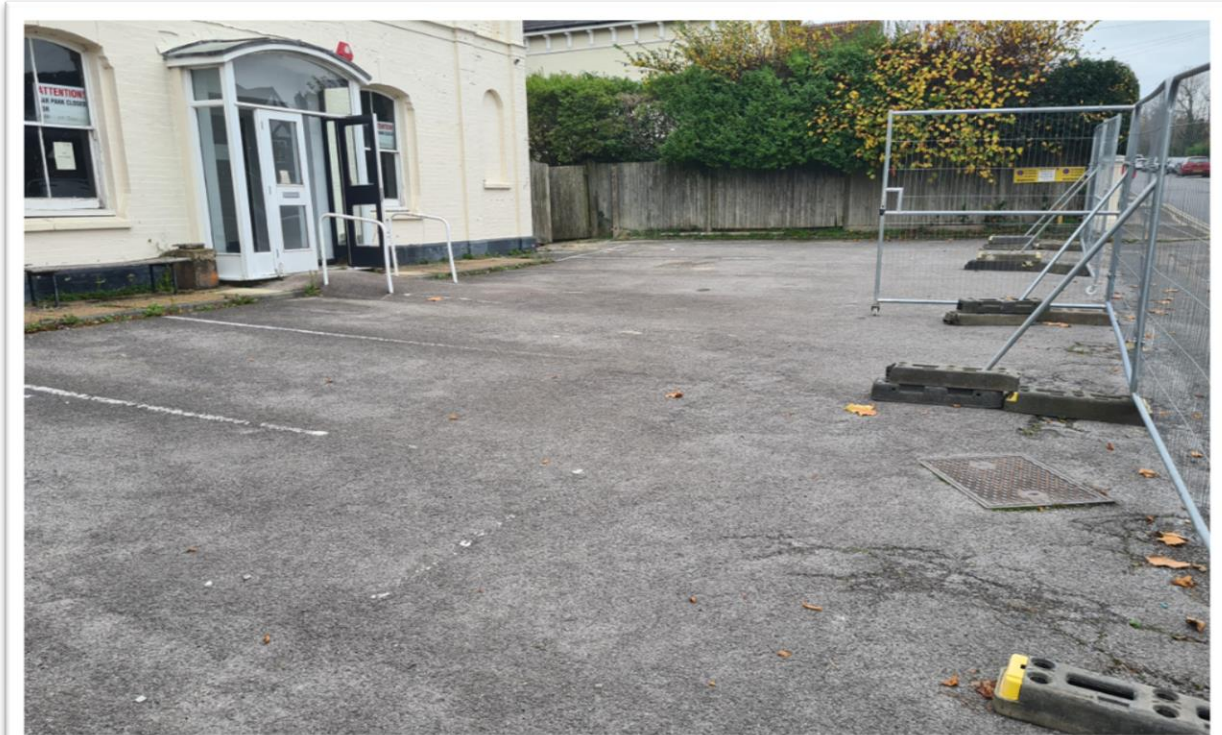
Plate 7.3: View across car park area to the front (south) of the building (looking north-east) – note the manhole indicating existing below ground services in this area

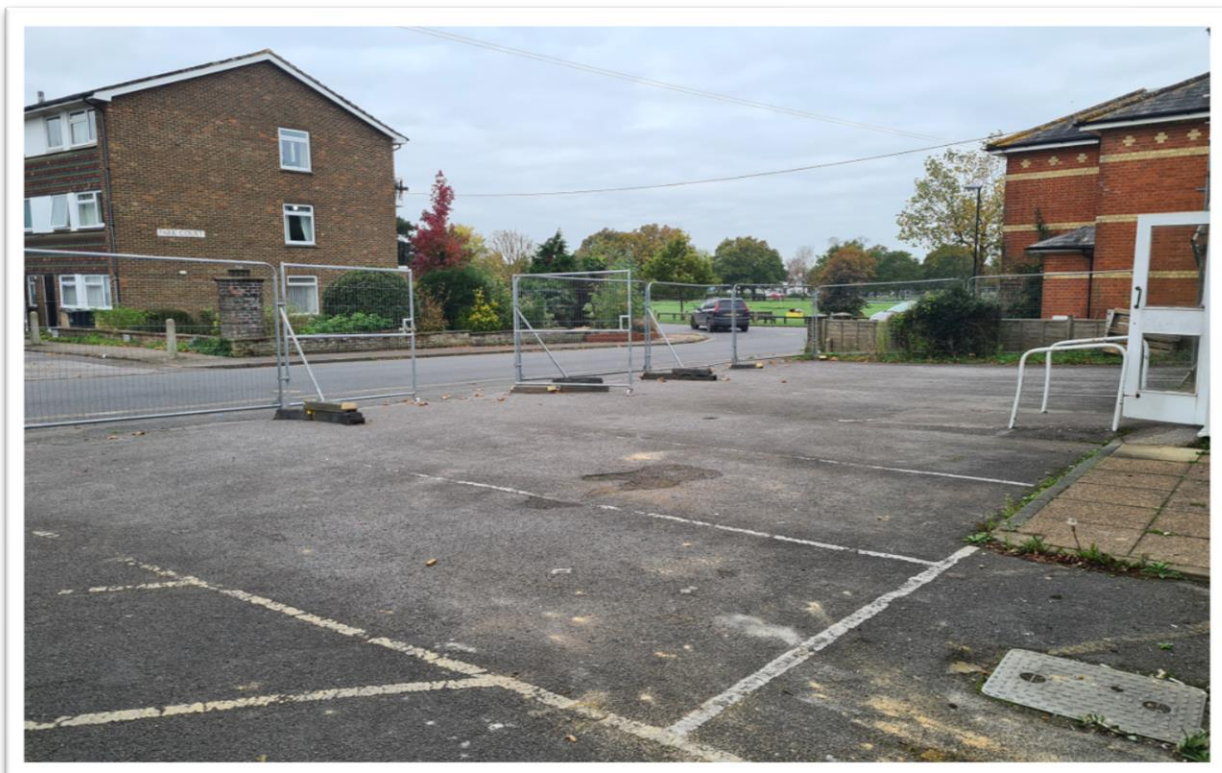
Plate 7.4: View across car park area to the front (south) of the building (looking south-west) towards the path – note the manhole indicating existing below ground services in this area

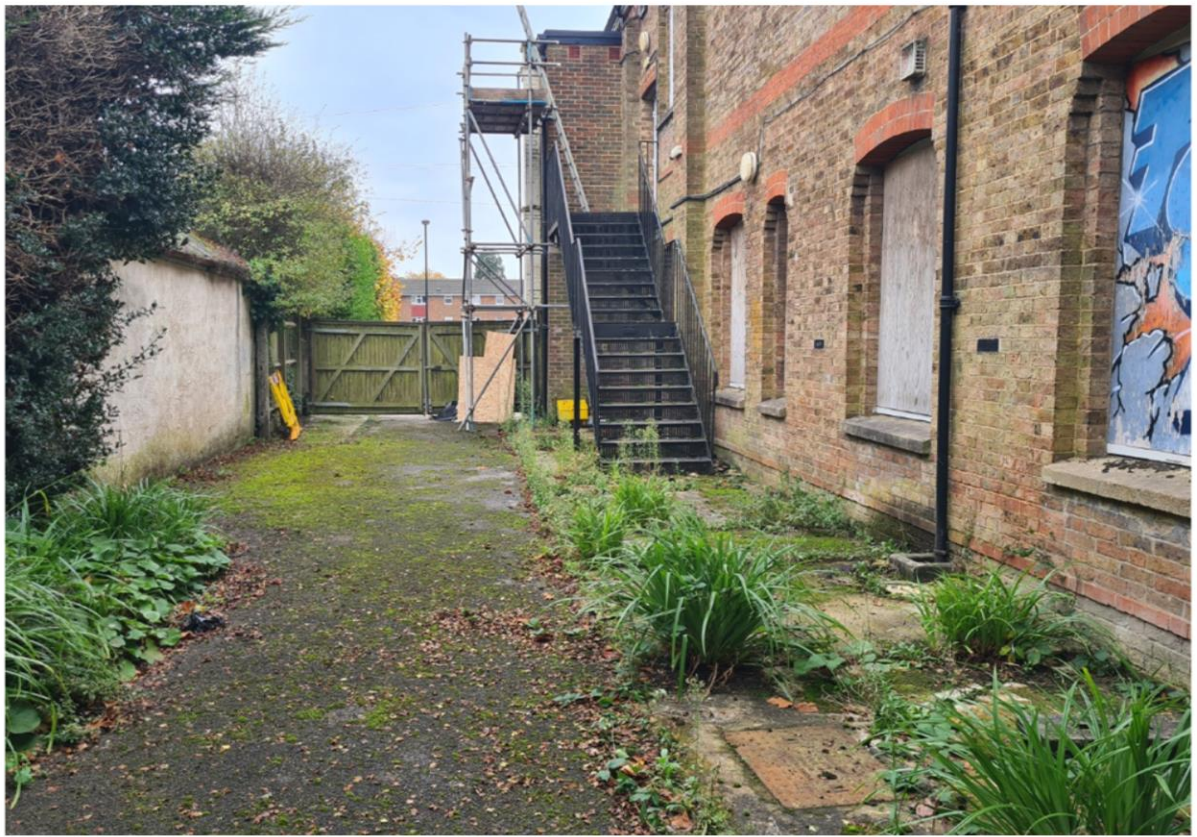
Plate 7.5: View of eastern side of the building where an extension is proposed (looking south)

- 7.4 To the east of the building, the area is laid to Tarmac and concrete with a metal fire-escape staircase emerging from the upper storey (Plates 7.5-7). There is a side doorway with a ramp leading up to it. The eastern boundary is demarcated by the side of a modern building (garage?) from the neighbouring property and some tall bushes. To the west of the building is a concrete path and a low timber fence-line with modern residences (constructed 2009-2012) immediately to the west (Plates 7.8-11). An alignment of manholes was observed on either side of the building where works are proposed (Plates 7.7 and 7.10-11). This would suggest the presence of existing below ground services in this area, as well as the likelihood of considerable past impact on any earlier remains.

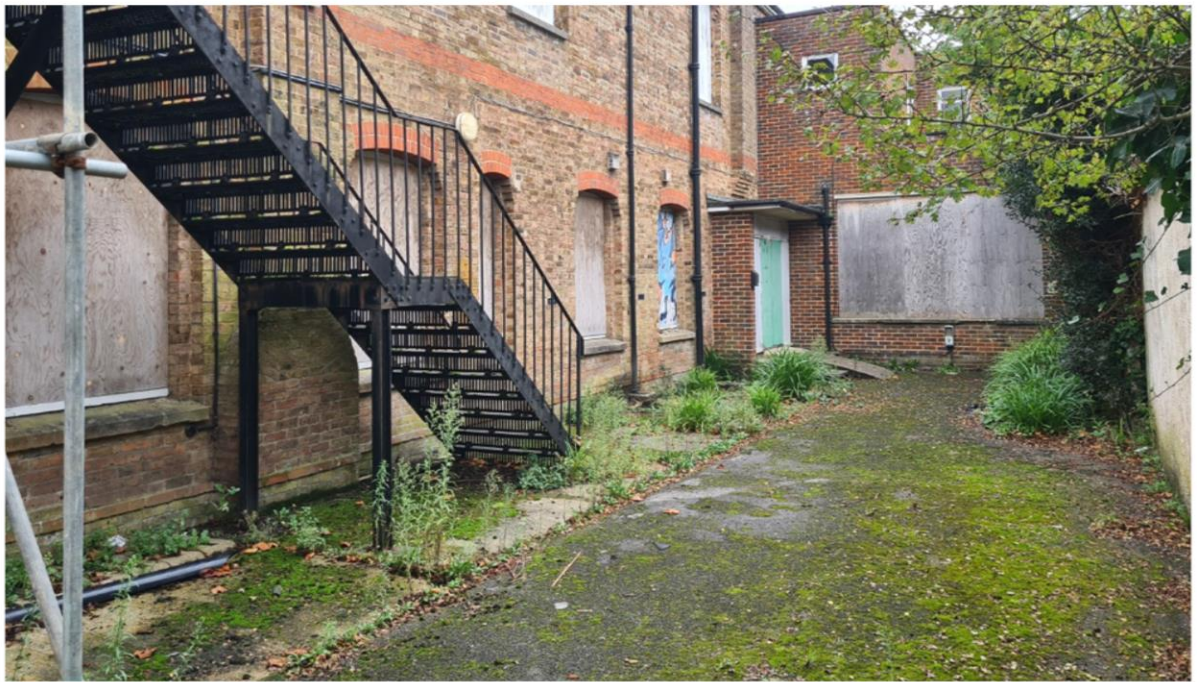
Plate 7.6: View of eastern side of the building where an extension is proposed (looking north)

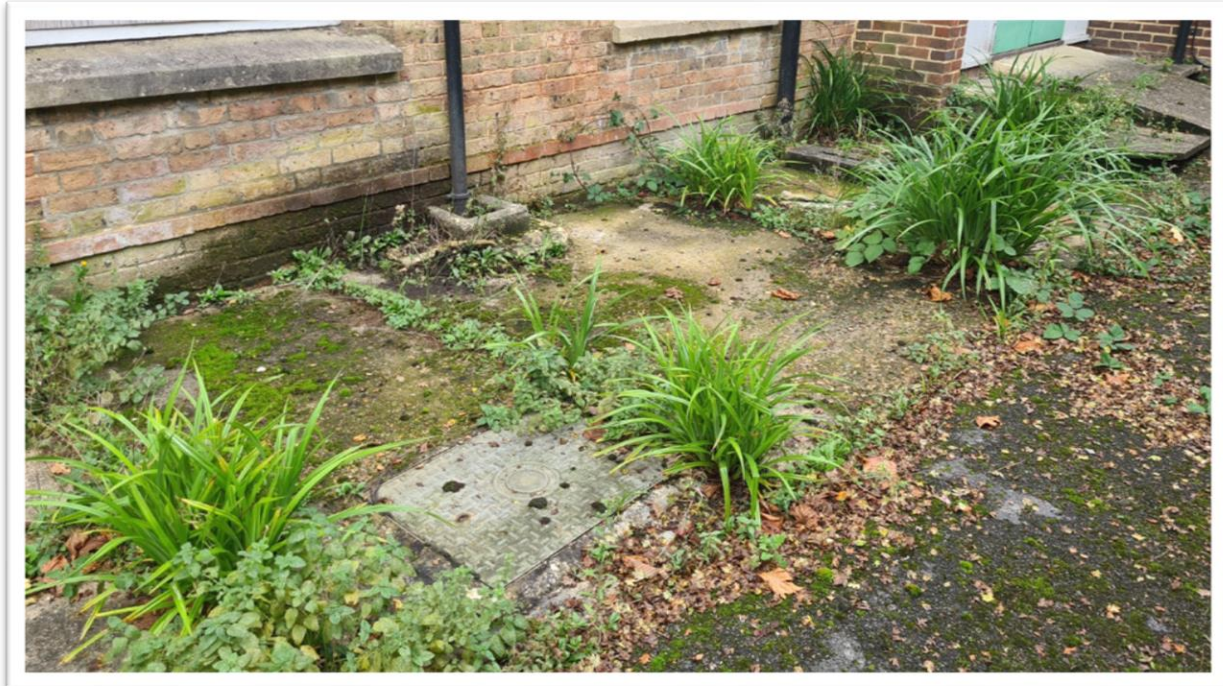
Plate 7.7: View of hardstanding areas and existing services in to the eastern side of the building where an extension is proposed

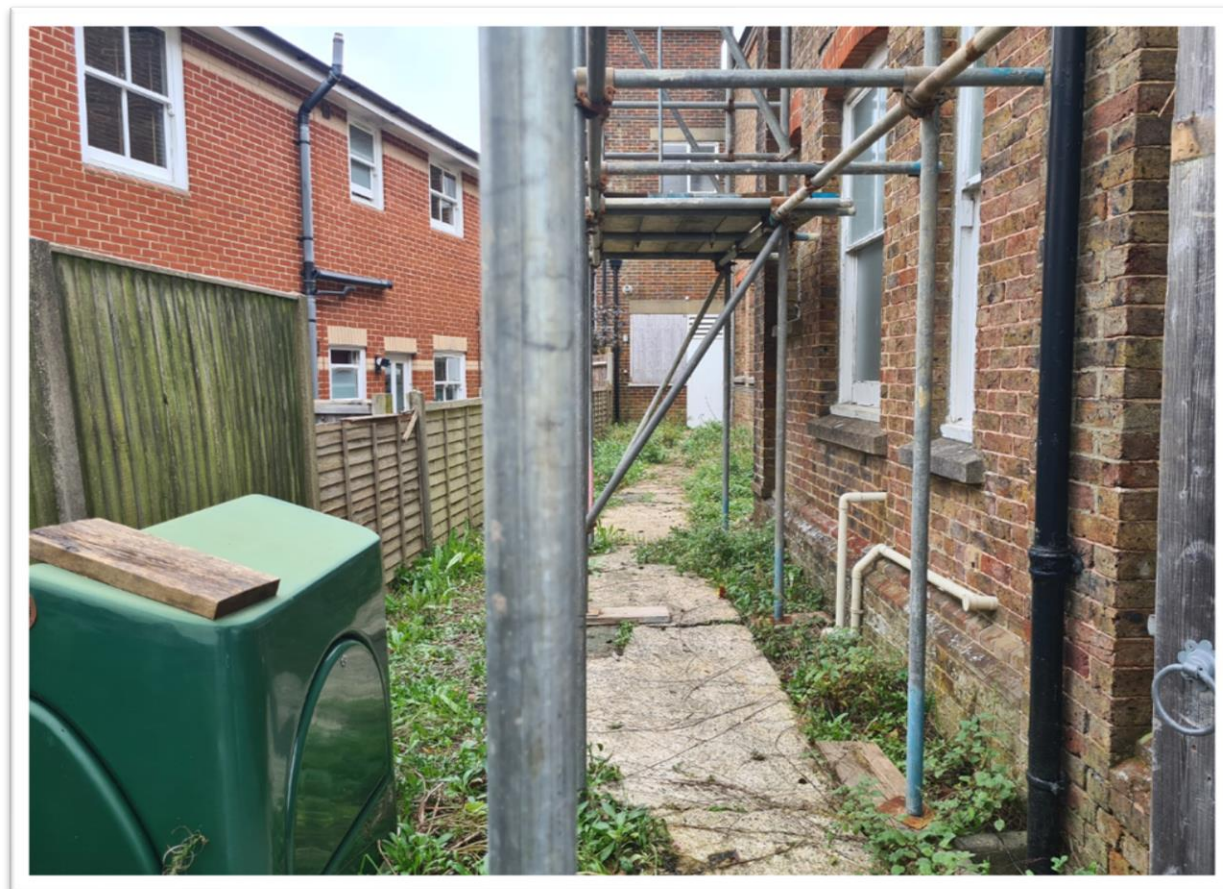
Plate 7.8: View of concrete path and area to the western side of the building where localised pad foundation and landscaping (paving) works are proposed (looking north)

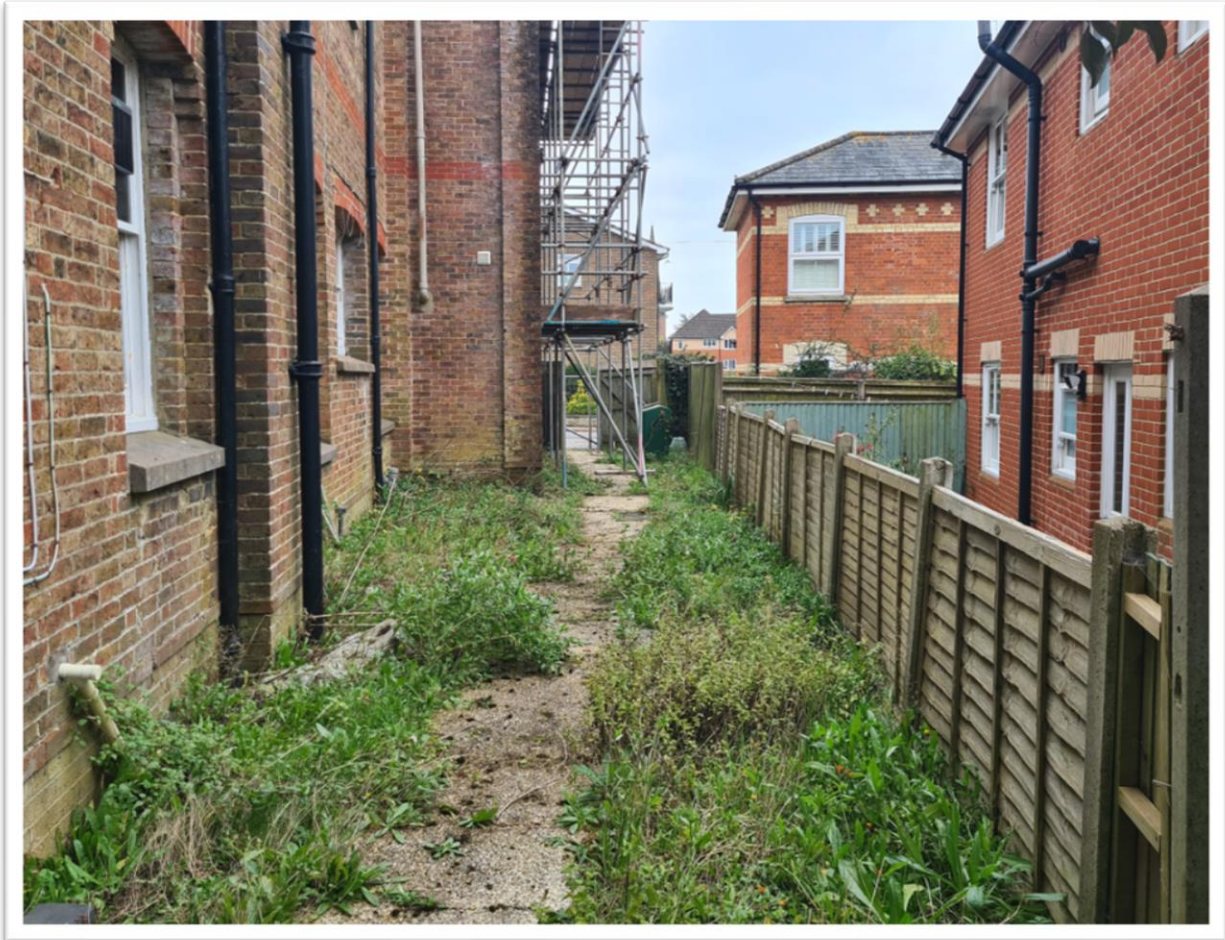
Plate 7.9: View of concrete path and area to the western side of the building where localised pad foundation and landscaping (paving) works are proposed (looking south)

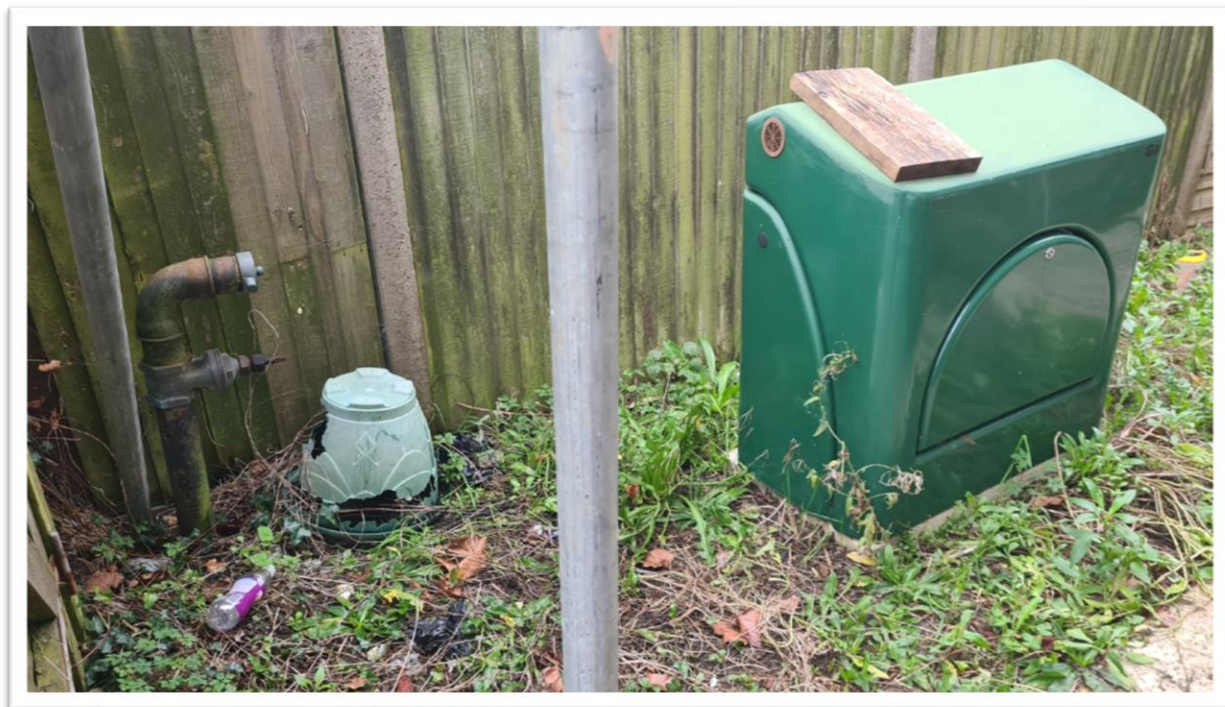
Plate 7.10: View of existing services to the west of the building

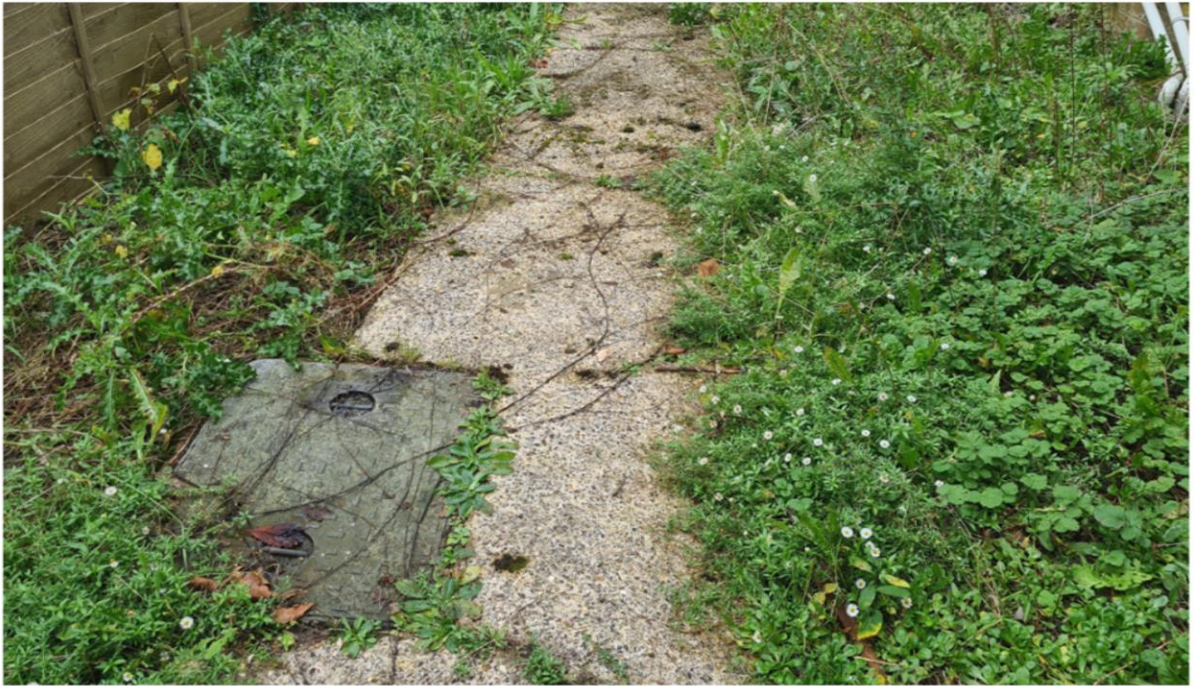
Plate 7.11: View of concrete path and existing below ground services to the western side of the building where localised pad foundation and landscaping (paving) works are proposed (looking north)

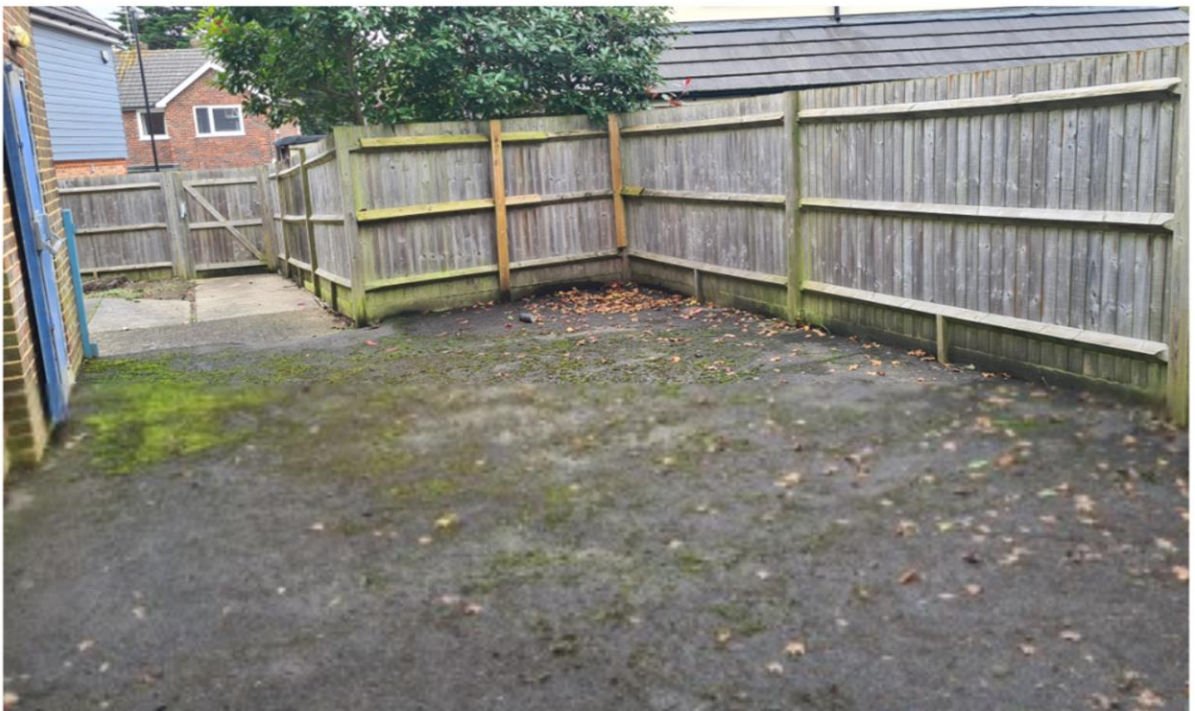
Plate 7.12: View of Tarmac area to the rear (north-east) of the building (looking north-west) – note the alignment of the culvert crosses the Tarmac area towards the gate along the western boundary

- 7.5 A culvert was observed crossing the rear garden in the north of the Site. Across the garden, it is overlain by various levels of hardstanding and concrete slabs (Plates 7.12-13), but is visible at the eastern boundary (Plate 7.13). This culvert follows the alignment of the former field/land parcel boundary which historic mapping shows crossing in this location from 1845 (Figs. 6-11). It is not clear whether the culvert itself dates to this period, but it is possible that when it was constructed, it made use of an existing drainage ditch which formerly demarcated the boundary of the field.

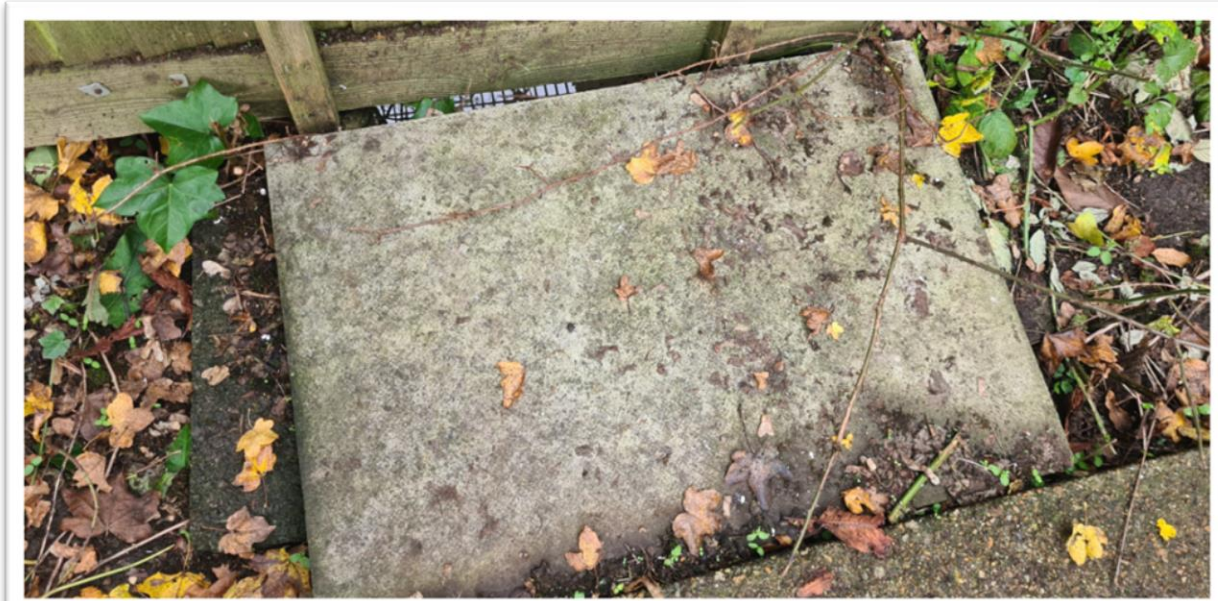
Plate 7.13: View of slab covering the culvert where it runs under the eastern boundary in the rear garden

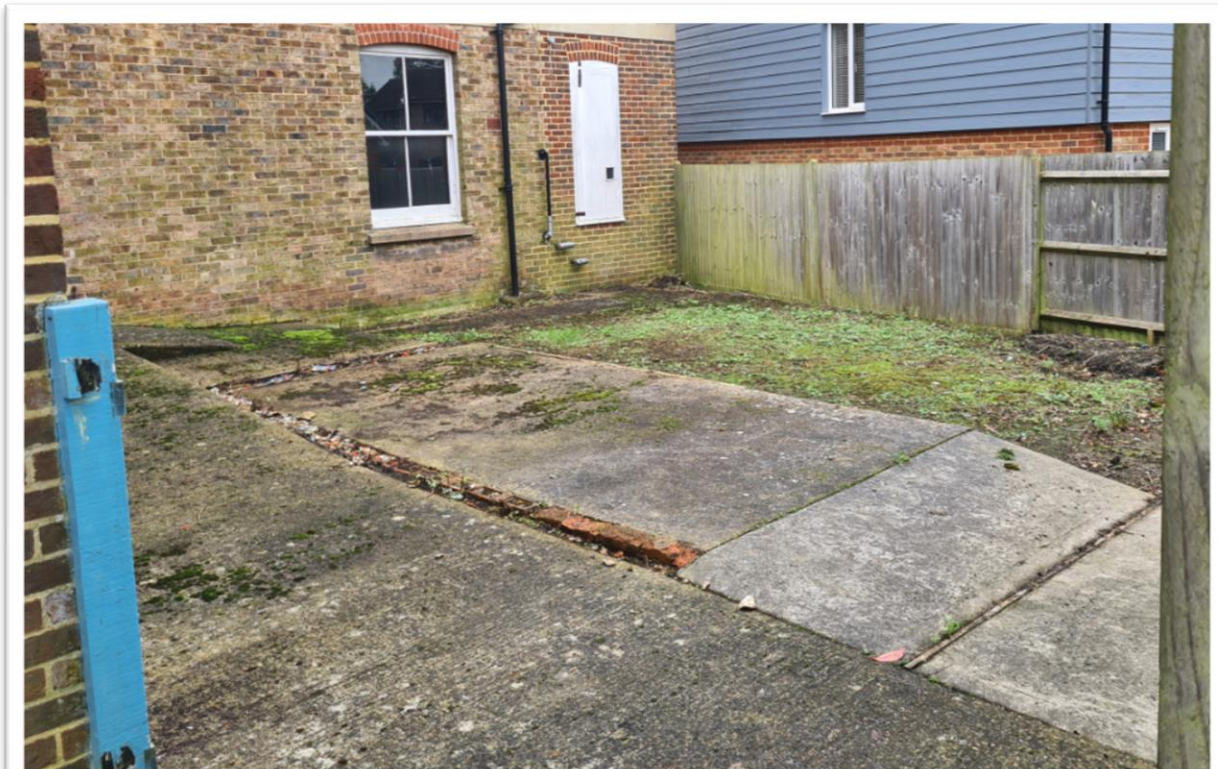
Plate 7.14: View of area to the rear (north-west) of the building (looking south-west) – note the various levels of concrete hard-landscaping – it is possible that some of this concrete is capping a below-ground feature, such as a soakaway or wartime shelter/bunker

- 7.6 A couple of the large rectangular concrete slabs laid in the rear garden in the north-west of the plot may have been deliberately placed to cover a below ground feature, such as a soakaway or wartime bunker/shelter (Plates 7.14-15).

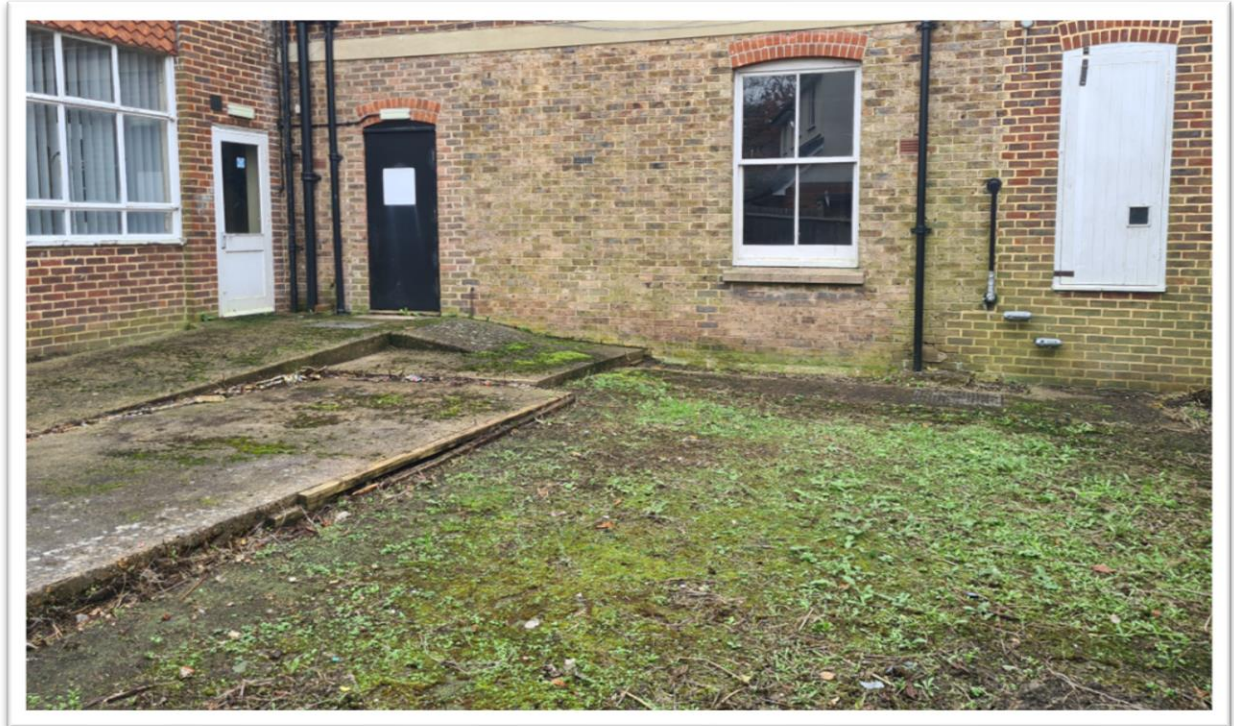
Plate 7.15: View of area to the rear (north-west) of the building (looking south) – note the various levels of concrete hard-landscaping – it is possible that some of this concrete is capping a below-ground feature, such as a soakaway or wartime shelter/bunker

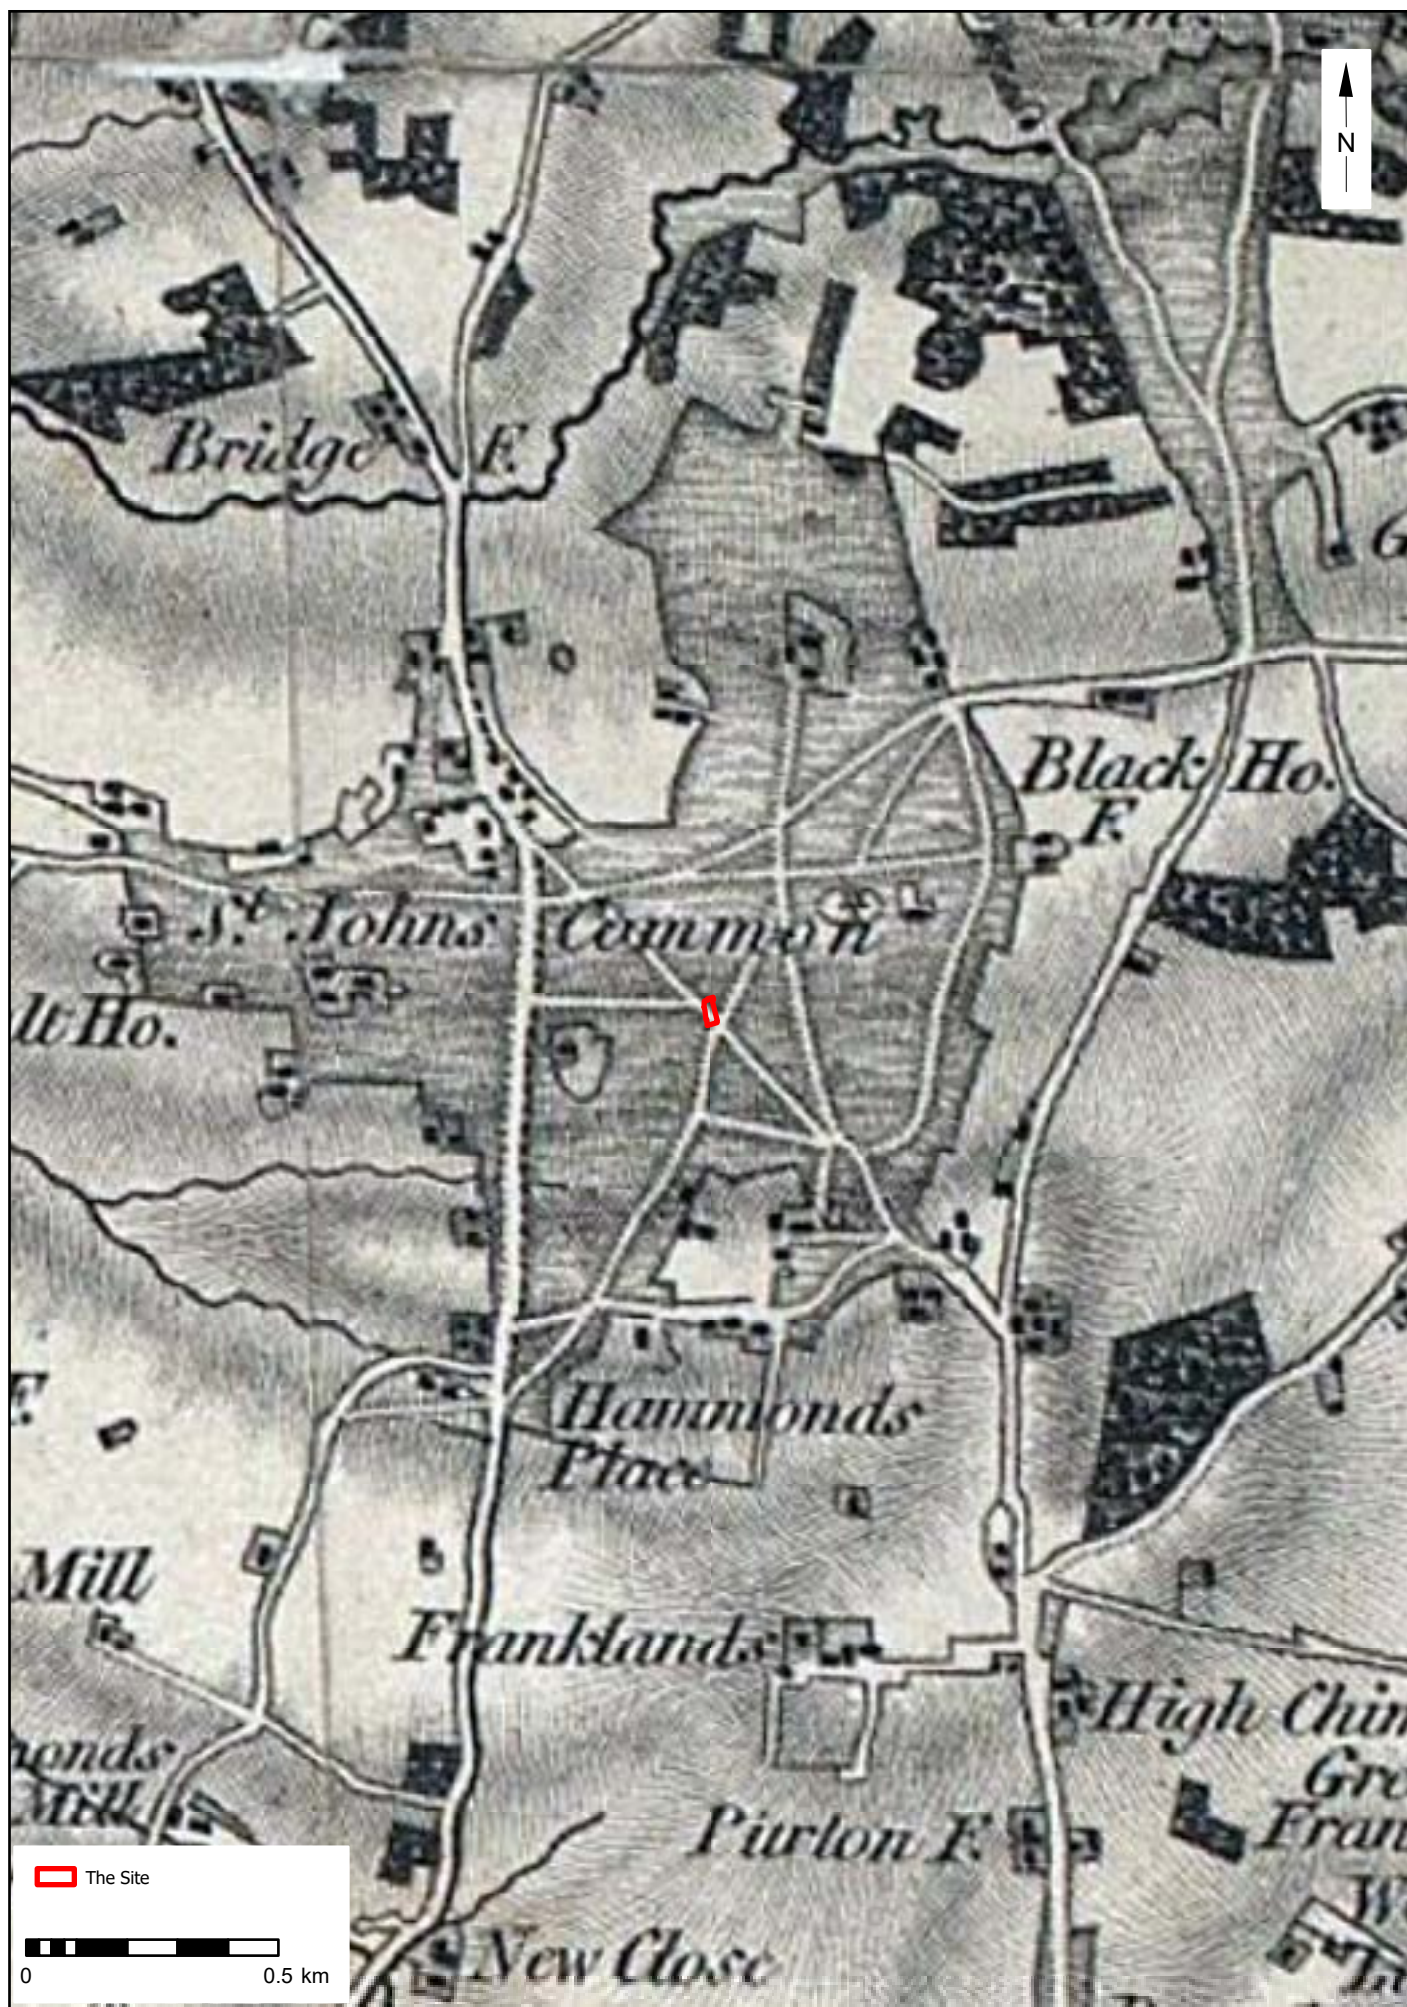
| © Archaeology South-East | | Park Centre, 60 Park Road, Burgess Hill, West Sussex | Fig. 5 |

| Project Ref: 240596 | October 2024 | Extract from Ordnance Survey draft map of 1813 | |

- 5.2 The Ordnance Survey (OS) map of 1813 (Fig. 5) shows the Site over St. John's Common. It is located at a junction of trackways crossing the common, the one shown on a north-east to south-west alignment, mirroring the projection of the Roman road (10).

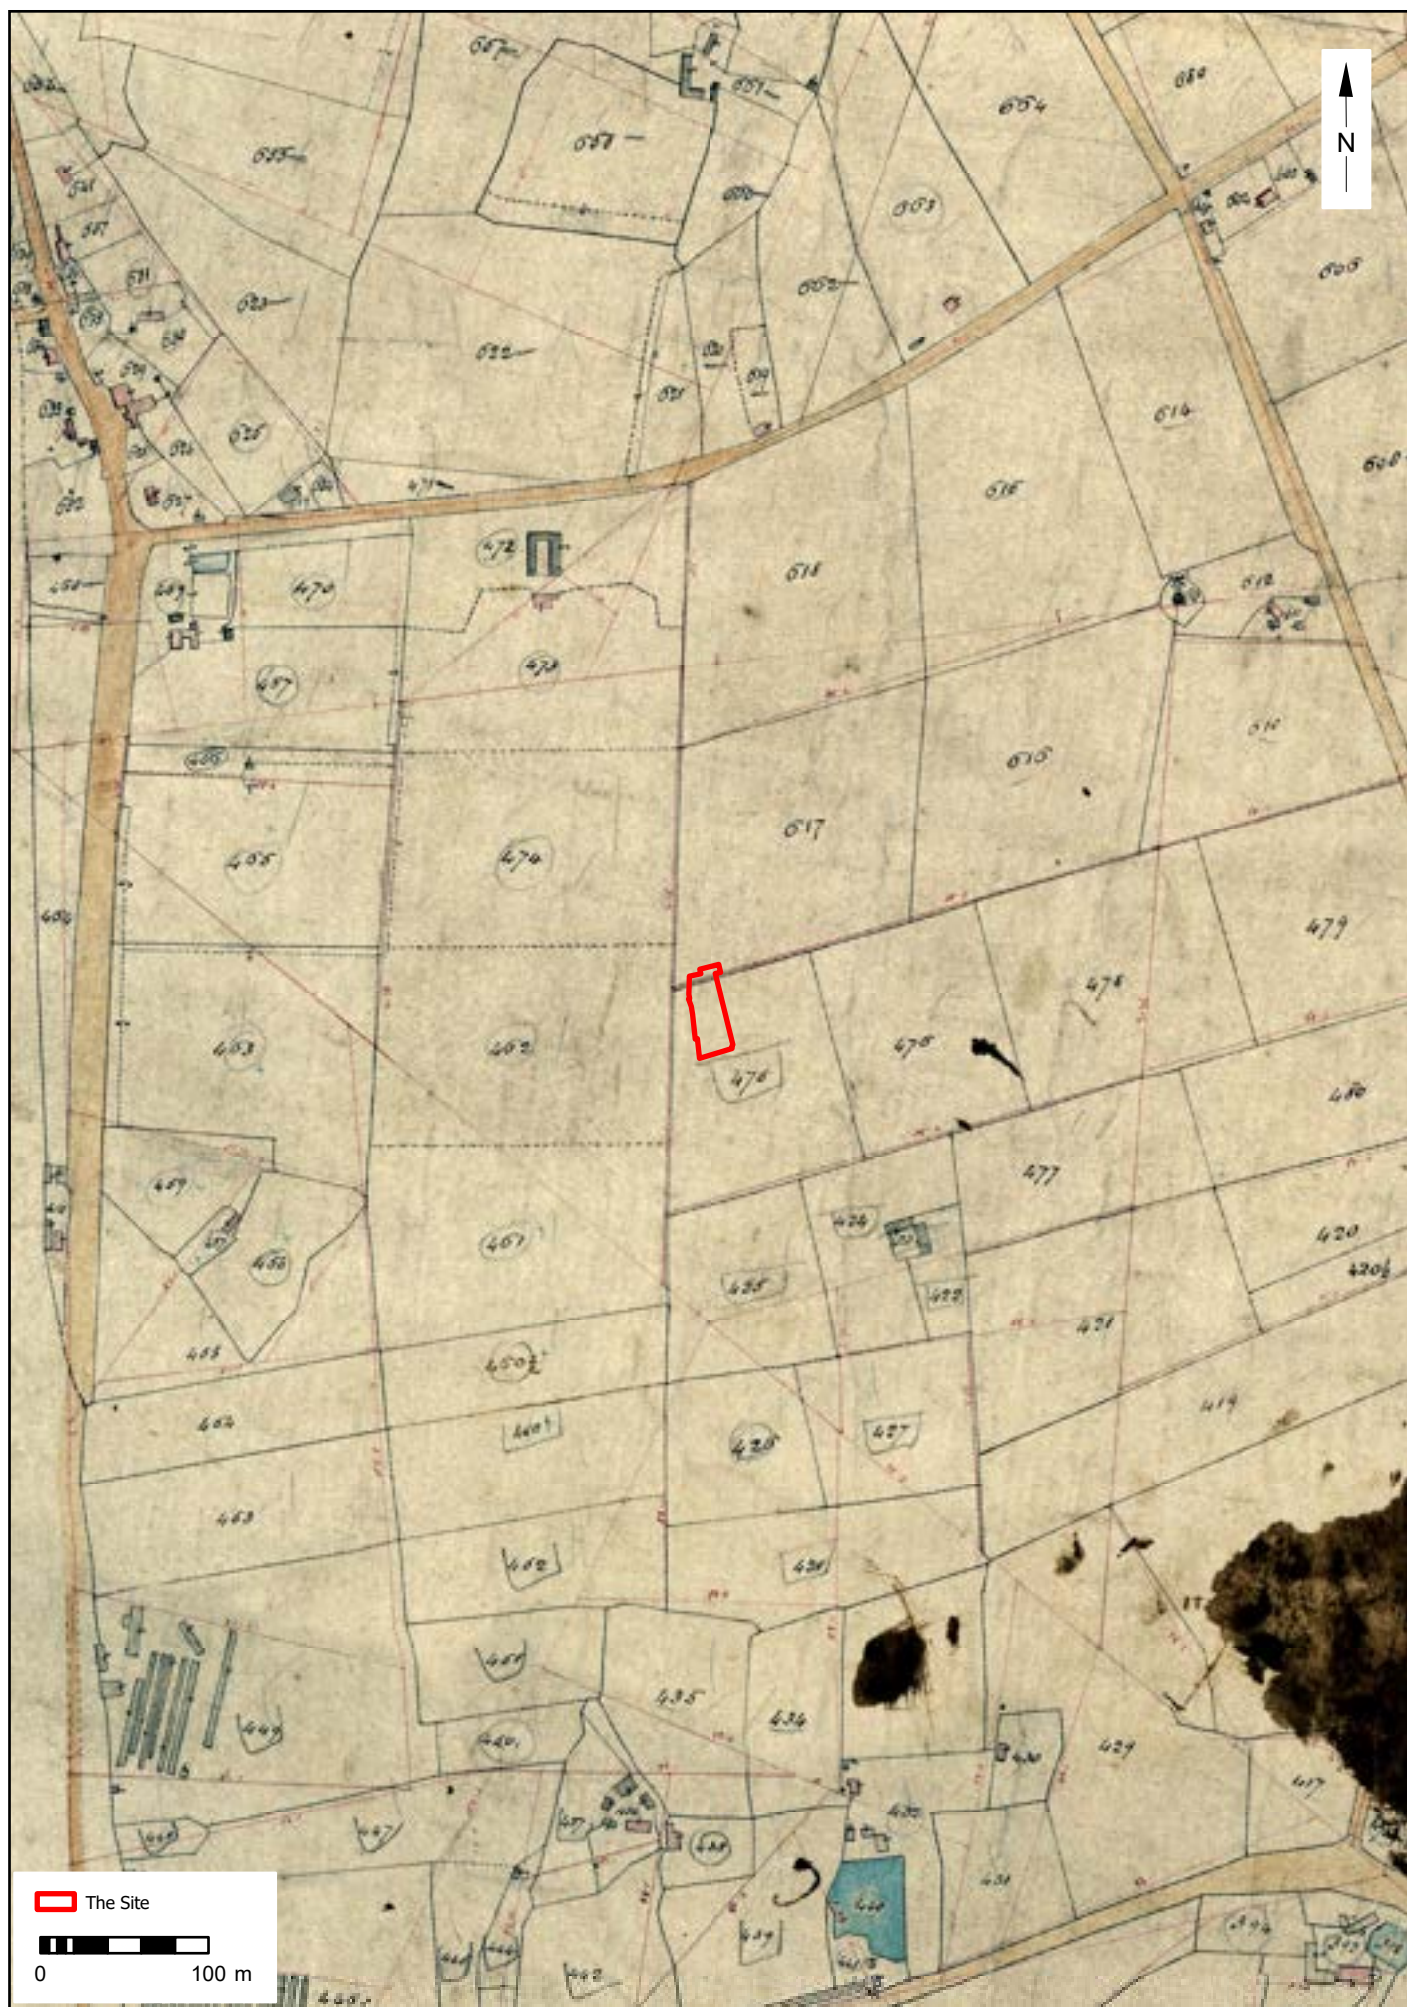
| © Archaeology South-East | | Park Centre, 60 Park Road, Burgess Hill, West Sussex | Fig. 6 |

| Project Ref: 240596 | October 2024 | Extract from Keymer Tithe map of 1845 | |

- 5.3 The 1845 tithe map for Keymer Parish (ref. TD E 77) (Fig. 6) shows the Site within an undeveloped field (plot 475) which was owned by Reverend Powell and occupied/tenanted by Phillip Jenner under arable cultivation. The northern part of the Site slightly staggers the northern field boundary, on which alignment a culvert was observed crossing the rear garden area during the walkover survey
