## **ARBORICULTURAL METHOD STATEMENT**

**Nether Walstead, East Mascalls Lane, Lindfield**

*- prepared on behalf of **Mr & Mrs E Ball** -*

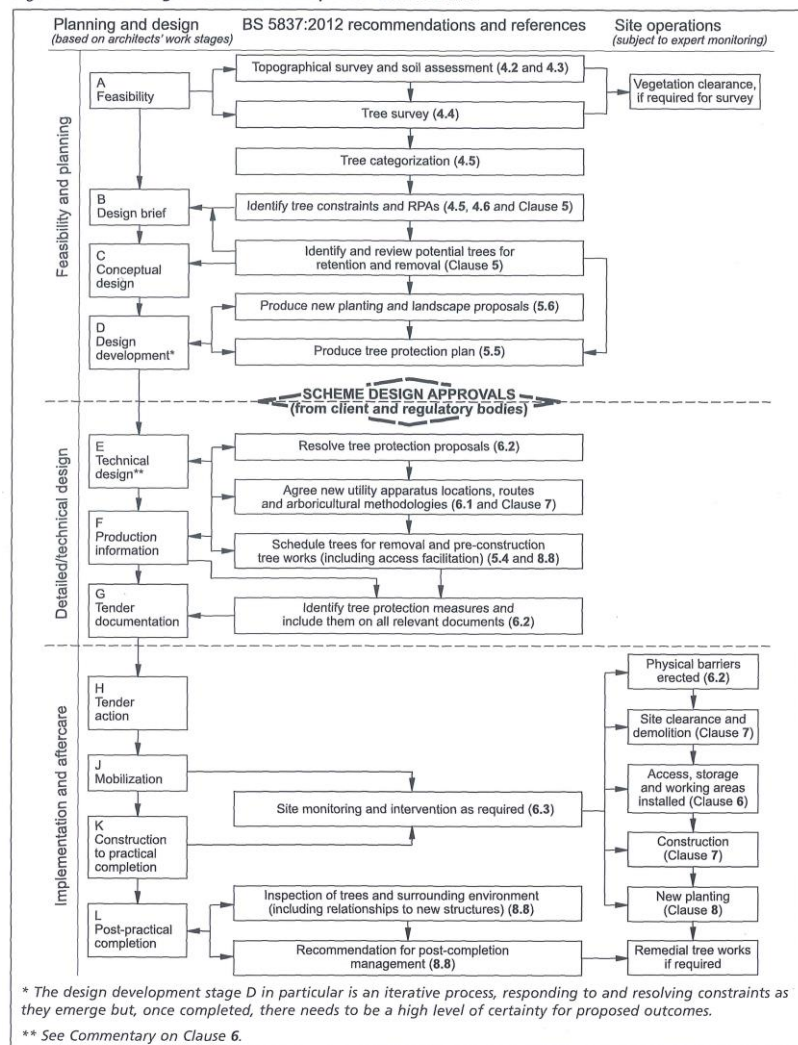
Figure 1 - Flow Diagram  
& Tree Survey Notes

Figure 1 The design and construction process and tree care

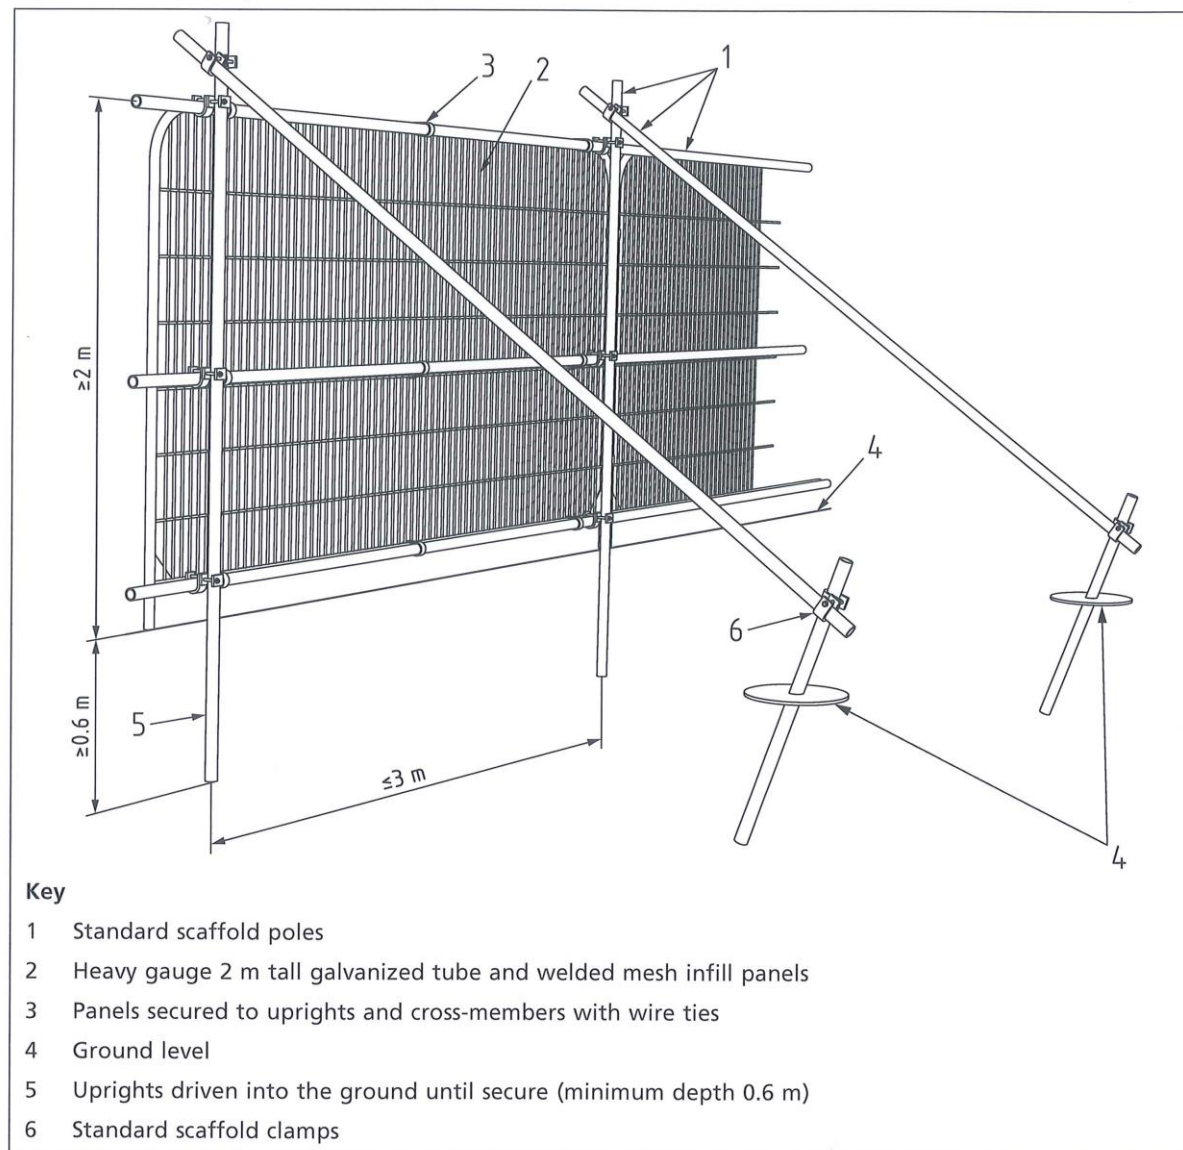
+ BS5837:2012 – Figure 2

Figure 2 Default specification for protective barrier

- 6.2 Erect the protective fencing as specified and shown on the **Tree Protection Plan BJH03/04** at [appendix BH3](#). Barriers are to be 'Fit For Purpose' to exclude construction activity and must be maintained to ensure that they remain rigid and complete and in the original setting out positions. These checks will need to be incorporated into a schedule of site monitoring visits to be agreed with the clients subject to phased development operations and subsequently copies of these site visit reports will need to be copied in to the Council.
