Table 3.2: Catchment B Photographs

Appendix E Long Sections and Additional Information/Figures

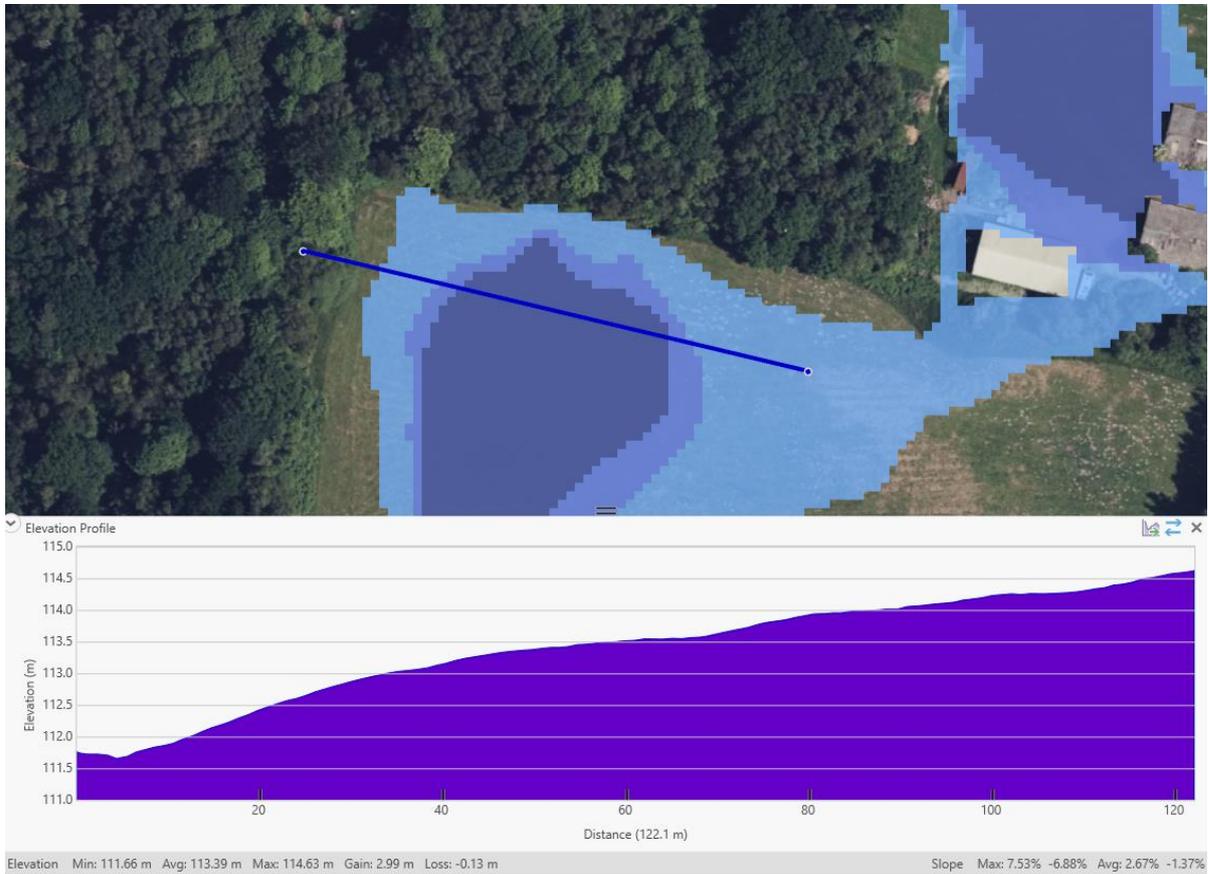
Figure AE.1: Field 1 Long Section

The cross section profile presented in Figure AE.1 shows the topography of the dark blue line drawn in the above related image, as it moves across the land from approximately west to east.

The dark blue line measures approximately 122 m in length. At the western edge of Field 1, at a chainage of approximately 12 m, the elevation stands at approximately 112 m AOD. At a chainage of approximately 38 m, where the area at a High risk of surface water flooding is met, the elevation stands at approximately 113 m AOD.

As is clear from the long section profile presented in Figure AE.1, the topography continues to rise along the entire length of the chainage as it moves from west to east. Hence, it is not possible for the area along the middle part of the chainage to be at a higher surface water flood risk than that further west.

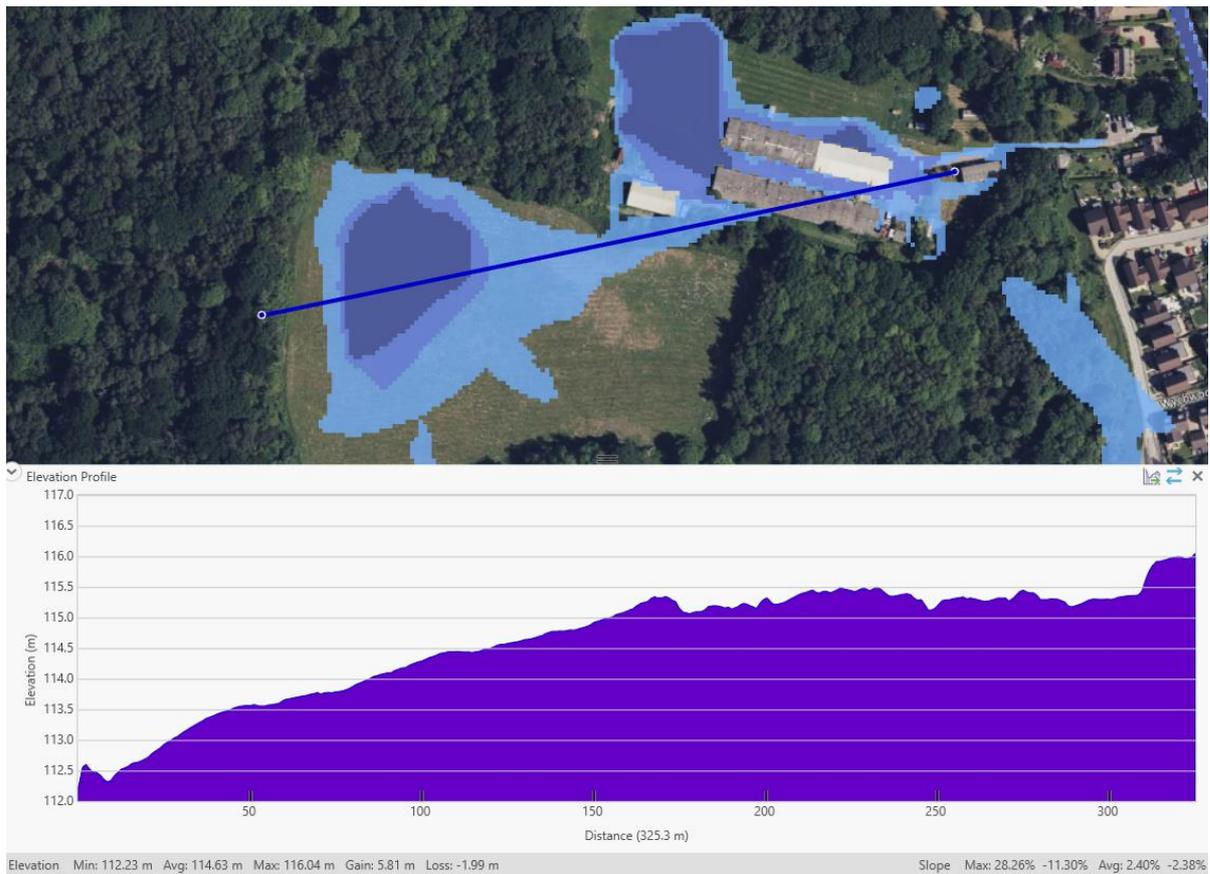
Figure AE.2: Field 1 Long Section 2

The cross section profile presented in Figure AE.2 shows the topography of the dark blue line drawn in the above related image, as it moves across the land from approximately west to east.

The dark blue line measures approximately 325 m in length. At the western edge of Field 1, at a chainage of approximately 9 m, the elevation stands at approximately 112 m AOD. At a chainage of approximately 40 m, where the area at a High risk of surface water flooding is met, the elevation stands at approximately 113 m AOD.

As is clear from the long section profile presented in Figure AE.2, the topography typically continues to rise along the length of the chainage as it moves from west to east. Hence, it is not possible for the area along the middle part of the chainage to be at a higher surface water flood risk than that further west.

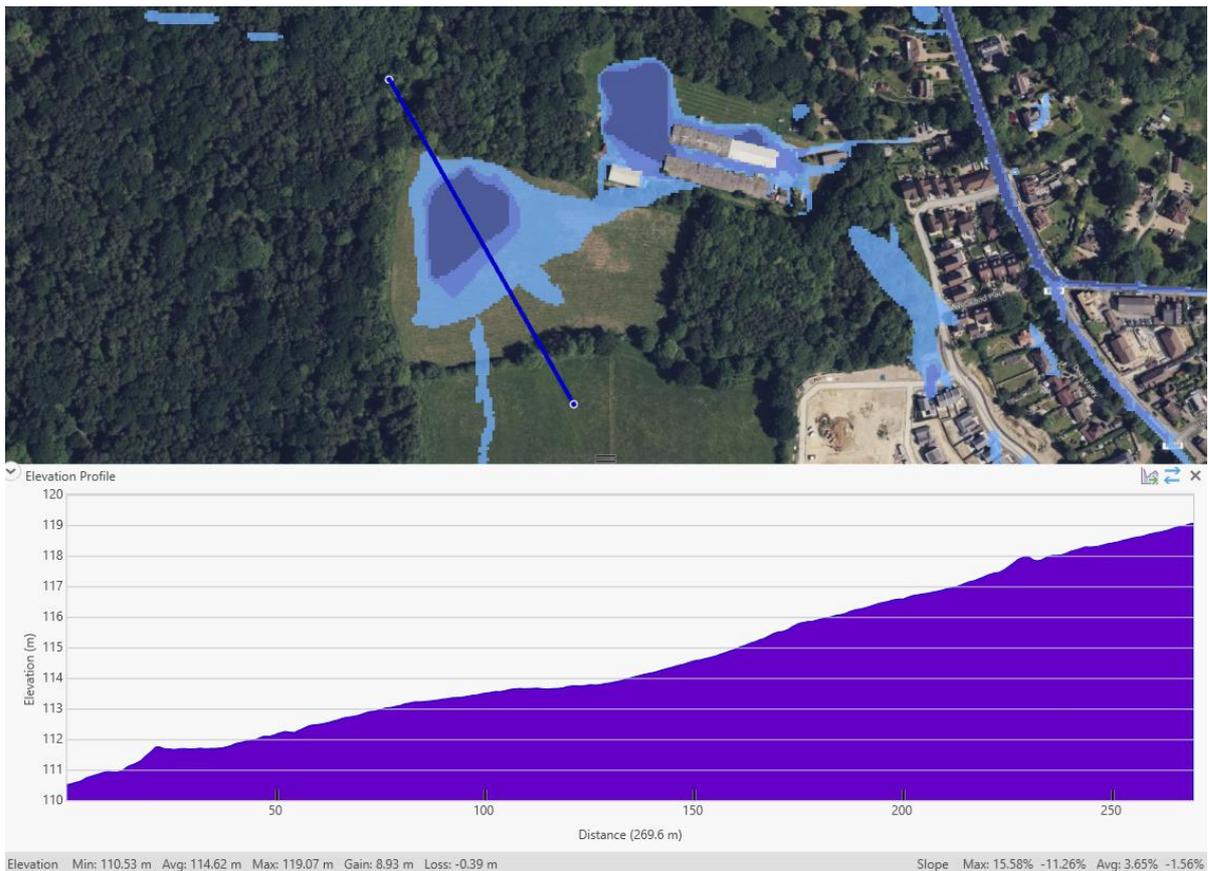
Figure AE.3: Field 1 Long Section 3

The cross section profile presented in Figure AE.3 shows the topography of the dark blue line drawn in the above related image, as it moves across the land from approximately northwest to southeast.

The dark blue line measures approximately 270 m in length. At the northwestern point of the line, at a chainage of 0 m, the elevation stands at approximately 110.5 m AOD. At a chainage of approximately 86 m, where the area at a High risk of surface water flooding is met, the elevation stands at approximately 113 m AOD.

As is clear from the long section profile presented in Figure AE.3, the topography continues to rise along the length of the chainage as it moves from northwest to southeast. Hence, it is not possible for the area along the middle part of the chainage to be at a higher surface water flood risk than that further northwest.

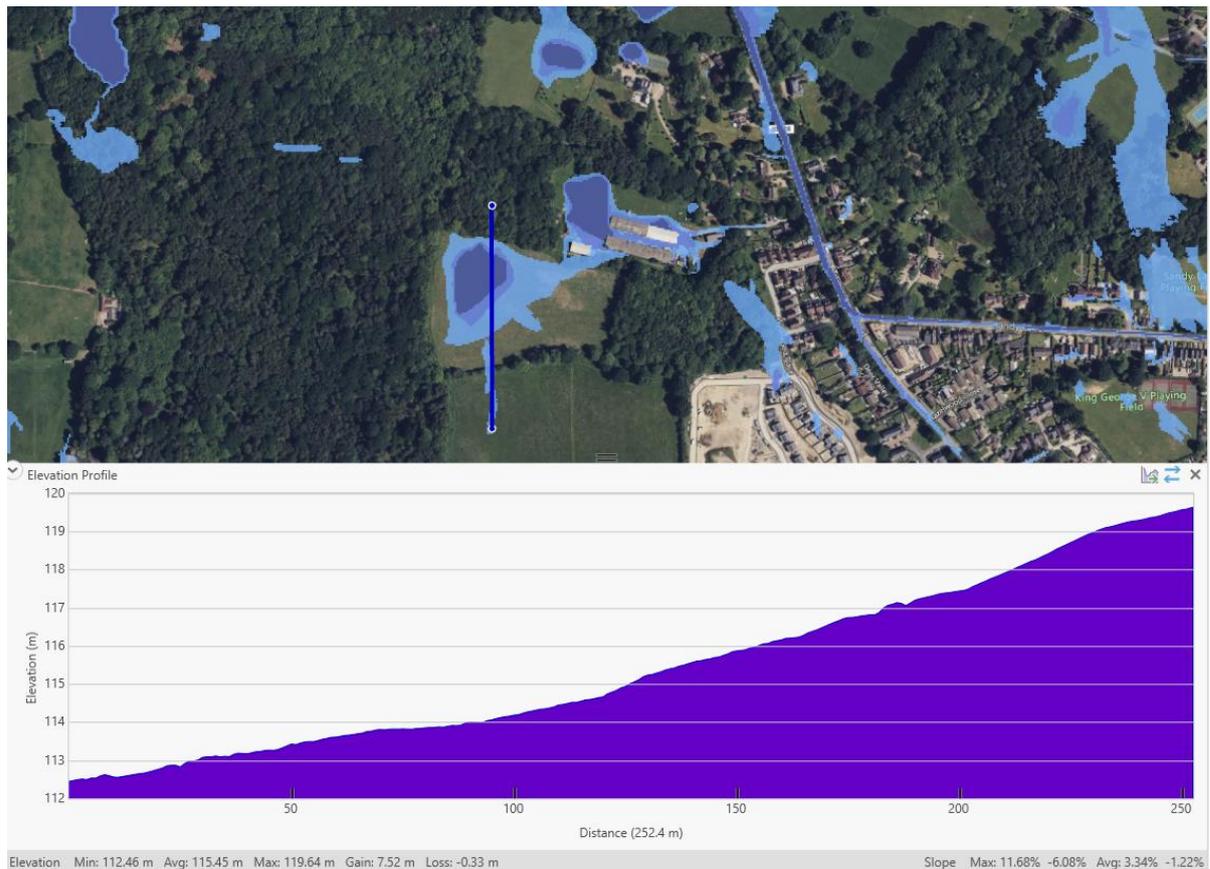
Figure AE.4: Field 1 Long Section 4

The cross section profile presented in Figure AE.4 shows the topography of the dark blue line drawn in the above related image, as it moves across the land from approximately north to south.

The dark blue line measures approximately 252 m in length. At the northern end of the line, at a chainage of 0 m, the elevation stands at approximately 112.5 m AOD. At a chainage of approximately 56 m, where the area at a High risk of surface water flooding is met, the elevation stands at approximately 113.5 m AOD.

As is clear from the long section profile presented in Figure AE.4, the topography continues to rise along the length of the chainage as it moves from north to south. Hence, it is not possible for the area along the middle part of the chainage to be at a higher surface water flood risk than that further north.
