## RUGBY TURF FIELD TEST REPORT FOR REGULATION 22

**Centre for Outdoor Sport Burgess Hill**

Rugby Pitch  
Fieldturf Inc. - XM7 60-13 PP20 SBR

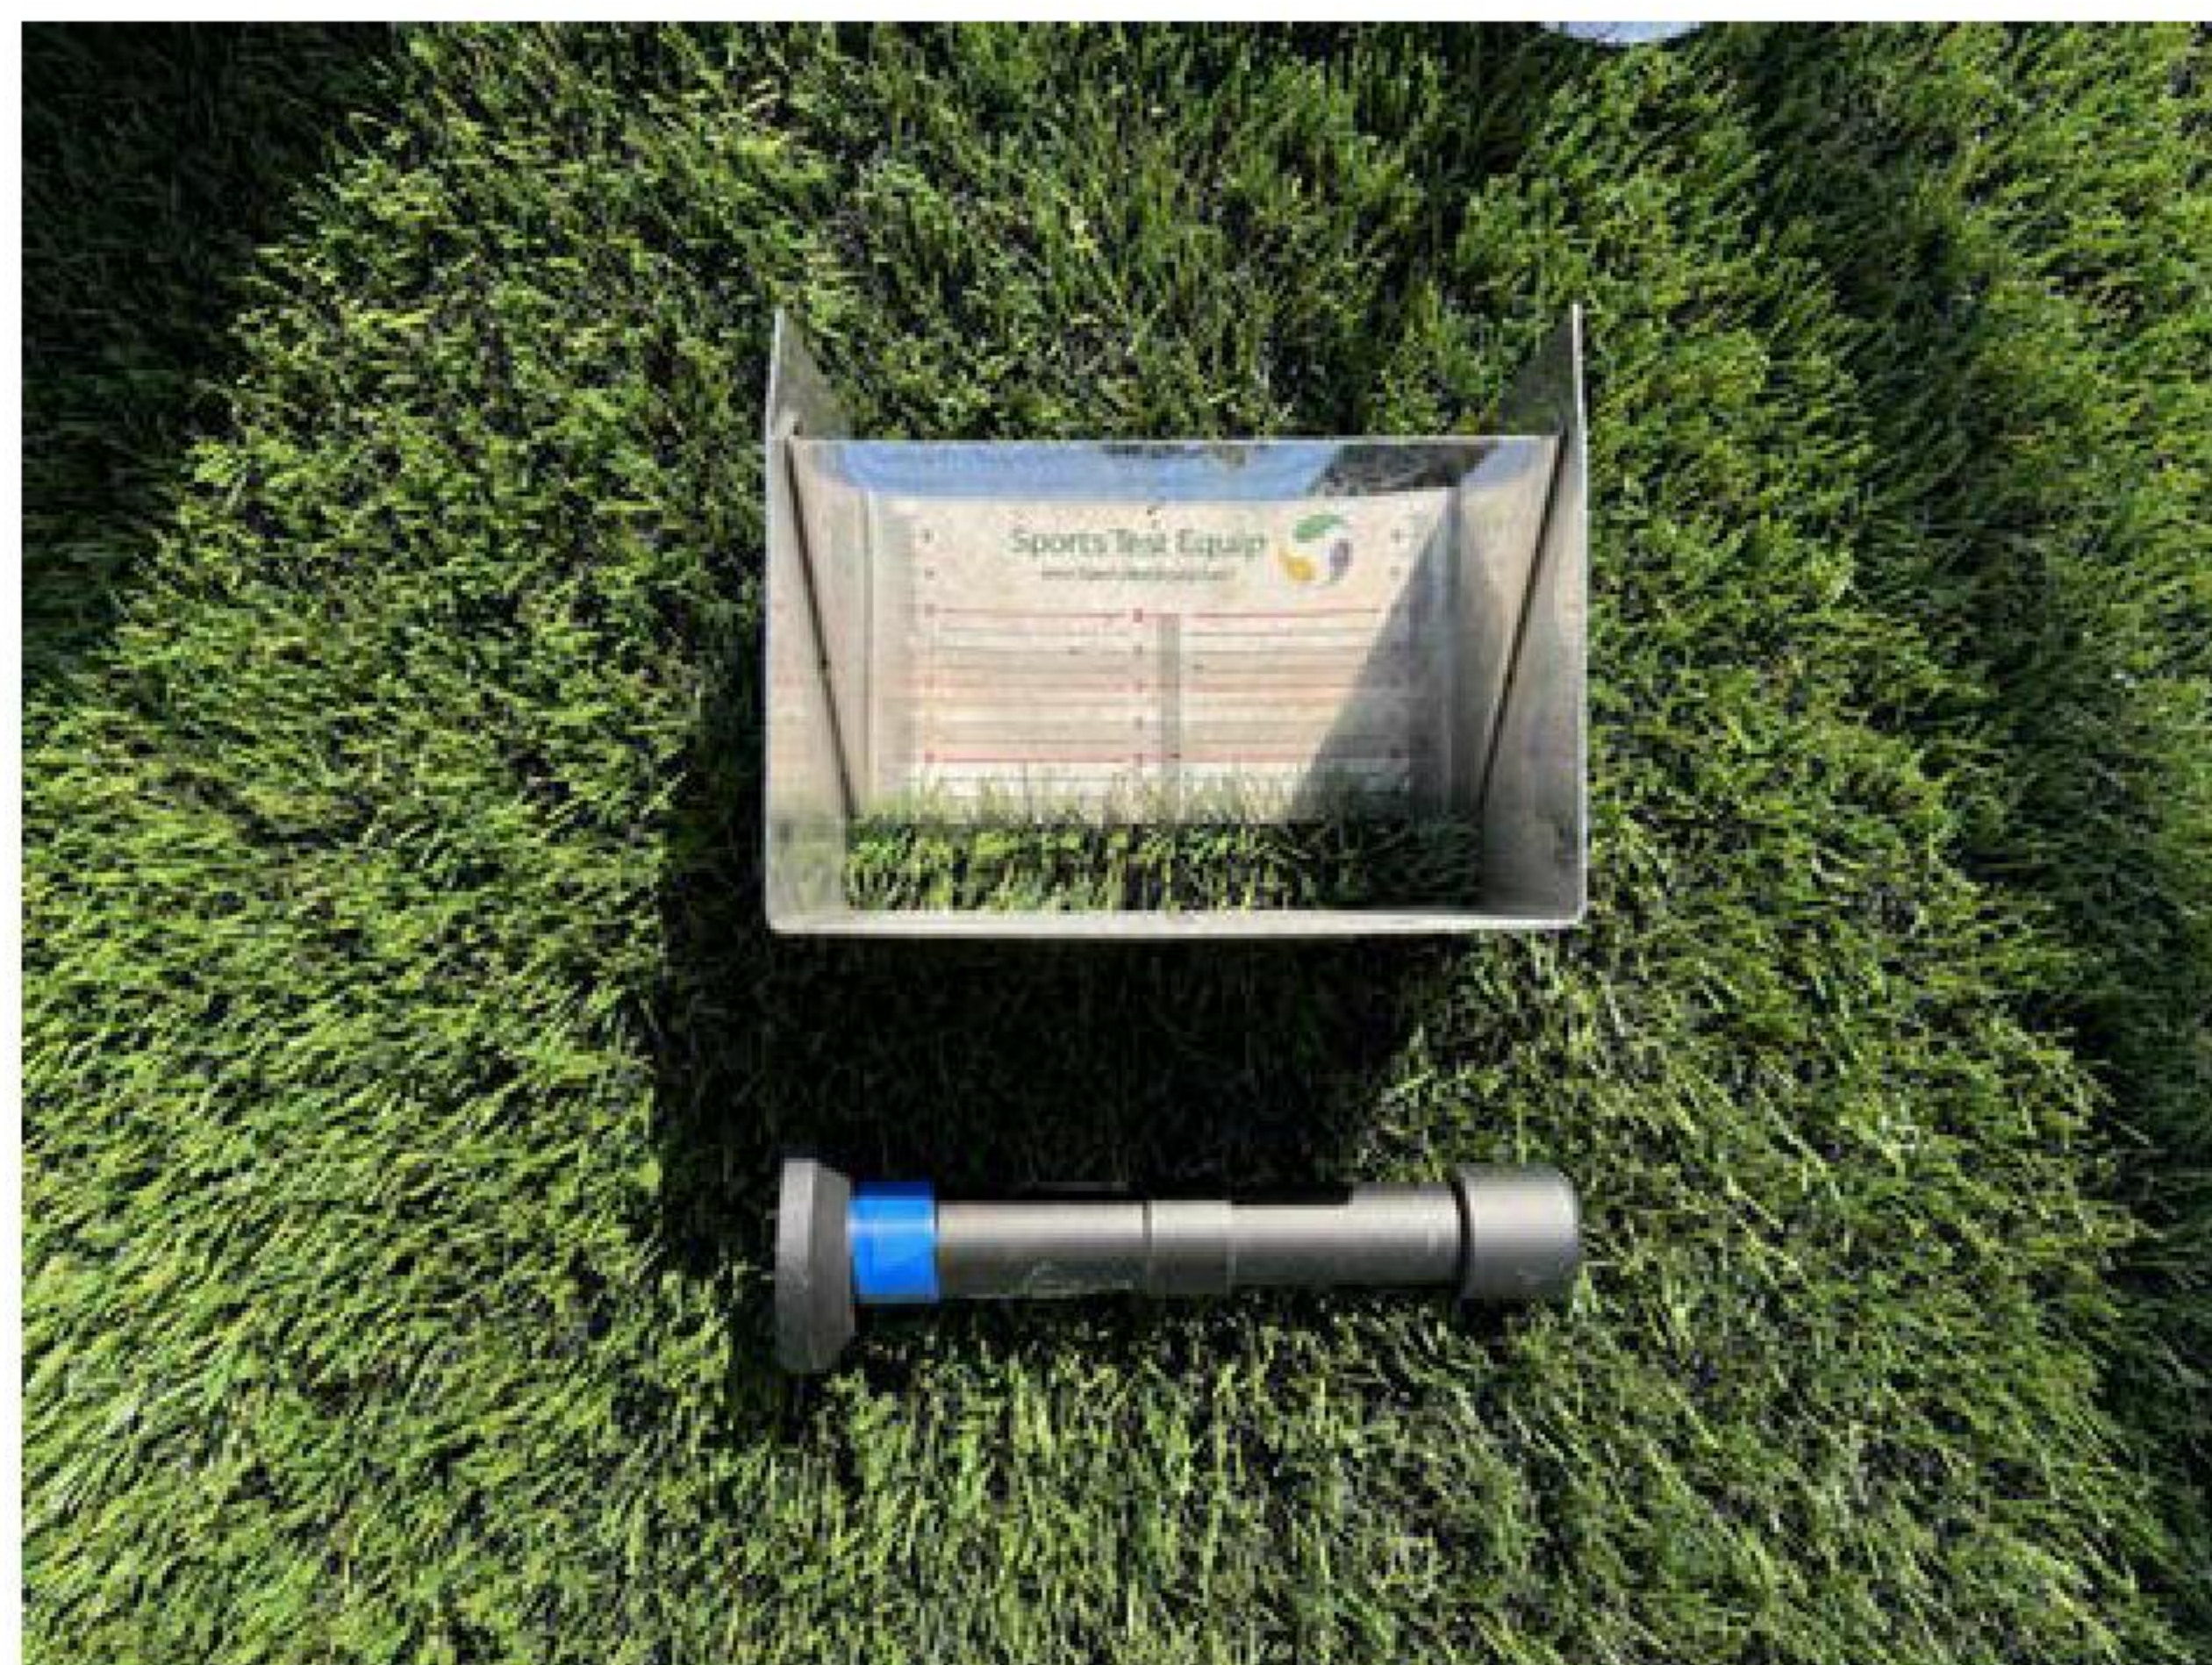
*Pile Height*

| Rugby Turf - Carpet | | | | |
|---|---|---|---|---|
| Pile length (mm) | 61 | 60 | $\leq \pm 5\%$ | Pass |
