**POLLARDS FARM, DITCHLING ROAD,  
BURGESS HILL, RH15 0SE  
PHASE II GEO-ENVIRONMENTAL  
ASSESSMENT  
PWX CONSTRUCTION LTD  
30<sup>TH</sup> MAY 2025  
LS8465**

| <b>Title:</b> | <b>PHASE II GEO-ENVIRONMENTAL ASSESSMENT</b> | |
| <b>Project:</b> | <b>CONVERSION OF AGRICULTURAL BARN INTO A DETACHED HOUSE</b> | |

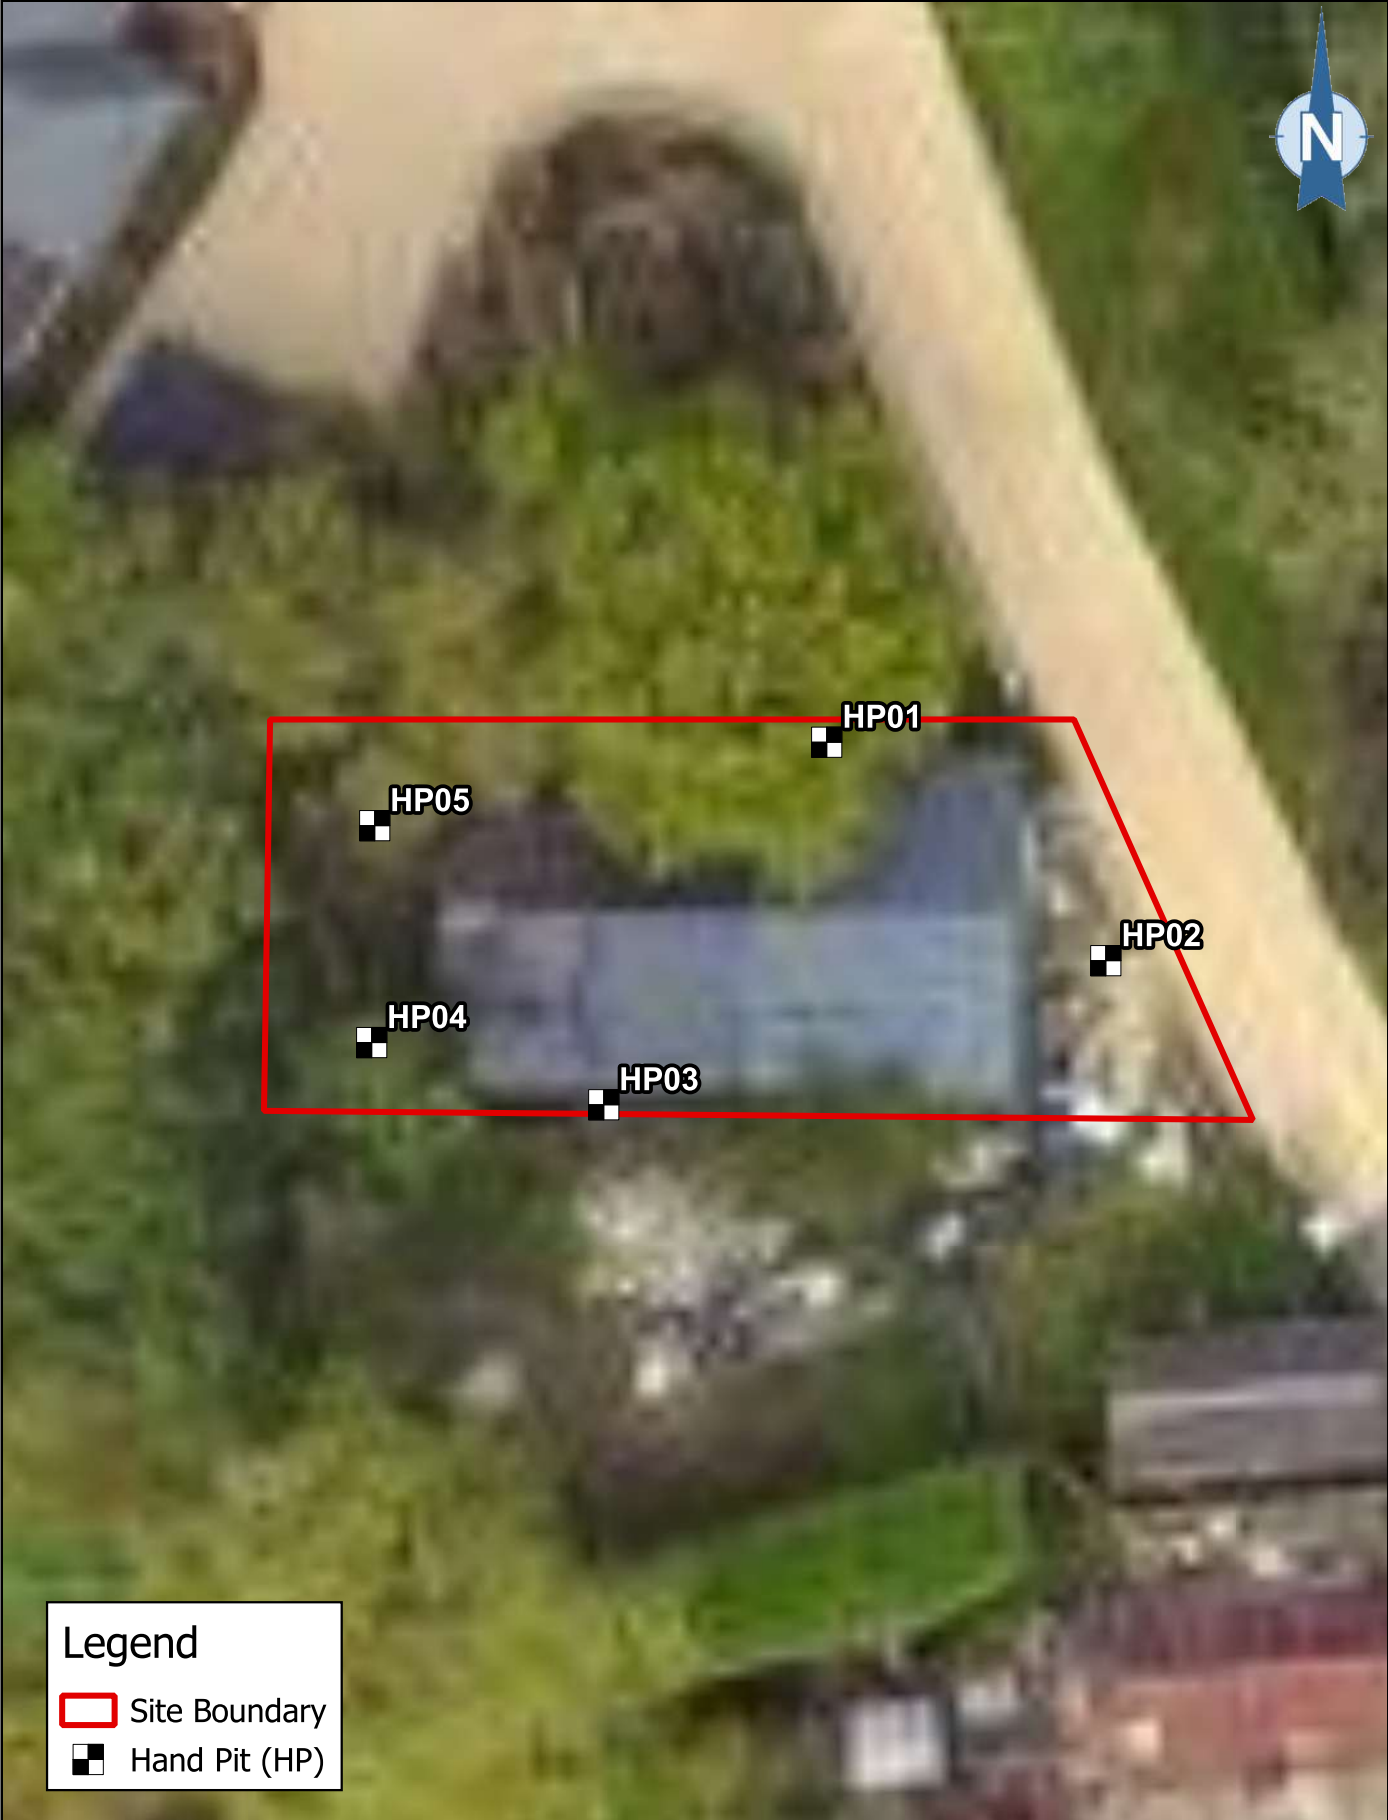
The area under investigation comprised an active construction site and the start of the new development. The foundation base had been laid, and construction of ground floor surface and walls had begun as detailed in the site investigation walkover survey in Appendix A. Areas of the site had been reduced in level by 400-600mm. The layout is indicated on Figure 2. The area was approximately 0.03 hectares.

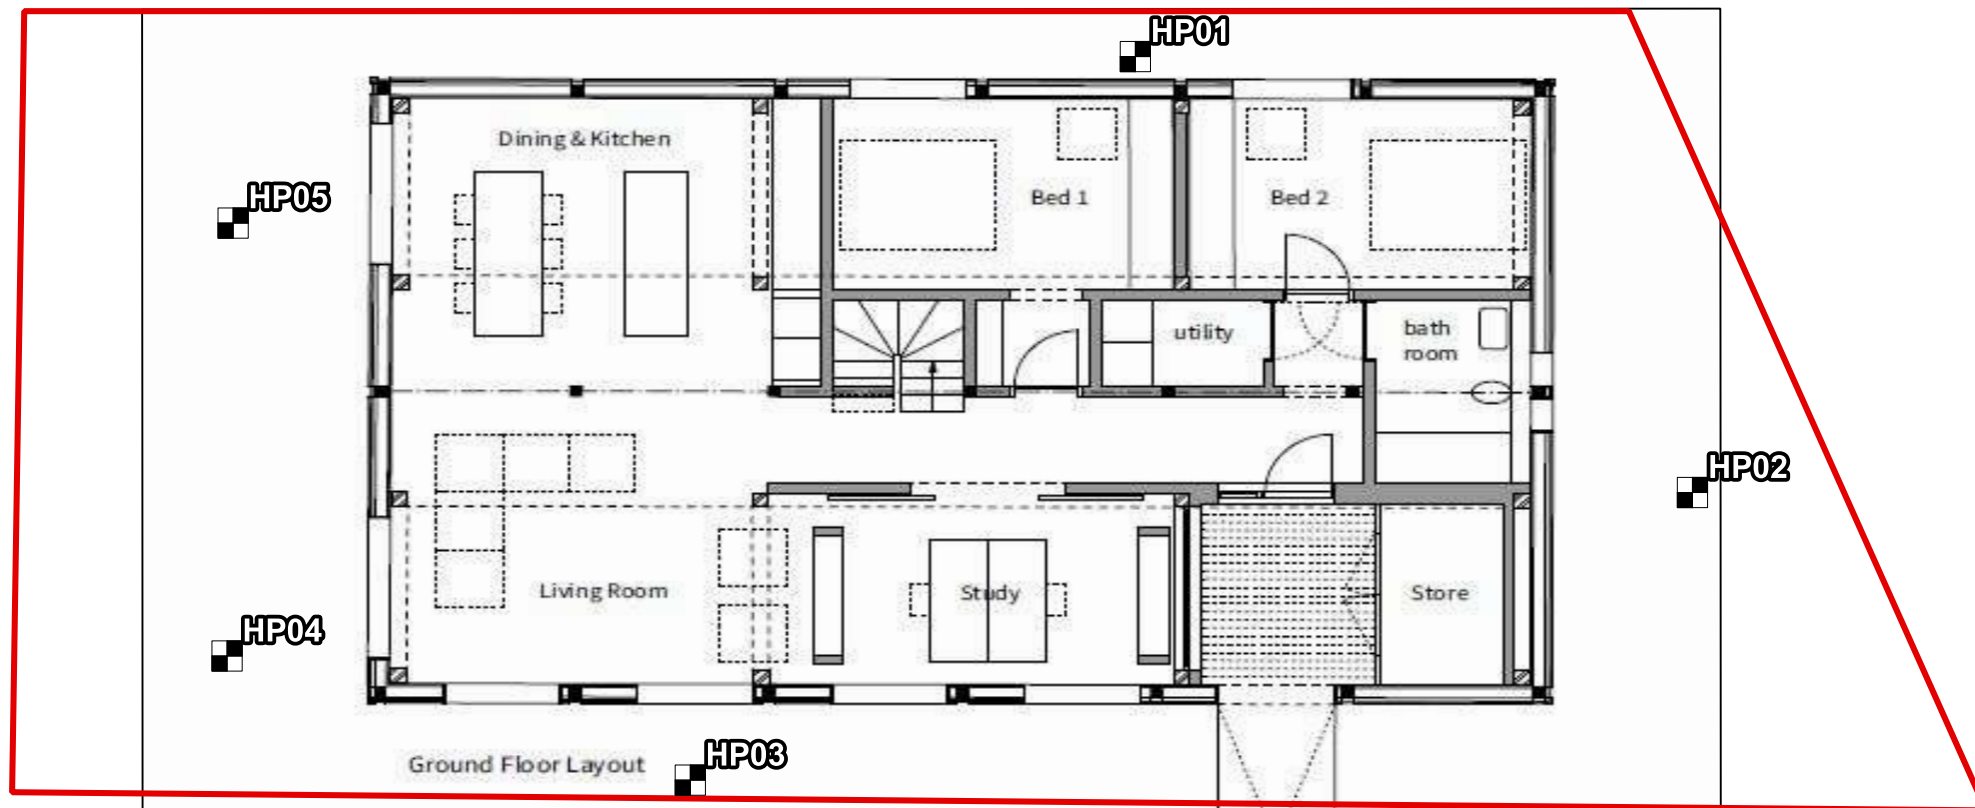
- Five hand pits were carried out to assess the composition and depth of any Made Ground and any field evidence of contamination into the underlying soils.
- The positions were located to give broad coverage across the site, where accessible.
- Additionally, HP01 and HP03 were located next to the site boundaries specifically to investigate the potential for lateral migration of contaminants. HP02 was located to target the Made Ground under the driveway, and HP04 and HP05 were located to target the proposed garden area.

- Site Boundary
- Hand Pit (HP)

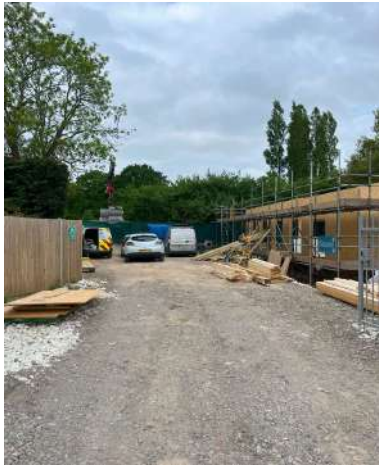
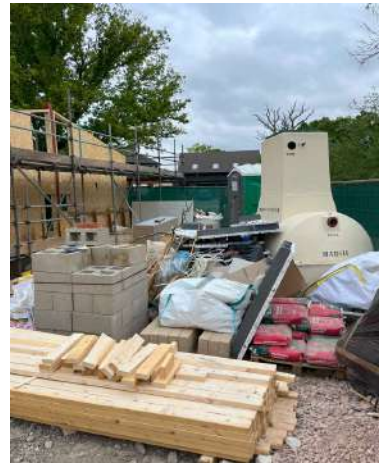
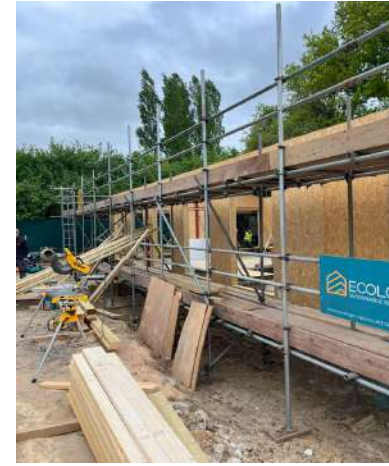
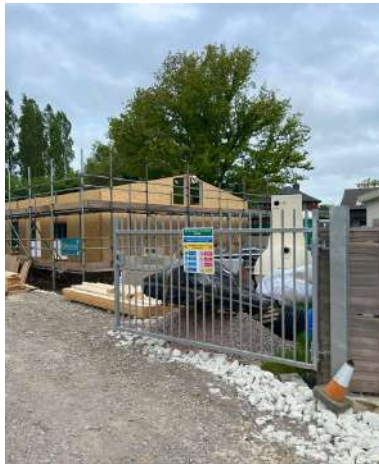
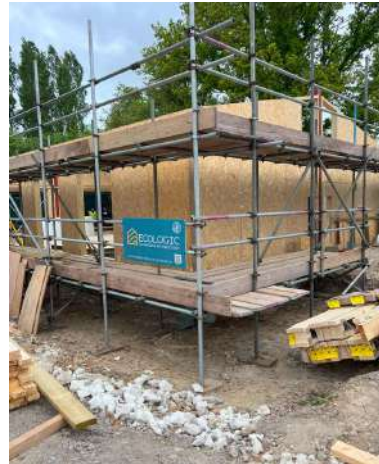
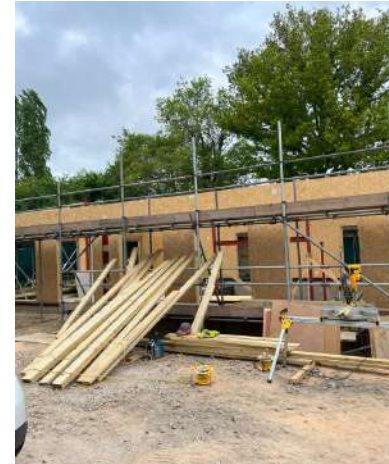
| <b>TITLE:</b> | Site Photos - Setting | <b>REF:</b> | LS8465 | <b>PREPARED:</b> | WP |

| SITE DETAILS | | | |
|---|---|---|---|
| General condition | Under construction – building materials, rubble piles etc surrounding the dwelling. | | |
| General lie of the site | The ground level had been reduced by approx. 1m where the foundations of the dwelling have been put in place, rest of the site surrounding was flat and level. | | |

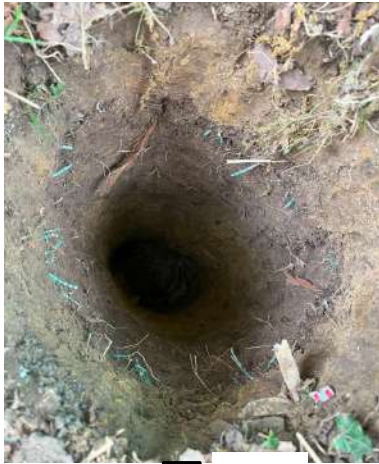
HP01

| Strata | Base Depth (mbgl) | | | | |
|---|---|---|---|---|---|
| Made Ground | 0.40 | 0.15 | 0.05 | 0.05 | 0.05 |

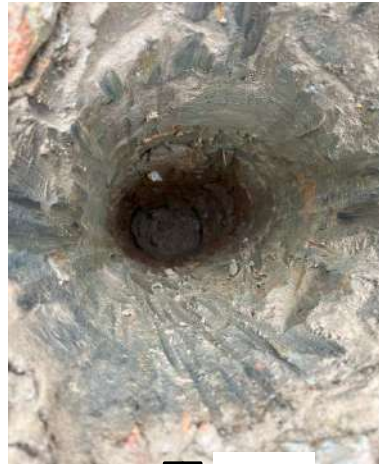
HP02

| Strata | Base Depth (mbgl) | | | | |
|---|---|---|---|---|---|
| Backfill | - | 0.50 | - | - | - |

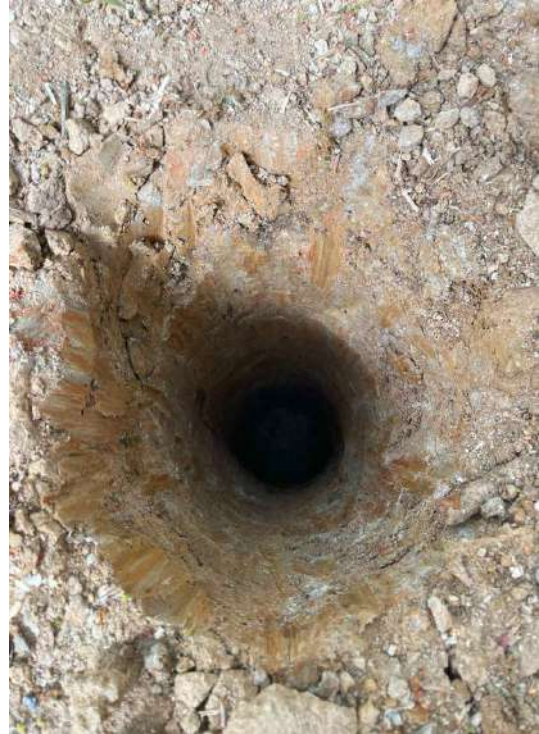
In summary, the Weald Clay comprised light brown/blue-grey/red-orange mottled blue-grey and orange-brown Clay (locally slightly silty), becoming mottled blue-grey and red-orange with depth. HP05 was noted as very gravelly with fine mudstone fragments 0.70-0.90mbgl.
