Biodiversity Net Gain Feasibility Assessment

Sayers Common

1.1 The Ecology Partnership was commissioned by Welbeck to undertake a Biodiversity Net Gain (BNG) feasibility assessment for the outline application for the development to Coombe Farm, London Road, Sayers Common, West Sussex, BN6 9HY, hereafter referred to as the 'site' (Figure 1).

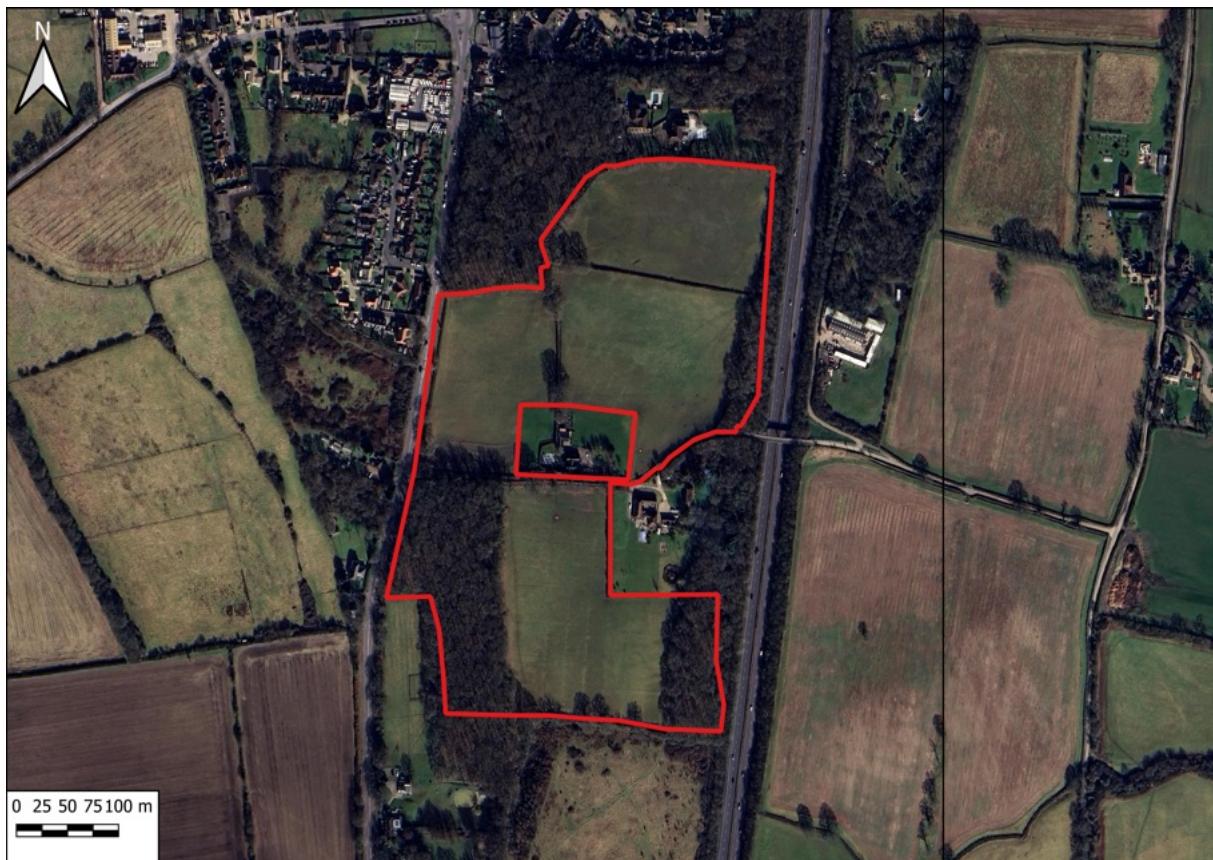
*Figure 1: Site application boundary (red line).
Satellite imagery obtained from Google Satellite via QGIS on 24/04/2025*

1.2 The site is located to the east of London Road (B2118) at Coombe Farm which lies to the south of the village of Sayers Common, West Sussex (TQ 26862 17823). It covers approximately 13.38ha and consists of woodland and grassland fields with tree lines and hedgerows. The wider landscape comprises largely of arable land and low-density housing.

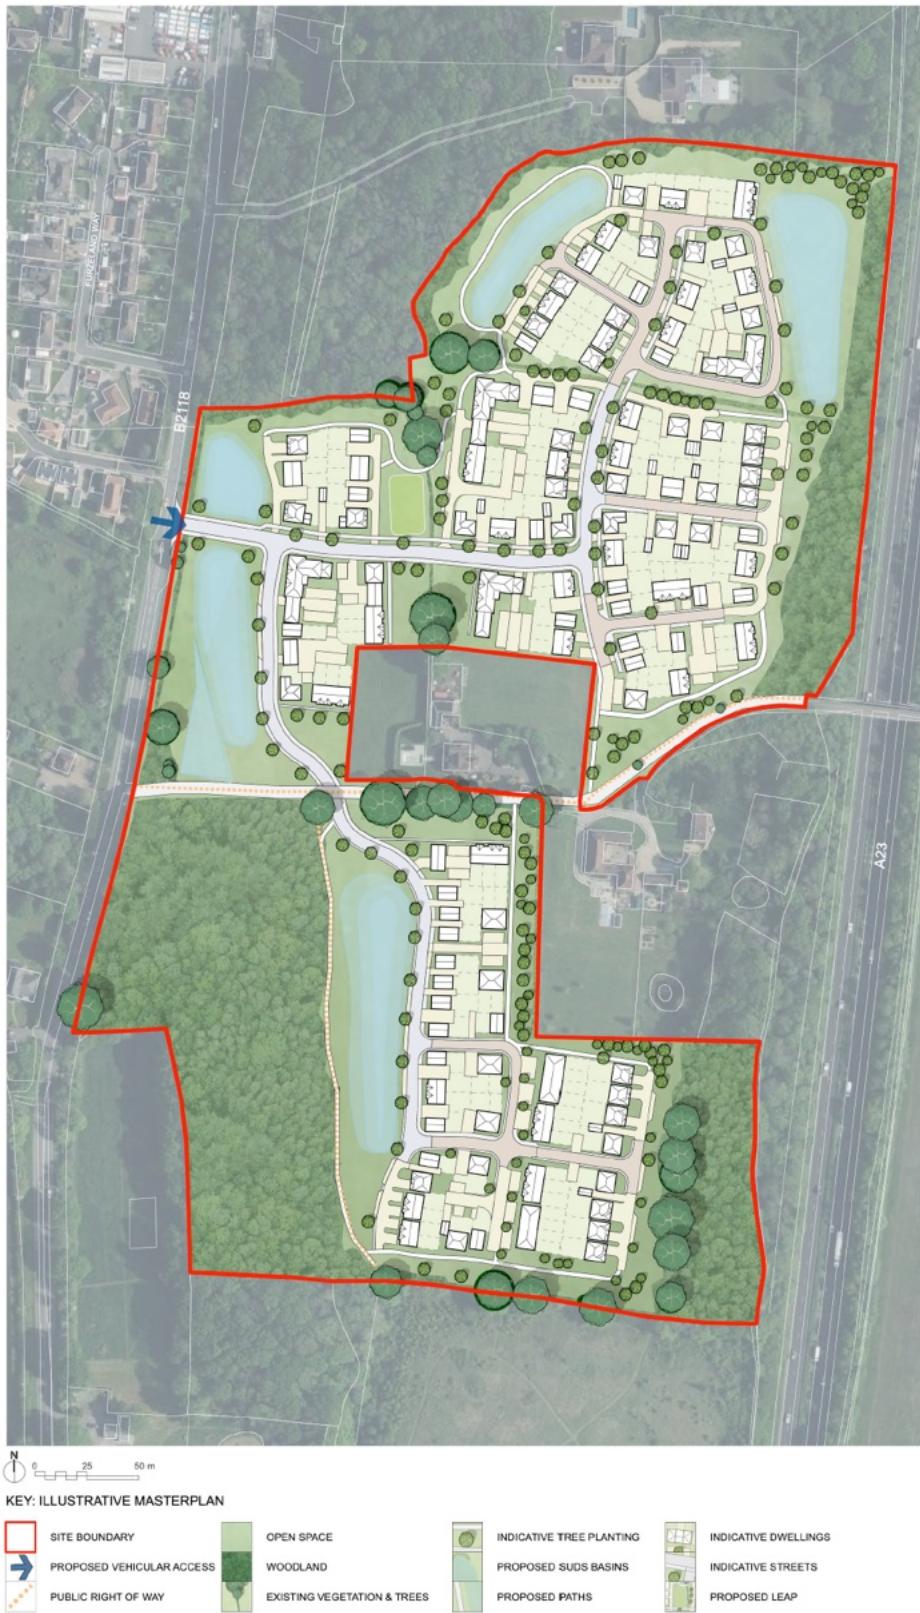
Figure 2: Illustrative Masterplan (Pegasus, 2025)

1.3 The assessment is based on the Illustrated Masterplan produced by Pegasus group (P24-2029_DE_002_E_05) (see Figure 2 below).

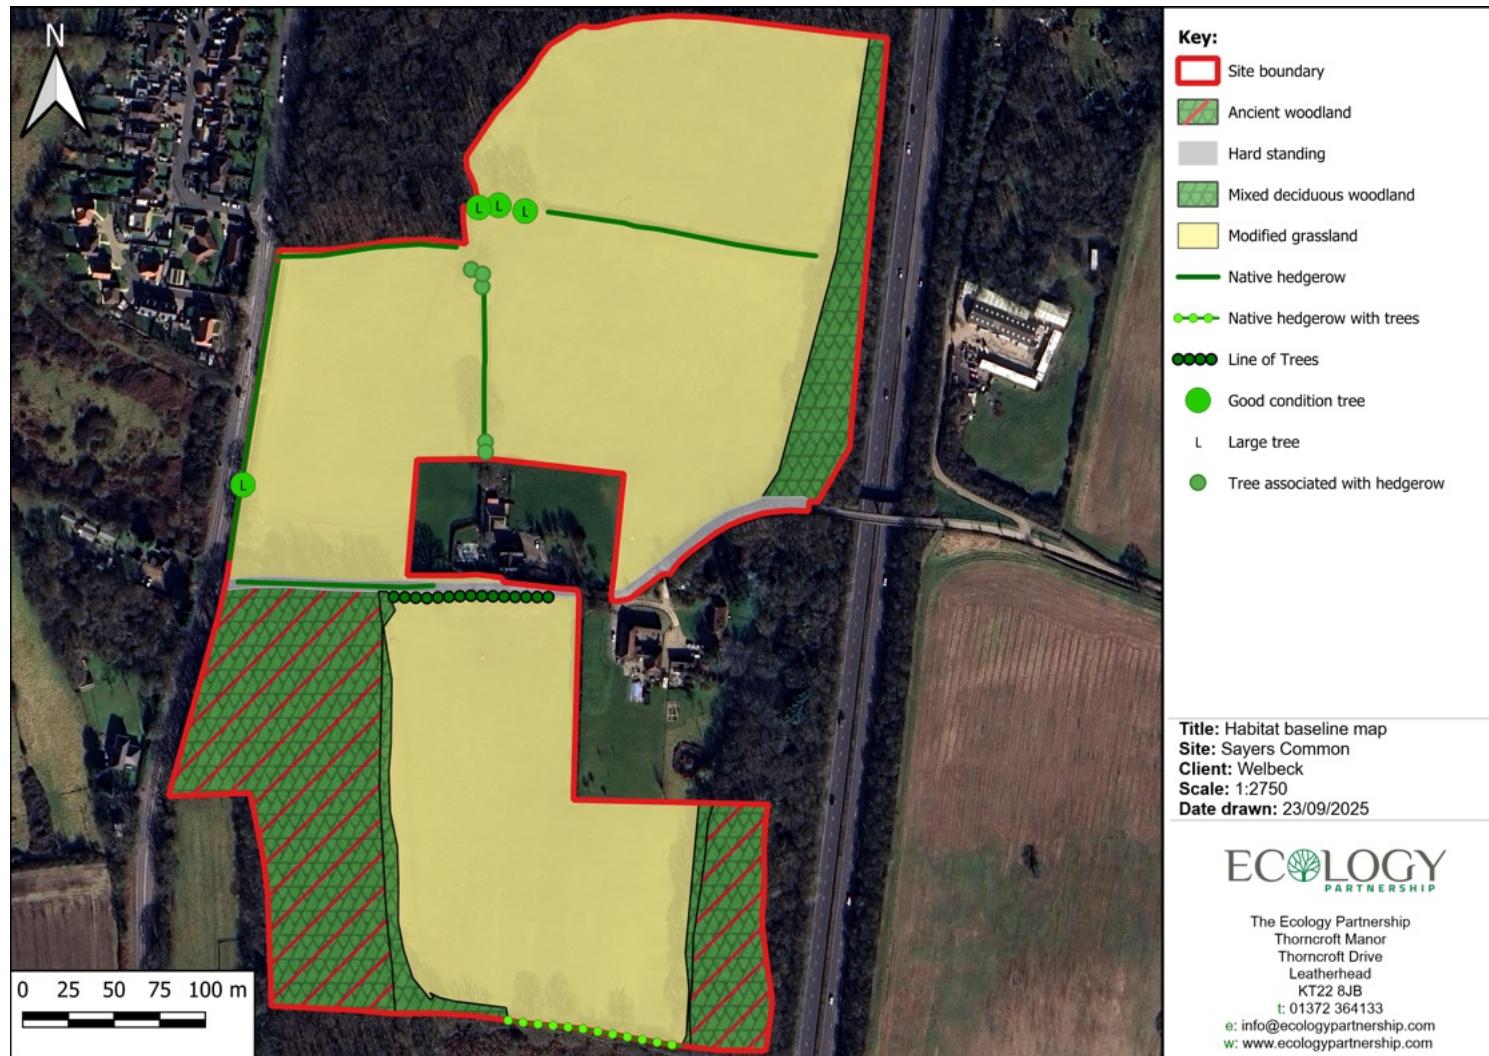
Figure 3: Baseline area habitats

2.4 The habitats currently present on site have been identified and assessed. These are shown in Figures 3 and 4 and in Tables 1 and 2, overleaf. A full condition assessment is presented in Appendix 1.

2.5 The four areas of grassland were considered to be largely similar in species composition and structure. Previous surveys recorded the fields being grazed by cows and sheep. The management of the fields appears to have maintained their low biodiversity value.

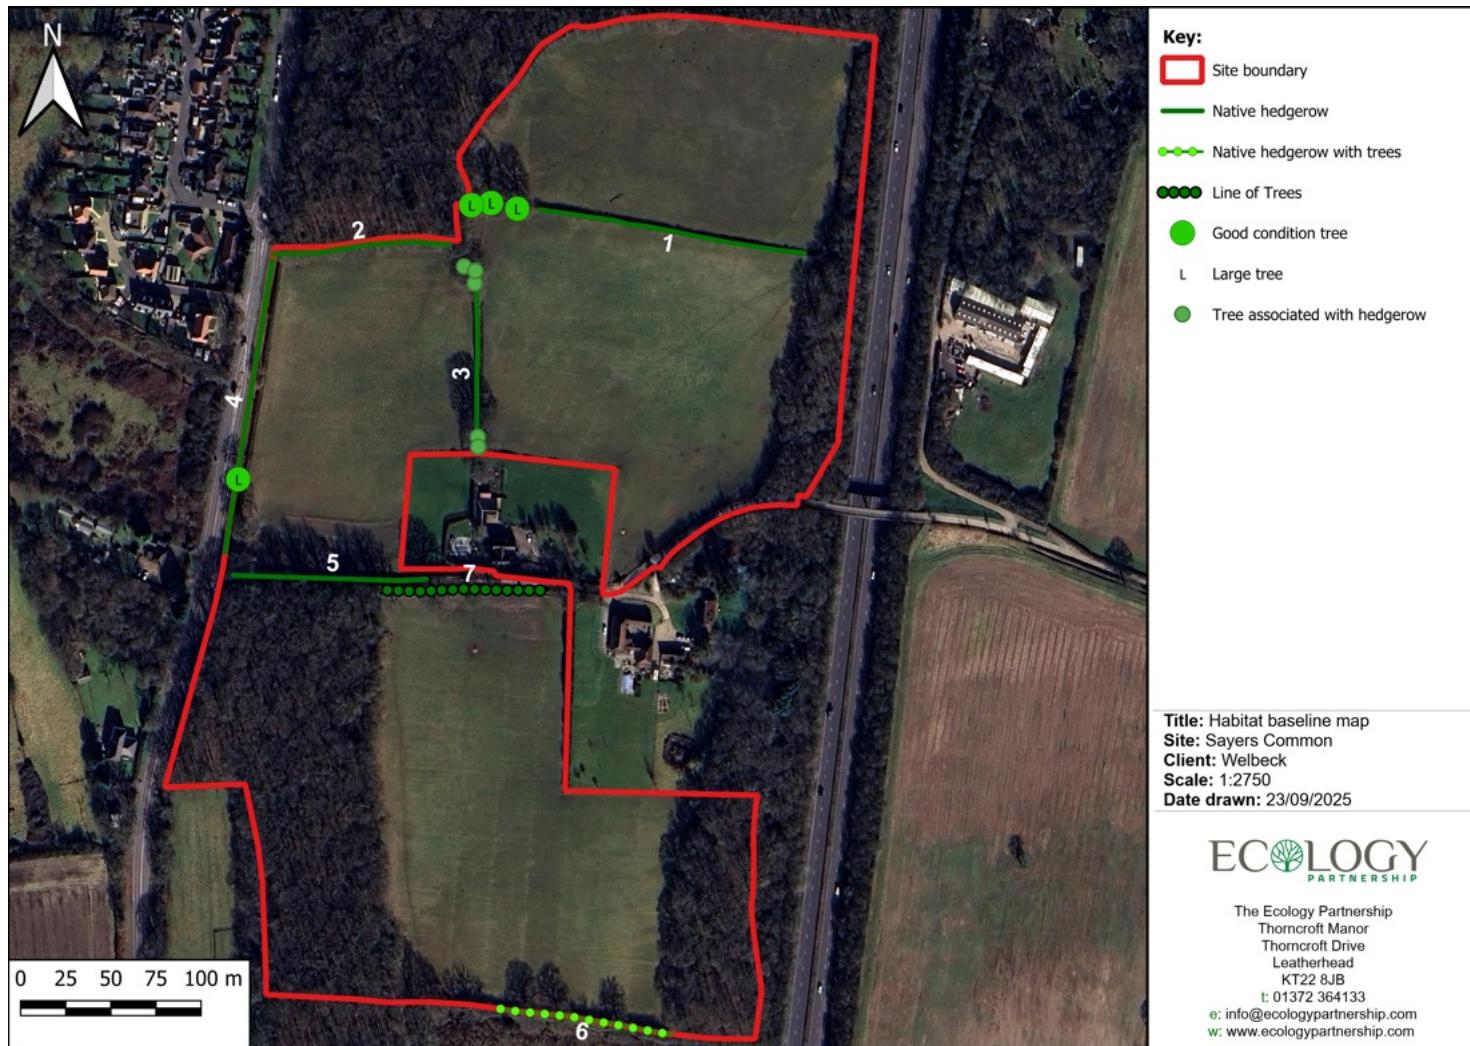
Figure 4: Baseline Linear habitats

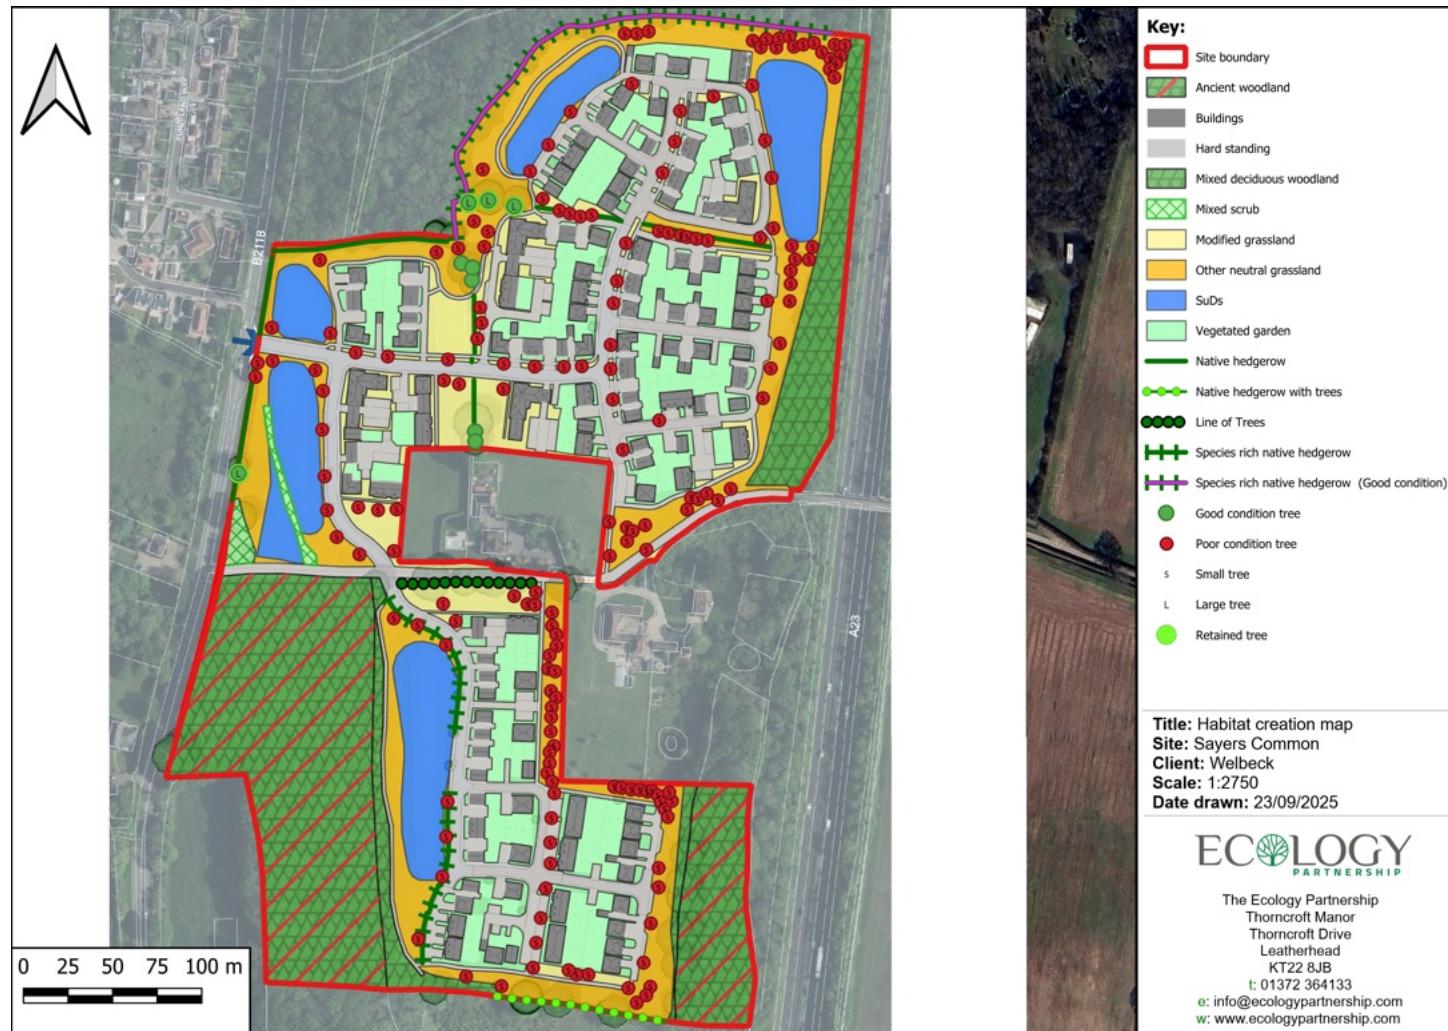
Figure 5. Proposed area habitats

- 2.6 The proposed development is largely centred within the grassland areas, whilst retaining/enhancing most of the boundary habitats, as well as all areas of woodland. The ancient woodland habitats are set within the red line boundary but are excluded from the metric.
- 2.7 The site boundaries will be enhanced with the creation of species-rich grassland, with scattered trees/scrub, and SUDS basins designed for wildlife. Extensive tree planting is proposed throughout the site and use of flowering lawns in areas which areas of grassland to be managed to a shorter sward.
- 2.8 The proposed habitat areas are detailed in Tables 3 and 4, and Figure 5 below for habitats and Figure 6 for the linear units.

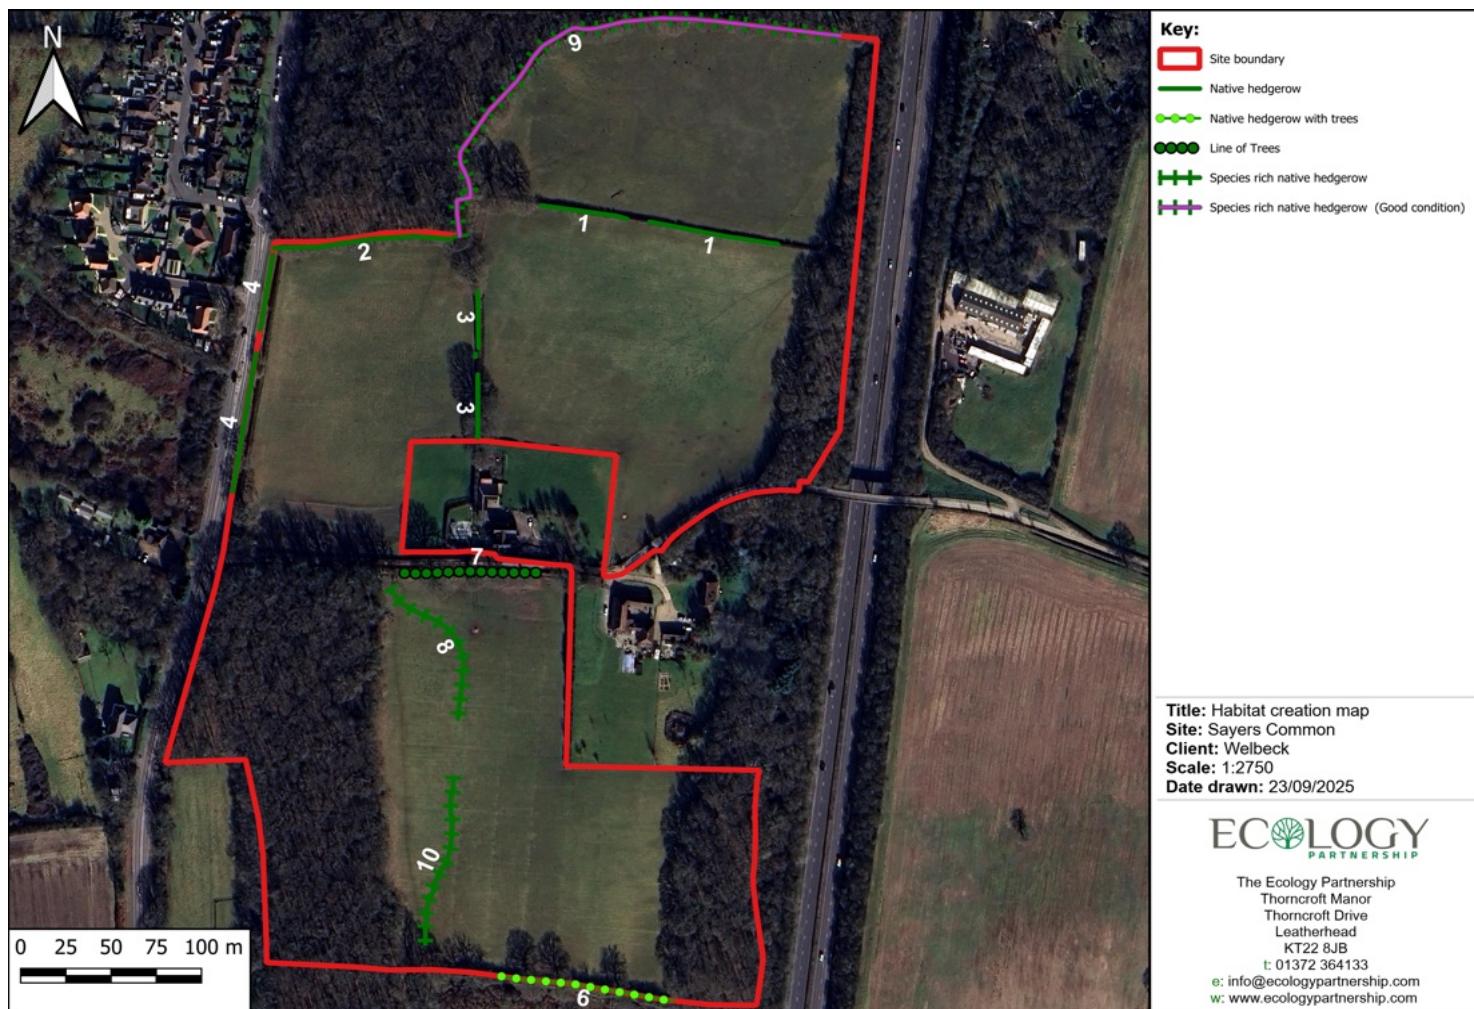
Figure 6. Proposed linear habitats

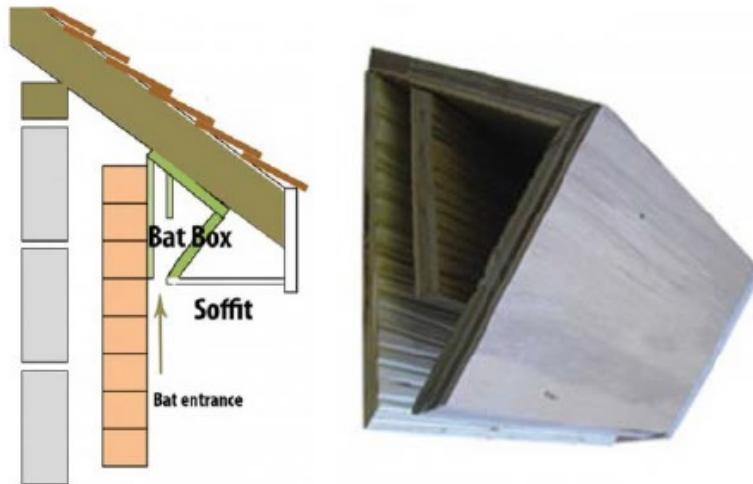
3.3 Examples of integrated roosts which can be incorporated into certain buildings such as a soffit bat box (Figure 7). This caters for crevice-dwelling species such as pipistrelles and certain *Myotis* species. This type of box makes use of an underutilised area of a building

and would require no maintenance as droppings would drop through the entrance hole. These should be located on buildings close to linear features and dark corridors and if installed on private buildings, the owners should be made aware of their purpose and legal protection.

Figure 7: Soffit bat box (Wildcare)

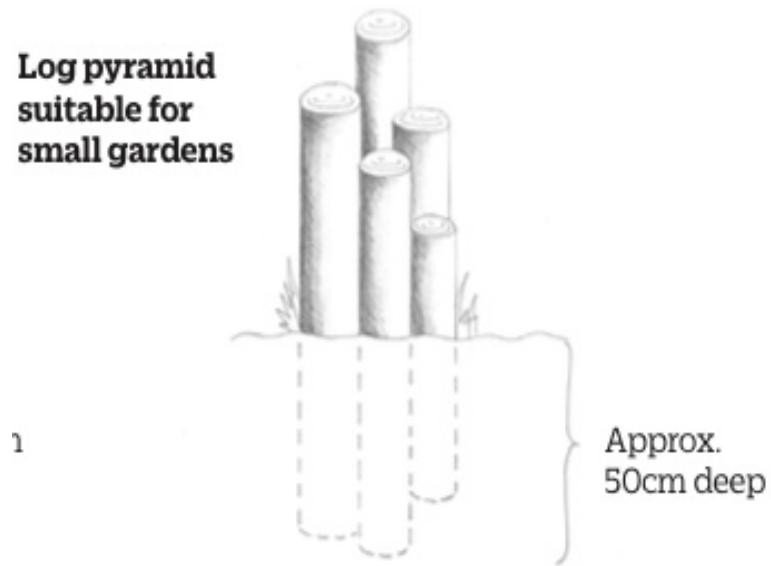
3.4 Log piles should be created on Site, especially in the newly created wildflower meadow, in order to provide further habitats for a wide range of invertebrates, which in turn provides a food source for larger fauna, and hence increasing the biodiversity of the Site. Log piles should be made from native, broadleaved trees, and should be partially buried (Figure 8). They should be located within shady areas of the Site and along the SuDS.

Figure 8: Example of a log pile to be built on Site

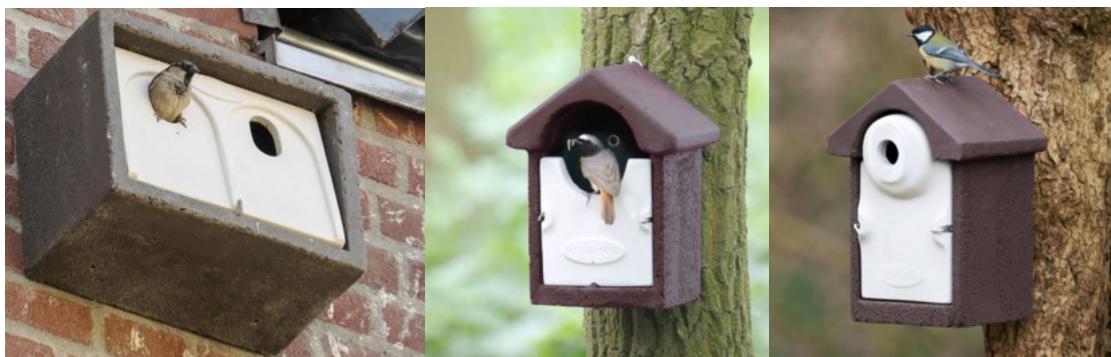
3.5 Additional nesting opportunities can be installed within existing trees on Site, or new buildings including garage areas. Again, hardwearing woodcrete boxes, or similar, are recommended. Figure 9 below gives examples of suitable bird boxes which could be installed onto the brickwork of the units or into the trees. The box should be positioned on a north or east facing aspect and at least 2m above the ground if possible. These would cater for species such as house sparrows and wagtails and the smaller garden birds.

Figure 9: Examples of suitable bird boxes which could be installed on site – Vivara Pro WoodStone House Sparrow Nest Box (left), Vivara Pro Barcelona WoodStone Open Nest Box (centre) and Vivara Pro Seville 32mm WoodStone Nest Box (right)

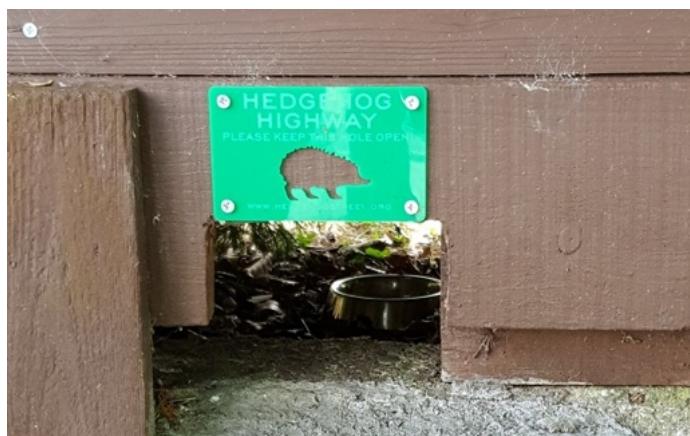
3.6 All adjoining garden fences on Site will have a 13cm x 13cm hole at the bottom to provide a passageway for hedgehogs to travel between gardens and other habitats on site. Fences and walls are one of the main reasons why hedgehog numbers are declining as the amount of land available to them is reduced. To ensure that new residents do not block these 'highways', small signs can be erected above the hole, such as those produced by the People's Trust for Endangered Species (PTES), informing them of their purpose (Figure 10).

Figure 10: Hedgehog highway sign for fences (hedgehogstreet.org)
