| Dwg No. | 25041E-P-102 / |
| Drawing Title | New Opening in Balustrade |
| Address | Wykehurst House |
| Stage | Planning |

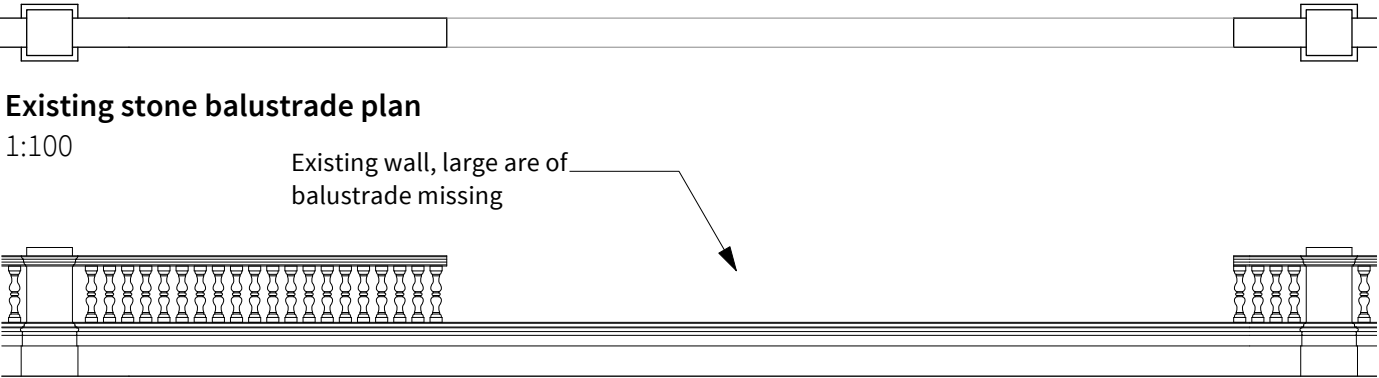
Existing stone balustrade elevation 1:100

Reinstate historic opening in wall. Wall currently in disrepair. Refer to following applications for information on proposed wall repair: DM/25/2644 and 2645. This will be an additional opening within the repaired wall. Pillar stonework design to match existing, using traditional techniques.

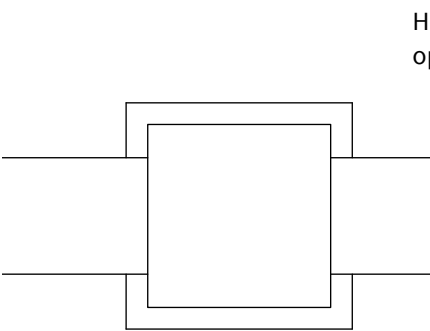
Historic pedestrian opening

Historical photo and map below illustrates there was originally a pedestrian opening within this wall. Therefore this is being reinstated. The pillars will be replicated in style and material.

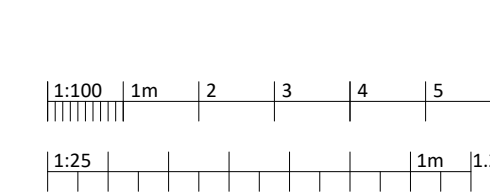
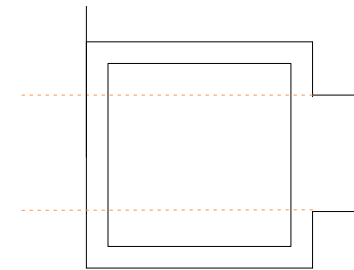
Proposed Stone Balustade - Standard Elevation Detail 1:25 @A1

Lower section of wall to be cut away to create new opening
