IPX1218

Soil Infiltration Testing Report
Penland Farm, Hanlye Lane, Cuckfield,
Haywards Heath, RH17 5HR

October 25

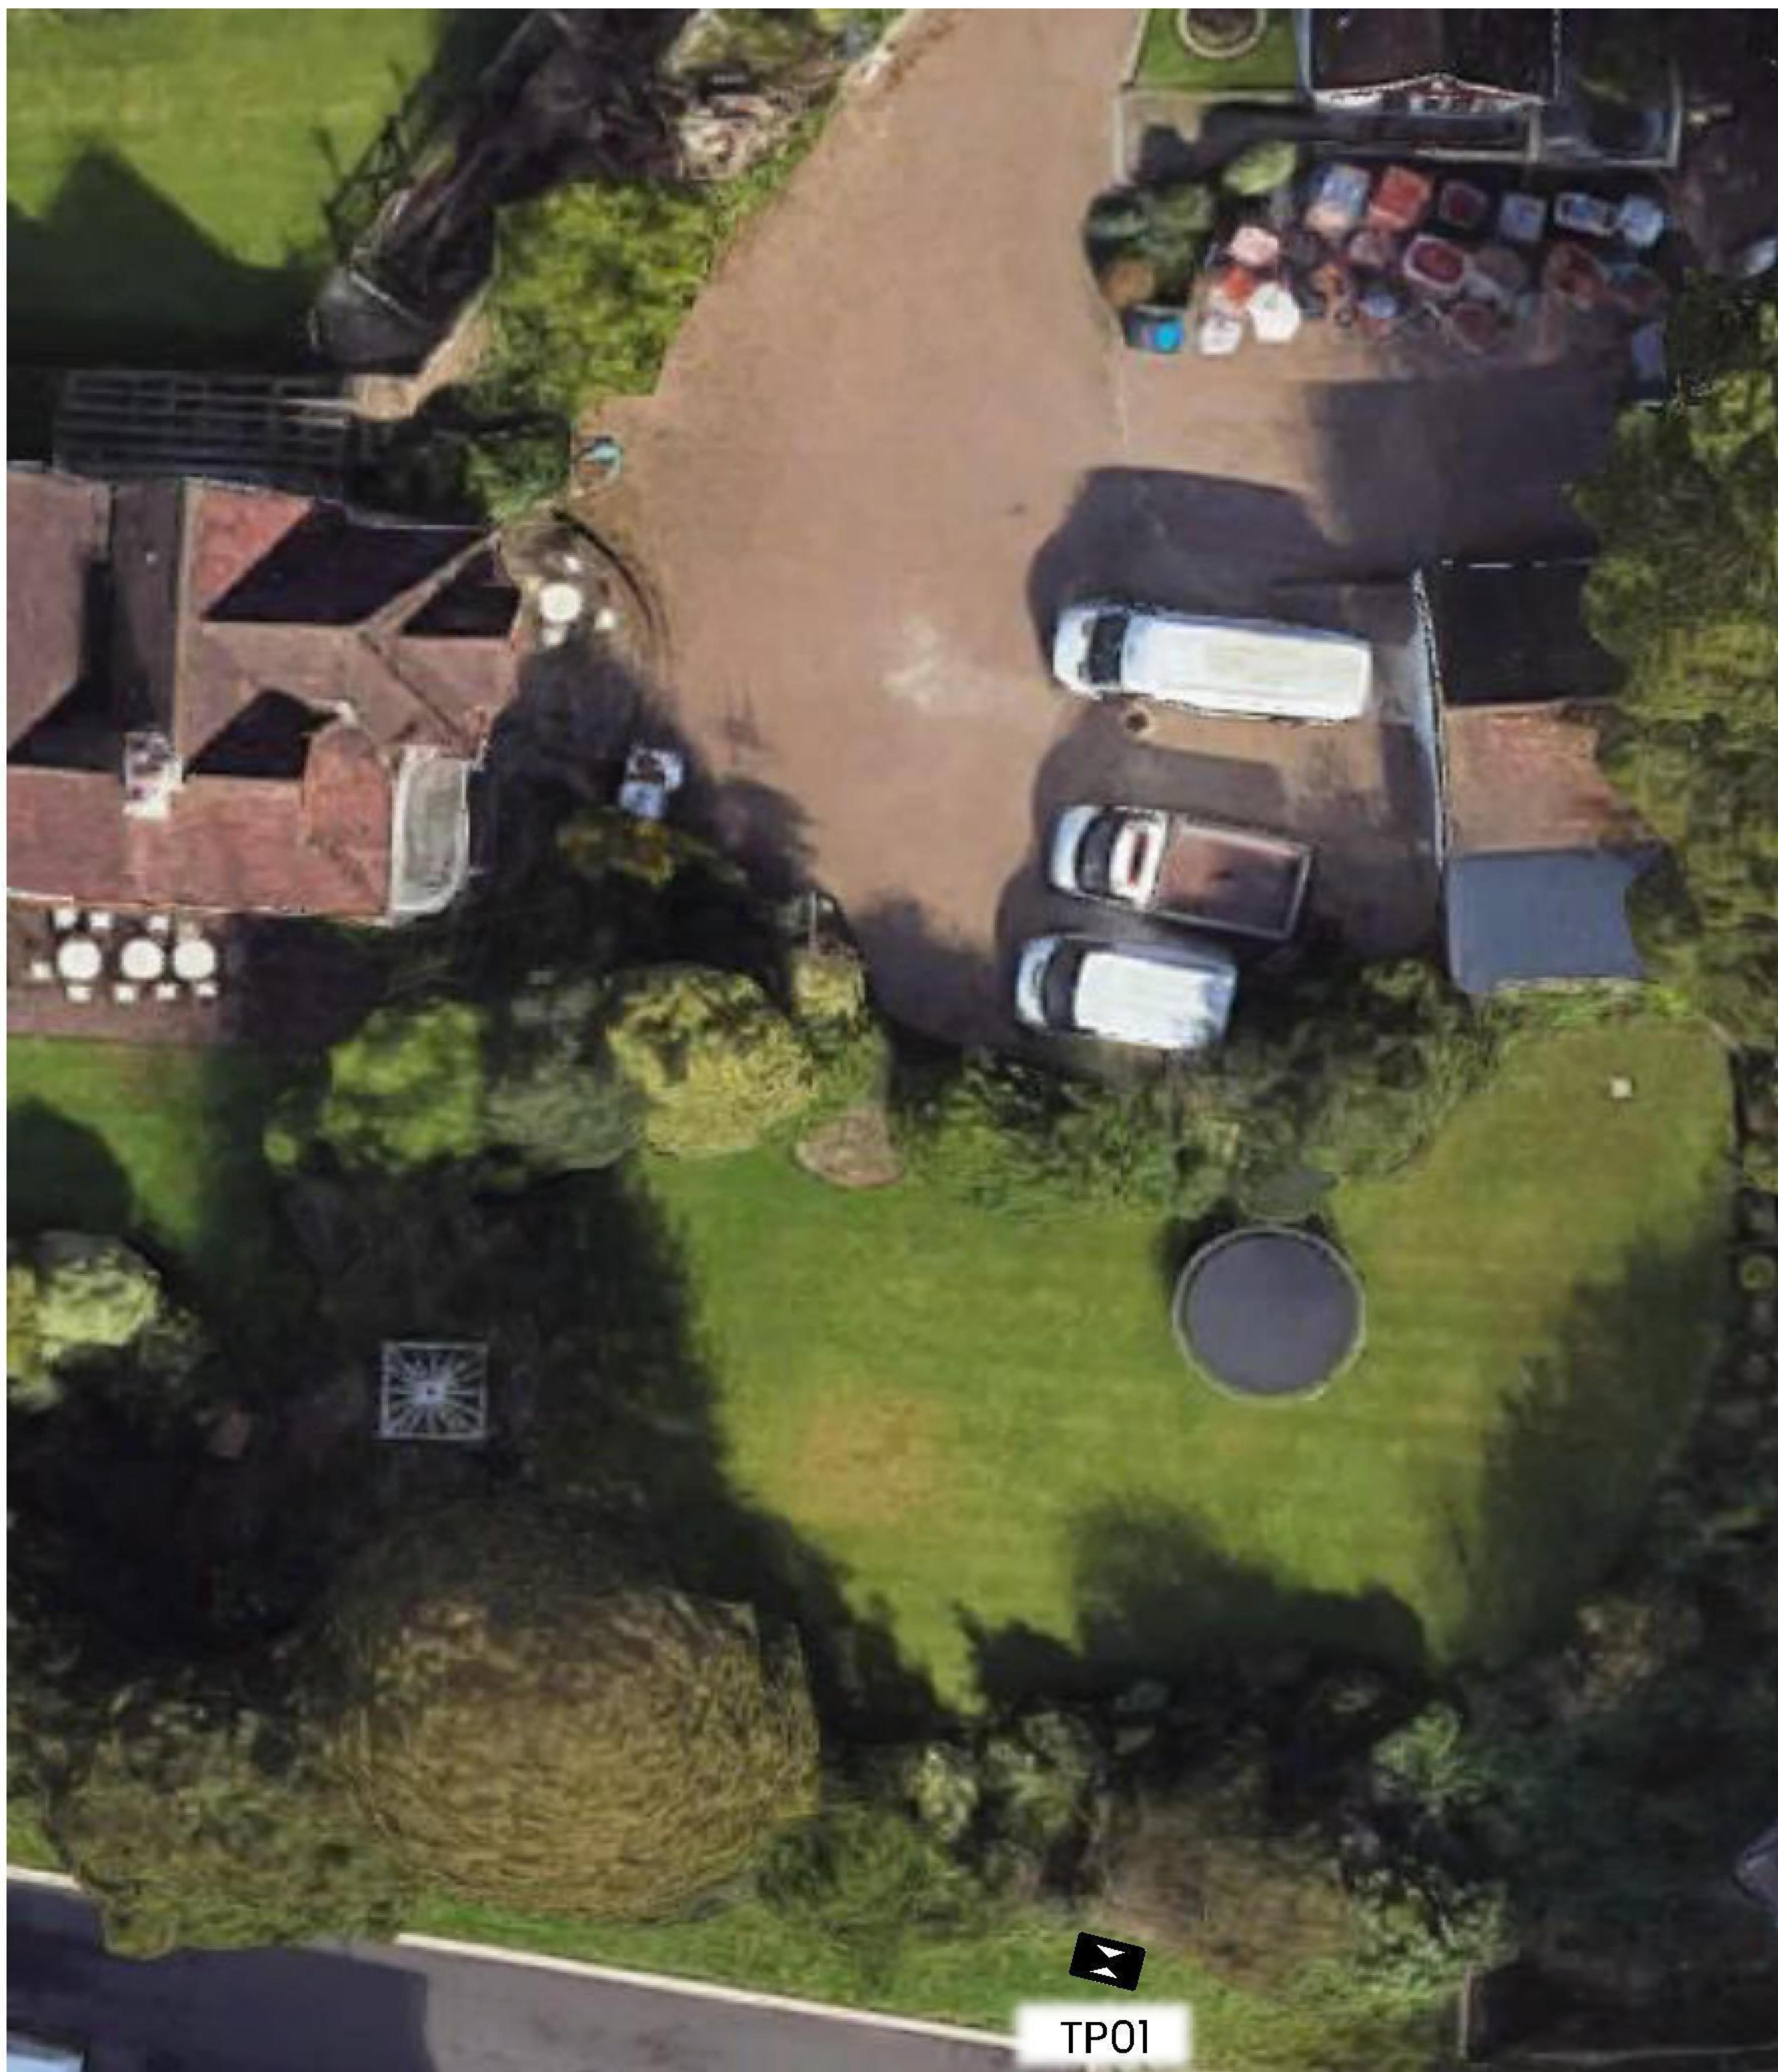
Site Investigation Plan

TP01

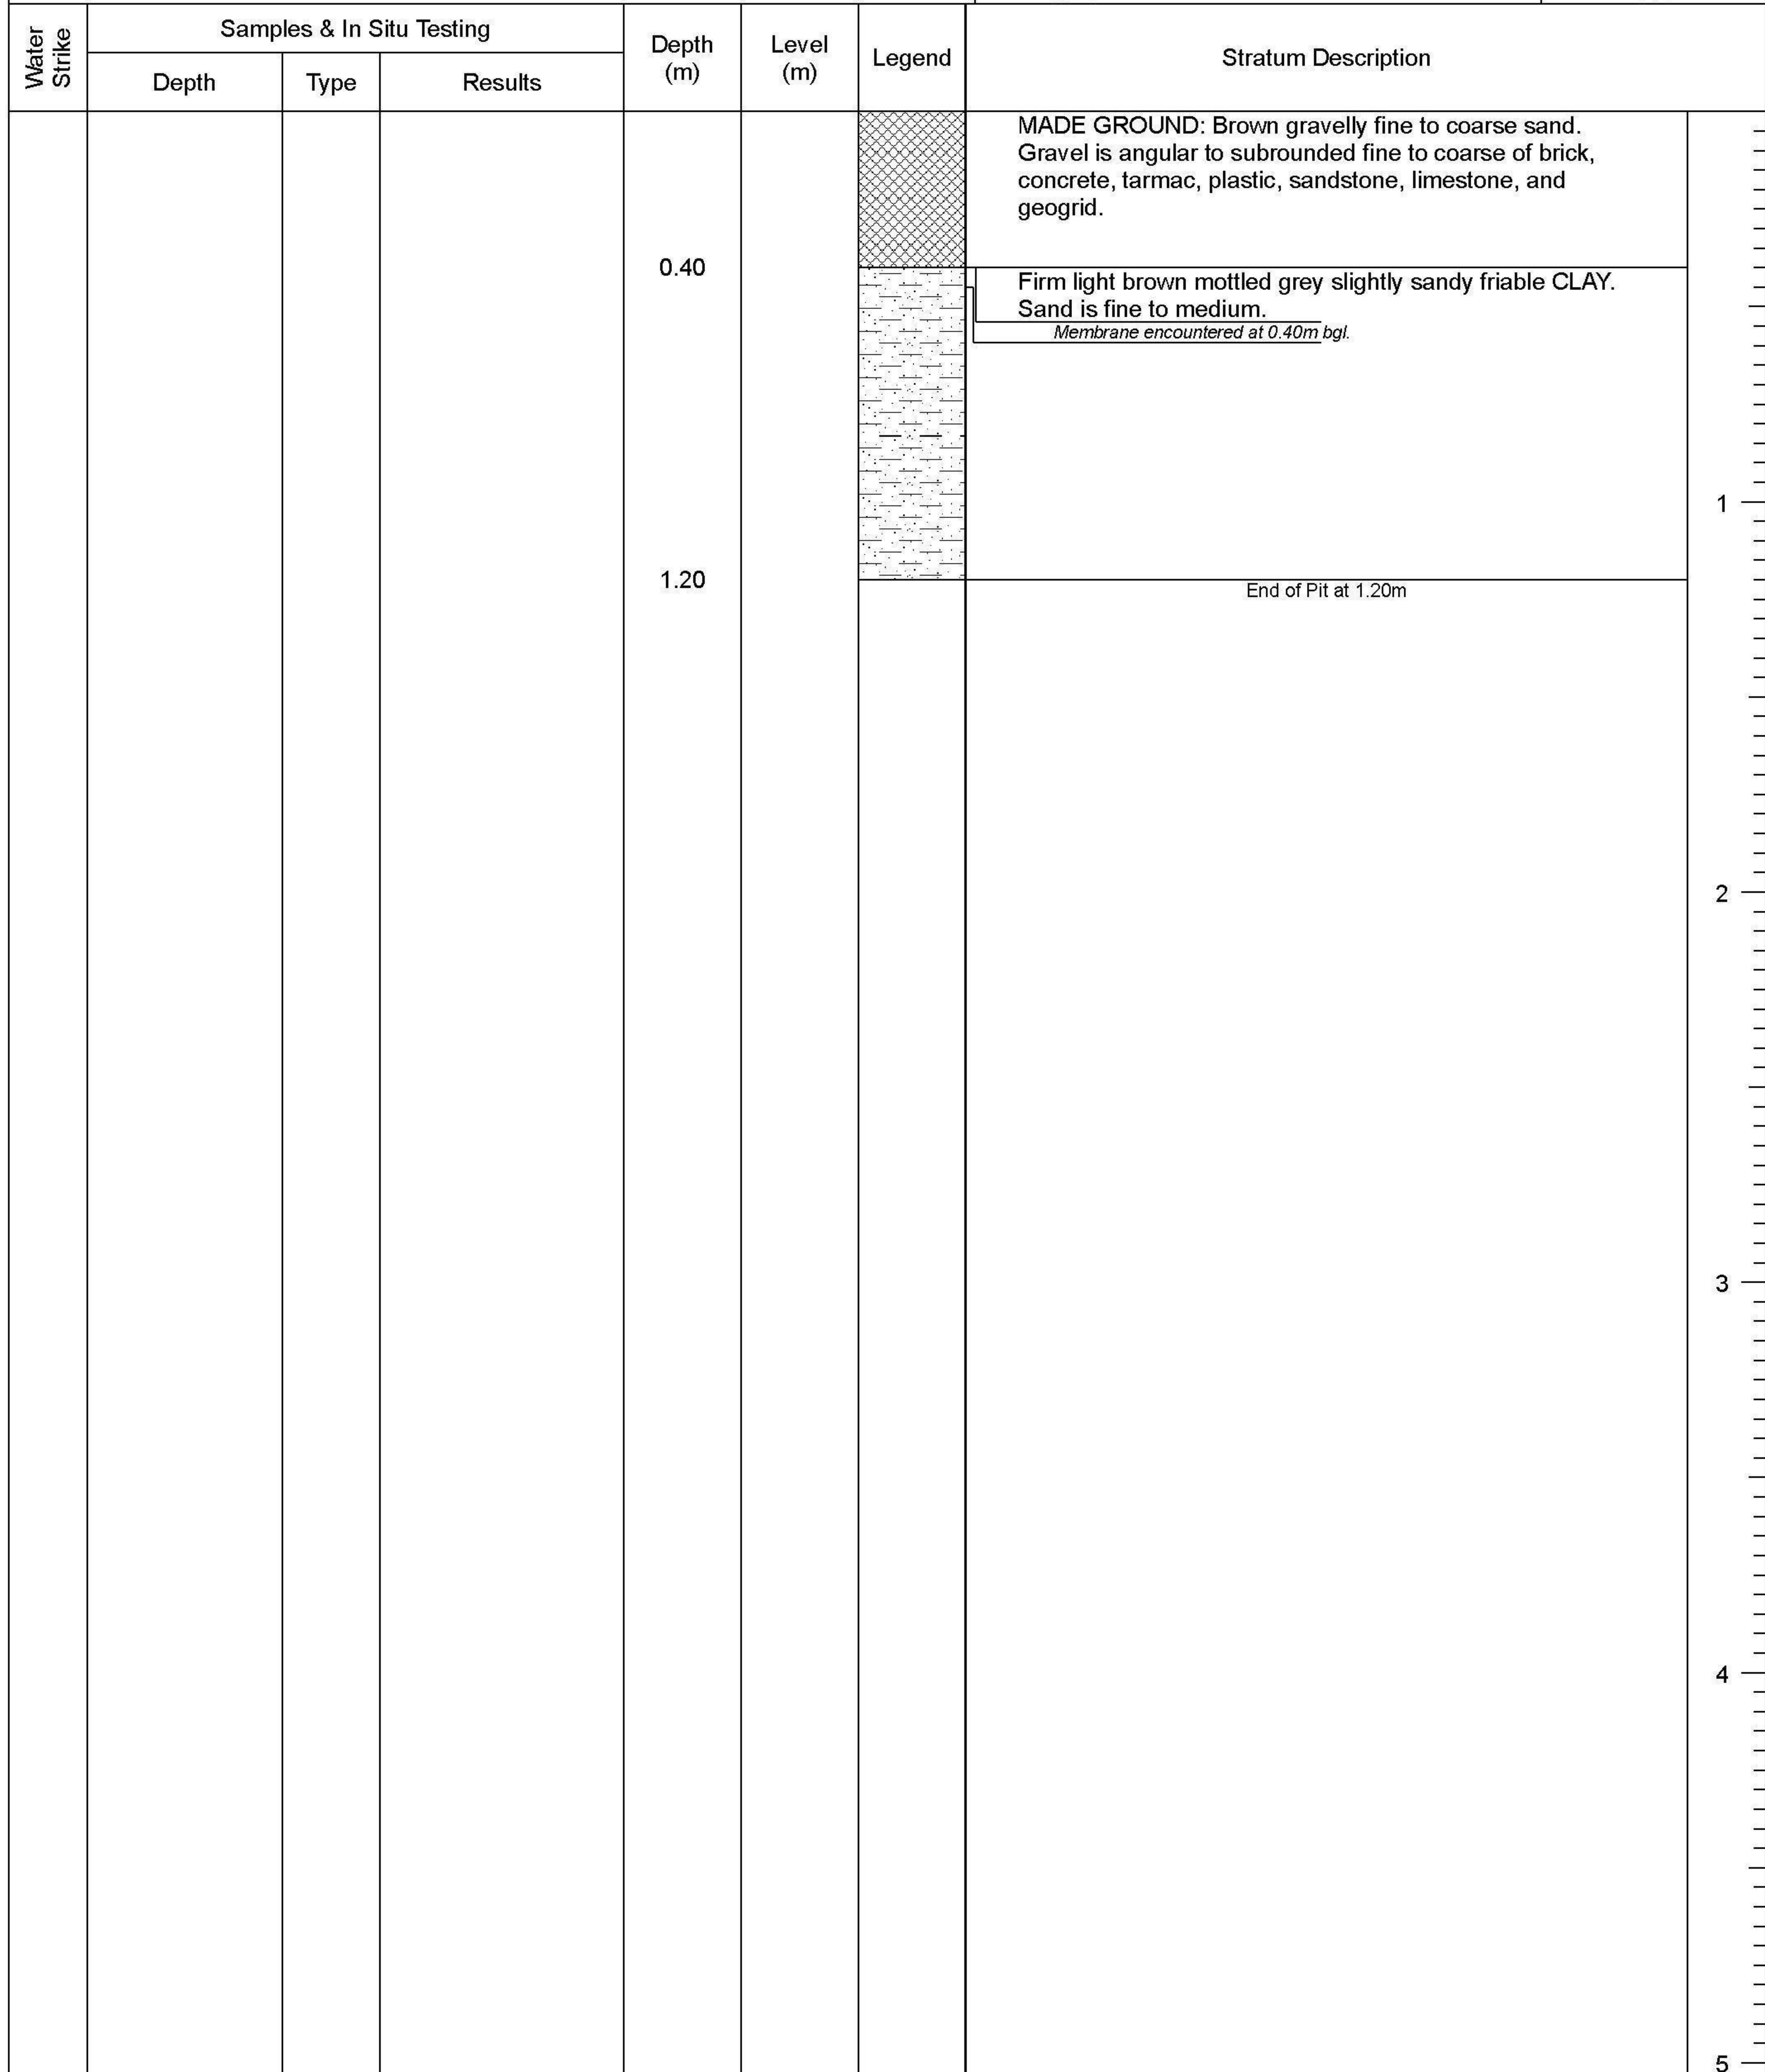
Trial Pit Log

Made Ground was encountered in TP01 from ground level to a depth of 0.40m bgl and comprised brown gravelly fine to coarse sand with constituents of brick, concrete, tarmac, plastic, sandstone, limestone, and geogrid.

Bedrock deposits were encountered in TP01 from a depth of 0.40m bgl to a depth of 1.20m bgl and comprised firm light brown mottled grey slightly sandy friable CLAY.

Remarks: Location cleared of services using handheld CAT scanner. Trial pit excavated to 1.20m bgl. No groundwater encountered. Soil infiltration testing carried out. Trial pit backfilled with arisings.

Stability: Stable

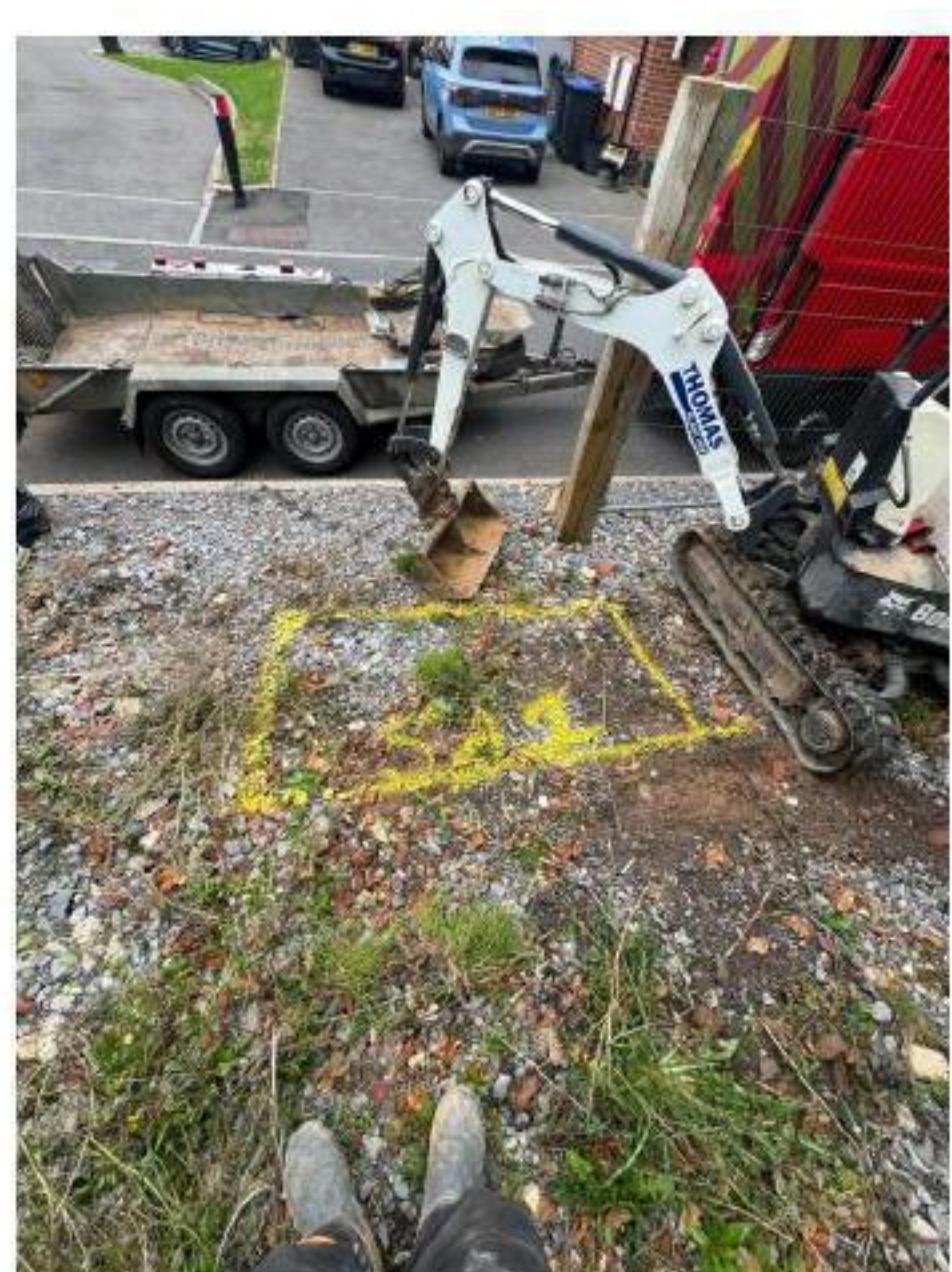
Location of TP01

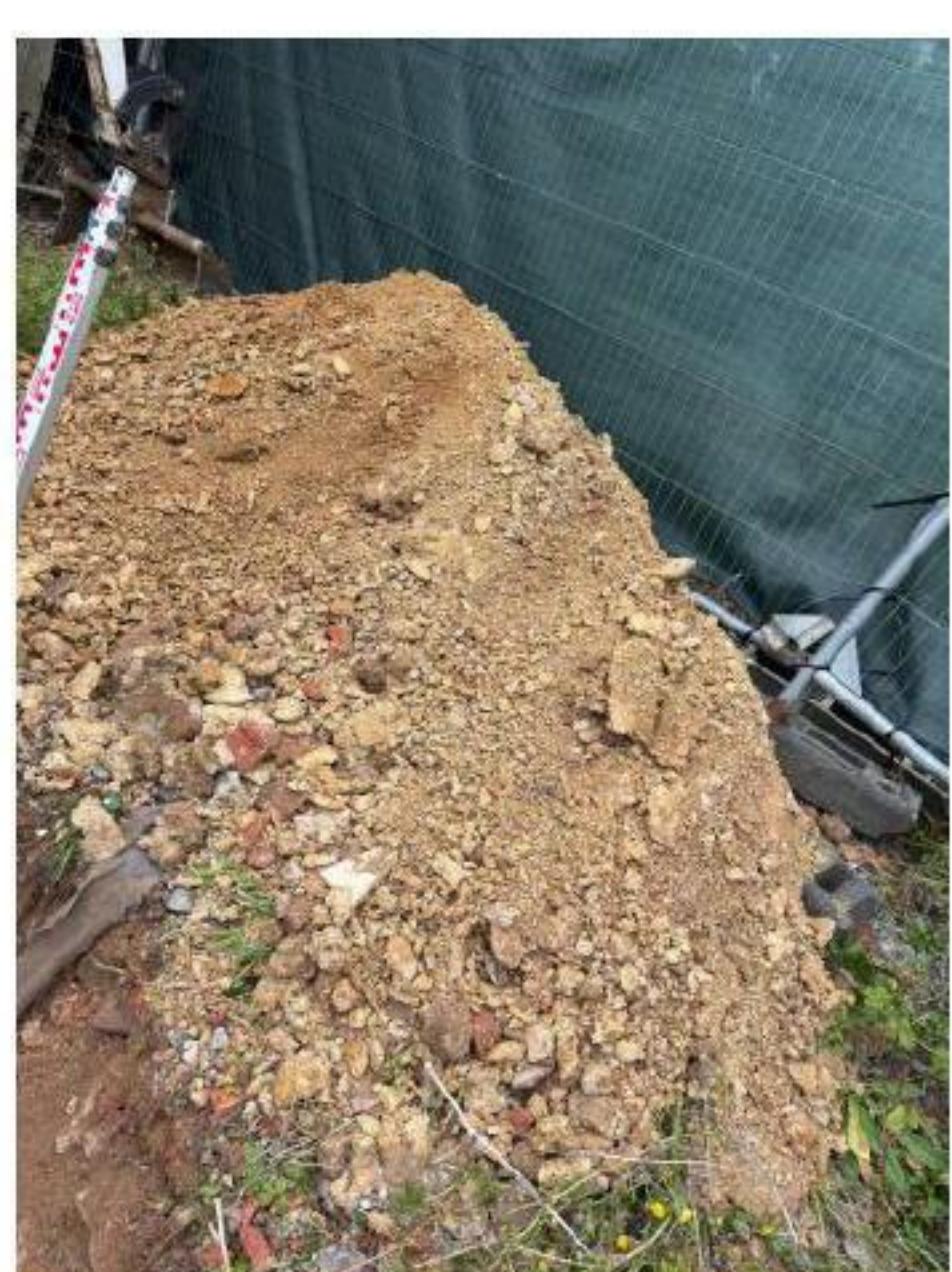
Arisings from TP01

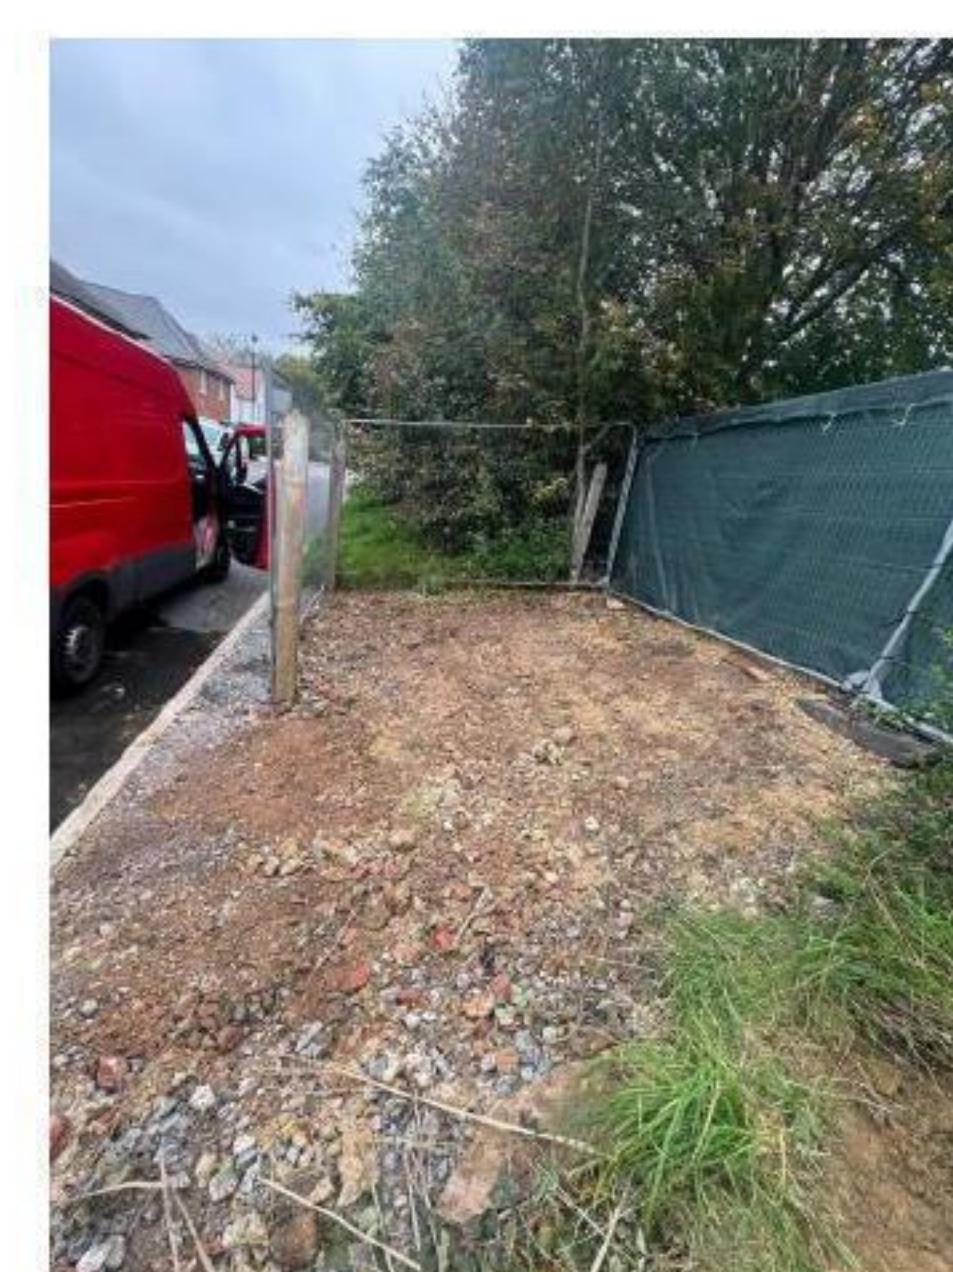
TP01 Backfilled

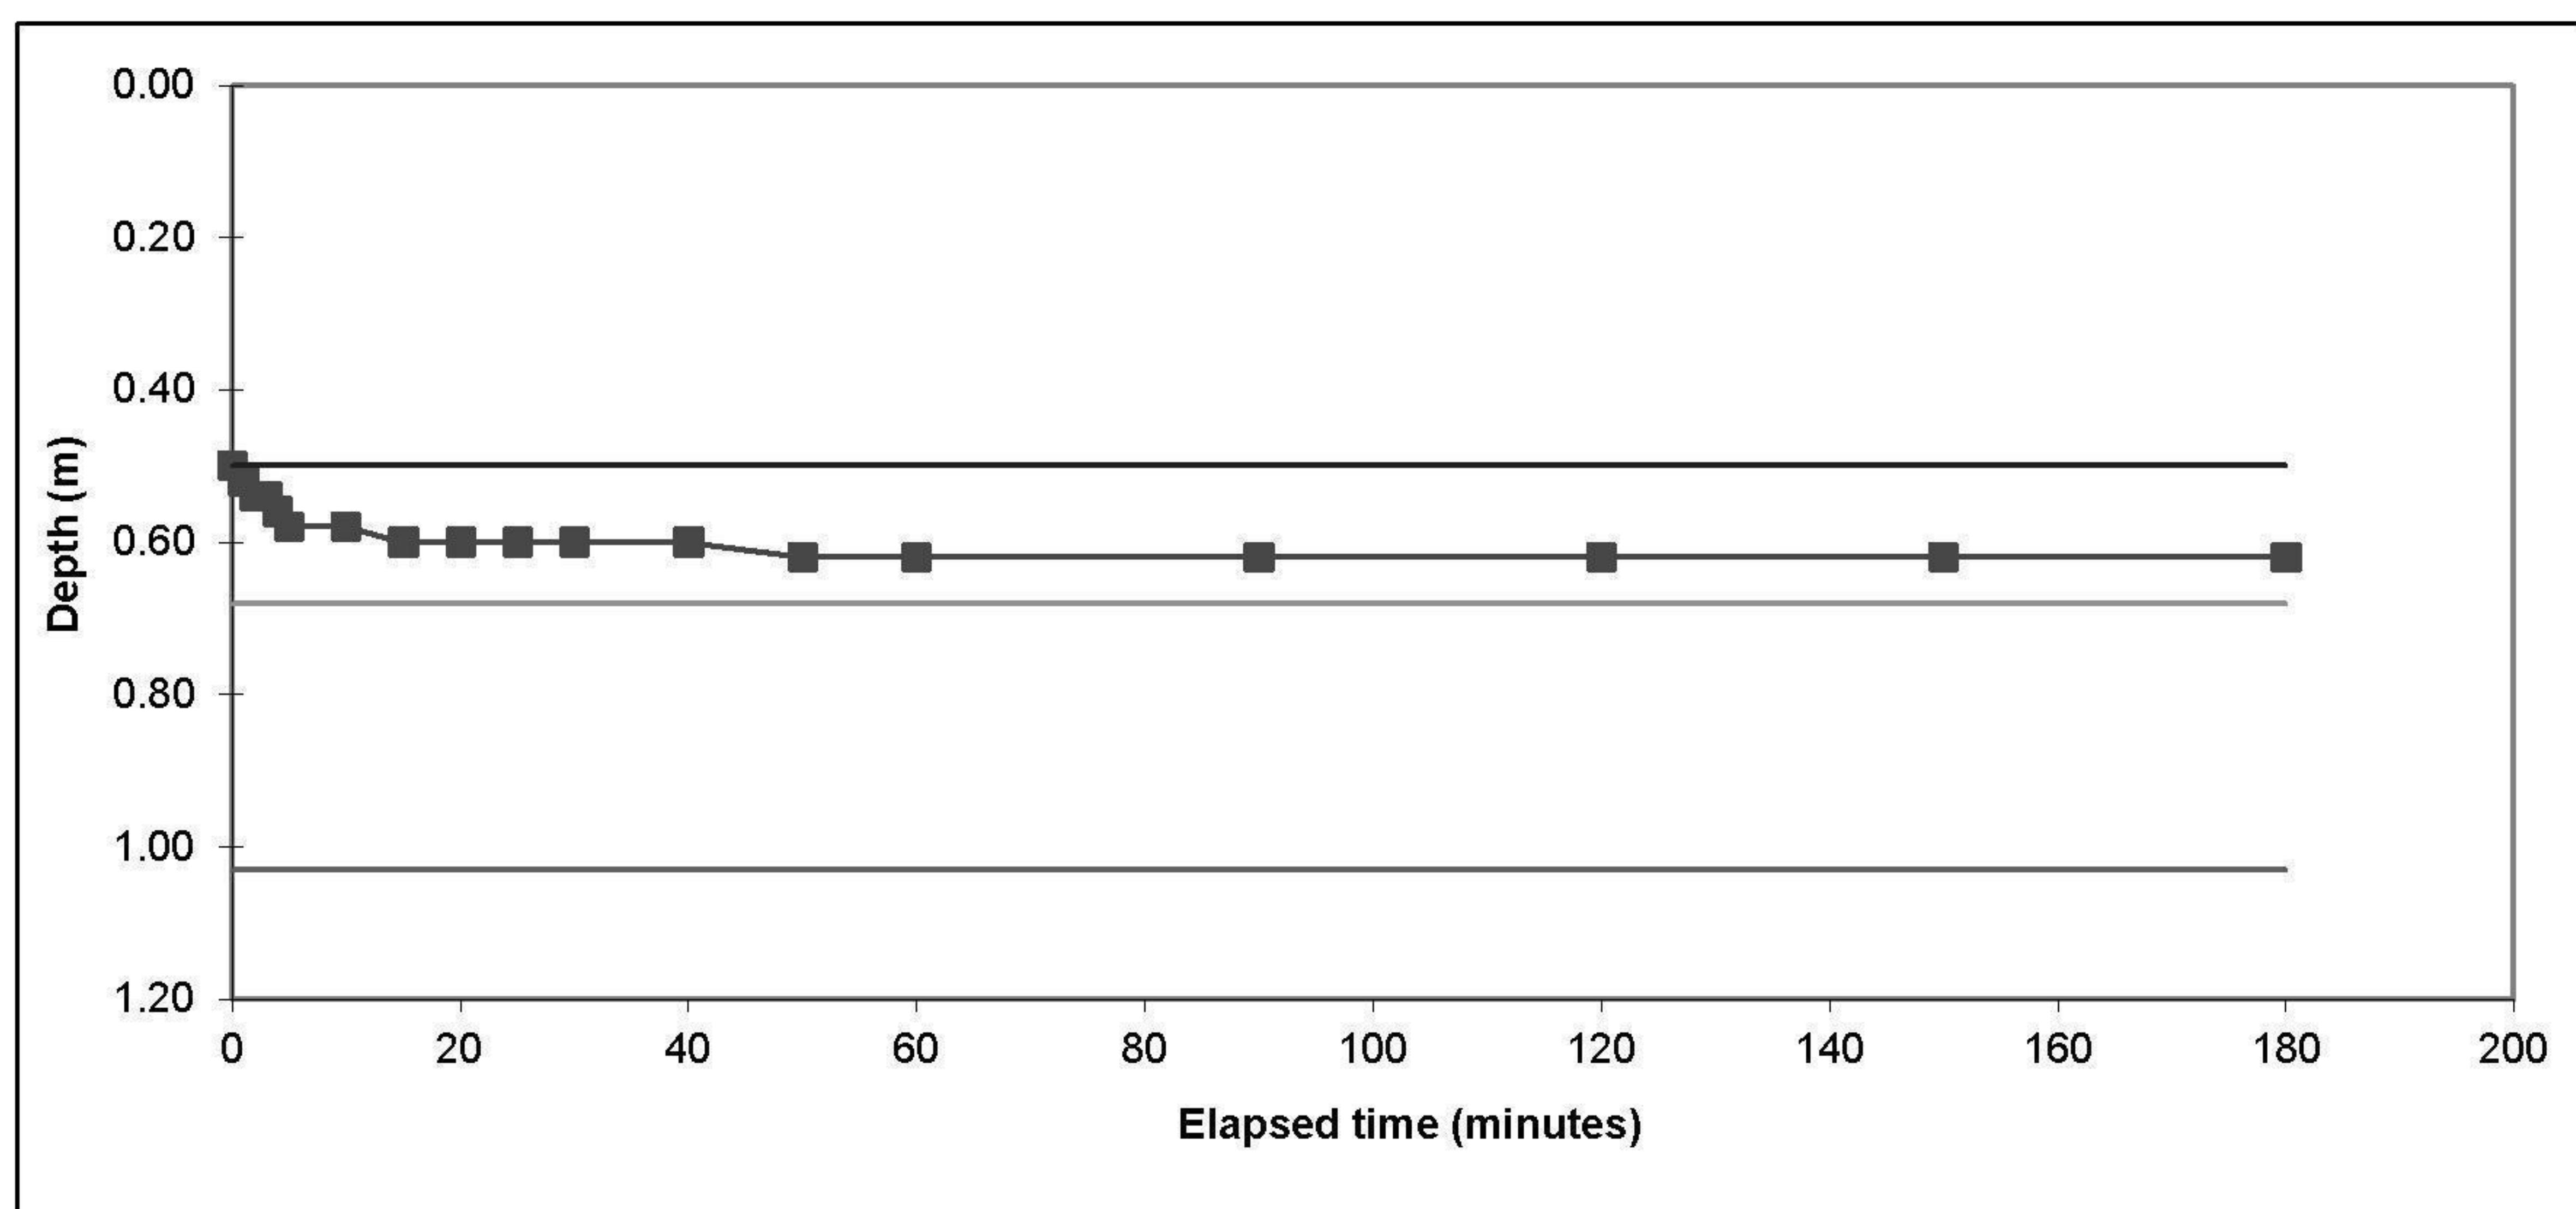
Trial Pit No:	TP01	Test No:	1	Date:	10/10/2025
Length (m):	1.50	Datum Height:	0.00 m agl		
Width (m):	1.30	Granular infill:	None		
Depth (m):	1.20	Porosity of infill:	1	(assumed)

Start water depth for analysis (mbgl):	0.50	Elapsed time (mins):	#N/A
75% effective depth (mbgl):	0.68		
50% effective depth (mbgl):	0.85		
25% effective depth (mbgl):	1.03	Elapsed time (mins):	#N/A
Base of soakage zone (mbgl):	1.20		
Volume outflow between 75% and 25% effective depth (m ³):			
Mean surface area of outflow (m ²):		3.25	
(side area at 50% effective depth + base area)			
Time for outflow between 75% and 25% effective depth (mins):			
Soil infiltration rate (m/s):	Test incomplete as 25% effective depth not achieved. Unable to reliably determine soil infiltration rate.		
Remarks	Results processed following BRE 365 (2007).

The shallow soils encountered beneath the site were found to be sandy Clay. The soakage rates obtained during the investigation were found to be poor. Given the data from the test, it is considered that the use of shallow soakaways is not suitable for this site.

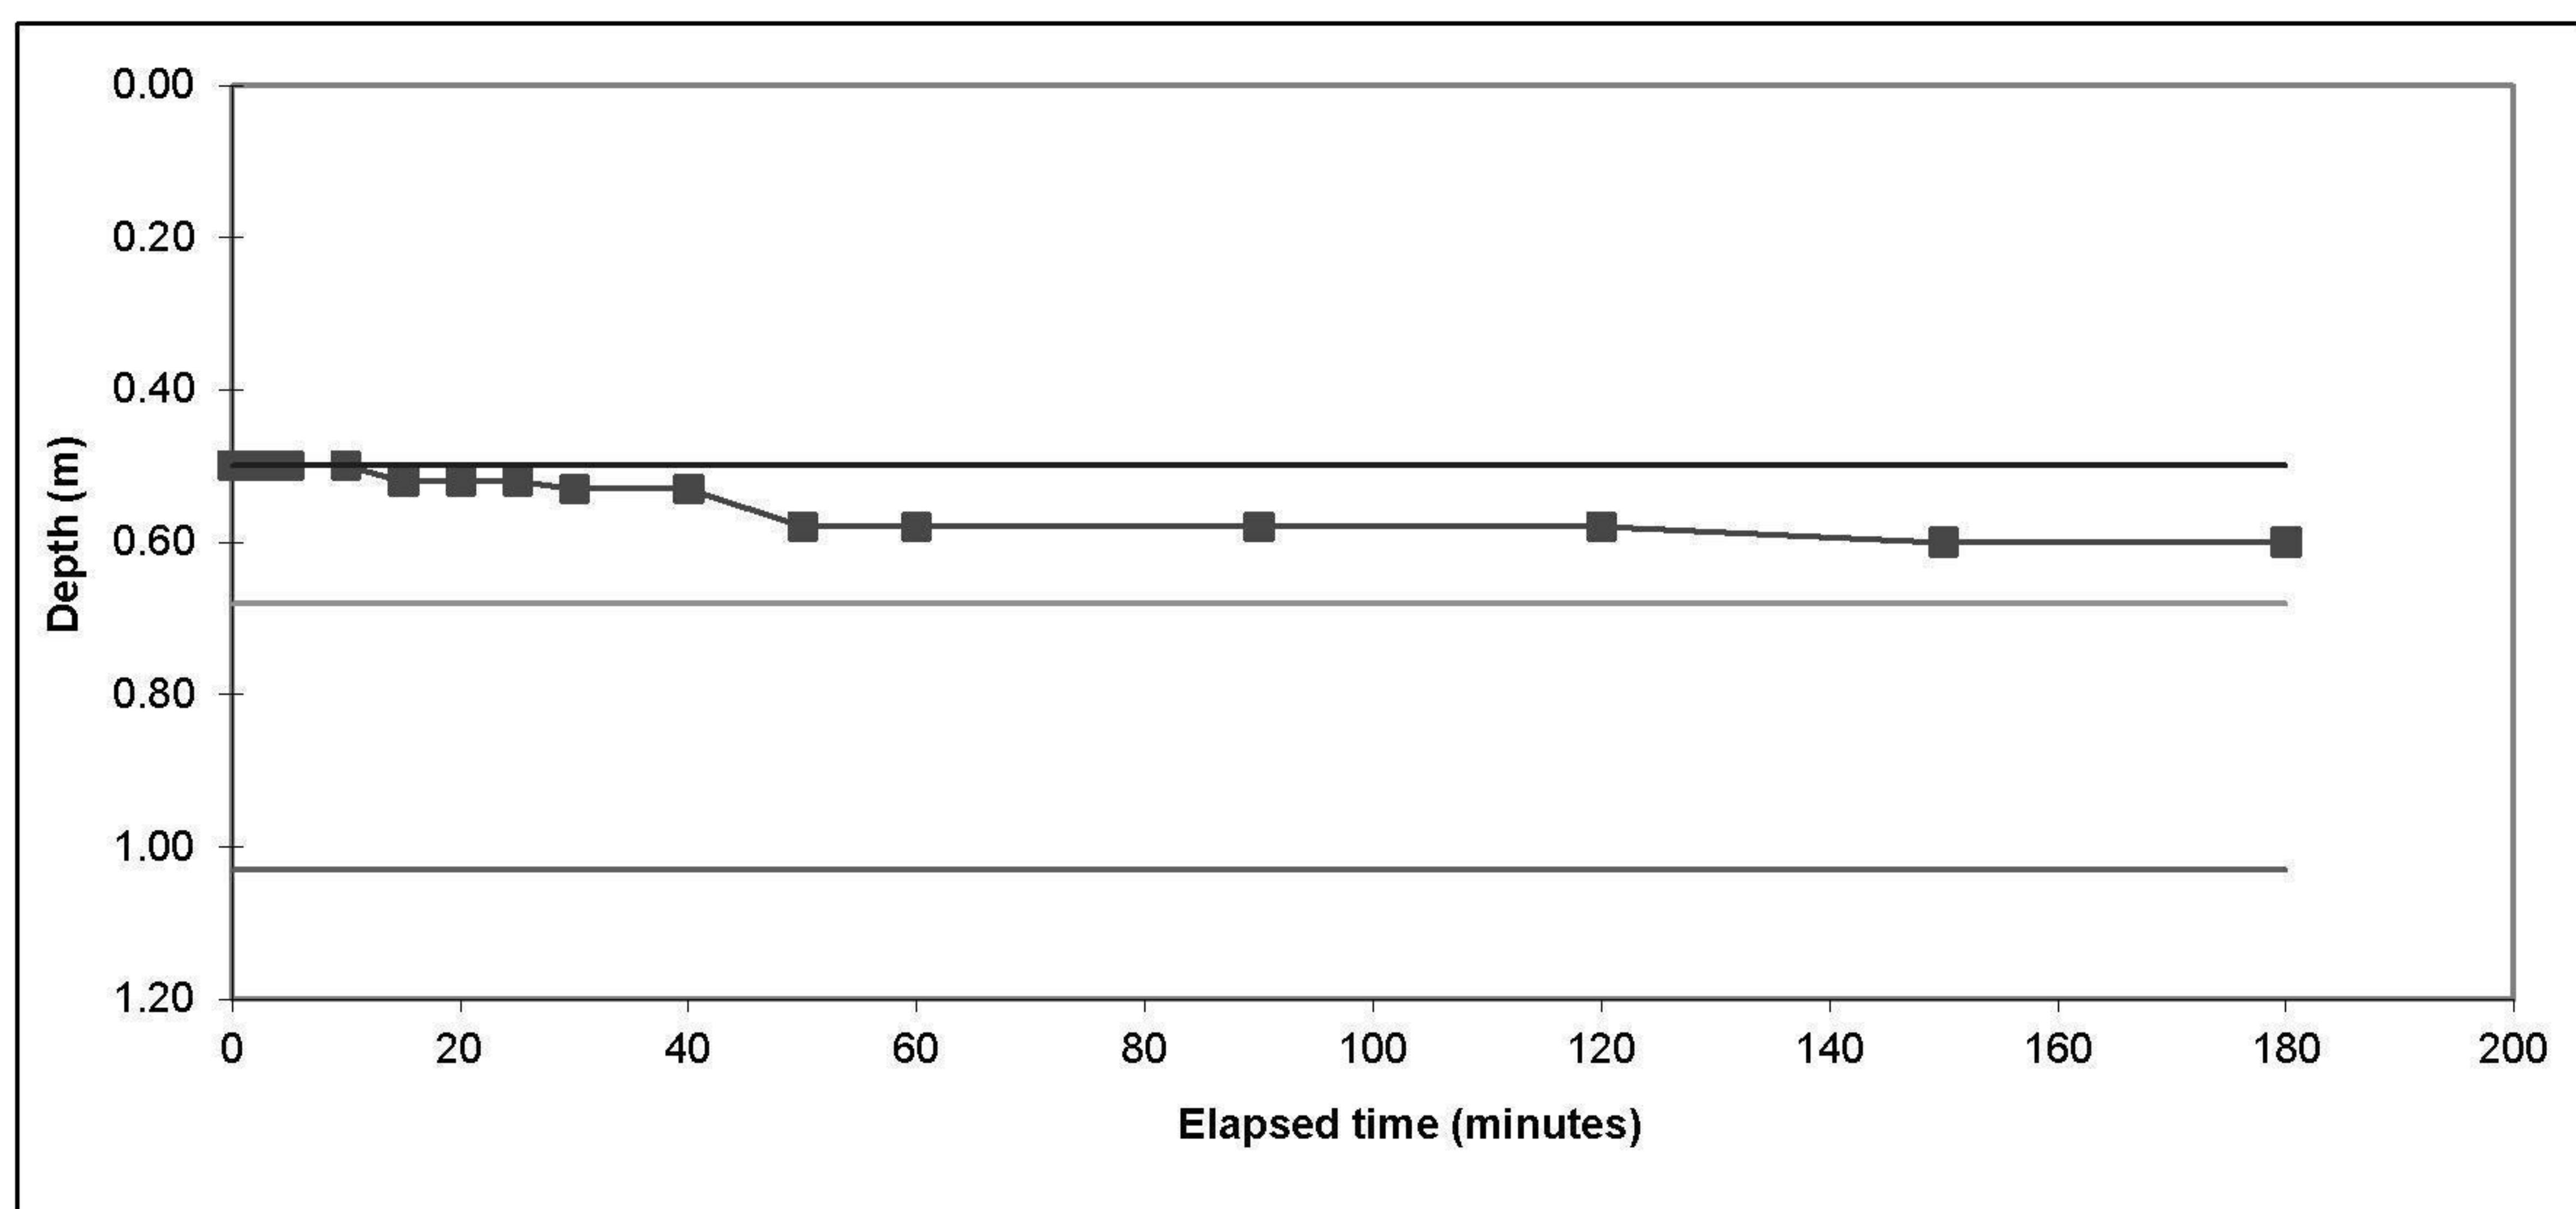
Trial Pit No:	TP01	Test No:	2	Date:	10/10/2025
Length (m):	1.50	Datum Height:	0.00 m agl		
Width (m):	1.30	Granular infill:	None		
Depth (m):	1.20	Porosity of infill:	1	(assumed)

Start water depth for analysis (mbgl):	0.50	Elapsed time (mins):	#N/A
75% effective depth (mbgl):	0.68		
50% effective depth (mbgl):	0.85		
25% effective depth (mbgl):	1.03	Elapsed time (mins):	#N/A
Base of soakage zone (mbgl):	1.20		
Volume outflow between 75% and 25% effective depth (m³):			
Mean surface area of outflow (m²):			3.25
(side area at 50% effective depth + base area)			
Time for outflow between 75% and 25% effective depth (mins):			
Soil infiltration rate (m/s):		Test incomplete as 25% effective depth not achieved. Unable to reliably determine soil infiltration rate.	
Remarks	Results processed following BRE 365 (2007).

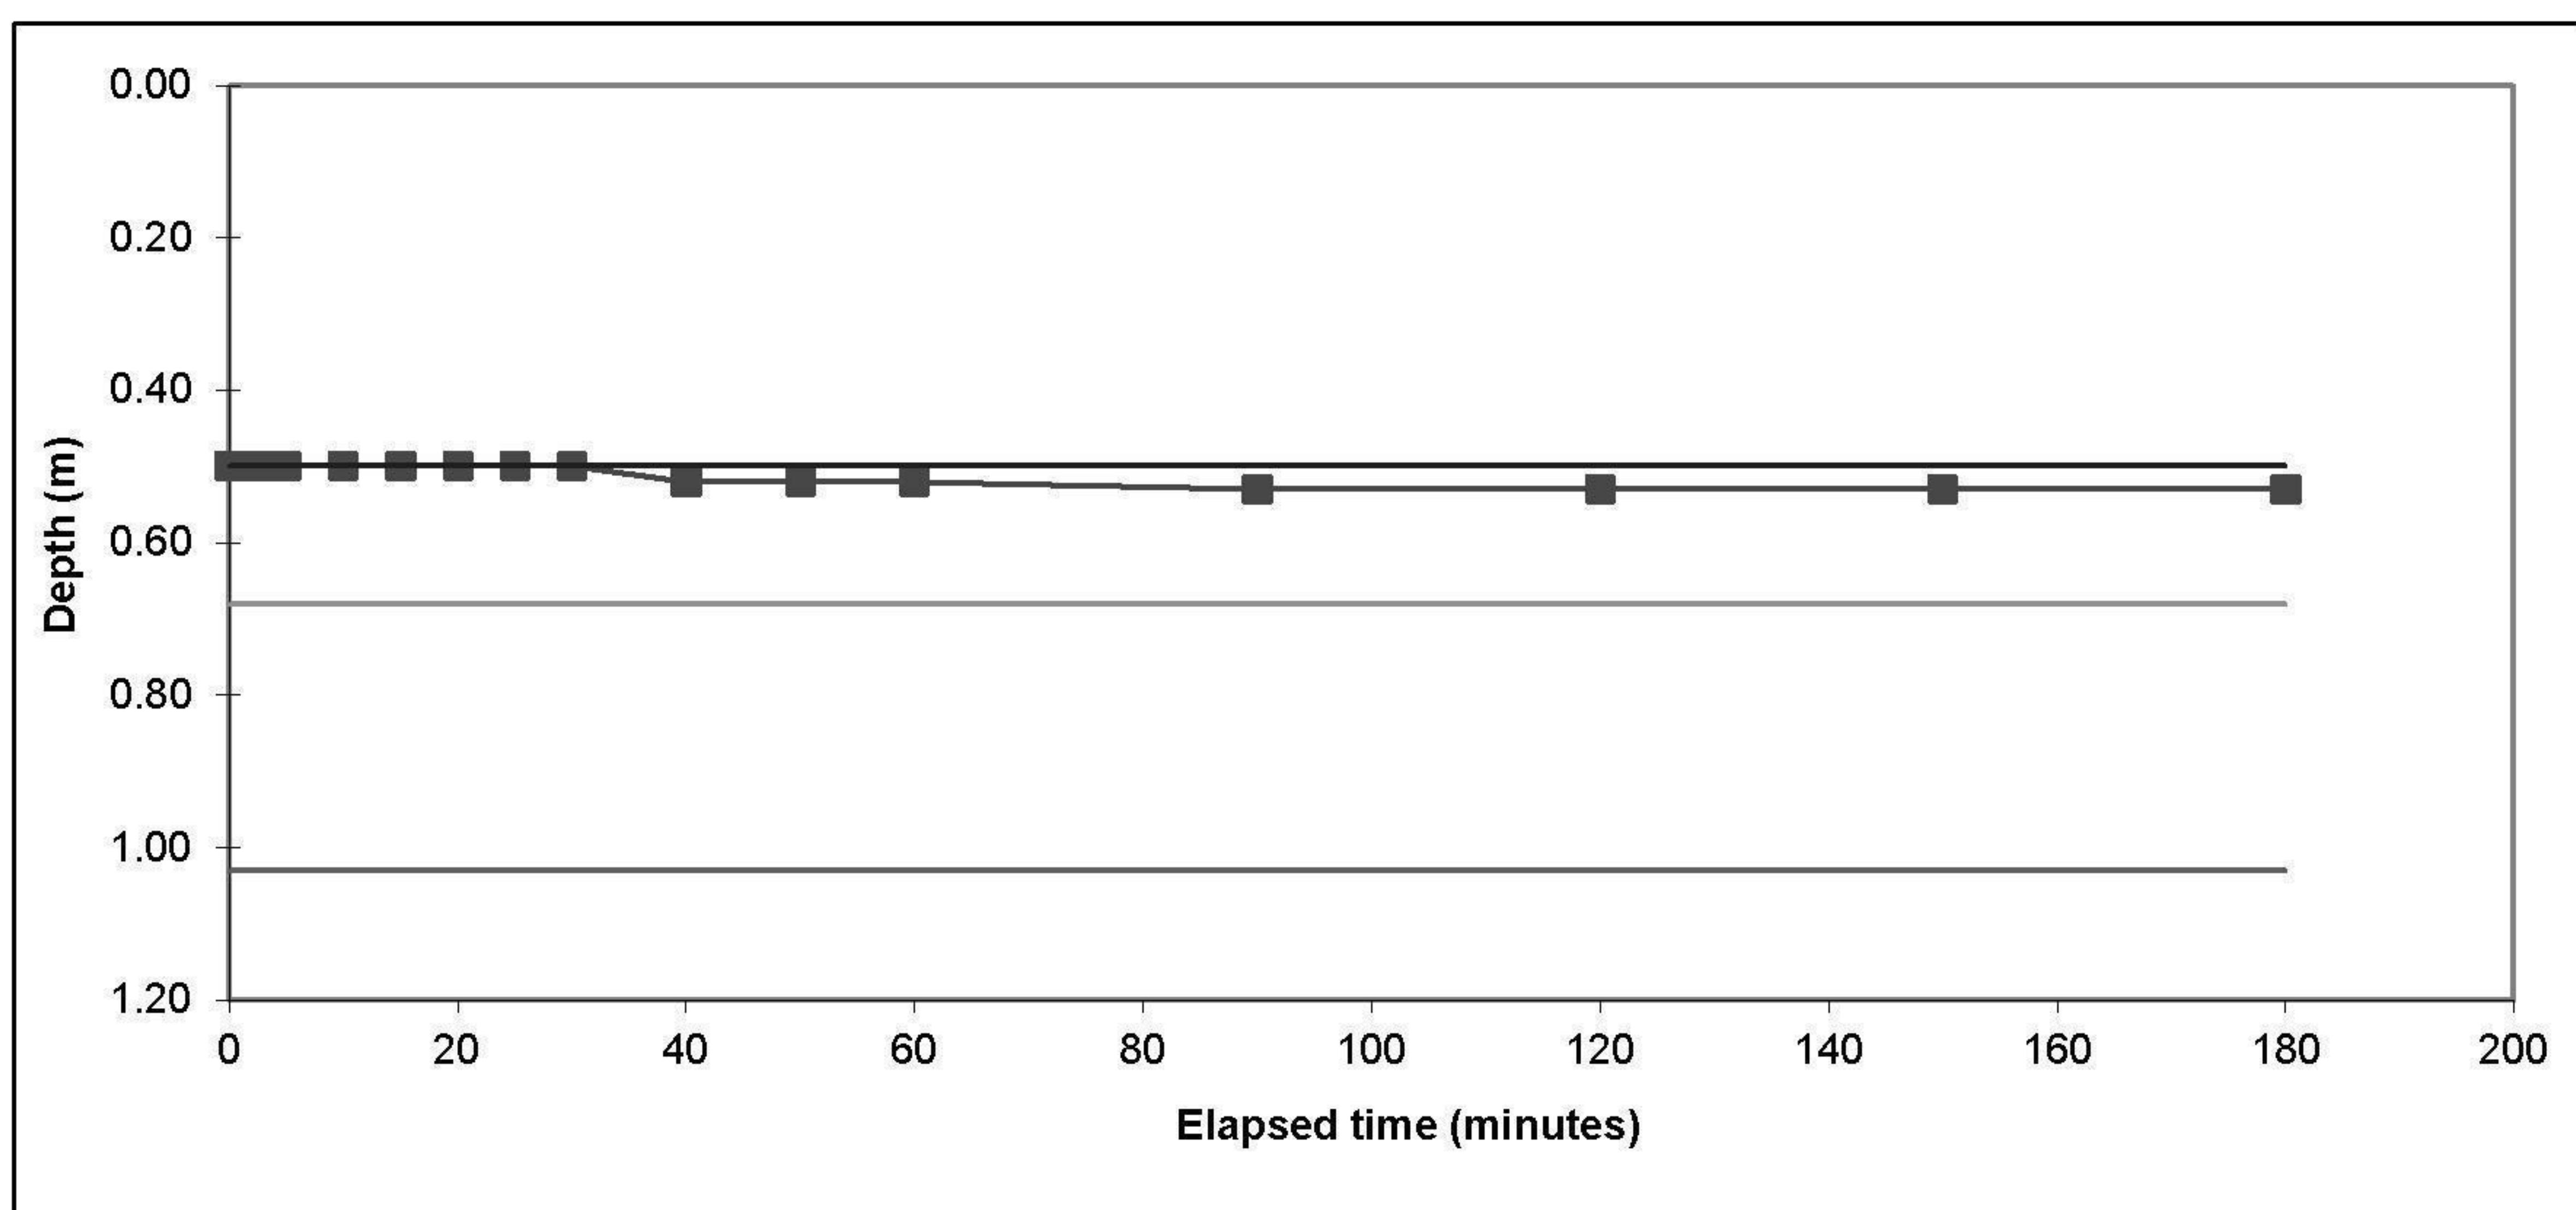
Trial Pit No:	TP01	Test No:	3	Date:	10/10/2025
Length (m):	1.50	Datum Height:	0.00 m agl		
Width (m):	1.30	Granular infill:	None		
Depth (m):	1.20	Porosity of infill:	1	(assumed)

Start water depth for analysis (mbgl):	0.50	Elapsed time (mins):	#N/A
75% effective depth (mbgl):	0.68	Elapsed time (mins):	#N/A
50% effective depth (mbgl):	0.85	Elapsed time (mins):	#N/A
25% effective depth (mbgl):	1.03	Elapsed time (mins):	#N/A
Base of soakage zone (mbgl):	1.20		
Volume outflow between 75% and 25% effective depth (m³):			
Mean surface area of outflow (m²):			3.25
(side area at 50% effective depth + base area)			
Time for outflow between 75% and 25% effective depth (mins):			
Soil infiltration rate (m/s):		Test incomplete as 25% effective depth not achieved. Unable to reliably determine soil infiltration rate.	
Remarks	Results processed following BRE 365 (2007).
