# BS 5837:2012 Tree Survey, Arboricultural Impact Assessment, Arboricultural Method Statement & Tree Protection Plan

94-98 London Road  
East Grinstead  
RH19 1EP

27<sup>th</sup> February 2025

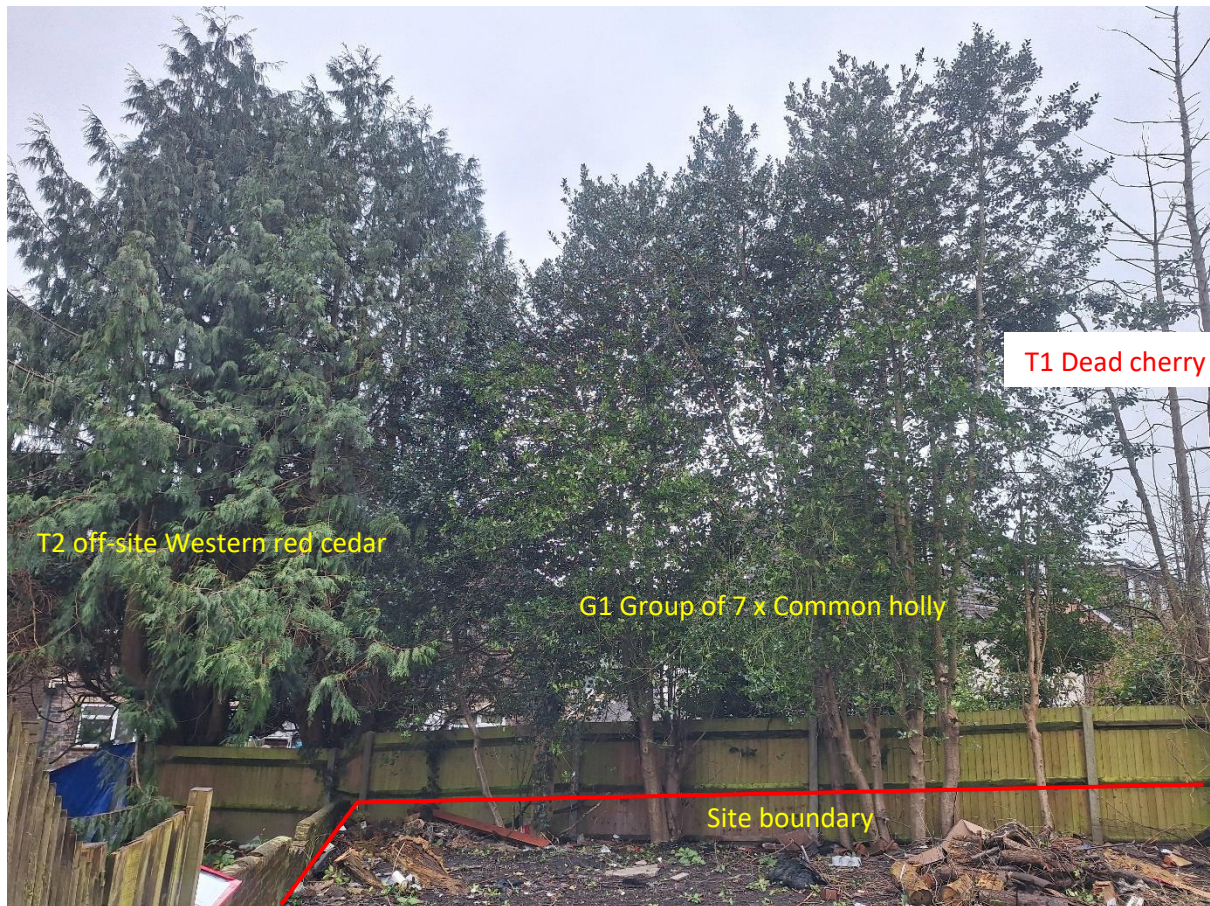
## Photo of subject trees

The photo above showing T1 dead cherry, G1, a linear group comprising 7 category C holly and T2, a category C off-site Cypress. T1 and G1 are to be removed and replaced due to their condition and likelihood of impact upon their root systems from the proposed building.

- Contractor to remove **T1** and **G1**.

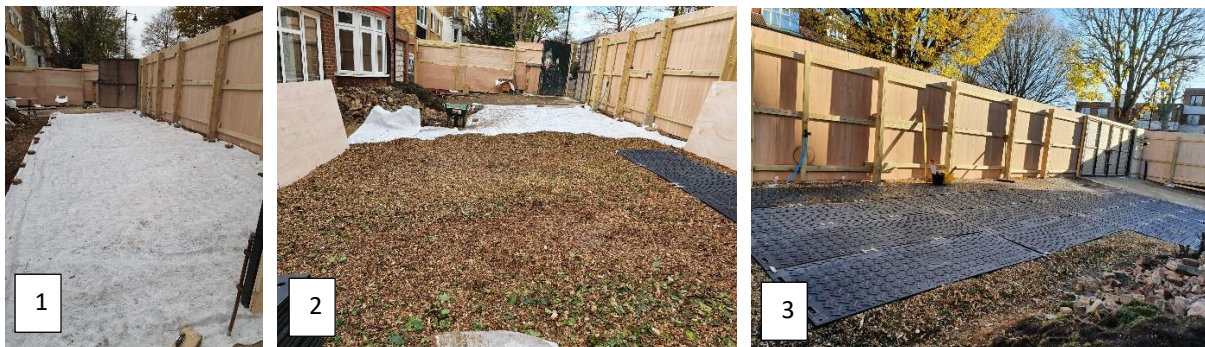
Images above from a site managed by Usherwood Arboriculture and showing the three stages of ground protection installation.

Image 1- laying of geotextile membrane upon existing surface.

Image 2- hand spreading of 100-150mm depth of woodchip mulch.

Image 3- Trakmat ground protection mats directly laid upon woodchip mulch.

- In this instance, Trakmat will be substituted with closely abutted 18mm plywood boards.

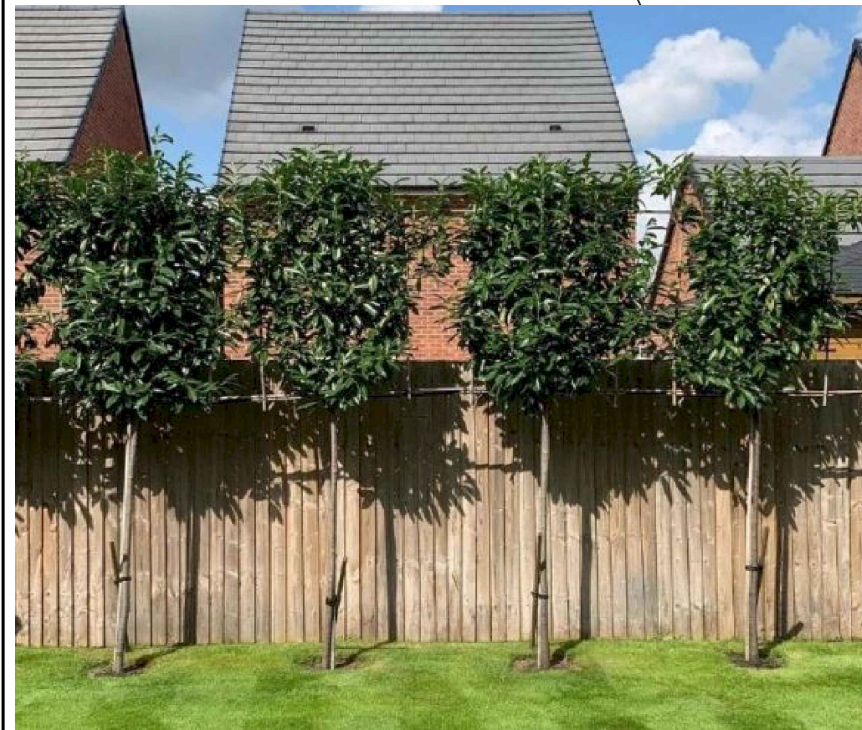
| Proposed Landscape Planting | | | |

Pleached Laurel hedging planted at 1.5m centres. 8-10cm stem girth with a height at planting of 2.7m. Plants will be container grown or root-balled stock and planted following construction of the building.

- Pleached Laurel trees will be planted in 1000mm x 1000mm x 500mm deep tree pits.
- Planting pits will be backfilled with a mix of the existing garden soil and approximately 20% organic matter such as a good quality tree and shrub compost.

- The planting pits will be mulched around each tree with approximately 80mm depth of composted woodchip mulch. Mulch will be kept away from the immediate trunk to avoid stem scorch.

- Trees will be supported by 2 stakes and rubber ties fastened no more than a third of the way up the stem.
- Supports will be checked on a regular basis to ensure they are supporting and not damaging the tree stem.

Following construction of the building, a linear group of 7 pleached trees will be planted along the rear boundary.

The pleached trees will comprise 7 x *Prunus laurocerasus* 'Caucasica'. The trees will be planted at 1.5m centres with a minimum stem girth of 8-10cm.

At the time of planting, the trees would be approximately 2.7m in height. We suggest the trees are allowed to grow to a height of approximately 3.5-4m in order to provide an attractive evergreen screen.
