Desk Study, Ground Investigation & Risk Assessment Report

**Site: Queensmere House, 49 Queen's Road,
East Grinstead, RH19 1BG**

Report Date: 7th November 2024

Project Reference: J15841
(Previous Reference: J13542)

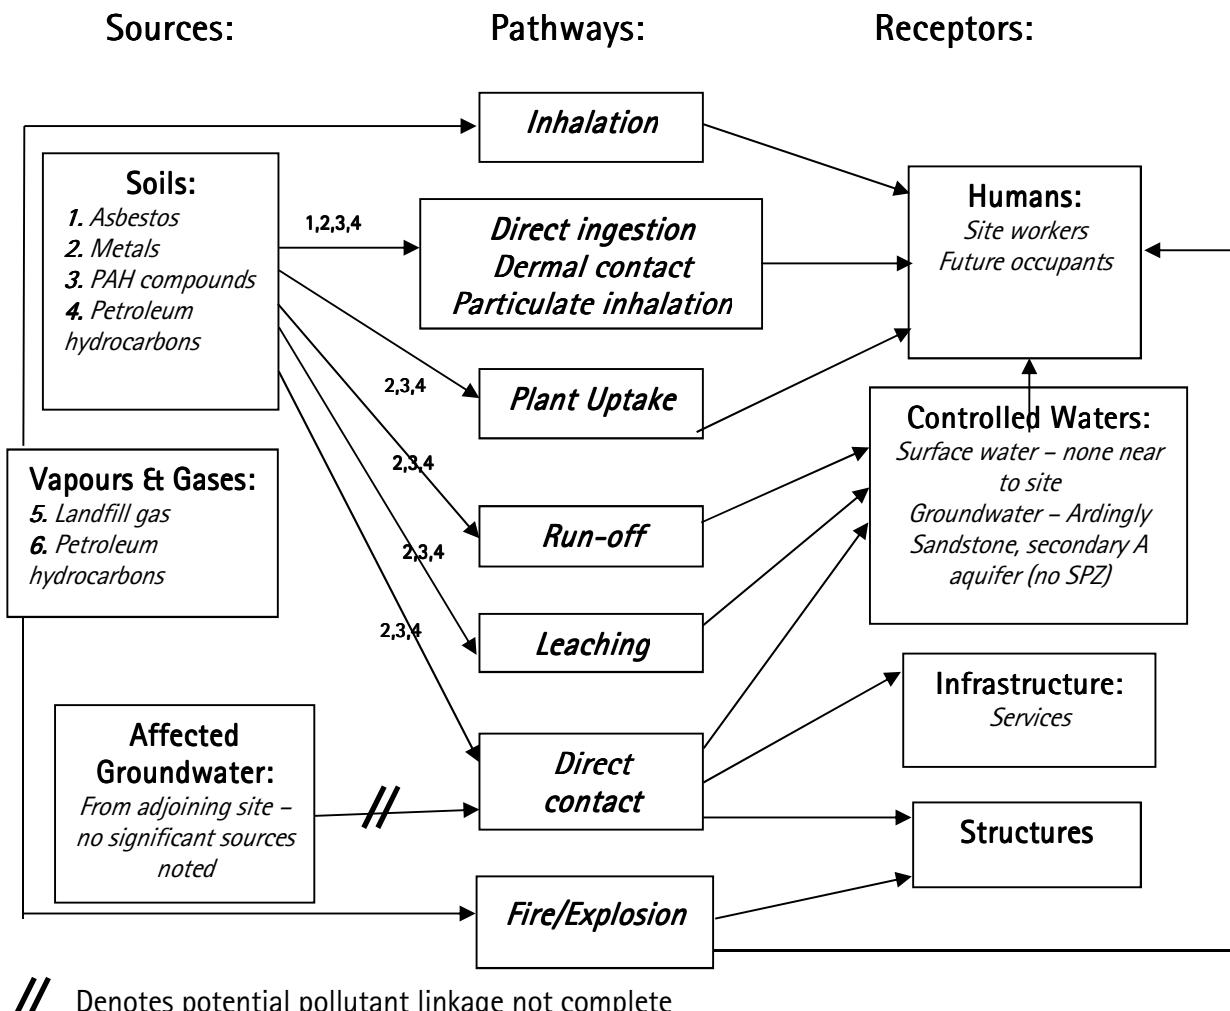
The following diagram shows the potential pollutant linkages identified for the site and summarises the preliminary conceptual model:

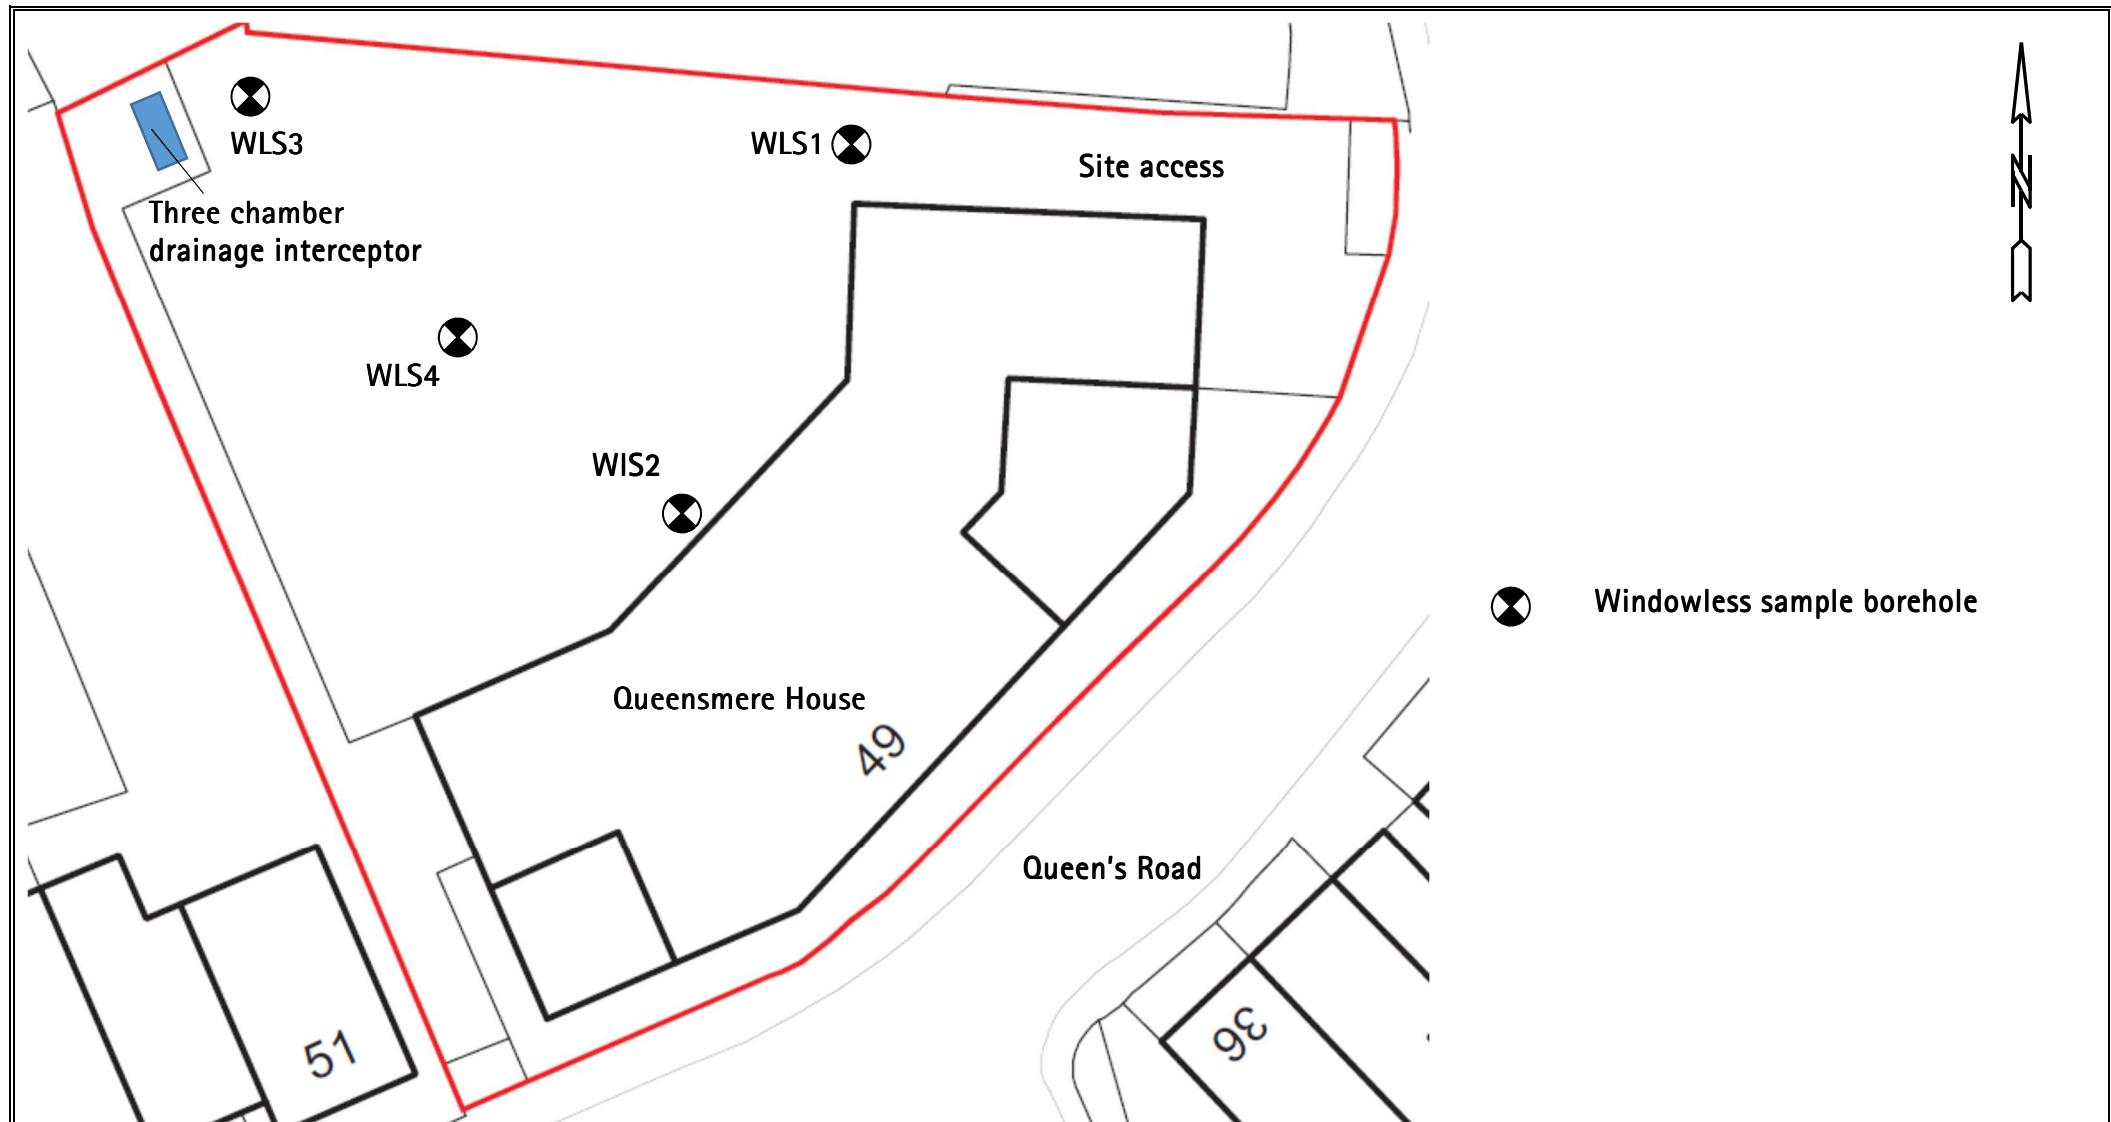
Trial Hole Location Plan – Not to Scale

NB: Positions of Boreholes are only indicative.

Loose sands and gravels were encountered in WLS3 and these may be indicative of an infilled gull, associated with cambering, or the installation of the nearby three chamber drainage interceptor. Further investigation is recommended to determine the lateral extent and the depth of these loose soils.

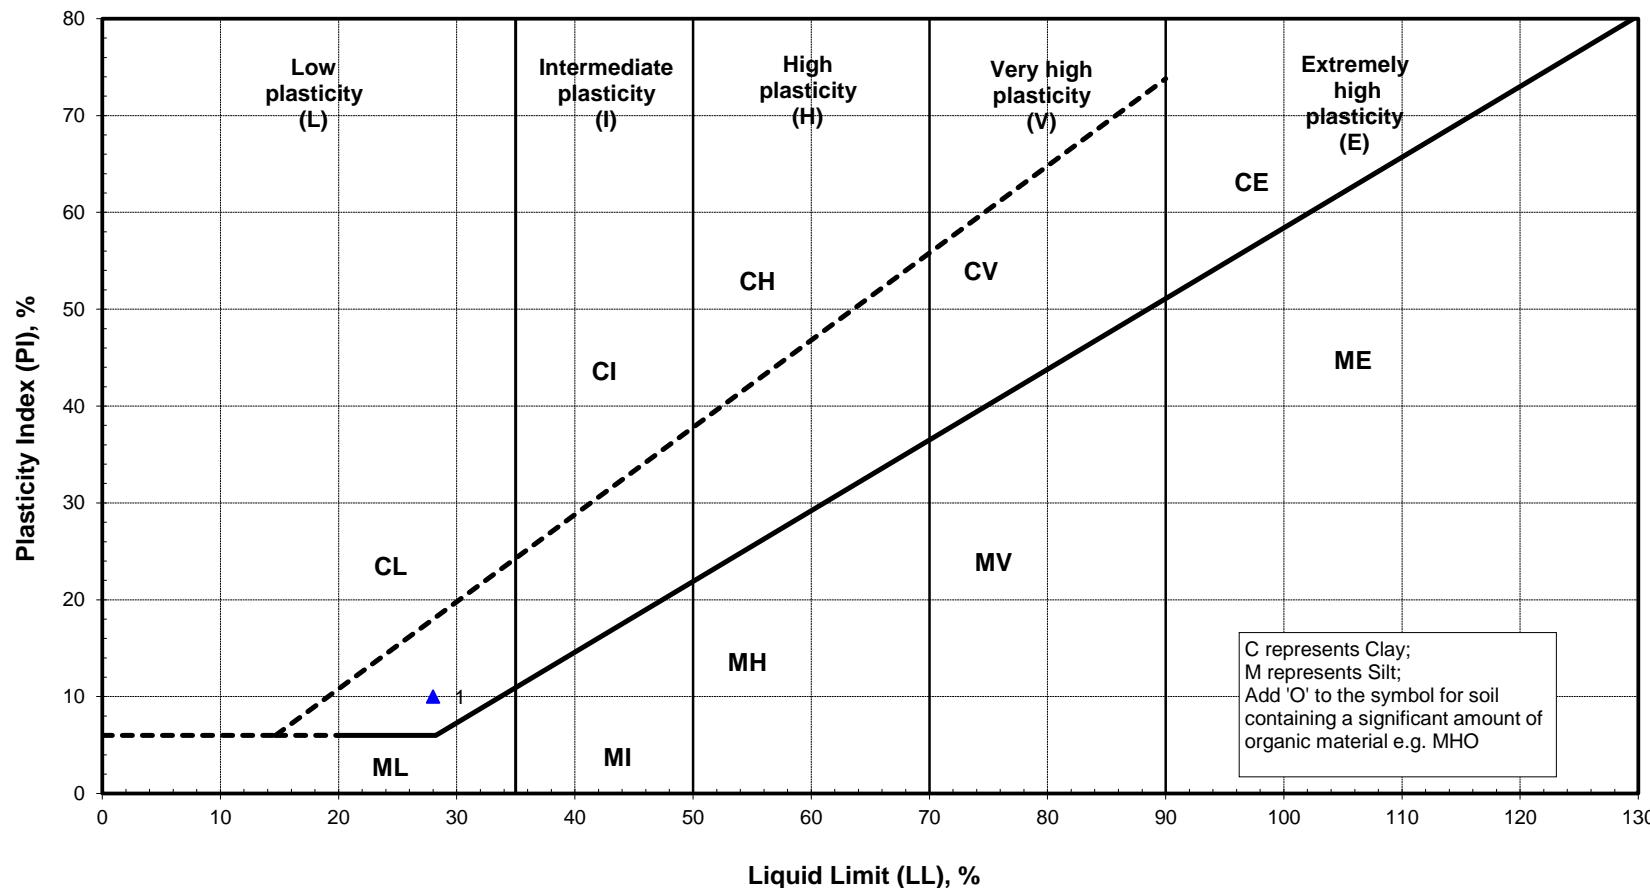
Liquid Limit	Plastic Limit	Plasticity Index
Maximum Value	28	Maximum Value
Minimum Value	28	Minimum Value
Average Value	28	Average Value

NHBC Classification for Volume Change Potential

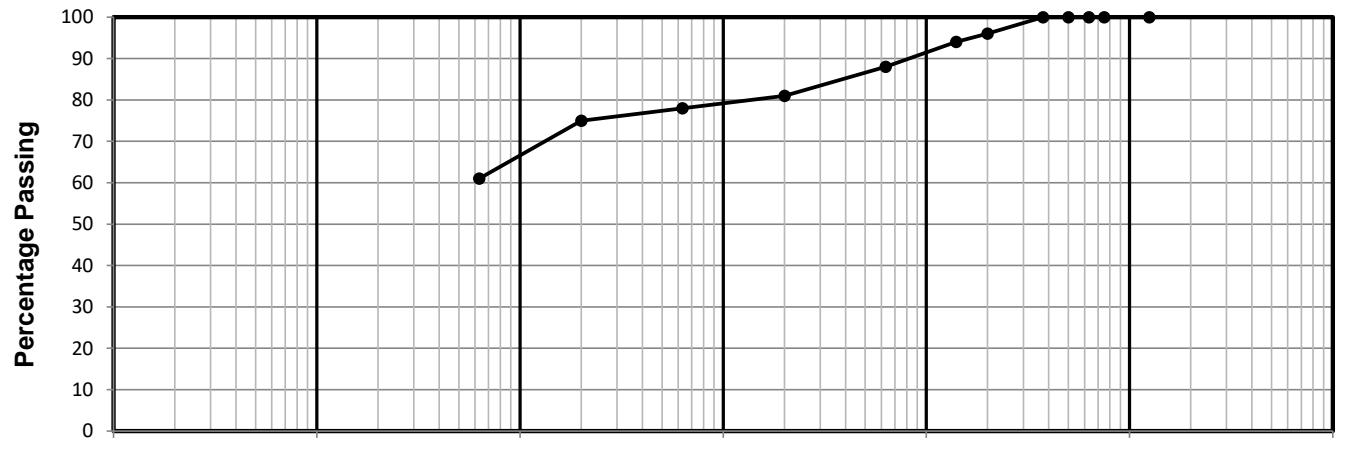
Particle Size Distribution Chart

Particle Size	% Passing
125mm	100
75mm	100
63mm	100
50mm	100
37.5mm	100
20mm	96
14mm	94
6.3mm	88
2mm	81
630µm	78
200µm	75
63µm	61

CLAY	Fine	Medium	Coarse	Fine	Medium	Coarse	Fine	Medium	Coarse	COBBLES
	SILT	SAND	GRAVEL							
	61	20	19							0

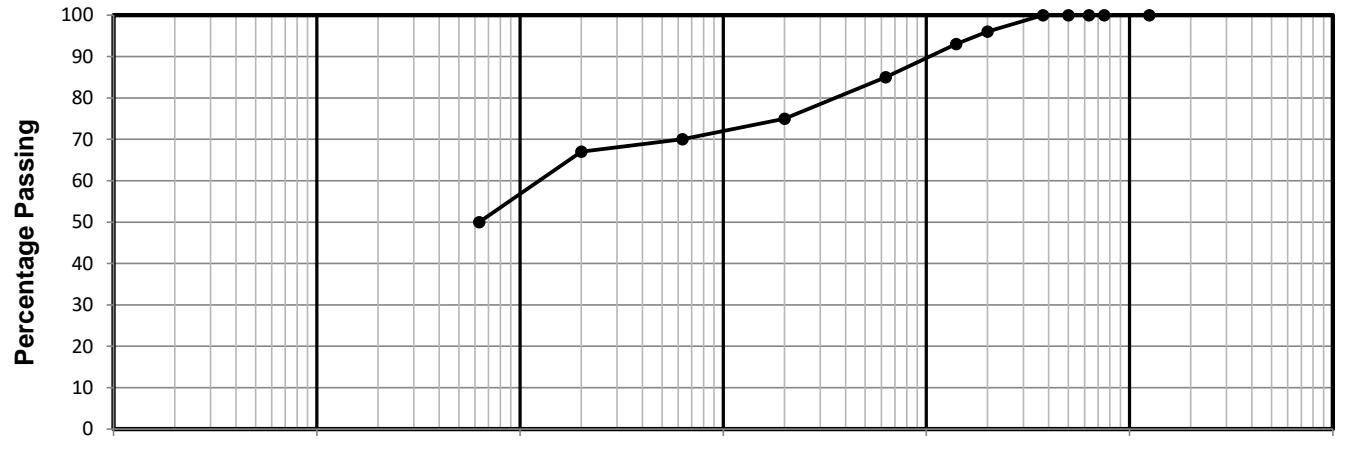
Particle Size Distribution Chart

Particle Size	% Passing
125mm	100
75mm	100
63mm	100
50mm	100
37.5mm	100
20mm	96
14mm	93
6.3mm	85
2mm	75
630µm	70
200µm	67
63µm	50

CLAY	Fine	Medium	Coarse	Fine	Medium	Coarse	Fine	Medium	Coarse	COBBLES
	SILT	SAND	GRAVEL							
	50	25	25							0

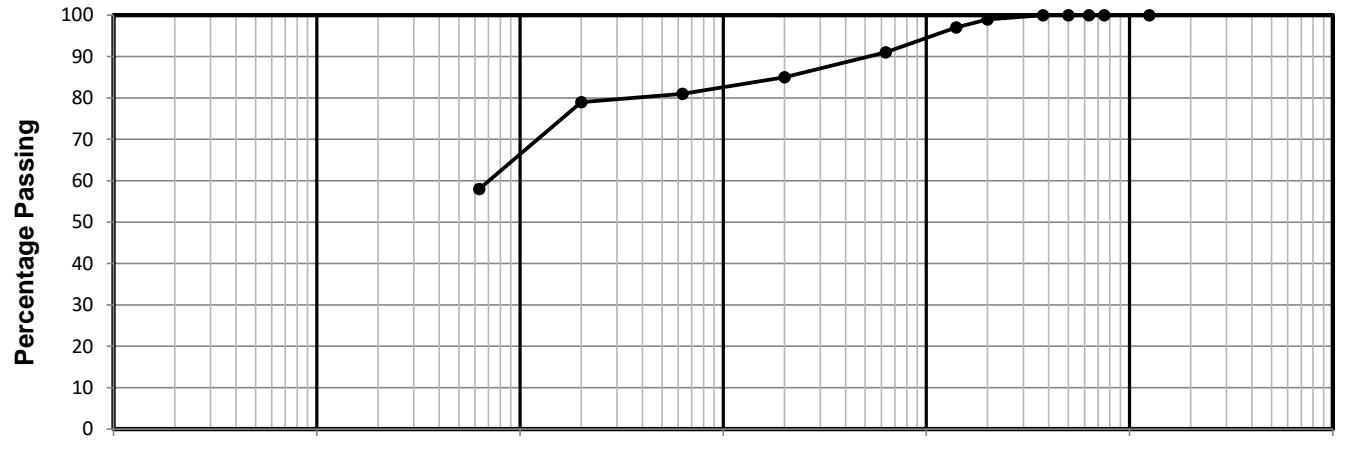
Particle Size Distribution Chart

Particle Size	% Passing
125mm	100
75mm	100
63mm	100
50mm	100
37.5mm	100
20mm	99
14mm	97
6.3mm	91
2mm	85
630μm	81
200μm	79
63μm	58

CLAY	Fine	Medium	Coarse	Fine	Medium	Coarse	Fine	Medium	Coarse	COBBLES
	SILT	SAND	GRAVEL							
	58	27	15							0

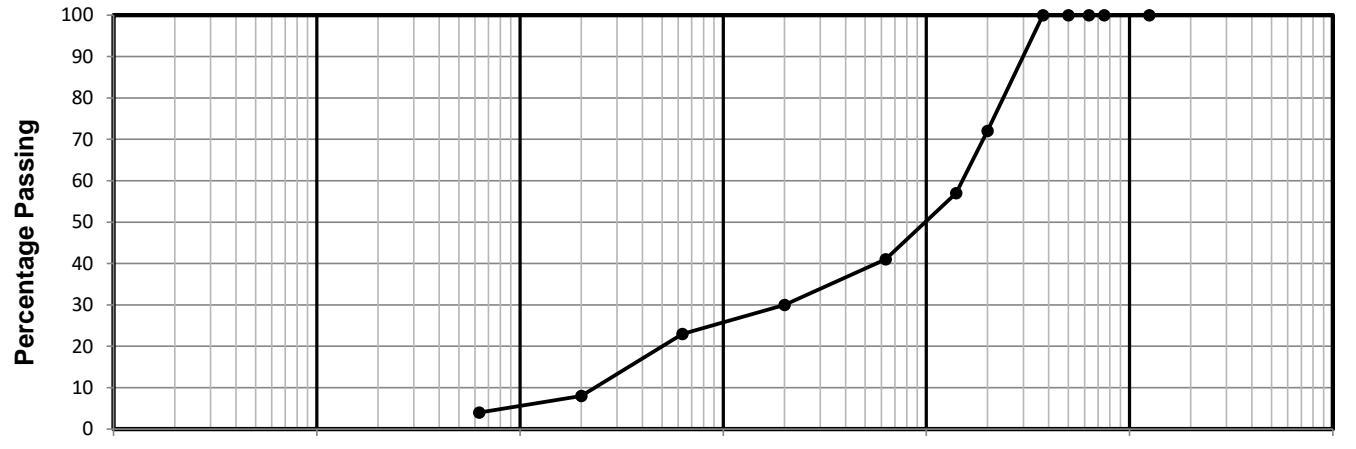
Particle Size Distribution Chart

Particle Size	% Passing
125mm	100
75mm	100
63mm	100
50mm	100
37.5mm	100
20mm	72
14mm	57
6.3mm	41
2mm	30
630µm	23
200µm	8
63µm	4

CLAY	Fine	Medium	Coarse	Fine	Medium	Coarse	Fine	Medium	Coarse	COBBLES
	SILT			SAND			GRAVEL			
	4			26			70			0

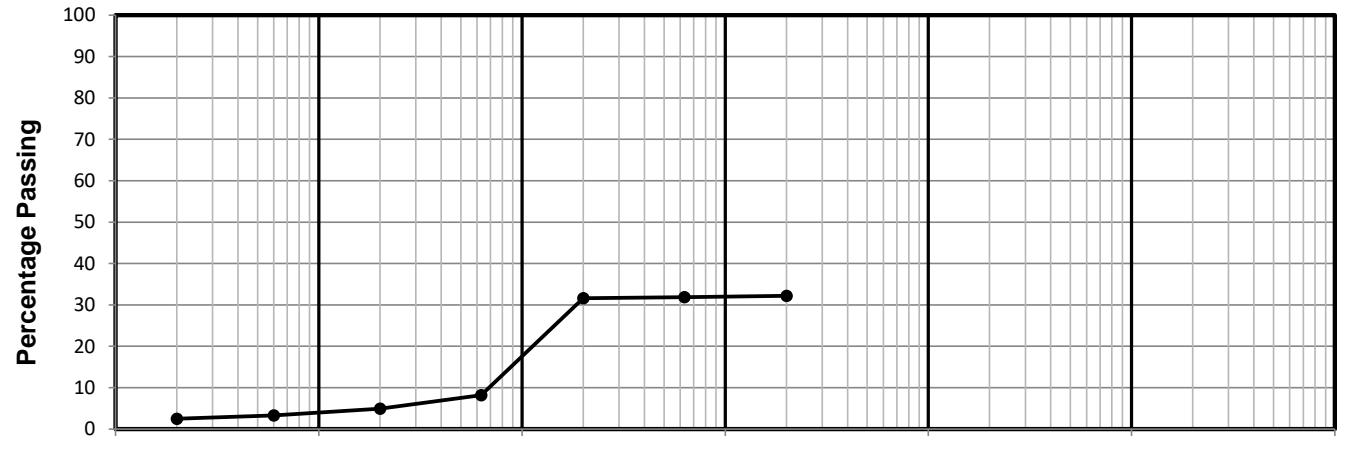
Particle Size Distribution Chart

Particle Size	% Passing
2mm	32
630µm	32
200µm	32
63µm	8
20µm	5
6µm	3
2µm	3
0.001 to 0.01	~2%
0.01 to 0.1	~8% to 32%
0.1 to 1.0	~32% to 33%
1.0 to 10.0	~33% to 33%

Sedimentation pre-treatment: None

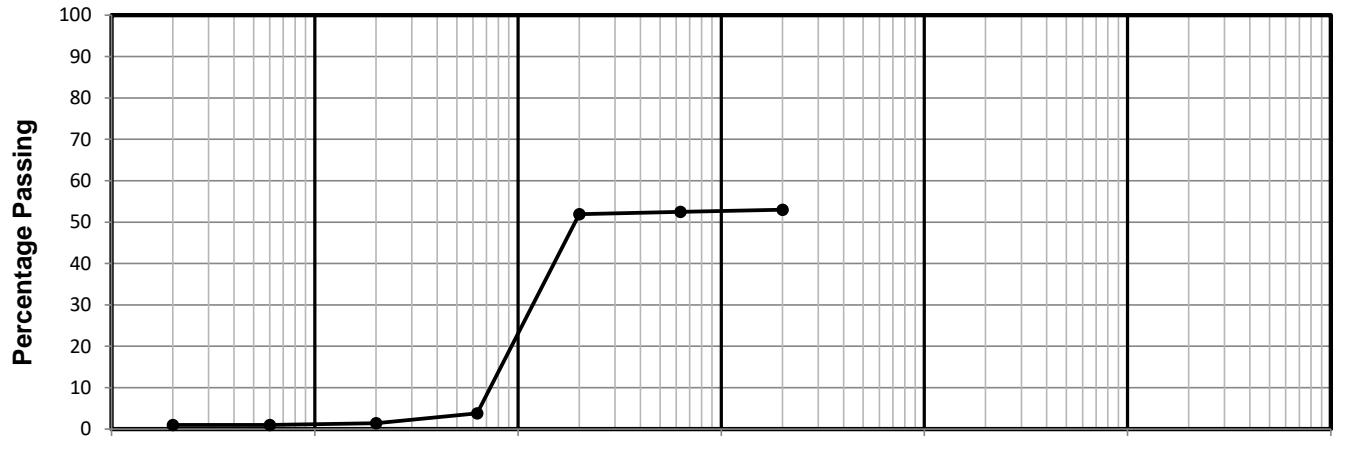
Particle Size Distribution Chart

Sedimentation pre-treatment: None

CLAY	Fine	Medium	Coarse	Fine	Medium	Coarse	Fine	Medium	Coarse	COBBLES
	SILT			SAND			GRAVEL			
1	3			49			47
