1593 - 203 JUNCTION ROAD BURGESS HILL RH15 0NX

FOR 201 JUNCTION ROAD BURGESS HILL WEST SUSSEX RH15 0NX

Site Plan - Proposed Foul
and Storm Water Drainage

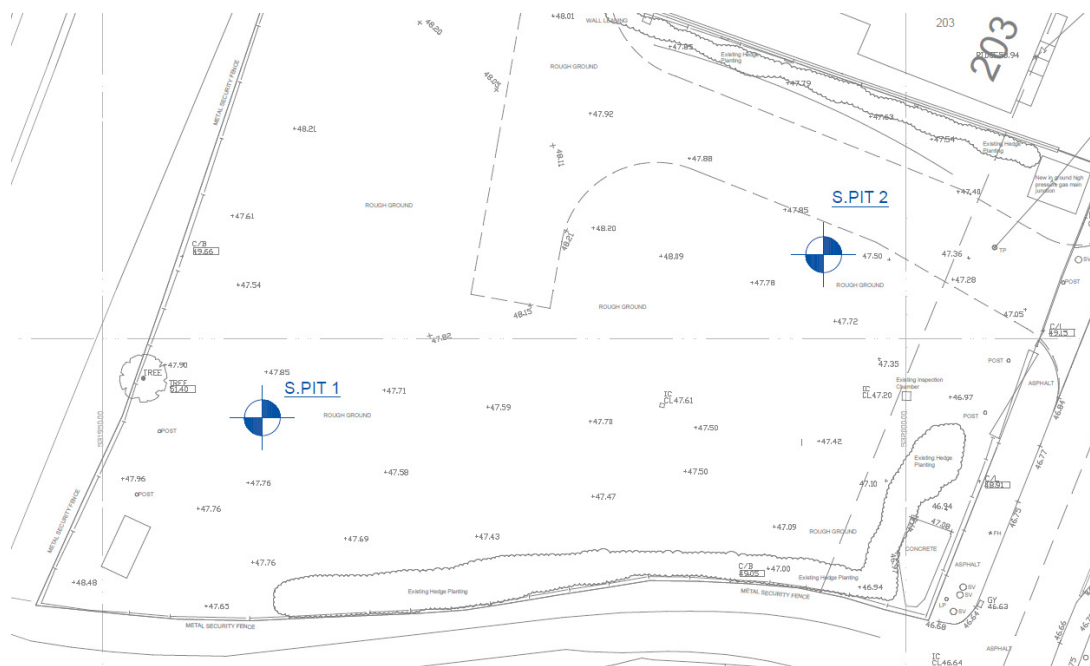
BRE 365 soakaway testing was requested by SDA to be carried out for the site. The client carried these out with SDA present partly. The test results were provided for two differing locations as shown on the test pit plan below.

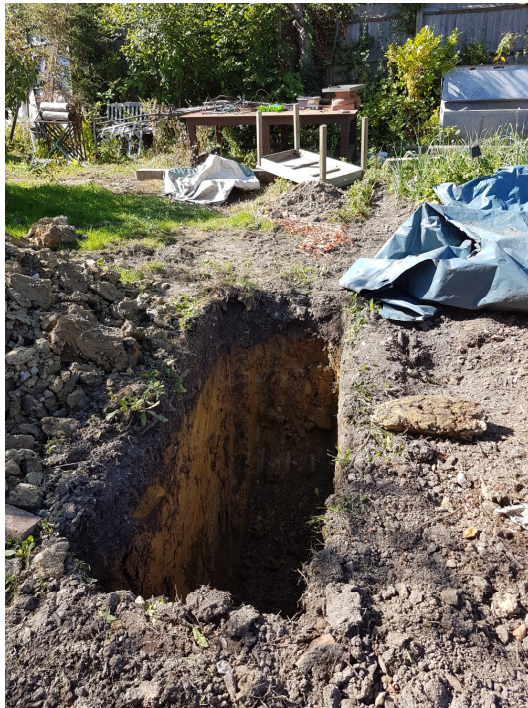
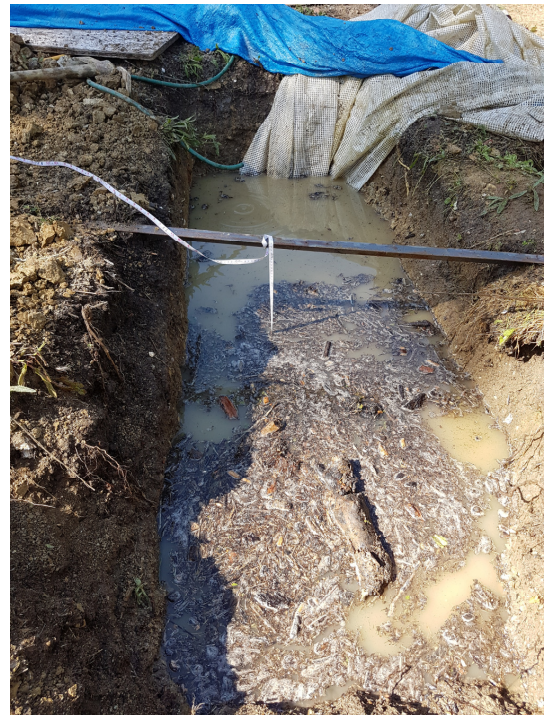
Fig 1 - Soakaway test pits in 2019

Each pit was excavated to 2.0m x 1.0m x 1.5m with the sides holding firm throughout.

Testing was carried out in November 2019 within two pits within.

No groundwater was encountered during the tests which were carried out in November 2019.

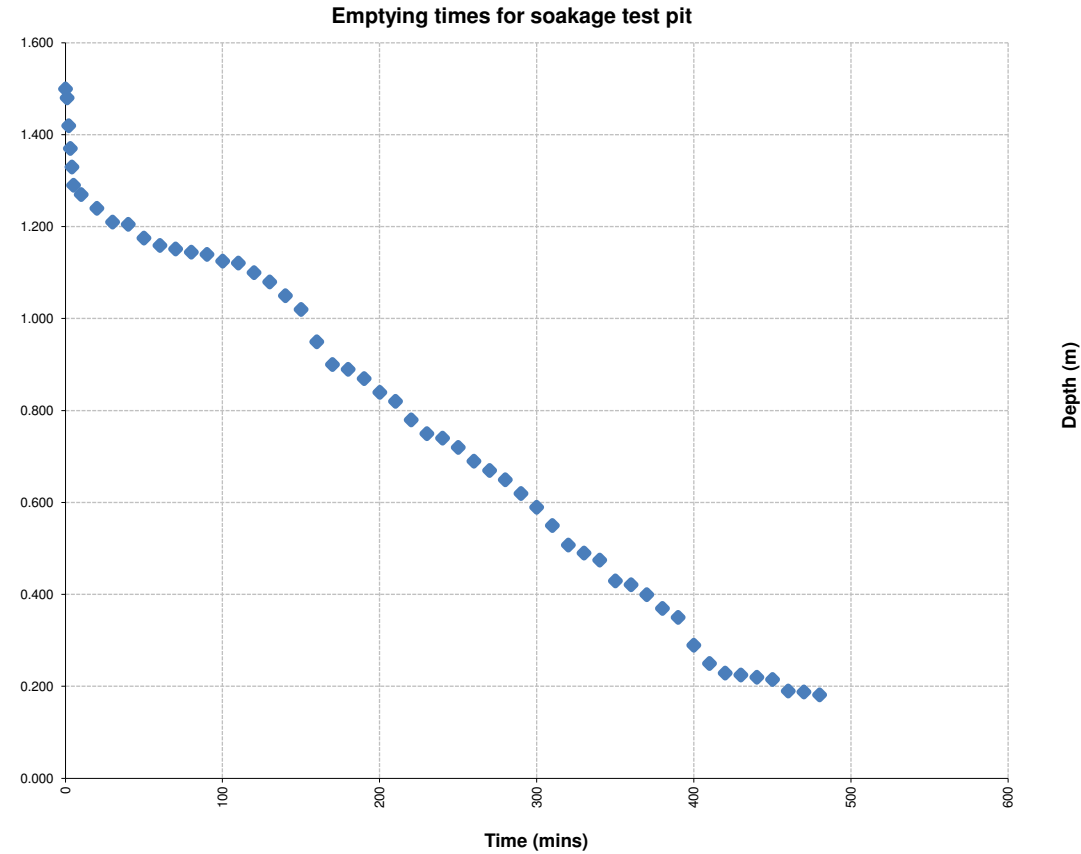
<div style="display: inline-block; vertical-align: middle;"> <h1 style="margin: 0;">SIMON DENT ASSOCIATES</h1> </div>		14 Sullington Way Shoreham-By-Sea West Sussex BN43 6PJ t 0754 658 3150 e simondent@live.co.uk	
Project Title:	203 Junction Road Burgess Hill - PIT No. 1 - Test 1	No.:	1593
Infiltration test and rate calculation

1. Permeability rate calculations				2. Test Outflow results		3. Infiltration coefficient (q) (m/h)	
Test pit L:	2.00	Tot vol.:	3	a _{sq} (sq.m):	4.50	Rate (q) provided by SI=	
Test pit W:	1.00	a _{p50} :	6.5	Inflow (cu.m):	#REF!	Calculated Soil Rate (f)=	0.05793
Test pit D:	1.50	V _{p75-25} :	1.318	Outflow(cu.m):	1.50		
Free vol (%):	100	t _{p75-25} :	210	Storage(cu.m):	#REF!		
Effective depth:		1.318					
Infiltration rate (f):		1.609E-05

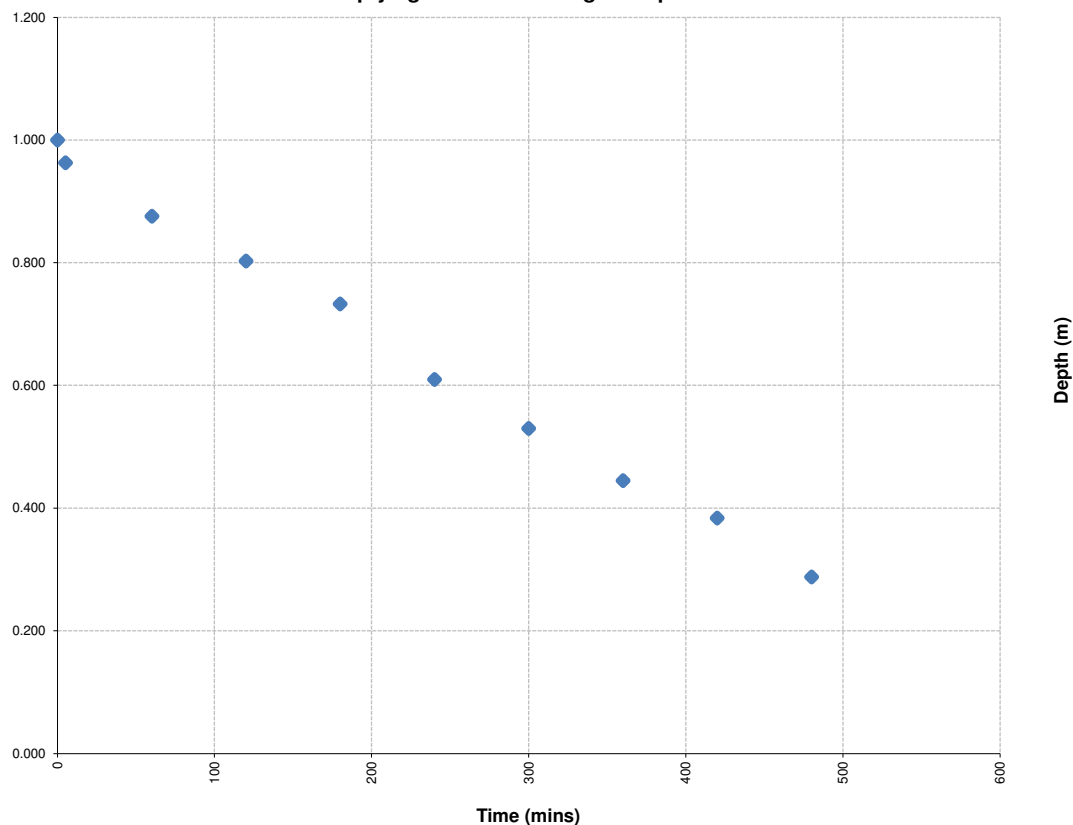
203 Junction Road Burgess Hill - PIT No. 1 - Test 2

1. Permeability rate calculations				2. Test Outflow results		3. Infiltration coefficient (q) (m/h)	
Test pit L:	2.00	Tot vol.:	3	a _{sq} (sq.m):	4.50	Rate (q) provided by SI=	
Test pit W:	1.00	a _{p50} :	6.5	Inflow (cu.m):	#REF!	Calculated Soil Rate (f)=	0.03206
Test pit D:	1.50	V _{p75-25} :	0.712	Outflow (cu.m):	1.50		
Free vol (%):	100	t _{p75-25} :	205	Storage (cu.m):	#REF!		
Effective depth:							
Infiltration rate (f):

Emptying times for soakage test pit

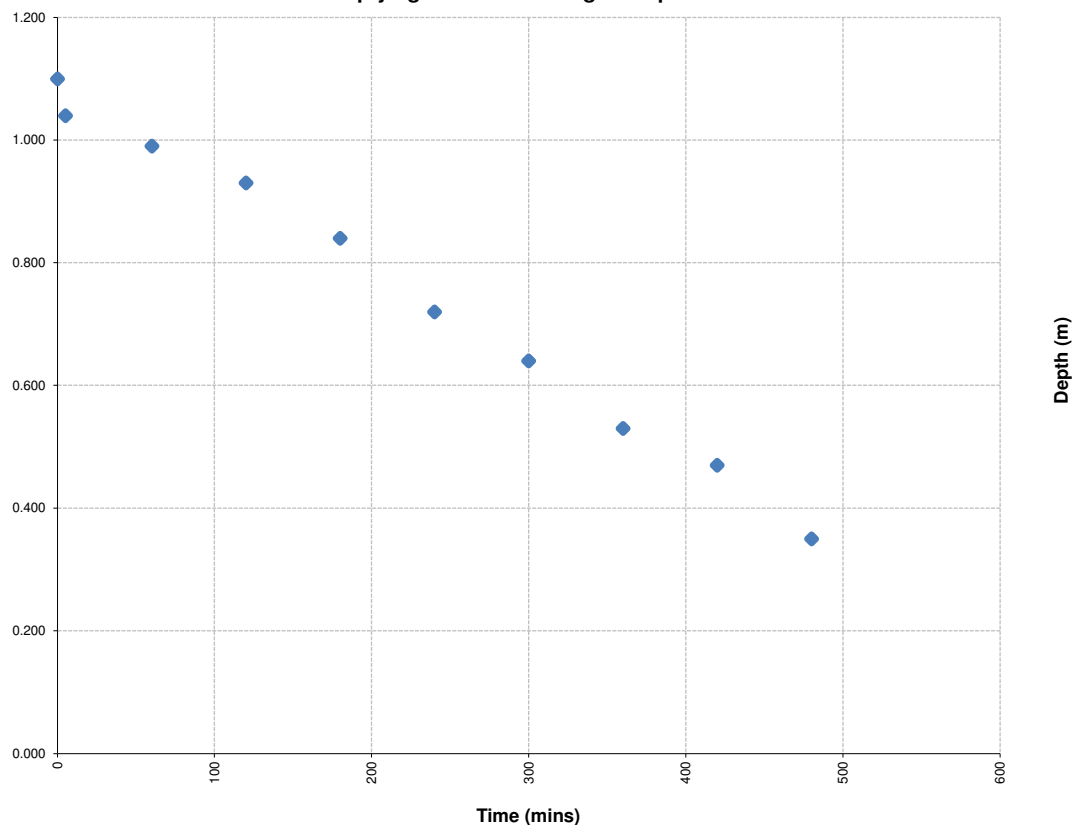
203 Junction Road Burgess Hill - PIT No. 1 - Test 3

1. Permeability rate calculations			2. Test Outflow results		3. Infiltration coefficient (q) (m/h)	
Test pit L:	2.00	Tot vol.:	3	a ₅₀ (sq.m):	4.50	Rate (q) provided by SI=
Test pit W:	1.00	a _{p50} :	6.5	Inflow (cu.m):	#REF!	Calculated Soil Rate (f)=
Test pit D:	1.50	V _{p75-25} :	0.75	Outflow (cu.m):	1.50	0.03462
Free vol (%):	100	t _{p75-25} :	200	Storage (cu.m):	#REF!	
Effective depth:		0.750				
Infiltration rate (f):		9.615E-06

Emptying times for soakage test pit

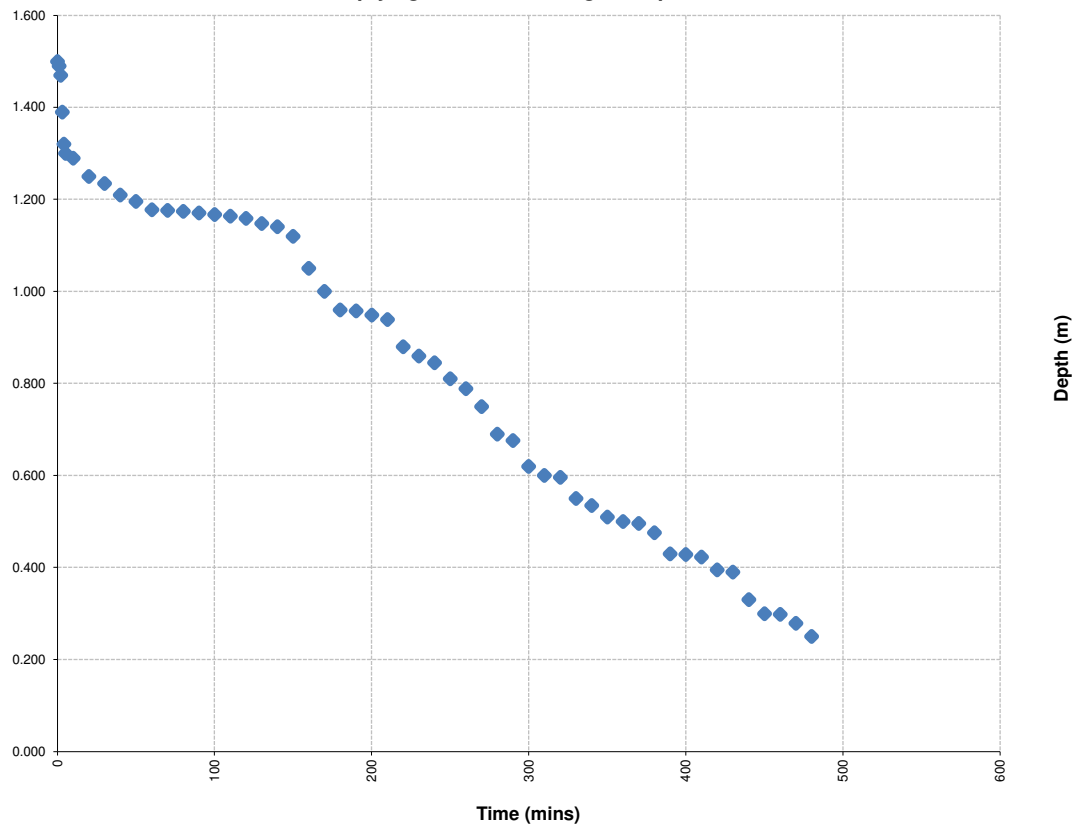
Project Title:	203 Junction Road Burgess Hill - PIT No. 2 - Test 1	No.:	1593
Infiltration test and rate calculation

1. Permeability rate calculations		2. Test Outflow results		3. Infiltration coefficient (q) (m/h)	
Test pit L:	2.00	Tot vol.:	3	a _{sq} (sq.m):	4.50
Test pit W:	1.00	a _{p50} :	6.5	Inflow (cu.m):	#REF!
Test pit D:	1.50	V _{p75-25} :	1.218	Outflow (cu.m):	1.50
Free vol (%):	100	t _{p75-25} :	210	Storage (cu.m):	#REF!
Effective depth:		1.218		Rate (q) provided by SI=	
Infiltration rate (f):		1.487E-05		Calculated Soil Rate (f)=	0.05354

Emptying times for soakage test pit

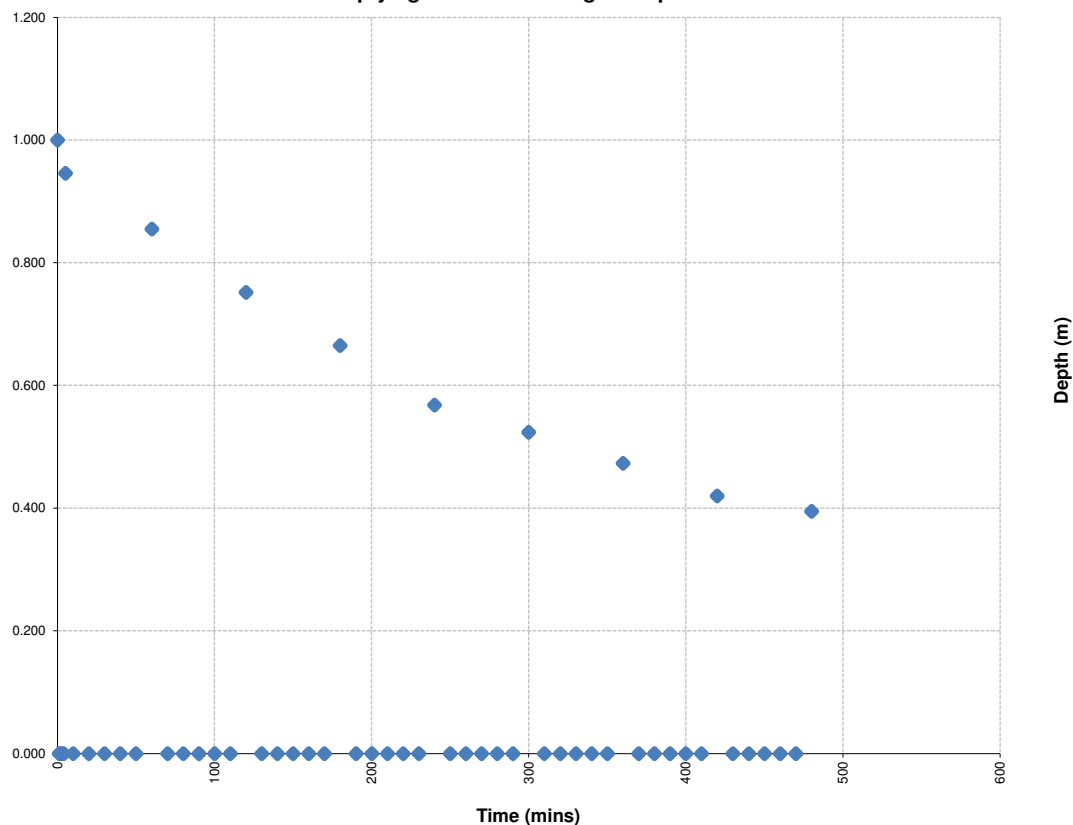
203 Junction Road Burgess Hill - PIT No. 2 - Test 2

1. Permeability rate calculations				2. Test Outflow results		3. Infiltration coefficient (q) (m/h)	
Test pit L:	2.00	Tot vol.:	3	a _{sq} (sq.m):	4.50	Rate (q) provided by SI=	
Test pit W:	1.00	a _{p50} :	6.5	Inflow (cu.m):	#REF!	Calculated Soil Rate (f)=	0.03206
Test pit D:	1.50	V _{p75-25} :	0.712	Outflow (cu.m):	1.50		
Free vol (%):	100	t _{p75-25} :	205	Storage (cu.m):	#REF!		
Effective depth:			0.712				
Infiltration rate (f):			8.906E-06

Emptying times for soakage test pit

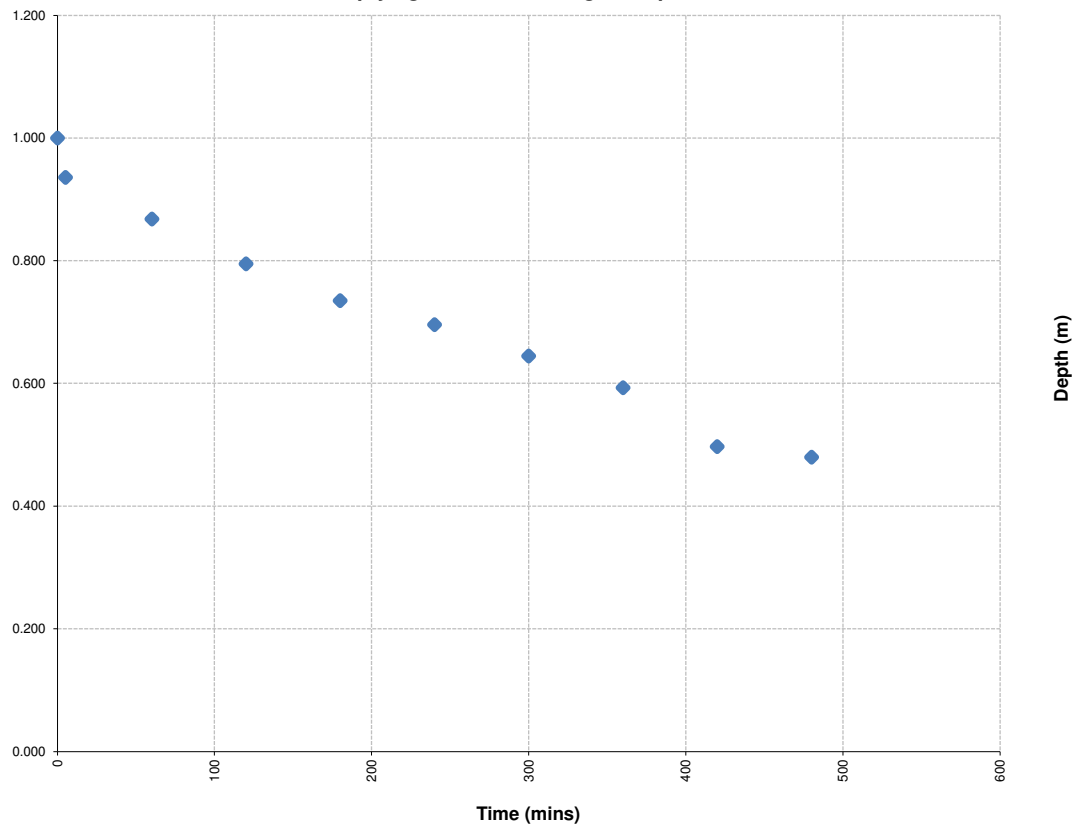
203 Junction Road Burgess Hill - PIT No. 2 - Test 3

1. Permeability rate calculations			2. Test Outflow results		3. Infiltration coefficient (q) (m/h)	
Test pit L:	2.00	Tot vol.:	3	a _{sq} (sq.m):	4.50	Rate (q) provided by SI=
Test pit W:	1.00	a _{p50} :	6.5	Inflow (cu.m):	#REF!	Calculated Soil Rate (f)=
Test pit D:	1.50	V _{p75-25} :	1.5	Outflow (cu.m):	1.50	0.06593
Free vol (%):	100	t _{p75-25} :	210	Storage (cu.m):	#REF!	
Effective depth:		1.500				
Infiltration rate (f):		1.832E-05

Emptying times for soakage test pit
