Drainage and Highway Details

Project  
NEW STAFF ACCOMMODATION

Client  
HURSTPIERPOINT COLLEGE

## Infiltration testing report at Ruckford House, Hurstpierpoint College, Malthouse Lane, Hurstpierpoint, Hassocks, West Sussex, BN6 9JX

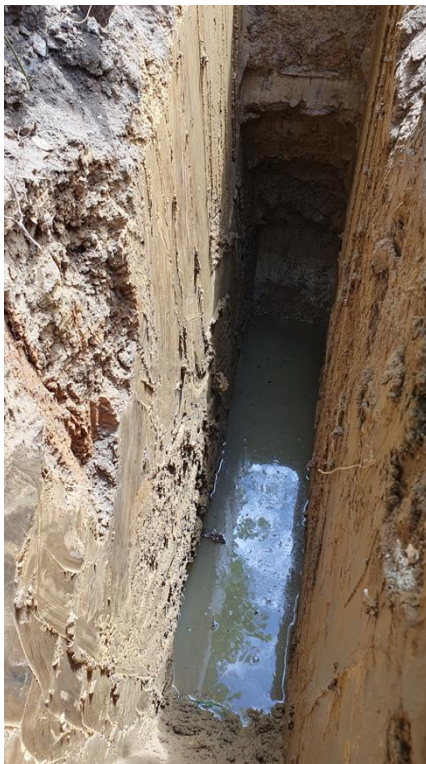
*Photo 3 Pit A ground water*

The test pit (pit A) was excavated to 2200mm. Water was observed lining the bottom of the pit almost immediately. After one hour this had risen to a depth of 234mm. Further testing for this pit was therefore cancelled.

Test pit A. It was not possible to measure infiltration at this pit as ground water was encountered at 2.2m. After 1 hour ground water had filled the bottom of the pit to a depth of 254mm.

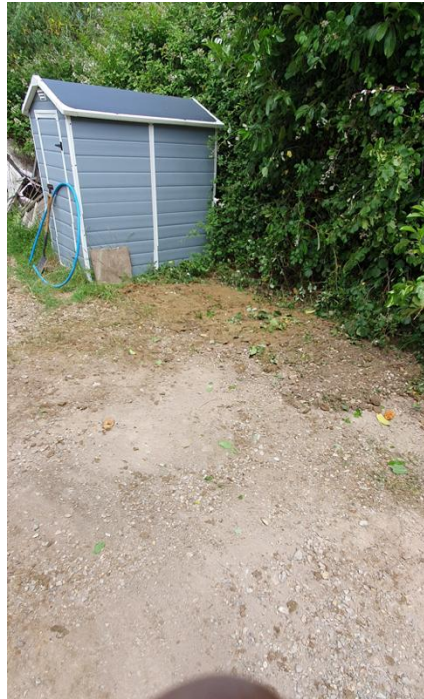
*Photo 4 Pit A extracted clay mouldable by hand and damp.*

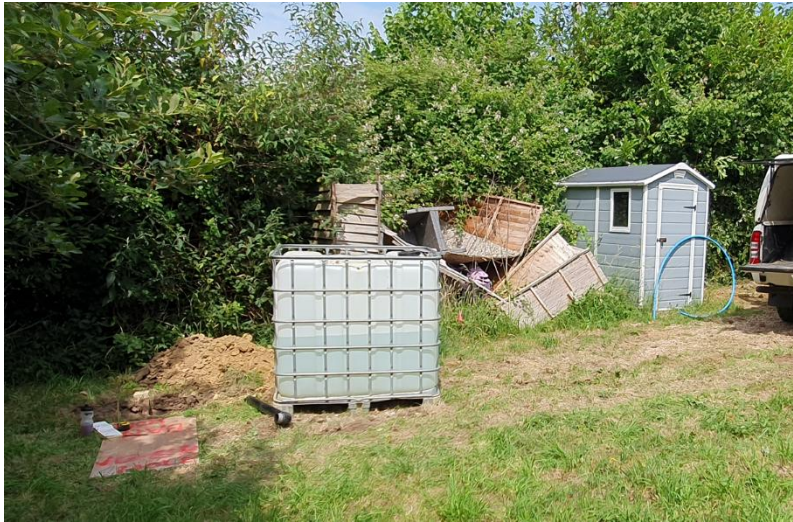
Photo 6 Pit P side elevation

Test Pit P. Only one test was possible in the day due to slow infiltration. BRE 365 requires 3 tests to be made but this would not have been possible to complete in a day.

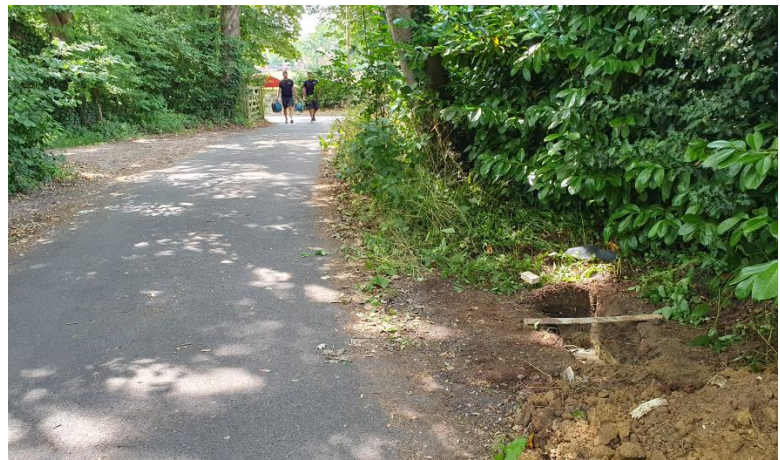
Photo 11 Pit Q from above

Test Pit Q. Only one test was possible due to very slow infiltration and a projected measurement was made to achieve 75% drainage.

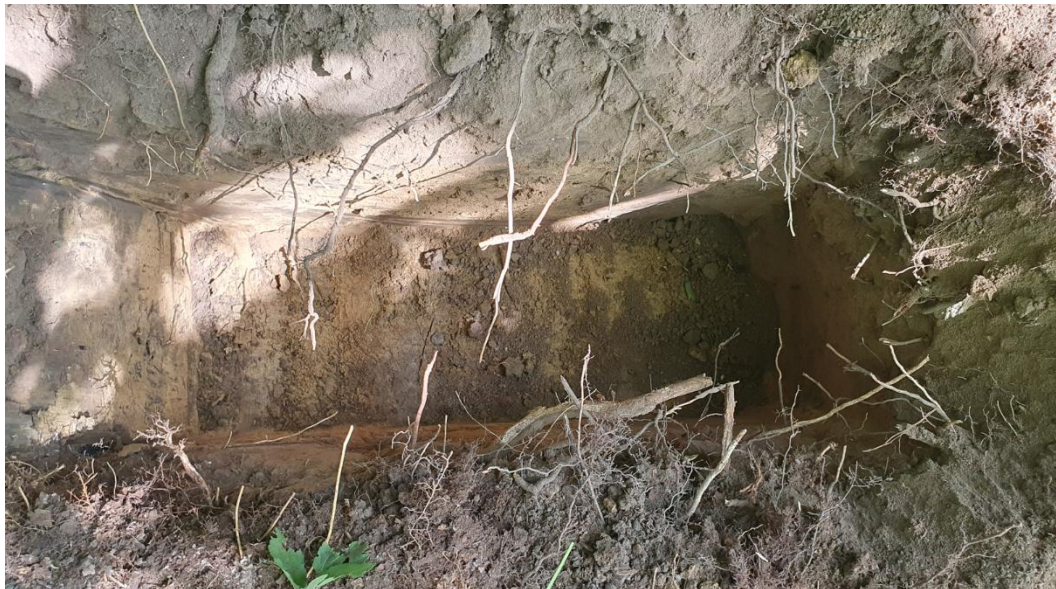
Photo 12 Pit Q side elevation

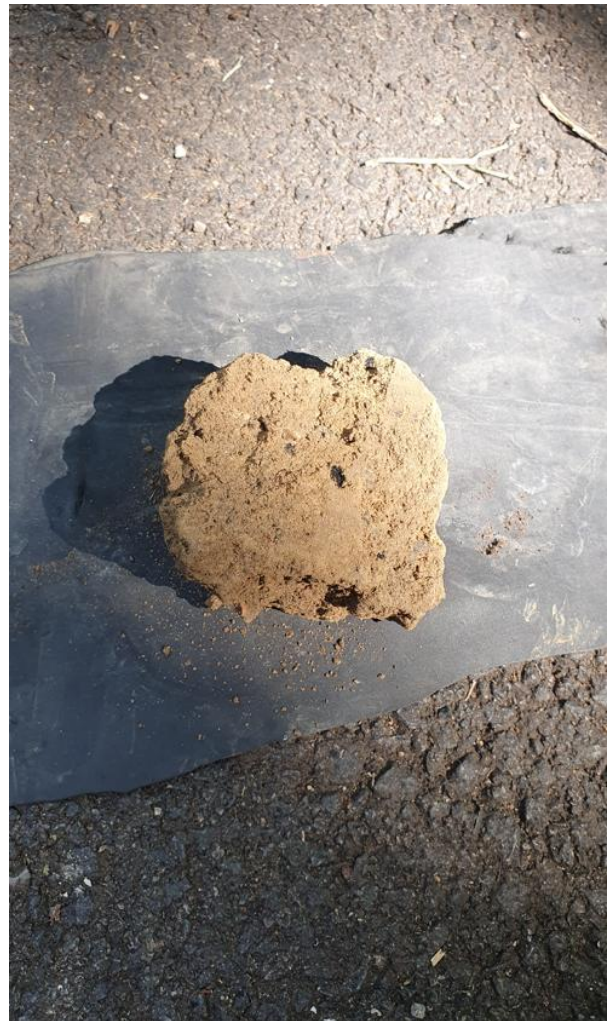
Photo 13 Pit Q clay excavated

| Pit label | Location | What3Words | Soil Profile from top | Dimensions (mm) |
|---|---|---|---|---|
| <b>Q</b> | N 50°56'<br>41.4384"<br>W 0° 9' 46.6776" | ///protests.united.measuring<br>(see photo 9) | 230mm top-<br>soil<br>325mm clay | 970L x 320W x<br>555D |
