## DESIGN, ACCESS AND HERITAGE STATEMENT

Shepherds Farm  
Turners Hill Road  
Crawley Down  
Sussex  
RH10 4HQ

Project: replacement of two dangerous chimney stacks and repointing of a third chimney.

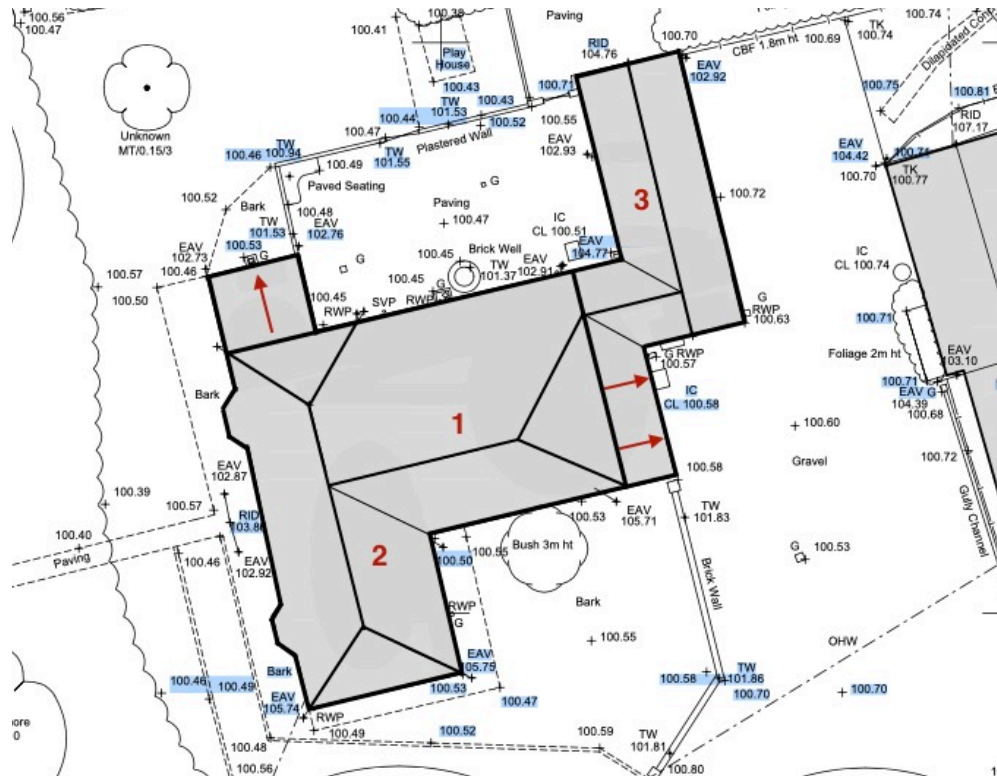
Plan of Shepherds Farm and its three ranges with extensions shown by the arrows.

- 2.4. The farmhouse today can be seen to consist largely of three ranges. The first range includes the core, two-storey building orientated east-west. This is not immediately obvious on first arriving as it has been extended to the north and therefore appears squarer in plan. There is also a small single-storey addition to the east. The second range to the west is also two-storeys and runs predominantly north-south. This includes part of the core and later extensions. This has a single-storey addition at its northern end. A third range which is also single-storey is attached at the north-east corner of the farmhouse and is orientated north-south. Planning has recently been approved to replace this modern element.

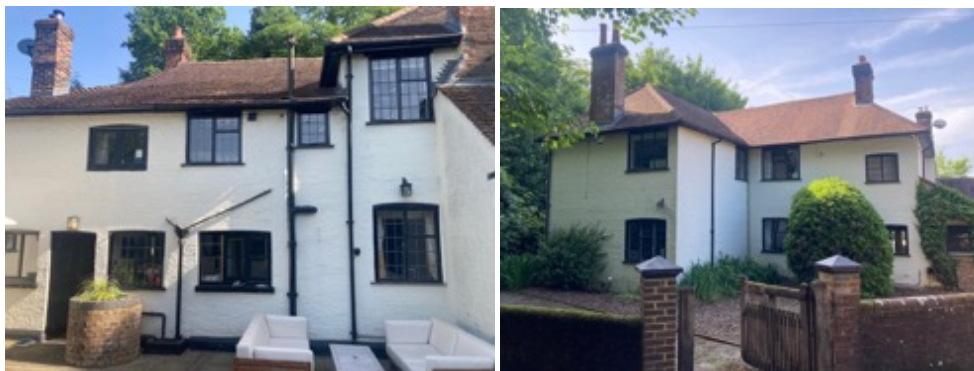
Fenestration on the north and south elevations.

- 2.5. The north and south elevations have a mixture of casement windows with the northern elevation generally containing windows of a smaller scale. These are in the first range and are all timber with split panes. The remainder of the windows are larger metal casements with top vents and leaded lights. All the windows on the ground floor and one on the first have segmental arches.

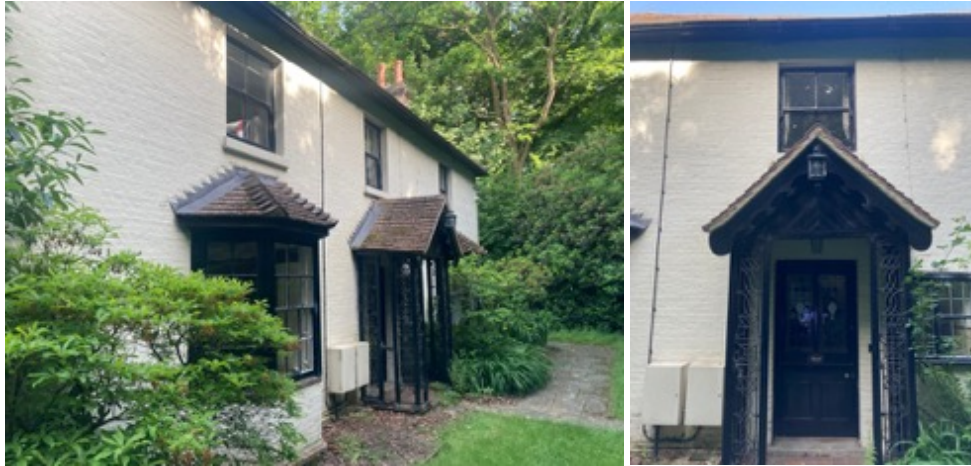
**The polite western elevation with its decorative porch and sash windows.**

- 2.6. The two main ranges are of brick construction in Flemish bond which has been painted cream. The third range is likely to be of masonry construction though has been coated in a render system and also painted cream.
- 2.7. The roofs are all red clay tile except for the single-storey eastern addition which is slate. There are two chimneys at the eastern end of the main range and chimneys at either end of the second range which are the subject of this application. These are all brick construction and remain unpainted, except for the chimney at the southern end of range 2 which is rendered.

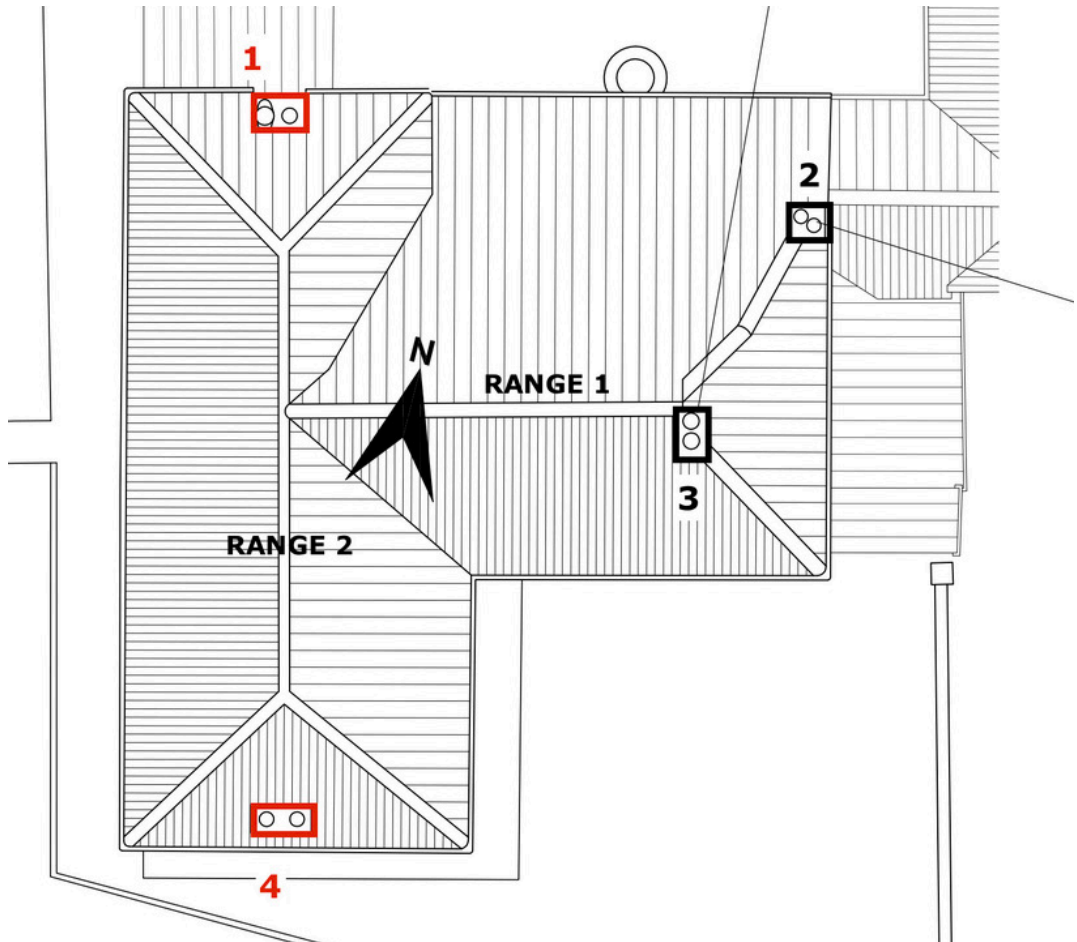
The chimney positions, with those in red to be replaced. © LT Pickering Architects Ltd

- 5.1. As mentioned above, Shepherds Farm has four brick chimneys, with two in the east range and two larger chimneys in the larger east range, located at the northern and southern ends. These are numbered on the plan below and correspond with the planning drawings, though those to be replaced, here are shown in red.
- 5.2. Chimney 1 is an exposed brick chimney whilst chimney 4 is rendered. The render appears to include ashlar lining suggesting that it was quite an early treatment. Chimney 3 will simply be repointed, and the caps replaced. These are currently too small.

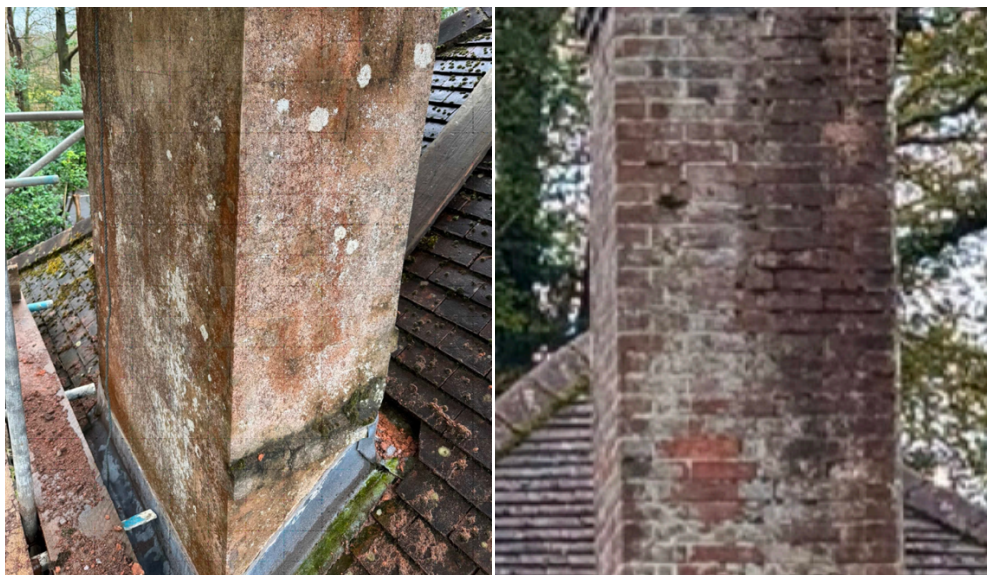
- 5.3. The two chimneys in the west range have both failed due to their developing condition. This has been brought about partly by lack of use which has encouraged damp and in the case of the southern chimney stack has been exacerbated by being covered in render which has potentially trapped moisture within the brick substrate.

The south stack coated in render and the northern stack damp with salts.

- 5.4. Chimney stack 1 was leaning towards the house and when touched (by others) could be easily moved, while stack 4 was also unstable with slate found bedded into the structure.
- 5.5. Due to the potential danger of both stacks collapsing, they were reduced (as emergency works) to a level where they were stable, with stack 4 having about 6ft of brickwork removed. They are also now surrounded by scaffolding.
- 5.6. The proposals seek to reconstruct both chimneys to the same design, though without the render on the southern stack. Stack 1 is constructed in alternating rows of stretcher bond and Flemish bond with brick spacers running down each side. The use of Flemish bond with spacers is a typical feature of 19<sup>th</sup> century brickwork that is important to retain and would be lost with stretcher bond applied throughout. The design to be replicated is shown below:

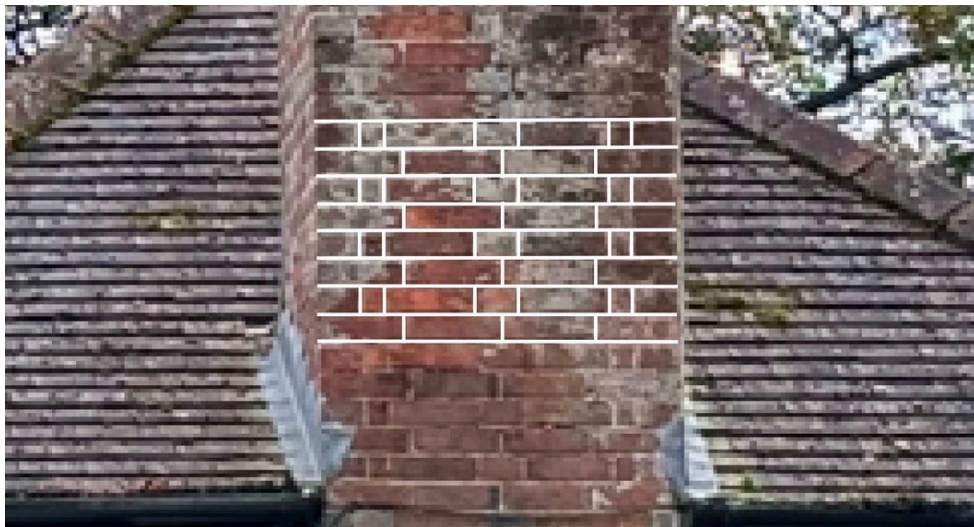
**The pattern of brickwork for chimney stack 1 which will be reproduced.**

- 5.7. The brick pattern on the southern stack is not visible but will employ a compatible design in accordance with the detailed drawings. The bricks will be a new matching type and laid in a matching lime render. For chimney work this is likely to be a mix using natural hydrated lime - NHL 5, with sharp sand and not standard building sand. NHL 5 is preferable for exposed areas such as chimneys. The string courses at the tops of the chimneys will also be matched according to the detailed drawings.

- 5.8. **Impacts:** the proposed rebuilding of the chimneys will match the existing and over time will weather down to a similar appearance. The use of spacers and lime mortar will help to maintain an authentic character which could otherwise be devalued with standard construction. The main change will be to the southern stack which will be reconstructed without render to allow the chimney to remain fully breathable.

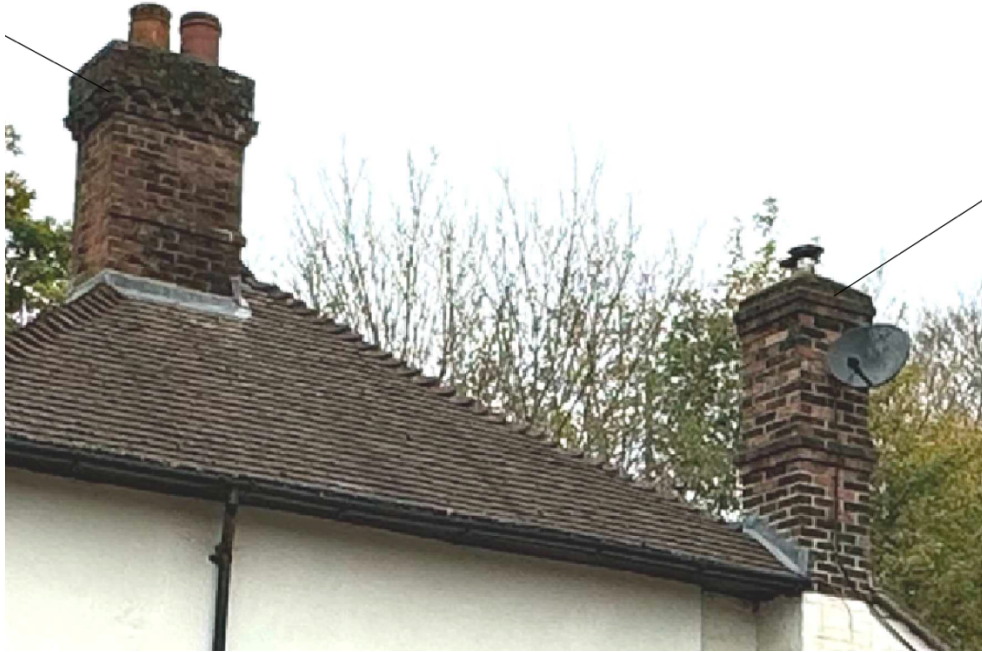
Chimney 3 to be repointed (left) and the unaffected chimney (right).

- 5.9. The repointing of chimney 3 will involve the removal of any loose mortar by hand and not with the use of mechanical tools. If the chimney has been repointed in cement and does not come off easily, then an *Arbortech* style brick saw may be employed with the permission of the LPA. This will then be repointed with a matching lime mortar with the joints set back and not flush. This will result in an increased joint depth and unsympathetic appearance. New pointing will be kept to a minimum and not replace healthy mortar. The caps will be replaced for a larger type.

- 5.10. **Impacts:** undertaken carefully this work should have no harmful impacts on the chimney or to the character of the listed building.
