**Unit 3A Acacia Grove, Copthorne Road, Copthorne, West Sussex RH10 3PD**

This rebuttal letter has been prepared to address the objections raised by the adjacent owner of Heathy Ridge dated 19<sup>th</sup> and 25<sup>th</sup> April 2024 with respect to the application at Unit 3A Acacia Grove (reference DM/23/2493).

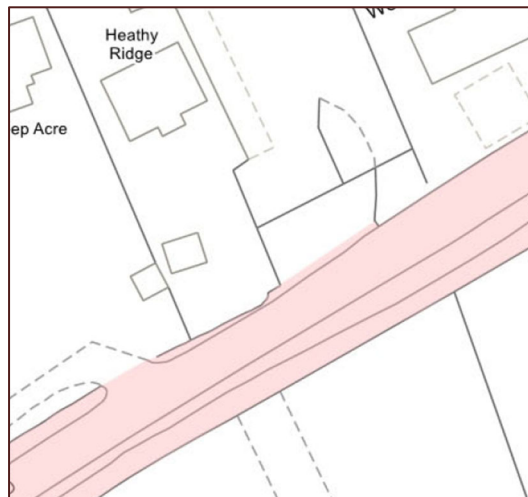
The letter from Heathy Ridge seems to indicate that Figure 2.1 (supplied by WSCC) is inaccurate "Highways ownership appear to cross a line and be undefined in the section between Acacia and Heathy Ridge". We cannot comment on accuracy of 3<sup>rd</sup> party drawings, but as it stands WBCC records confirm there is highway land adjacent to the carriageway (as shown below) which is not owned by either Acacia or Heathy Ridge (it would be highly unusual to have a running carriageway lane immediately against a private frontage).

A topographical survey was therefore commissioned to ensure the information used for the visibility splay is the most accurate possible, this is considered best practice in assessing visibility splays. Figure 2.1 is based on the OS map provided by West Sussex County Council and Figure 3.1 is based on the digital topographical survey with the highway boundary information overlaid. This explains the differences between the two drawings, but Figure 3.1 has to be considered as accurate.

2. The diagram, Figure 3.1, as mentioned for comment 1 above, is an accurate reflection of the layout of the carriageway of Copthorne Road as it currently exists and includes the land extending to the boundary lines either side of Copthorne Road. The carriageway surfacing and repairs were carried out by the highway authority where it was considered appropriate for the movement of traffic, and it is some 6.8m in width at this point.

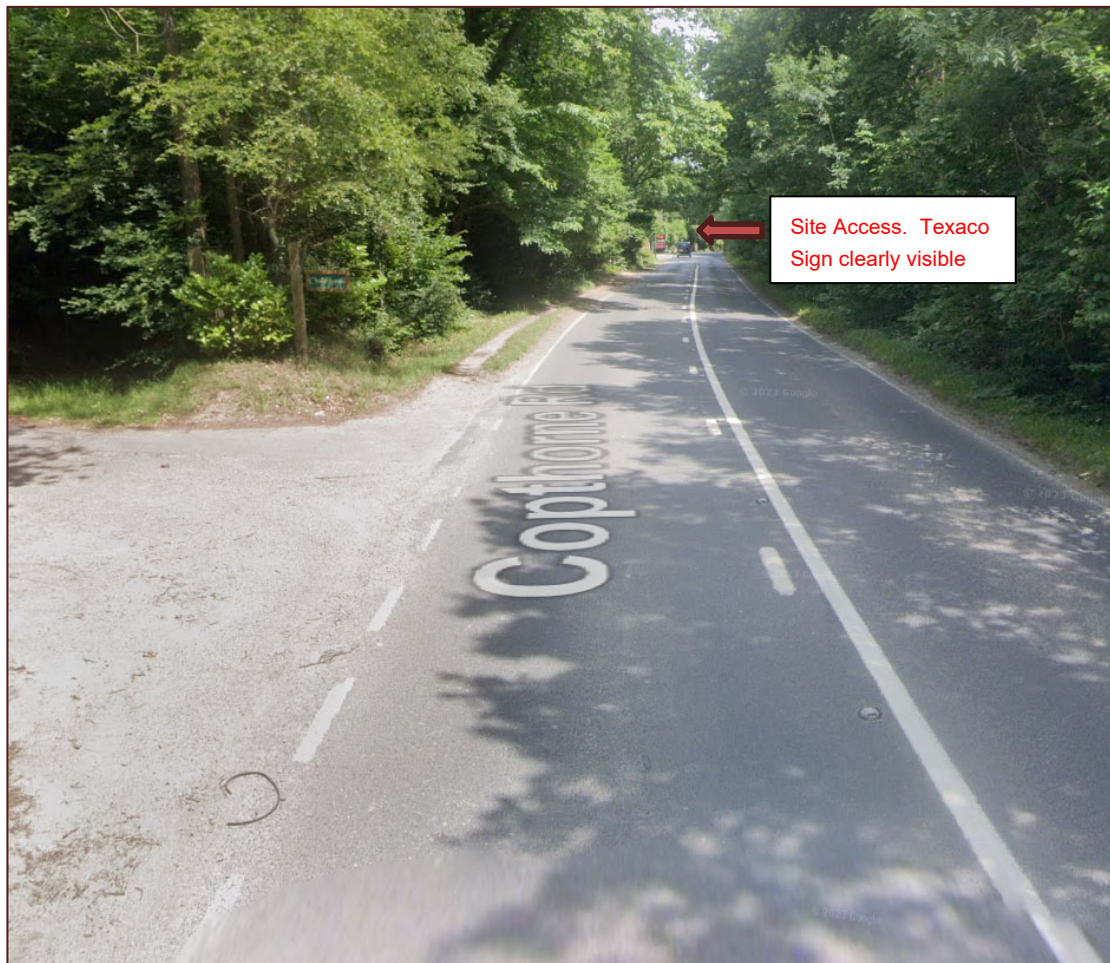
As shown in the picture below (and Figure 3.1) the site access is clearly visible from 130m (and beyond) south of the access, clearly there is no opportunity/possibility for motorcycle not to be visible.
