# **THE STABLES, COWFOLD ROAD, BOLNEY**

## **ECOLOGICAL ASSESSMENT, Including PRELIMINARY ROOST**

## **ASSESSMENT AND EMERGENCE SURVEY**

### **LOCATION: TQ 25744 22411**

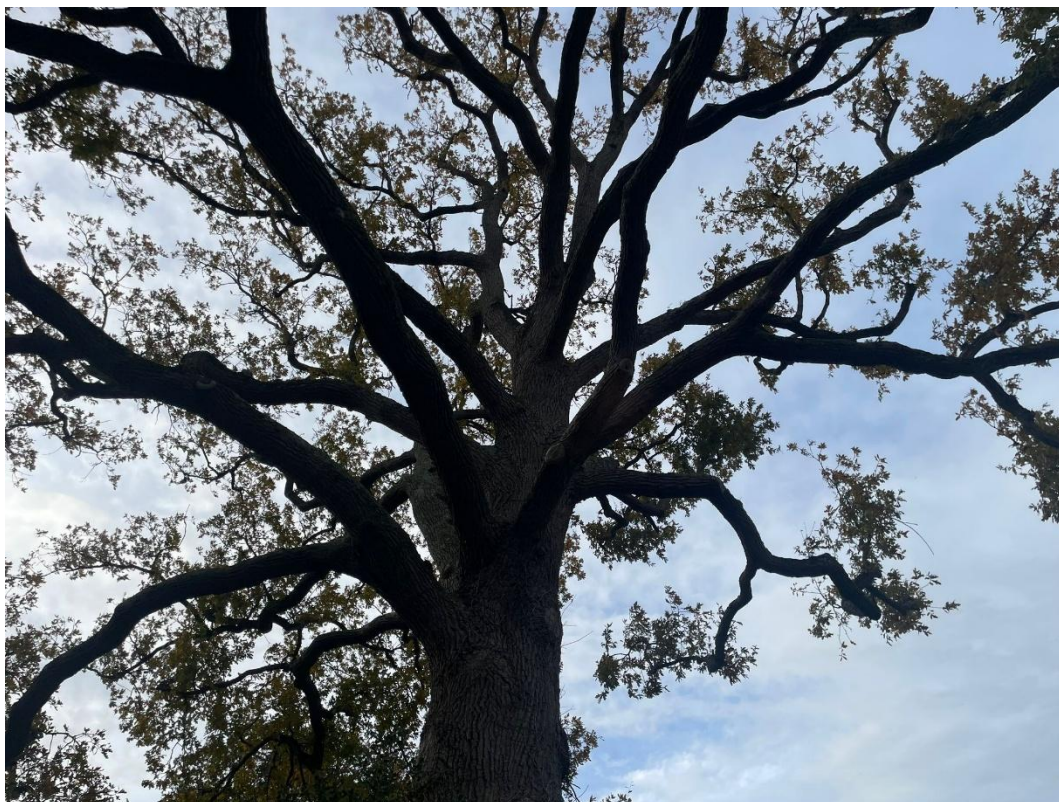
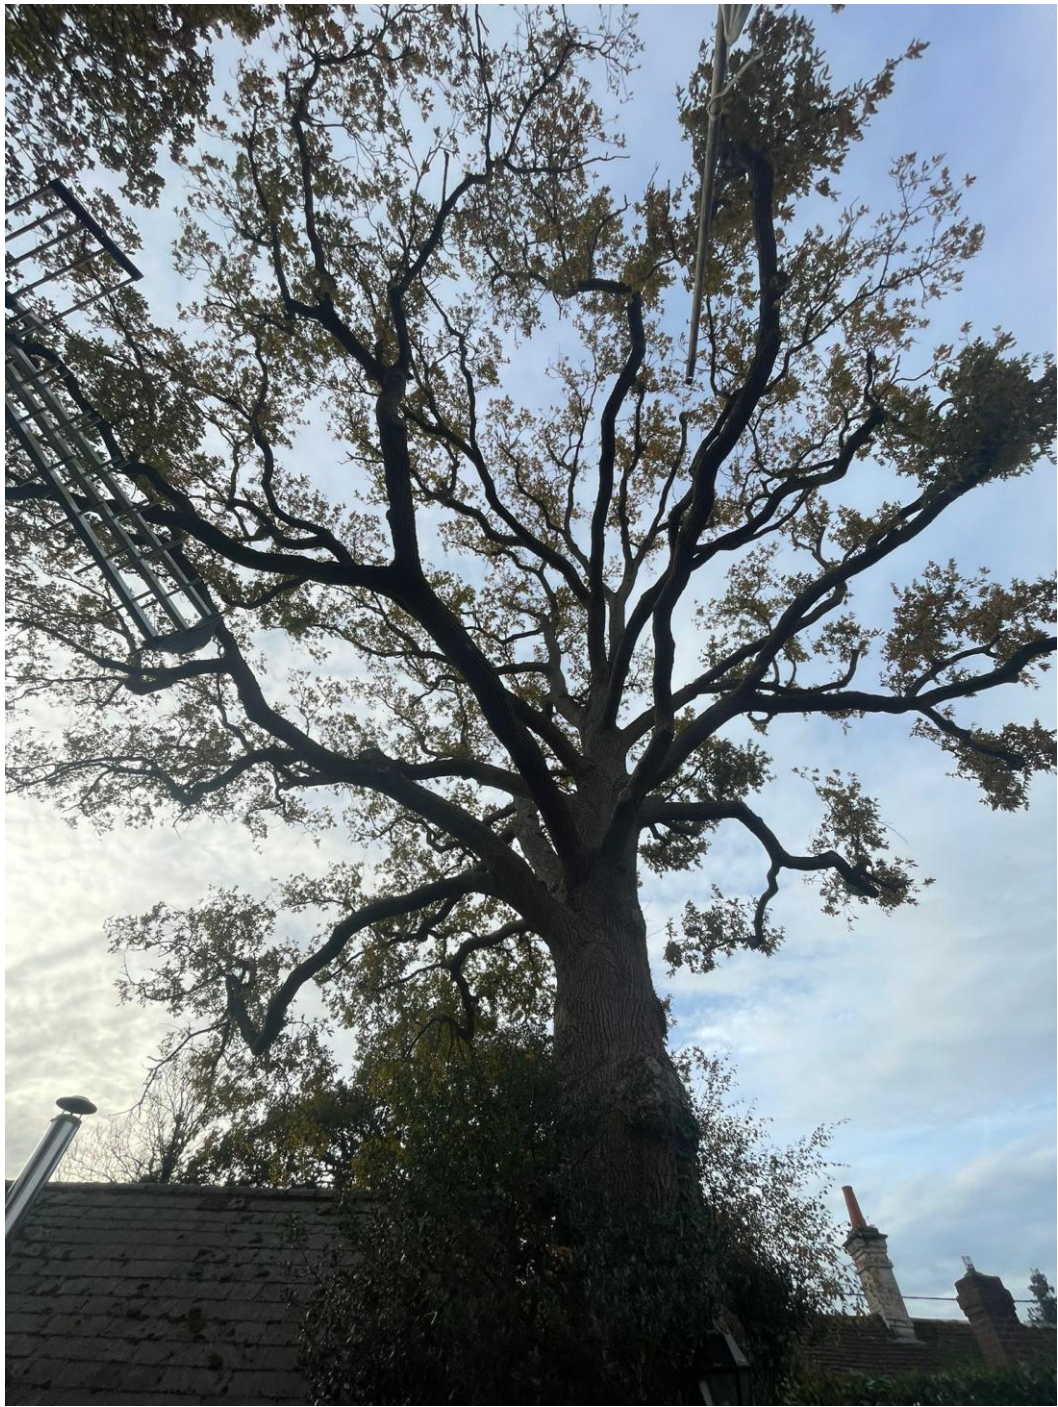
*Tree 4*

T4 was not seen to have any PRFs, however it was not possible to view all aspects of the tree, or into the canopy from ground level. Off site trees were noted to have potential for roosting bats.

| Tree Number | Description | Potential Roosting Features | Bat Roost Potential |
|---|---|---|---|
| <b>T4</b> | A veteran English oak tree of approximately 20m in size. | There are no visible PRFs from ground level, however, the tree is too tall to see into the canopy. | <b>FAR</b> |

- The mitigation hierarchy should be used when considering the design, to avoid impacts to bats (and other wildlife) where possible.
- Where the design cannot rule out impacts to trees directly or indirectly, the design should demonstrate how impacts will be minimised. Examples of direct impacts are felling, cutting or obstruction of bat roost features, indirect impact examples are light spillage, noise and disturbance.
- If modifications of the construction design result in being unable to retain T4 then this represents a direct impact, and further detailed surveys (aerial or emergence) will be necessary to confirm whether the feature supports roosting bats.
