# **HOBBS FIELD ACCESS, SAINT HILL MANOR, SAINT HILL ROAD, EAST GRINSTEAD**

## **PROPOSED ACCESS IMPROVEMENTS WORKS, OPTIONS.**

**Stage 1 Road Safety Audit**

**RW-KS-25-4905-RSA1**

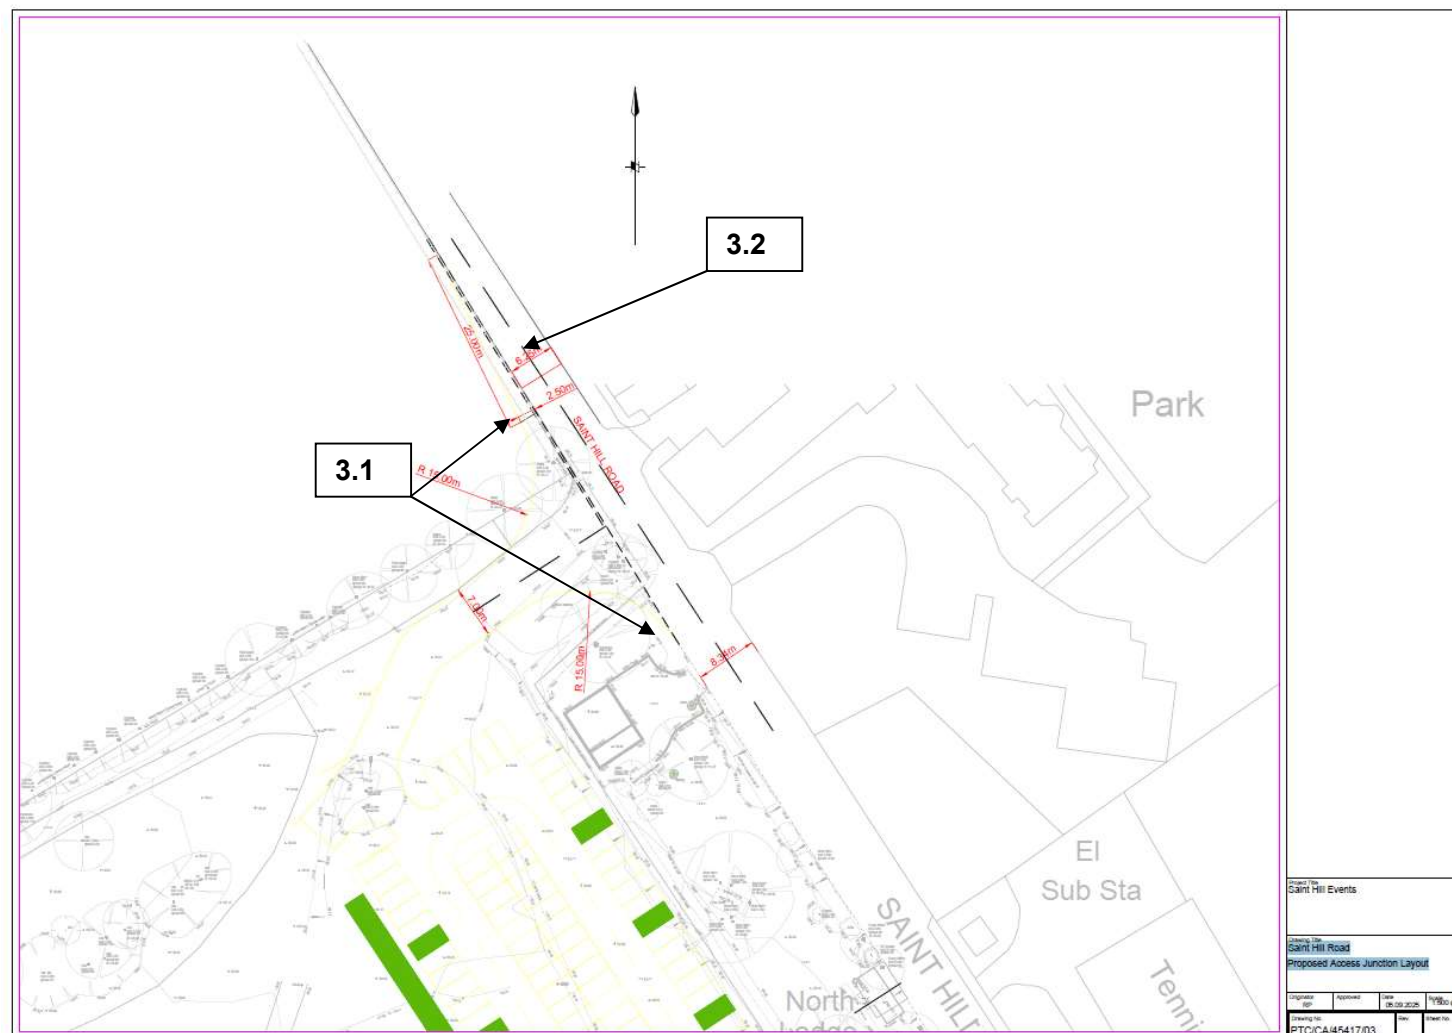
## OPTION 1, WITH TAPER.

LOCATION: South and north of site access.

SUMMARY: Trees and hedges in visibility splays.

There are a number of trees to the north and south of the site access which will obstruct the required visibility splays. The hedges are referred to and proposed to be cut to 600mm above carriageway level. The RSA Team are concerned that unless these are maintained on a robust and regular maintenance programme they will quickly regrow and obscure the junction visibility splay. There are also a number of trees that are likely to obscure or restrict the visibility splay.

Should adequate junction visibility not be available then emerging collisions may be more likely to occur.

LOCATION: Northbound past proposed site access.

SUMMARY: Possible head on collision risk.

Some vehicles may attempt to use the taper as a merge lane and this could lead to other northbound traffic effectively overtaking traffic in the taper and overrunning the centre line. This could lead to a risk of head on type collisions with southbound vehicles as the round the right-hand bend in the area of the East Grinstead Sports Club.

Additionally, emerging drivers using the taper may have a poor view to approaching northbound users and this may lead to emerging collisions.

Permanently remove all tree, hedges and vegetation from visibility splays (reference also paragraph 2.2 of this report).

Install measure to prevent or deter the taper being used as a merge lane, such as hatched road markings, or overrun areas.

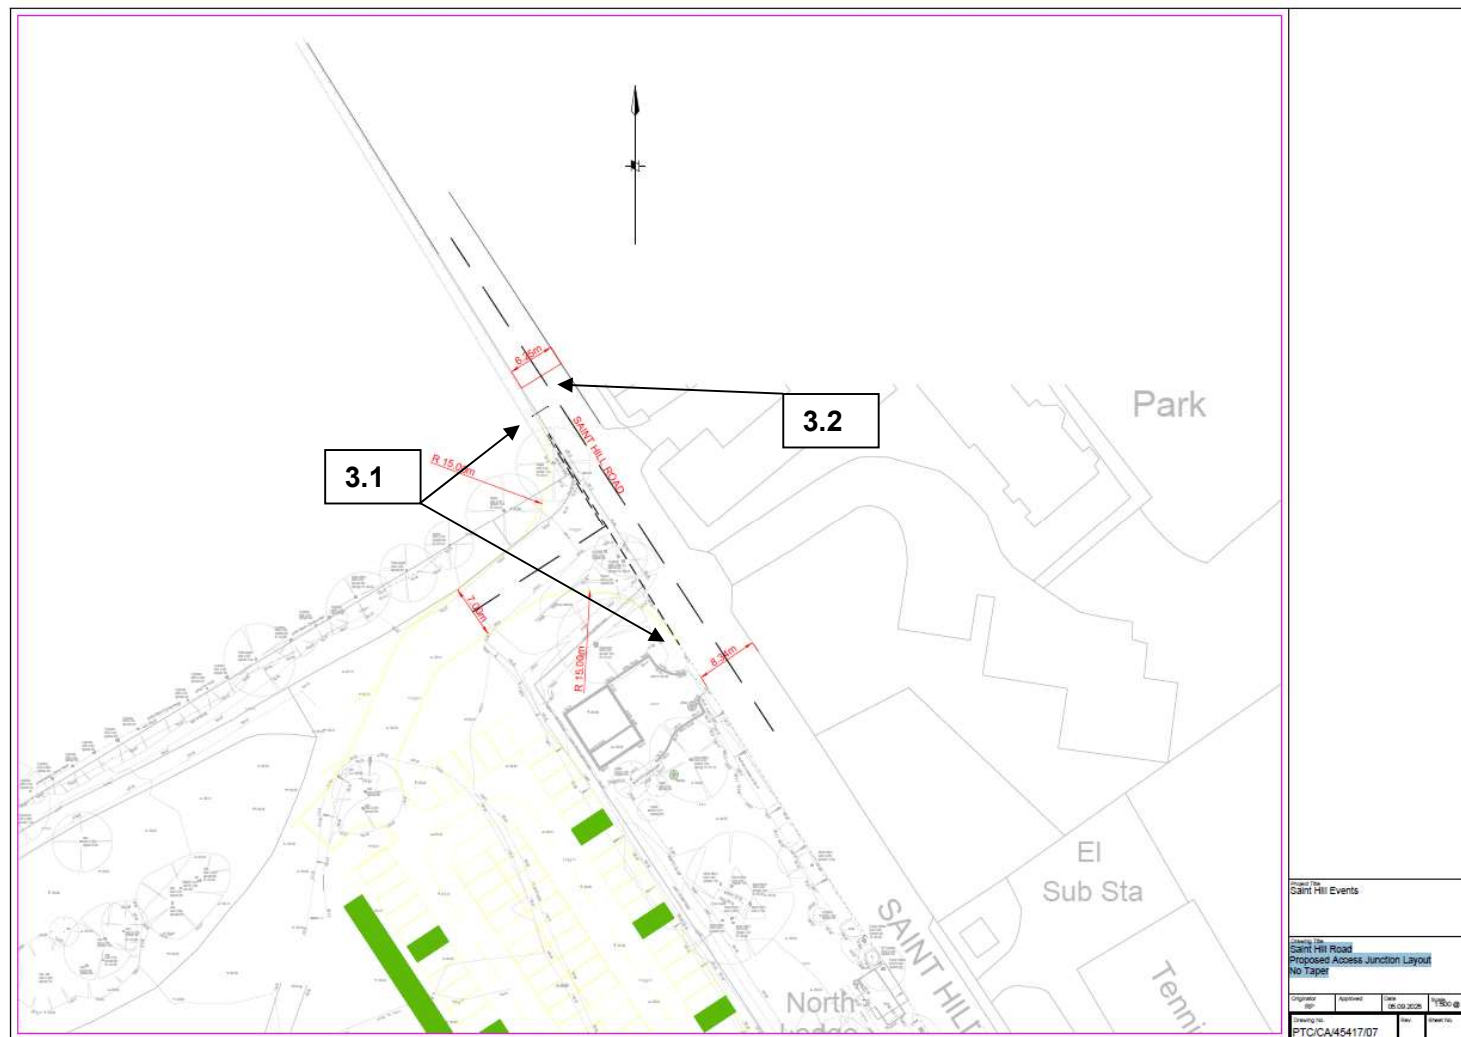
**OPTION 2, WITHOUT TAPER.**

LOCATION: South and north of site access.

SUMMARY: Trees and hedges in visibility splays.

There are a number of trees to the north and south of the site access which will obstruct the required visibility splays. The hedges are referred to and proposed to be cut to 600mm above carriageway level. The RSA Team are concerned that unless these are maintained on a robust and regular maintenance programme they will quickly regrow and obscure the junction visibility splay. There are also a number of trees that are likely to obscure or restrict the visibility splay.

Should adequate junction visibility not be available then emerging collisions may be more likely to occur.

LOCATION: Access at junction with Saint Hill Road.

SUMMARY: Long vehicles overrun opposing lane. Possible conflicts involving southbound traffic.

The swept path movements for long vehicles turning left from the site access show vehicles slightly overrunning the centre line. Visibility for a southbound vehicle driver approaching to a left turn exiting vehicle overrunning the centre line is restricted by the bend in Saint Hill Road. It is estimated that this visibility is restricted to approximately 125m. This is likely to be sufficient visibility for vehicles travelling within the 85<sup>th</sup> percentile speed to slow before conflicting with that left turn exiting vehicle. However vehicles travelling at higher speeds may be at risk of colliding with the turning vehicle or being forced to brake sharply, increasing risk of loss of control.

The RSA Team are also concerned that a southbound vehicle, which has slowed or to let a left turning vehicle exit the proposed access, could be at risk of being shunted by another southbound vehicle whose visibility to the slowing / stopped vehicle has been obscured by the carriageway alignment past the East Grinstead Sports Club access. The RSA Team could not measure out visibility through this bend safely during the site visit due to risk from live traffic.

Permanently remove all tree, hedges and vegetation from visibility splays (reference also paragraph 2.2 of this report).

Ensure that forward visibility through the bend past the East Grinstead Sports Club access is suitable to allow trailing vehicles to slow behind any slowing or stopped vehicles.

Provide junction ahead warning signs for those drivers travelling above the 85<sup>th</sup> percentile surveyed speed. This measure should not be adopted in lieu of any other measures which fail to provide suitable stopping sight distance to slowing or stationary vehicles for the survey speed of traffic.

Alternatively, alter the radius length for vehicles to turn left from the access so that vehicles do not overrun the centre line.
