## Appendix C

# Site Visit Photographs and Accompanying Figures

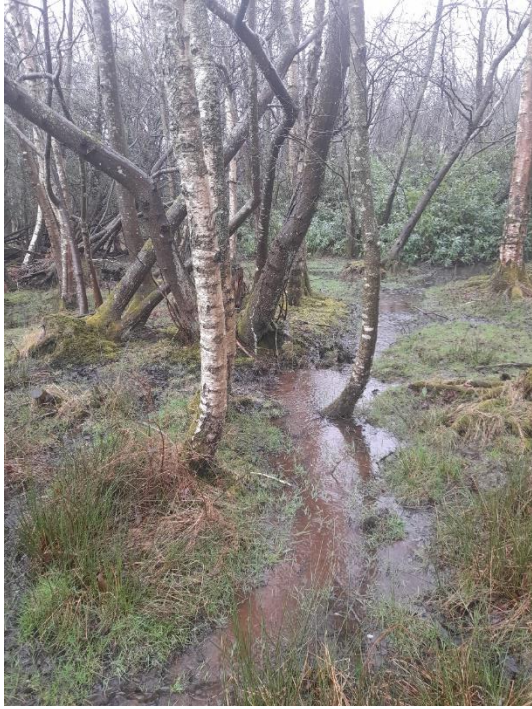
**5.** Surface water flooding in the north of the site. Looking west. Flow observed to be east to west.

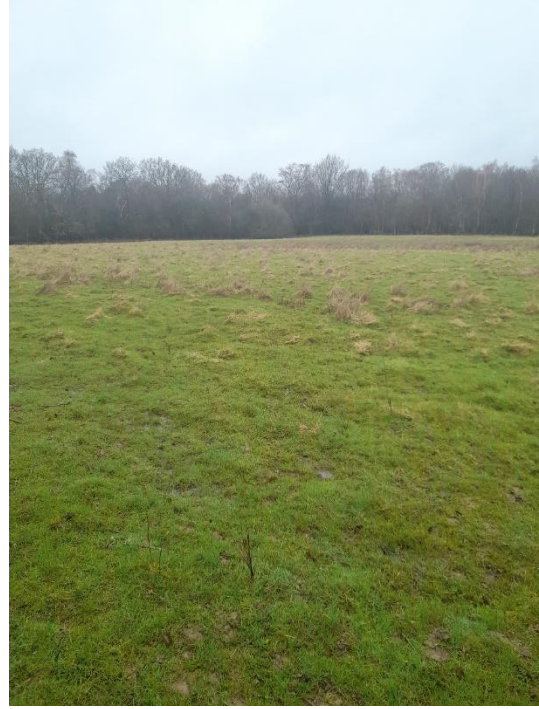
**6.** View of Catchment A looking northwest from the south of the catchment. Land shown to be sloping from southeast to northwest.
