## 2.10 The Site Planning History

## 3.0 Existing Building Character

### Existing Building Character

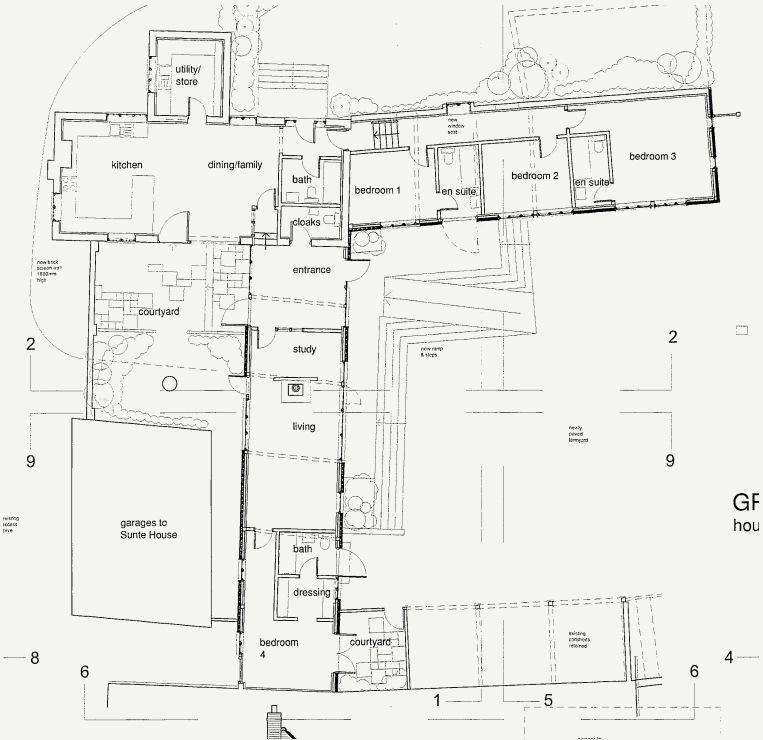
ABOVE: 2005 PERMITTED WORKS TO THE FARMYARD: GROUND FLOOR PLAN

As set out in the planning statement by Whaleback, numerous applications have taken place in this area. Most recently, the permitted works in 2005 which are extant and form a fall back to this application. There are commonalities between this and the proposed works set out in this document. However notably, the barn is not proposed as an independent dwelling (as per the extant) and rather remains ancillary to the residents use.

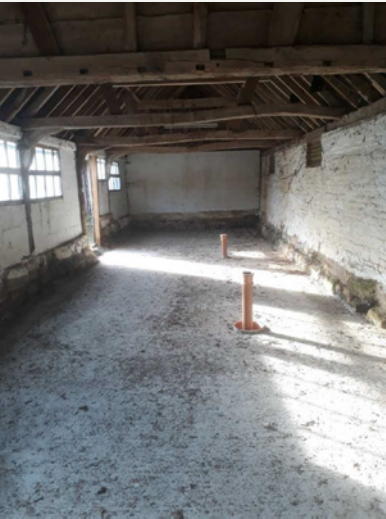
ABOVE: MEANINGFUL START DOCUMENTED WITHIN STABLES

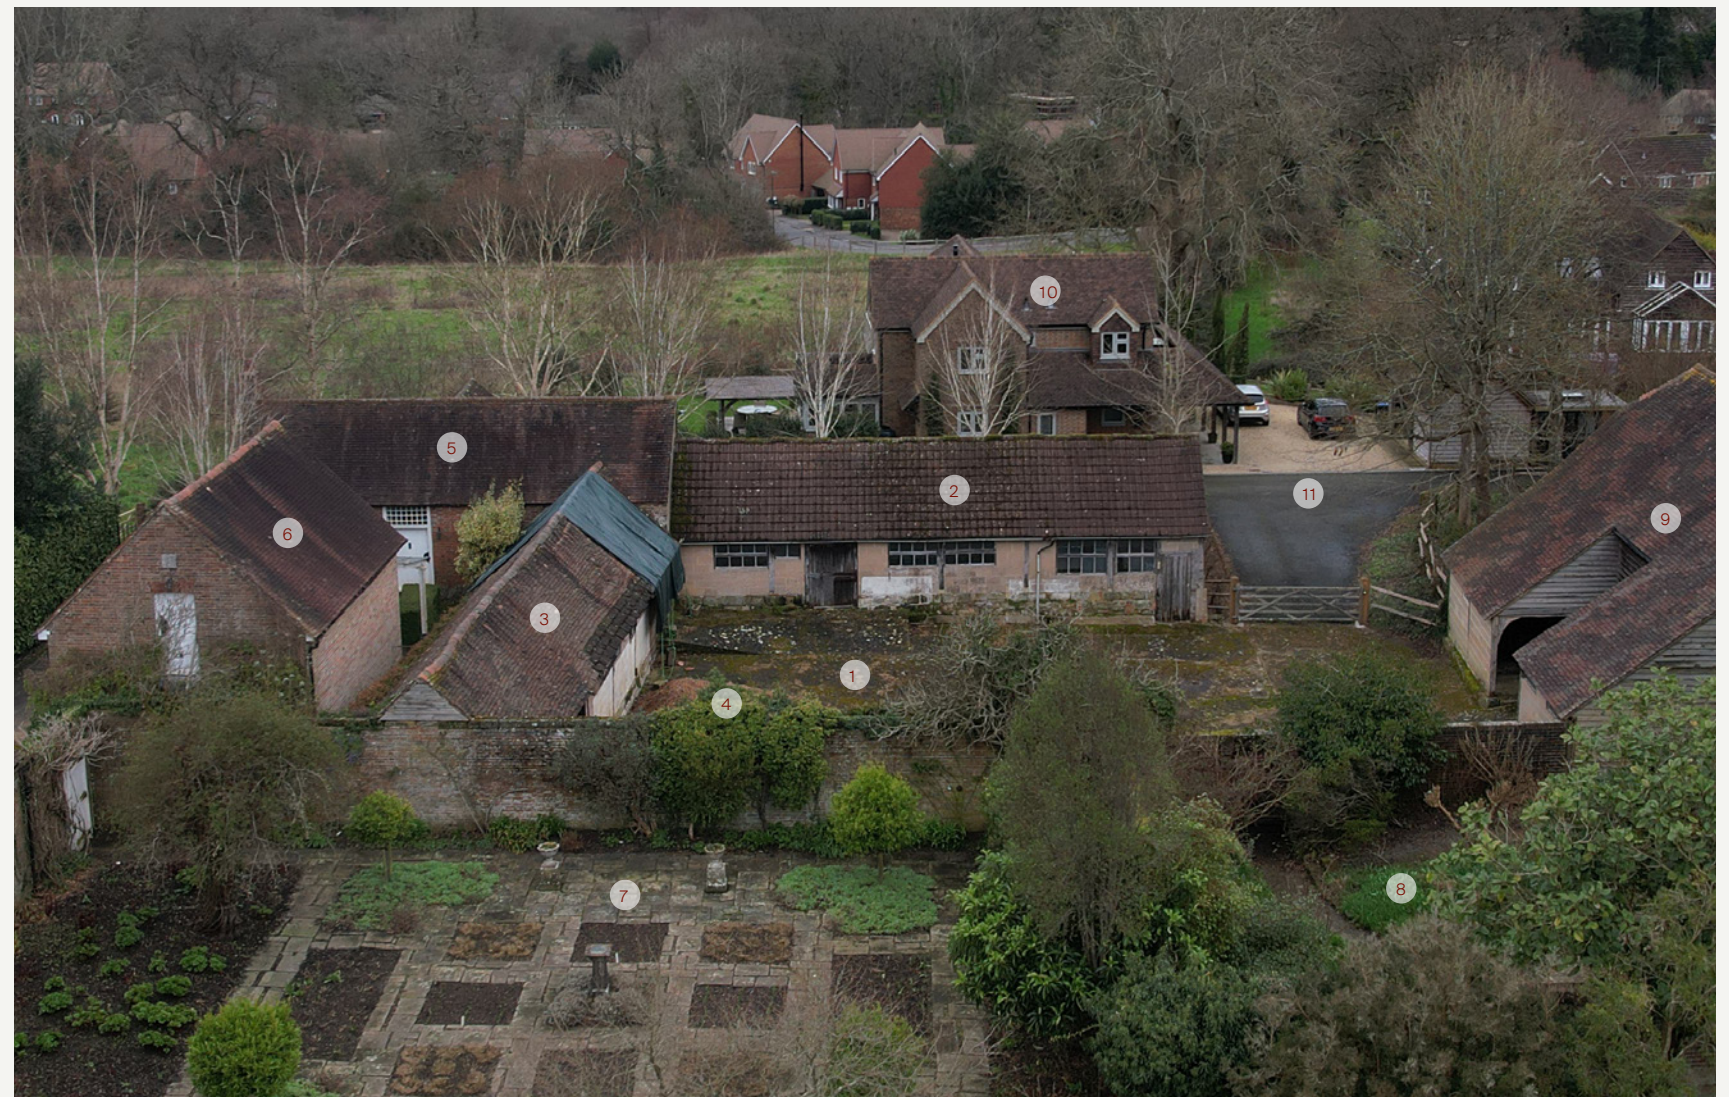
The collection of buildings forming the farmyard sit to the North of the property, and consist of the stables, cow shed and byre, which currently all stand redundant with a number suffering from water ingress (as shown by the temporary tarpaulin) and in urgent need of repair. The courtyard to these is accessed from a short drive to the North from Birchen Lane, also via an aperture formed in the Grade II listed walled garden to the South.

ABOVE: EXISTING VIEW OF FARMYARD AND ASSOCIATIVE BUILDINGS

- KEY:
- 1: THE FARMYARD
  - 2: STABLES
  - 3: COW SHED
  - 4: BYRE
  - 5: COTTAGE
  - 6: GARAGE
  - 7: FORMAL GARDENS
  - 8: WALLED GARDEN
  - 9: BARN
  - 10: GARDENERS COTTAGE
  - 11: BIRCHEN LANE

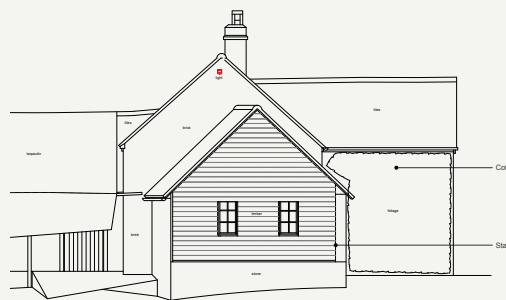
- Curtilage listed single storey building
- Extant planning permission
- Significant C20th alteration
- Absence of historical features internally
- Poor quality, concrete blockwork south facade
- Single glazed metal casement windows
- Modern replacement, clay tile roof
- Queen Post Timber beam system
- Building is currently derelict

GROUND FLOOR PLAN

ELEVATIONS

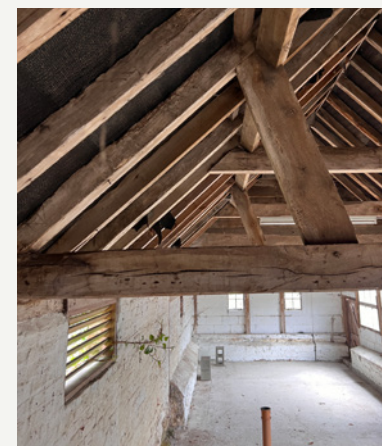
QUEEN POST TRUSS SYSTEM

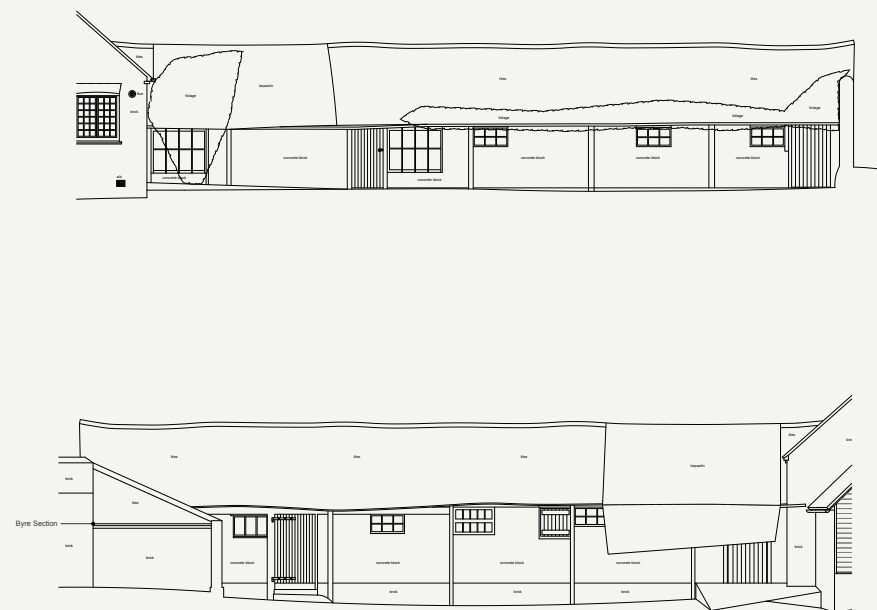
- Curtilage listed single storey building
- Extant planning permission
- Significant C20th alteration
- Absence of historical features internally, bar roof structure
- Poor quality, concrete block work east & west facade
- Single glazed metal casement windows
- Predominantly clay tile roof
- Queen Post Timber beam system
- Building is currently derelict suffering from significant water ingress and damage.

ELEVATIONS

PLAN

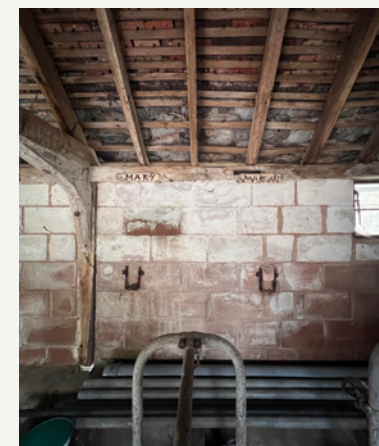
BLOCKWORK AND RAFTERS

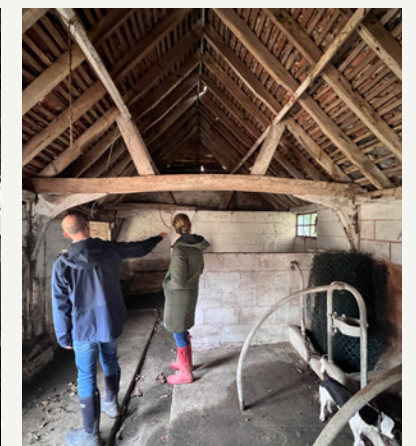
QUEEN POST TRUSS ROOF SYSTEM

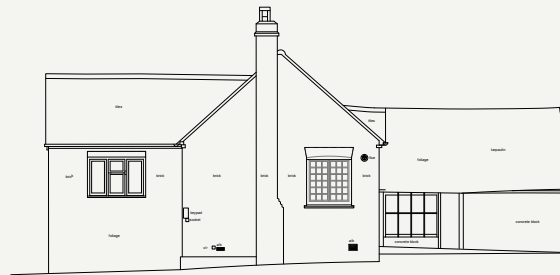
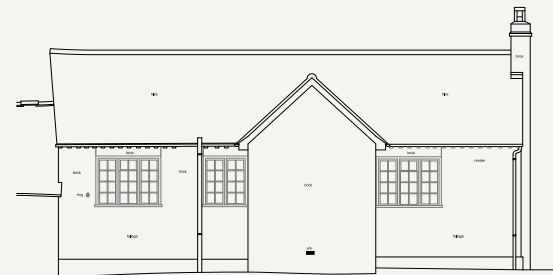
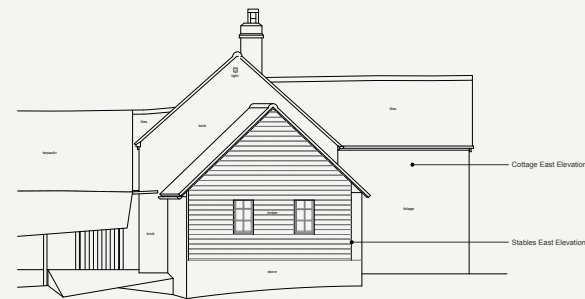
- Curtilage listed single storey building
- Red and grey brickwork facade (flemish-bond) to match the house
- Single glazed timber casement windows
- Predominantly clay tile roof
- Building is currently derelict suffering from water ingress and damage.

ELEVATIONS

PLAN

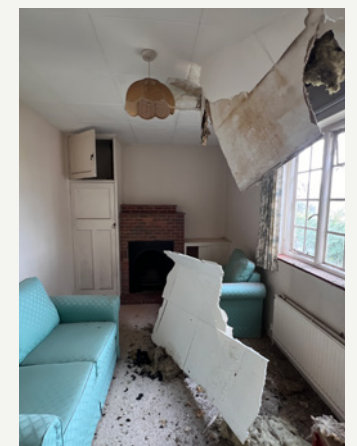
LOUNGE DAMAGE

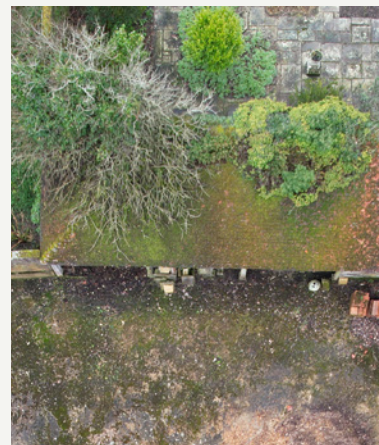
MOSS AND PLANTS OVERGROWN ON ROOF

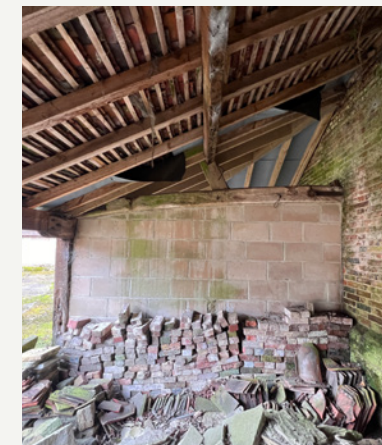
BLOCKWORK, RAFTERS AND BRICK WALL

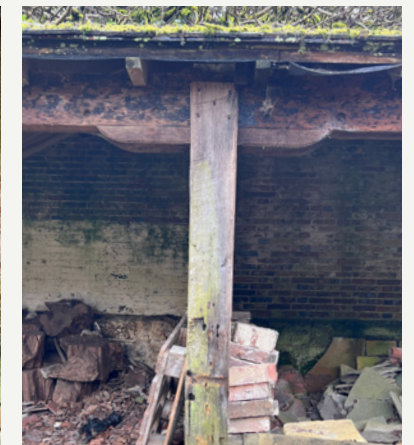
TIMBER POST AND EAVES DETAIL

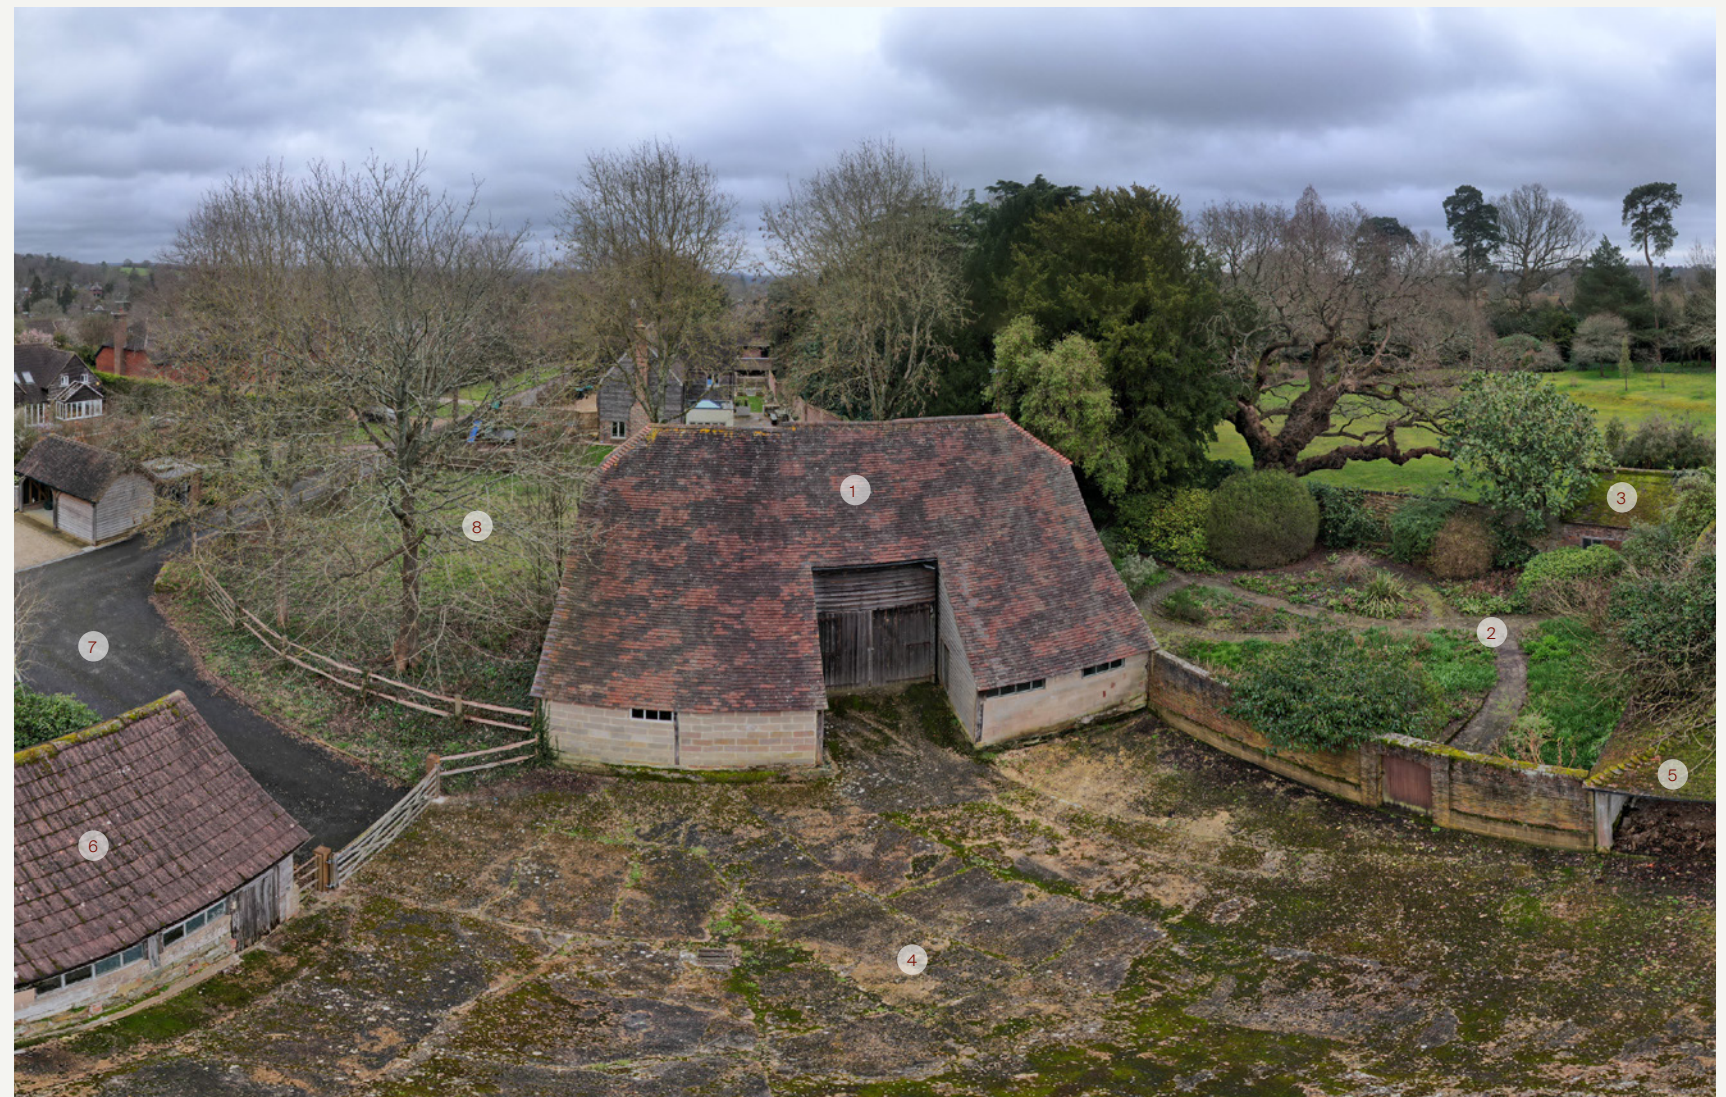
The Barn forms the Eastern perimeter of the Farmyard, enclosing the courtyard and providing a boundary at its southern elevation, to the walled garden. Whilst not a historic structure, there is precedent of a historic barn in this location.

Internally, the barn is a single volume with the catslide roof providing localised spaces under the eaves. Currently the space forms a weather tight area for storage. To the east and north, a large portion of grassed area, named the paddock, forms the perimeter of the property ownership.

ABOVE: EXISTING VIEW OF BARN WEST ELEVATION TO FARMYARD
