# Nether Walstead, East Mascall's Lane, Lindfield, West Sussex, RH16 2QJ

Ecological Assessment

A Report for Mrs T. and Mr E. Ball

| <b>Report Ref:</b> | J24-021567_P2_Rev A | |

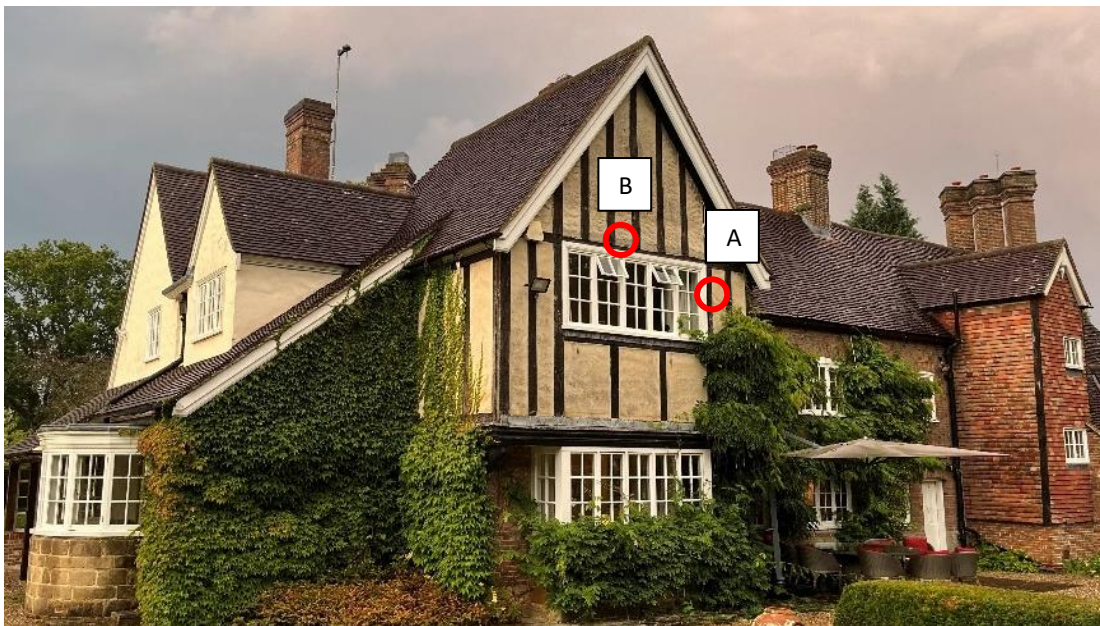
- 5.3.11 A total of ten bats was recorded emerging from Building B1: eight soprano pipistrelle bats and two common pipistrelle bats. The eight soprano pipistrelles were recorded emerging from a gap in the wall between the timber frame and wattle-and-daub composite to the right of the second-storey window on the southern elevation (Emergence Point A) between 21:08hrs and 21:14hrs, from 22-28 minutes after sunset (Image 2). One of the common pipistrelles emerged from above the same window (Emergence Point B) at 21:08hrs, 22 minutes after sunset (Image 2). The other common pipistrelle emerged from the north-western corner of the building (Emergence Point C) at 21:09hrs, 23 minutes after sunset (Image 3).

*Image 2 – The emergence point of 8 x soprano pipistrelle (A) and 1 x common pipistrelle (B) from a gap in the wall between the timber frame and wattle-and-daub composite to the right of a second-storey window on the southern elevation of Building B1*

- 2.10 Without mitigation, the proposed works will result in the loss/damage of the known roosts and therefore no external or loft works to B1 should commence until an appropriate European Protected Species (EPS) licence has been submitted to and approved by Natural England. An overview of the required bat mitigation strategy is provided in Section 6 of this report. It is not currently anticipated that any roof works are required to B2, therefore, these roosts will remain unaffected and do not require a licence. Building B3 and B4 have not been identified as supporting bat roosts and can therefore be undertaken without any further surveys or mitigation in relation to bats.

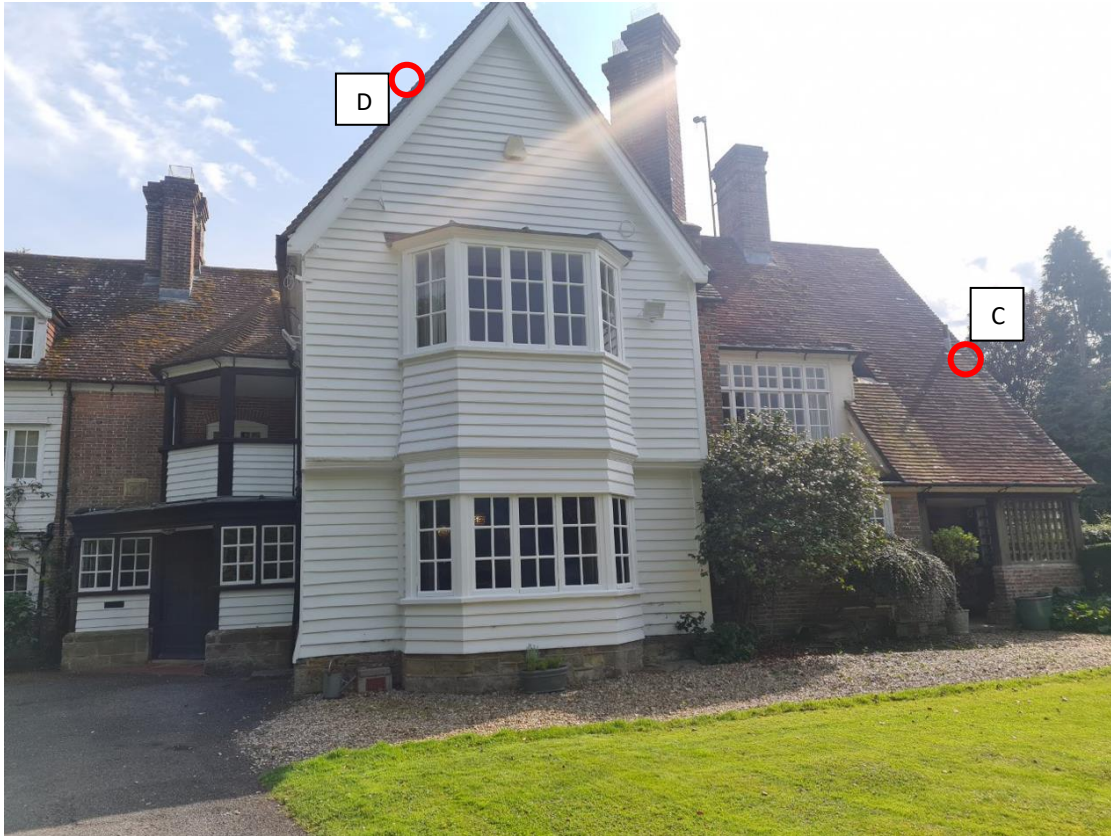
*Image 3 – The emergence point of 1 x common pipistrelle (C) from a roof tile on the north-west corner of Building B1 on 01.08.24; and 1 x brown long-eared bat (D) from near the ridge of the roof on the northern extension on 22.08.24*

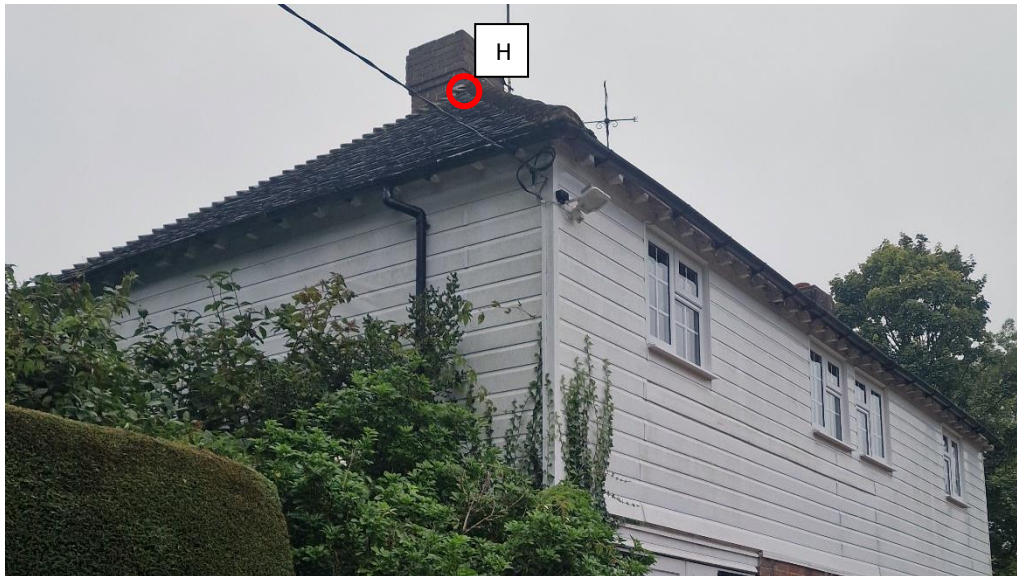
5.3.14 A total of three common pipistrelle *Pipistrellus pipistrellus* bats were recorded emerging from Building B2 during the survey. All three common pipistrelles emerged from a roof tile beneath the chimney on the southern elevation (Emergence Point H) between 20:23hrs and 20:41hrs, 11 minutes before sunset (Image 4).

*Image 4 – The emergence point of 3 x common pipistrelles from a roof tile beneath the chimney on the southern elevation of Building B2*

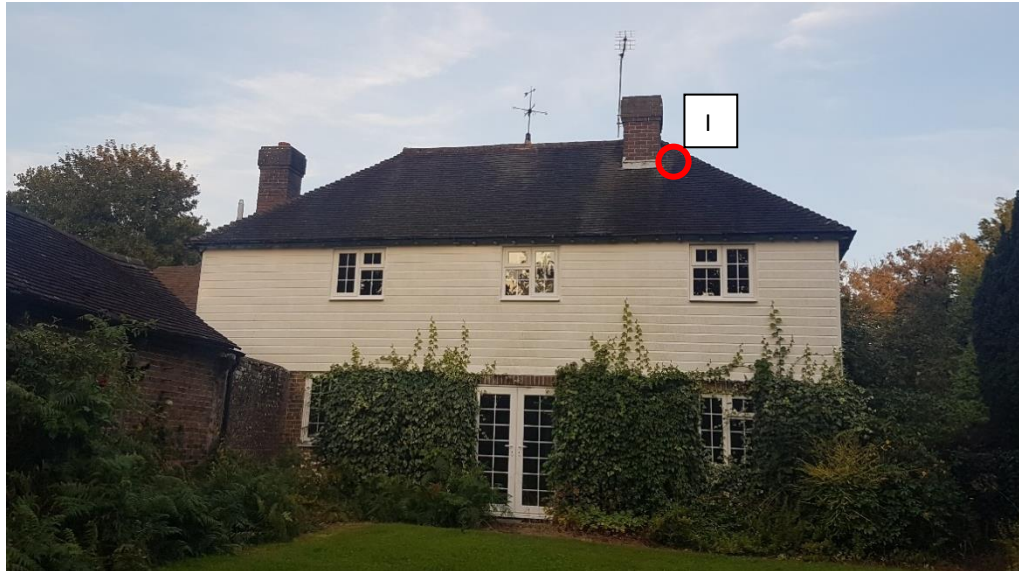
5.3.22 A total of two common pipistrelle bats were recorded emerging from Building B2 during the survey. One common pipistrelle emerged from a roof tile beneath the chimney on the western elevation at 20:06hrs (Emergence Point I), 15 minutes after sunset (Image 5).

*Image 5 – The emergence point of 2 x common pipistrelle from a roof tile next to the chimney on the western elevation of Building B2*

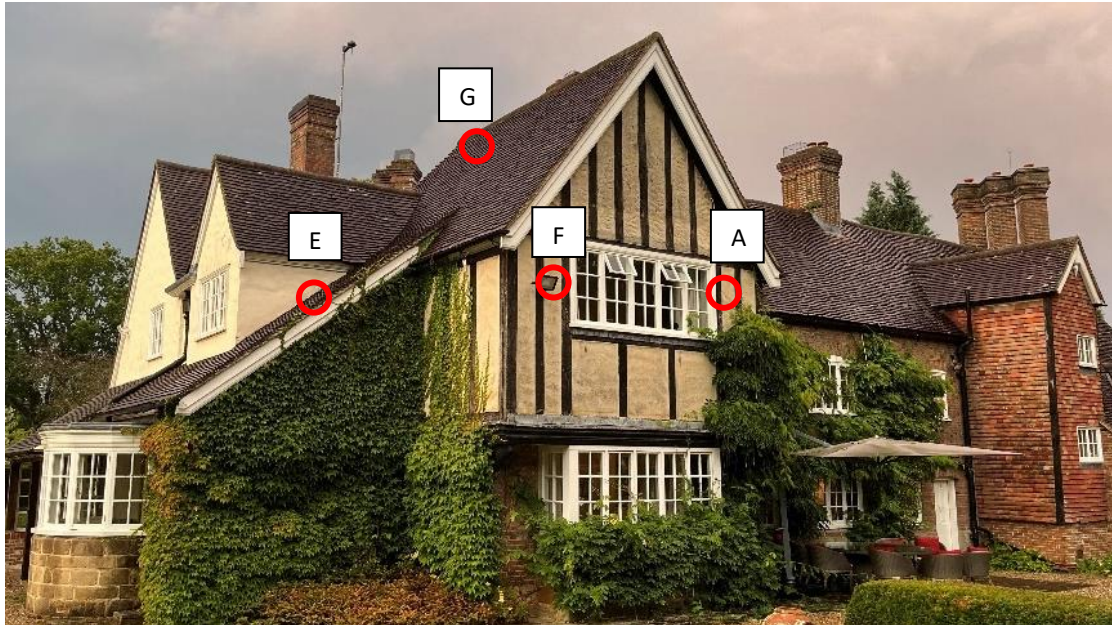
- 5.3.29 A brown long-eared bat emerged from beneath a roof tile on the western elevation (Emergence Point G) at 20:00hrs, 40 minutes after sunset (Image 6).

*Image 6 – The emergence points of 1 x soprano pipistrelle (Emergence Point A), 1 x non-echolocating suspected *Pipistrellus* sp. (Emergence Point F), 1 x common pipistrelle from the western elevation (on 22.08.24) Emergence Point E, and, 1 x brown long-eared bat (Emergence Point G) on the western elevation of the north-south ridge on Building B1*

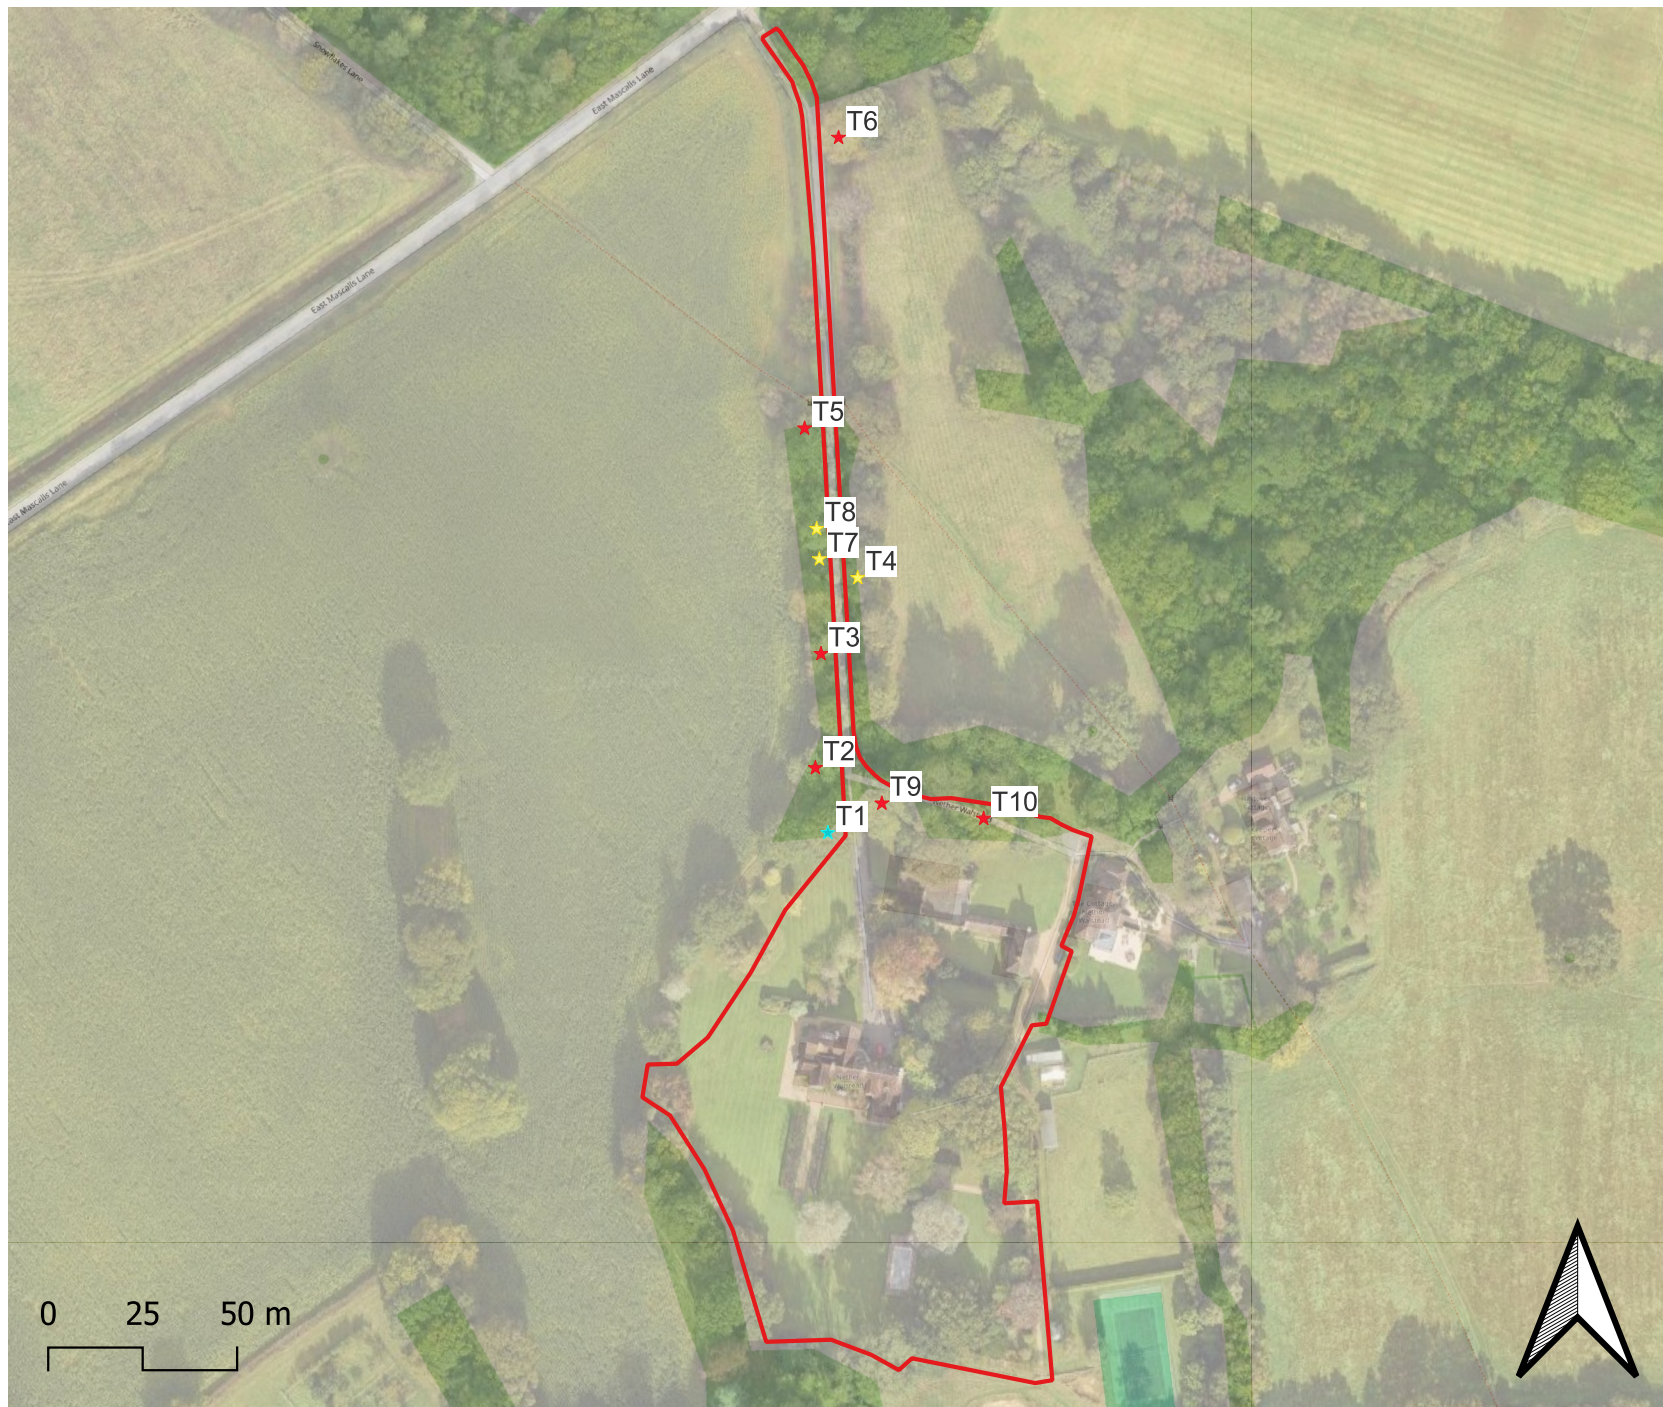
# J24-021567\_P2 Nether Walstead | Figure 3: Trees with suitability for Roosting Bats

| Tree Ref | Species | PRFs | Level of Suitability |
|---|---|---|---|
| T2 | Sweet chestnut | Knot hole 5m up the trunk, south-facing.<br>Dead limb with rot holes and splits 5m high, north-facing. | PRF-M |
| T3 | Oak | Dead tree with multiple splits/rot holes in the limbs between 10-15m high. | PRF-M |
| T4 | Yew | Large specimen with multiple densely-packed trunks and criss-crossing branches, starting around 5m high. | PRF-I |

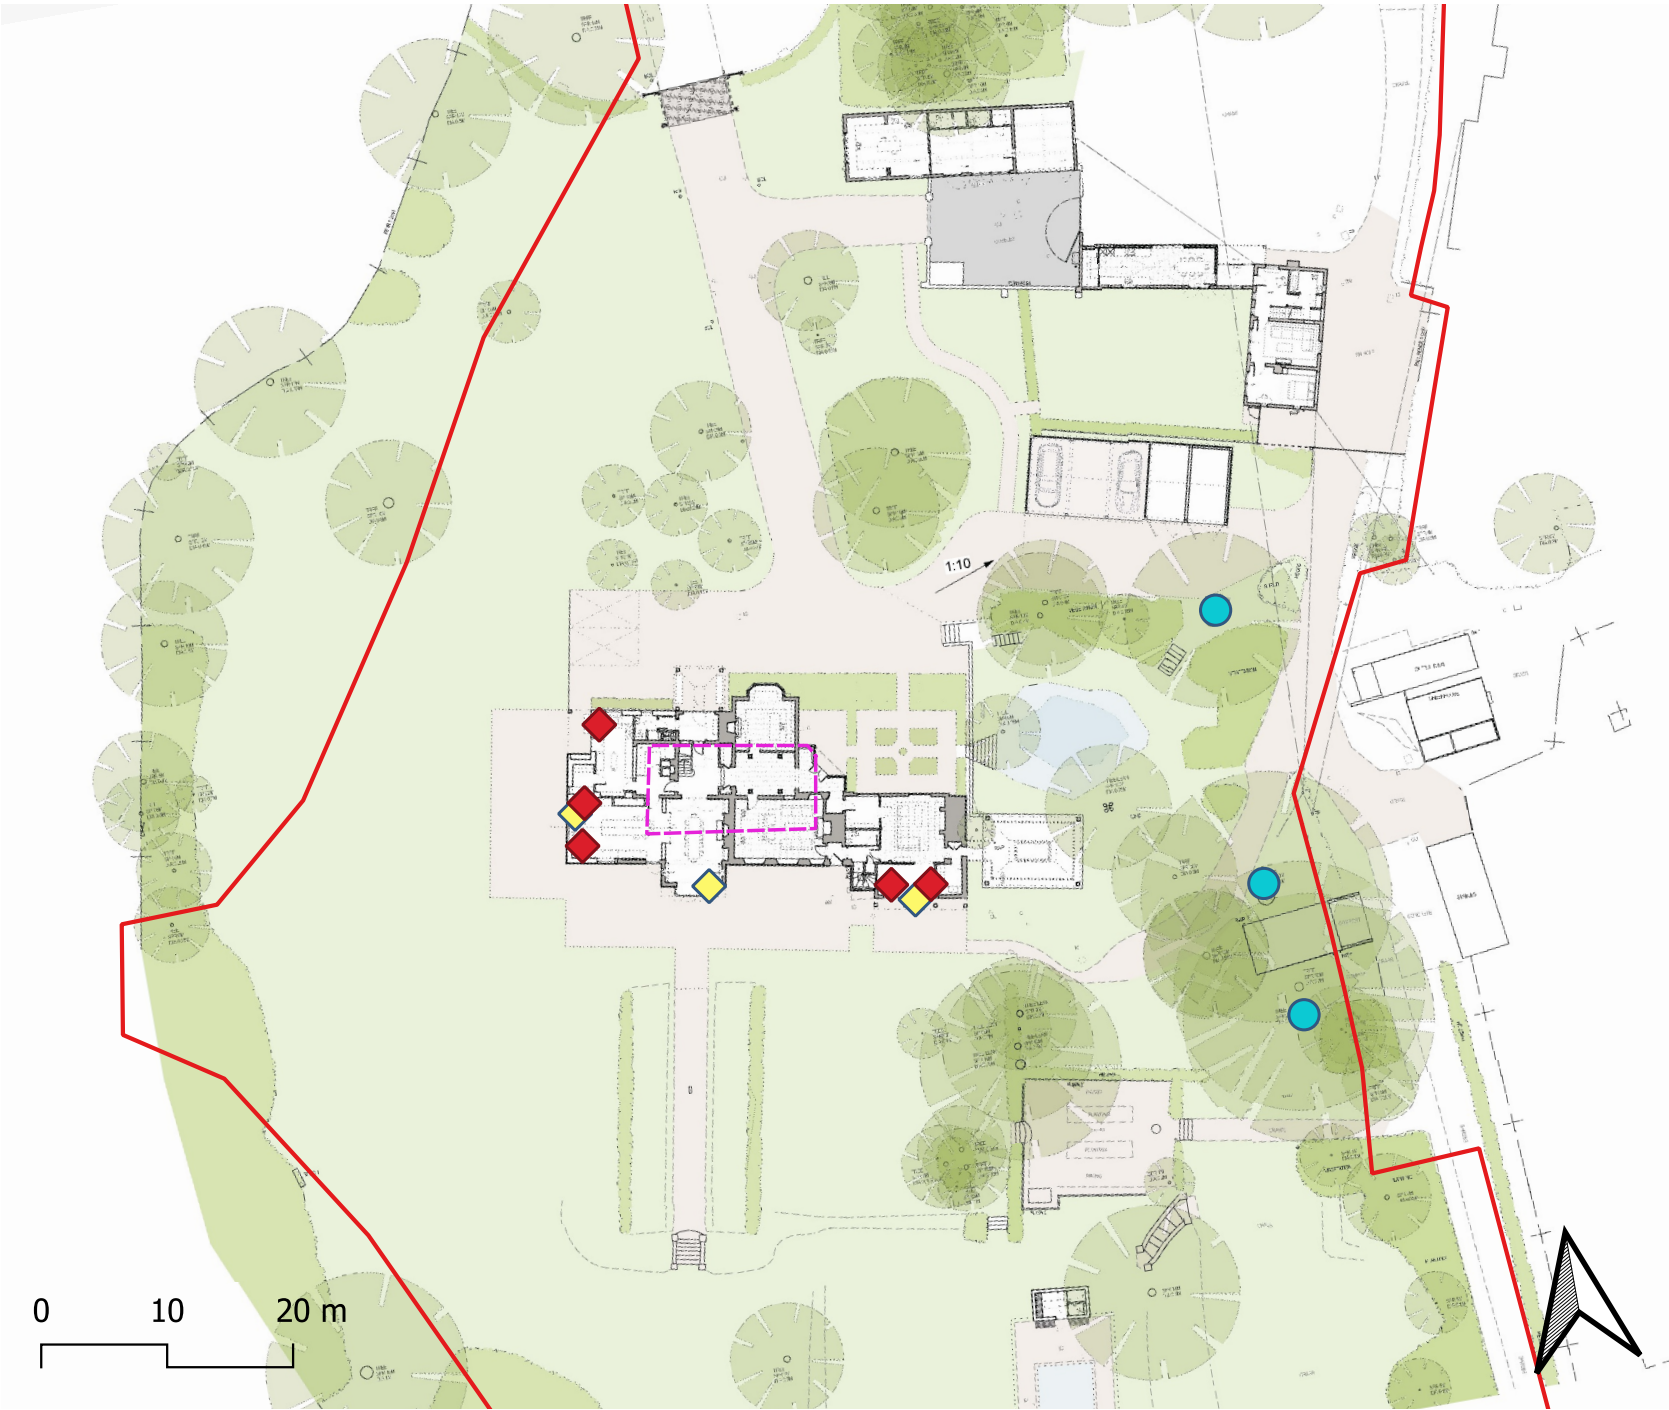
- Bat tiles
- Retained bat loft
- Integrated bat box
- Tree-mounted bat box

- To ensure continuity of roost sites for bats within the Site during works (and to provide a suitable roost location for any bats found during works to be relocated to), three bat boxes (one per species) will be installed on suitable trees within the Client's land ownership prior to the start of works; it is recommended that 1 x [Schwegler 2FN bat box](#) (or similar), 1 x [Schwegler 1FF bat box](#) (or similar) and 1 x [Schwegler 2FS \(Maternity\) bat box](#) (or similar) . Although multiple locations are available, and appropriate locations have been illustrated on Figure 6, the exact locations and orientations of the boxes will be identified on-site by the ECoW.

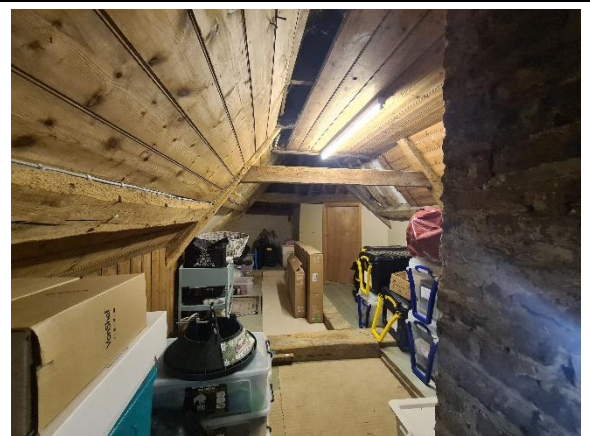
Plate 6. Internal aspect of Building B1's main loft void

- 5.3.5 Internally, there are two loft voids: a large main loft void and another lower loft void in the single-storey extension at the rear (south-east section) of the house. The roof lining comprises modern breathable roof membrane (BRM), with rock wool insulation present at floor level. Internal roosting features include a ridge board and rafters. One brown long-eared bat *Plecotus auritus* was observed roosting in the main loft (the approximate location is depicted on Figure 2), with c. 30 bat droppings scattered throughout the loft, as well as c. 15 droppings observed in the lower loft, which were also characteristic of bats. One dropping sample from each loft was collected and sent for DNA analysis. Building B1, therefore, supports a 'Confirmed Bat Roost' and has 'High' suitability for additional bat roosts.

- To avoid entanglement, Natural England do not approve licence applications in which the design includes the use of modern breathable roofing membrane (BRM) liners. Although it looks like the existing roof underlining within the building comprises modern BRM, any new roof lining in the extensions, or any replacement lining, will be achieved using either traditional Type 1F bitumastic felt or TLX Bat Safe membrane if felt not possible.

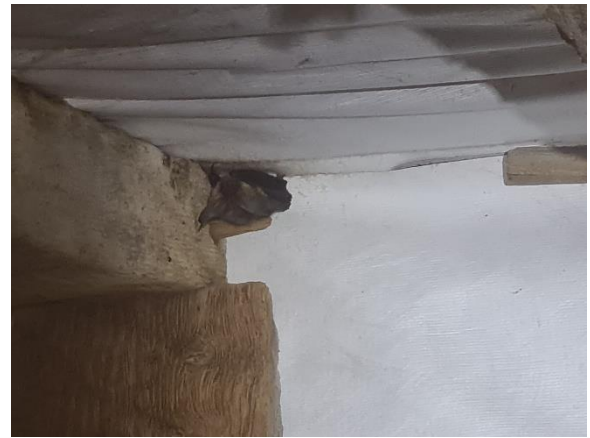
Plate 8. Brown long-eared bat roosting in main loft void

- 5.3.10 DNA analysis of the droppings collected inside the main loft void of building B1 confirmed them as being from brown long eared bats. However, the droppings found in the lower loft void were from pygmy shrew *Sorex minutus* and yellow-necked mouse *Apodemus flavicollis*.

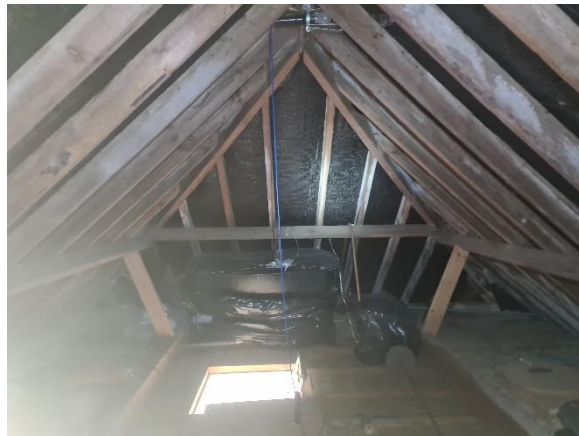
Plate 13. Internal aspect of Building B2's loft void

- 5.3.7 Internally there is a loft void. The roof lining comprises traditional felt, with rock wool insulation present on the floor. Internal roosting features include a ridge board, rafters, brick chimney breast, and lots of access at the eaves. No droppings indicative of bats were observed. Building B2 is considered to have 'High' roosting potential.

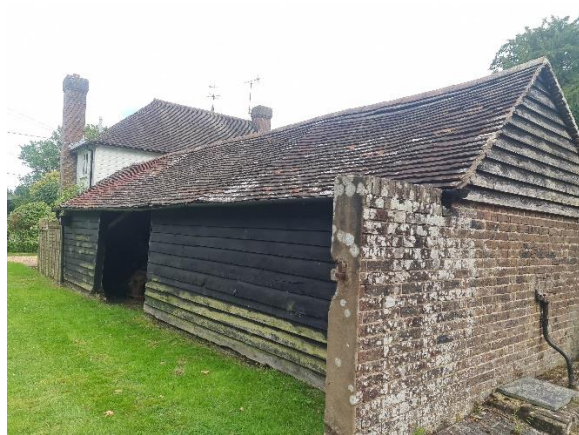
Plate 15. Outbuilding B3 – north-west aspect

- 5.3.8 The outbuilding (B3; Plates 15-16, Appendix A), used as a log store, is a single-storey barn constructed of single-skinned timber weatherboard walls, and with a pitched clay tiled roof. The roof is unlined and the building is open on the north-east aspect. Although there is a ridge beam present and rafters potentially with small gaps in joints and between wall boards and posts, the bat roost suitability of the building is deemed to be 'Moderate', due to the unstable environmental conditions and lack of a roof lining within this uninsulated building. No evidence of roosting bats was found.

5.3.46 An old barn owl *Tyto alba* nest box was present at the eastern end of the outbuilding/log store (building B3), but there were no pellets or any other signs of barn owl use present. A disused bird's nest was also observed inside building B4.

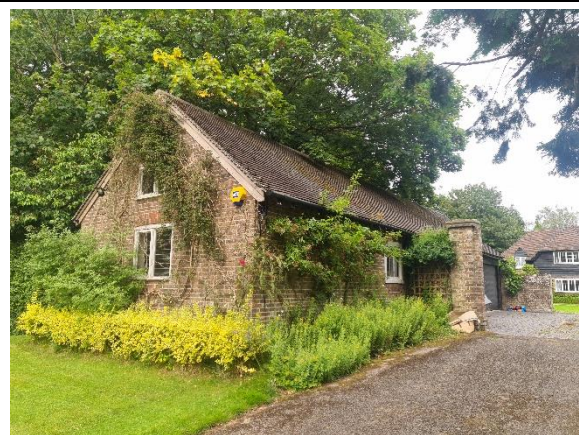
Plate 17. Barn B4 – south-west aspect

- 5.3.9 The barn (B4; Plates 17-18, Appendix A) is a large single-storey building of brick-built construction, with pitched clay tiled roof. Internally it is lined with timber sarking. The potential roosting features are confined to between the roof tiles and the timber lining. The bat roost suitability is considered to be 'Moderate'. No evidence of roosting bats was found.
